CENSEE EVENT REPORT

SERIAL: RSEP/79-1133

SUPPLEMENTAL INFORMATION
FOR
LICENSEE EVENT REPORT 79-26 REV. 1

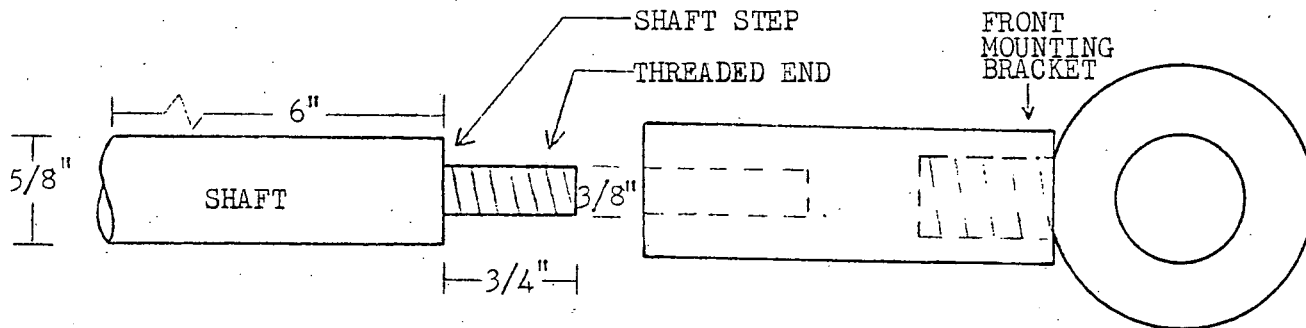
POSITION PRIOR TO FAILURE

Following the failure, it was noticed that the snubber's front mounting piece had not been threaded fully onto the front end of the shaft (see attached drawing). This resulted in the threaded end being subjected to loads much higher than normal. Angular loads are generated at the time of compression lockup due to the inherent flexibility of the 5/8 inch diameter, 6 inch stroke shaft. If the front mounting bracket had been seated against the shaft step, the threaded end would not have been exposed to these loads. Thus, the rigidity and strength of the shaft as a whole would have been enhanced to the extent that the failure probably would not have occurred.

Since the threaded end is exposed, it must act as a load supporting part of the shaft. Due to its smaller diameter it is much more vulnerable to failure than the shaft when exposed to angular loading.

Precautionary instructions will be added to both the functional test procedure and the reinstallation instructions to ensure that the front mounting bracket is seated against the shaft step. This action should eliminate further occurrences during either testing or while the snubber is in service.
