U. S. NUCLEAR REGULATORY COMMISSION

AUGMENTED INSPECTION TEAM (AIT) INSPECTION

Report Nos.: 50-261/93-34

Facility Name: H. B. ROBINSON UNIT 2

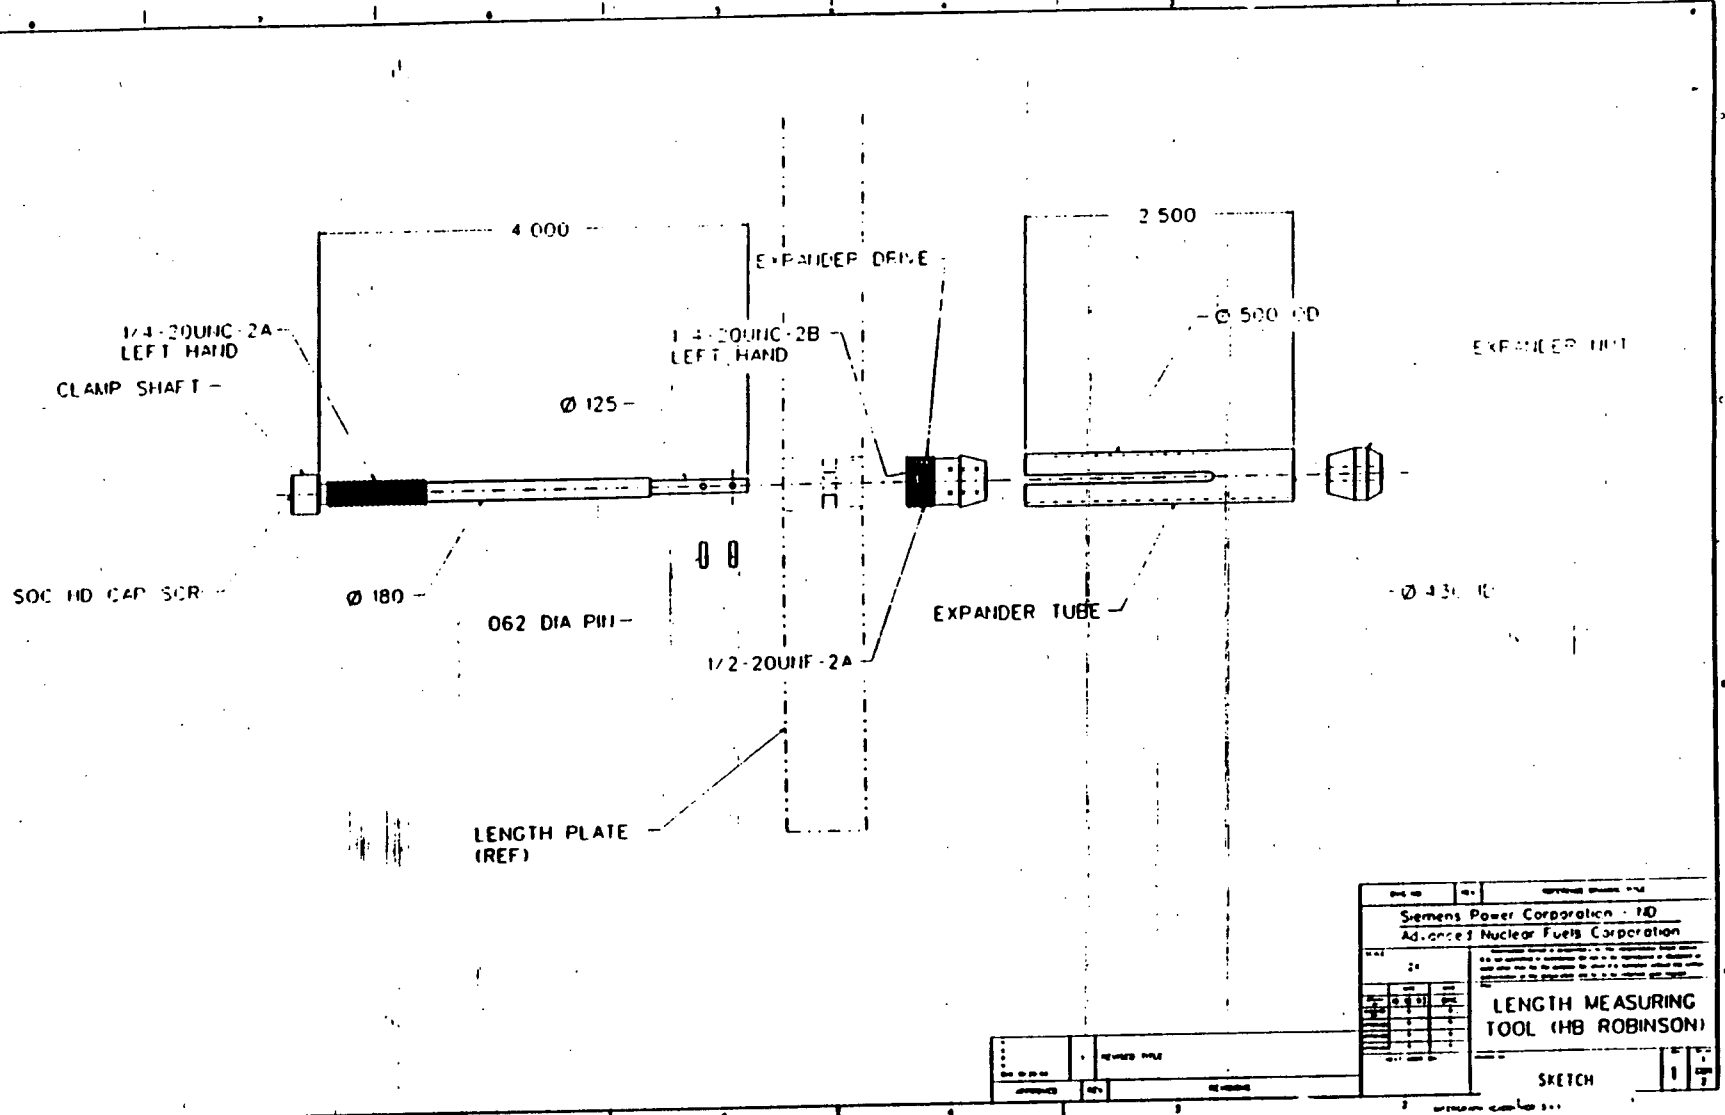
FIGURE Y

3. The plant operated with fuel having mis-positioned burnable poison. This did not result in fuel damage, but damage could have occurred if the plant had operated above 30 percent.

GADOLINIUM FUEL ASSEMBLY AS DESIGNED VS AS-BUILT
