**1998 DURITA SITE RECLAMATION  
AND  
CONSTRUCTION VERIFICATION REPORT**

**Hecla Mining Company**  
6500 Mineral Drive  
Coeur d'Alene, Idaho 83812-877

**Monster Engineering, Inc.**  
3031 Bonner Spring Ranch Road  
Laporte, Colorado 80535

November 5, 1998

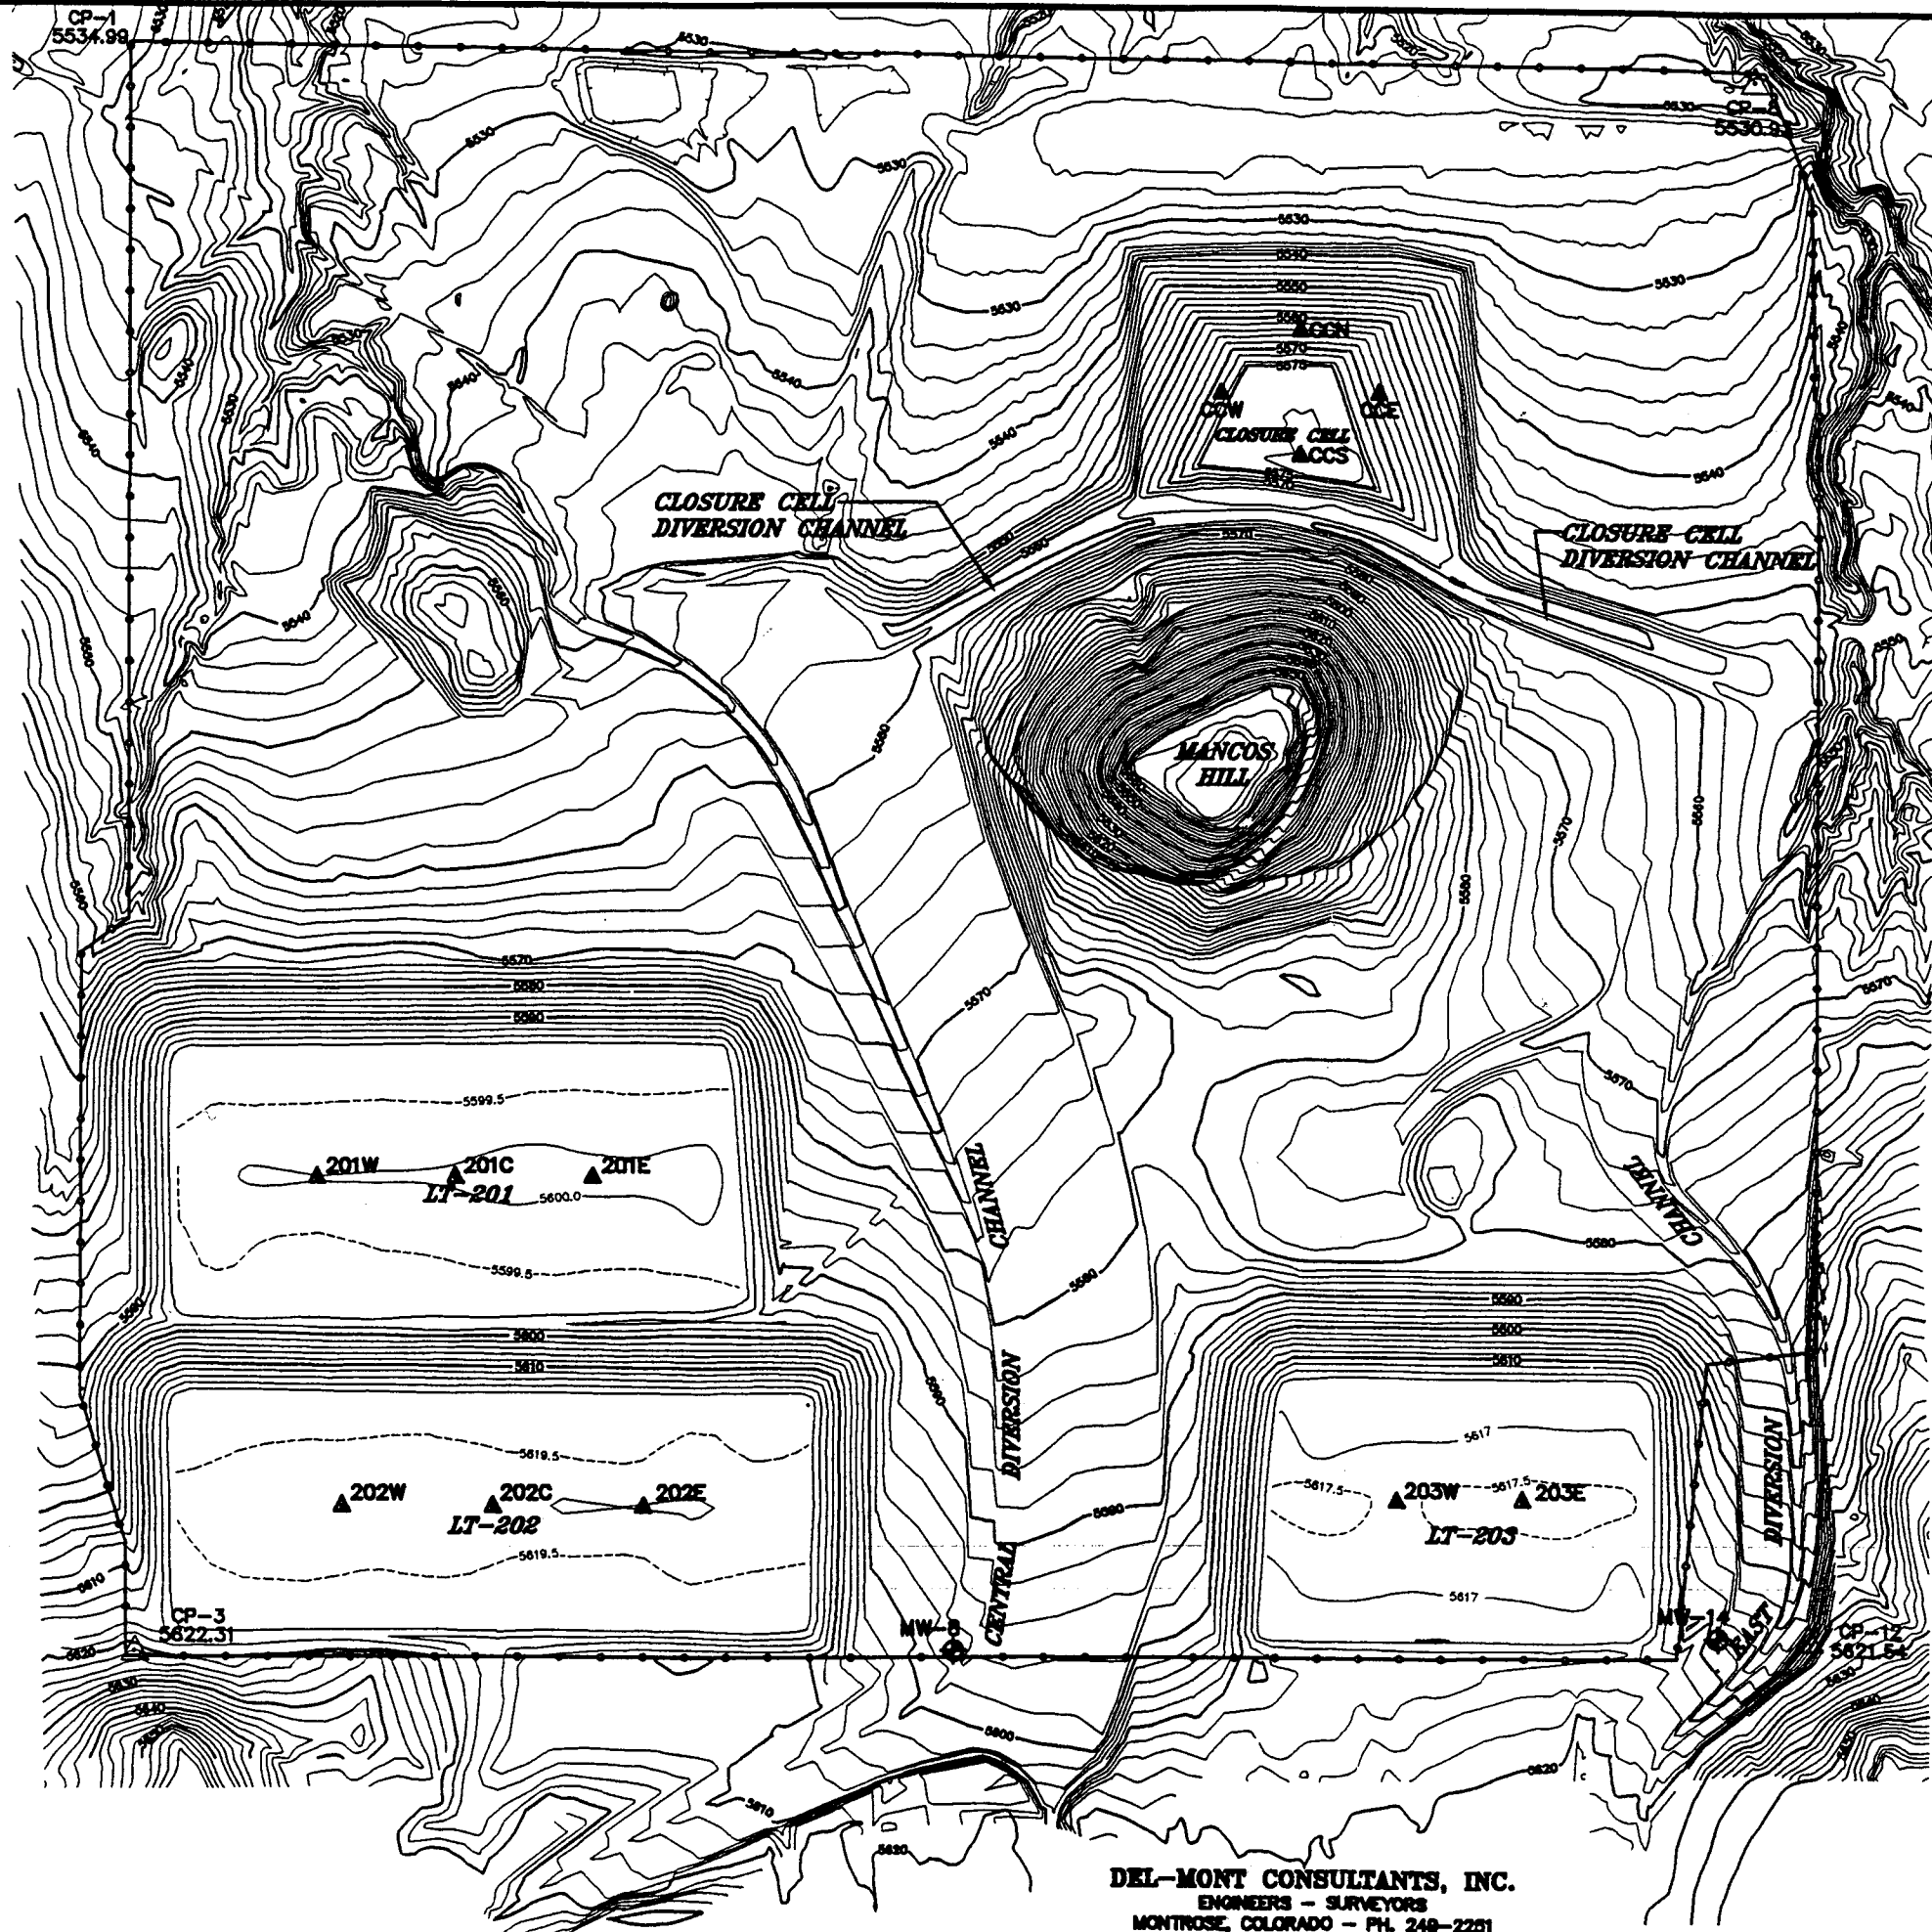
<b>FIGURE 2</b>	
<b>SITE MAP</b>	
<b>1998</b>	
DURITA SITE RECLAMATION	
FOR	
HELCA MINING COMPANY	
DATE: 10/15/98	FILE: 800-28
DRAWN BY: D.L.C.	DN NO: 9828

Figure 2 shows the site layout and each facility as it existed on June 12, 1998, the end of the construction season.

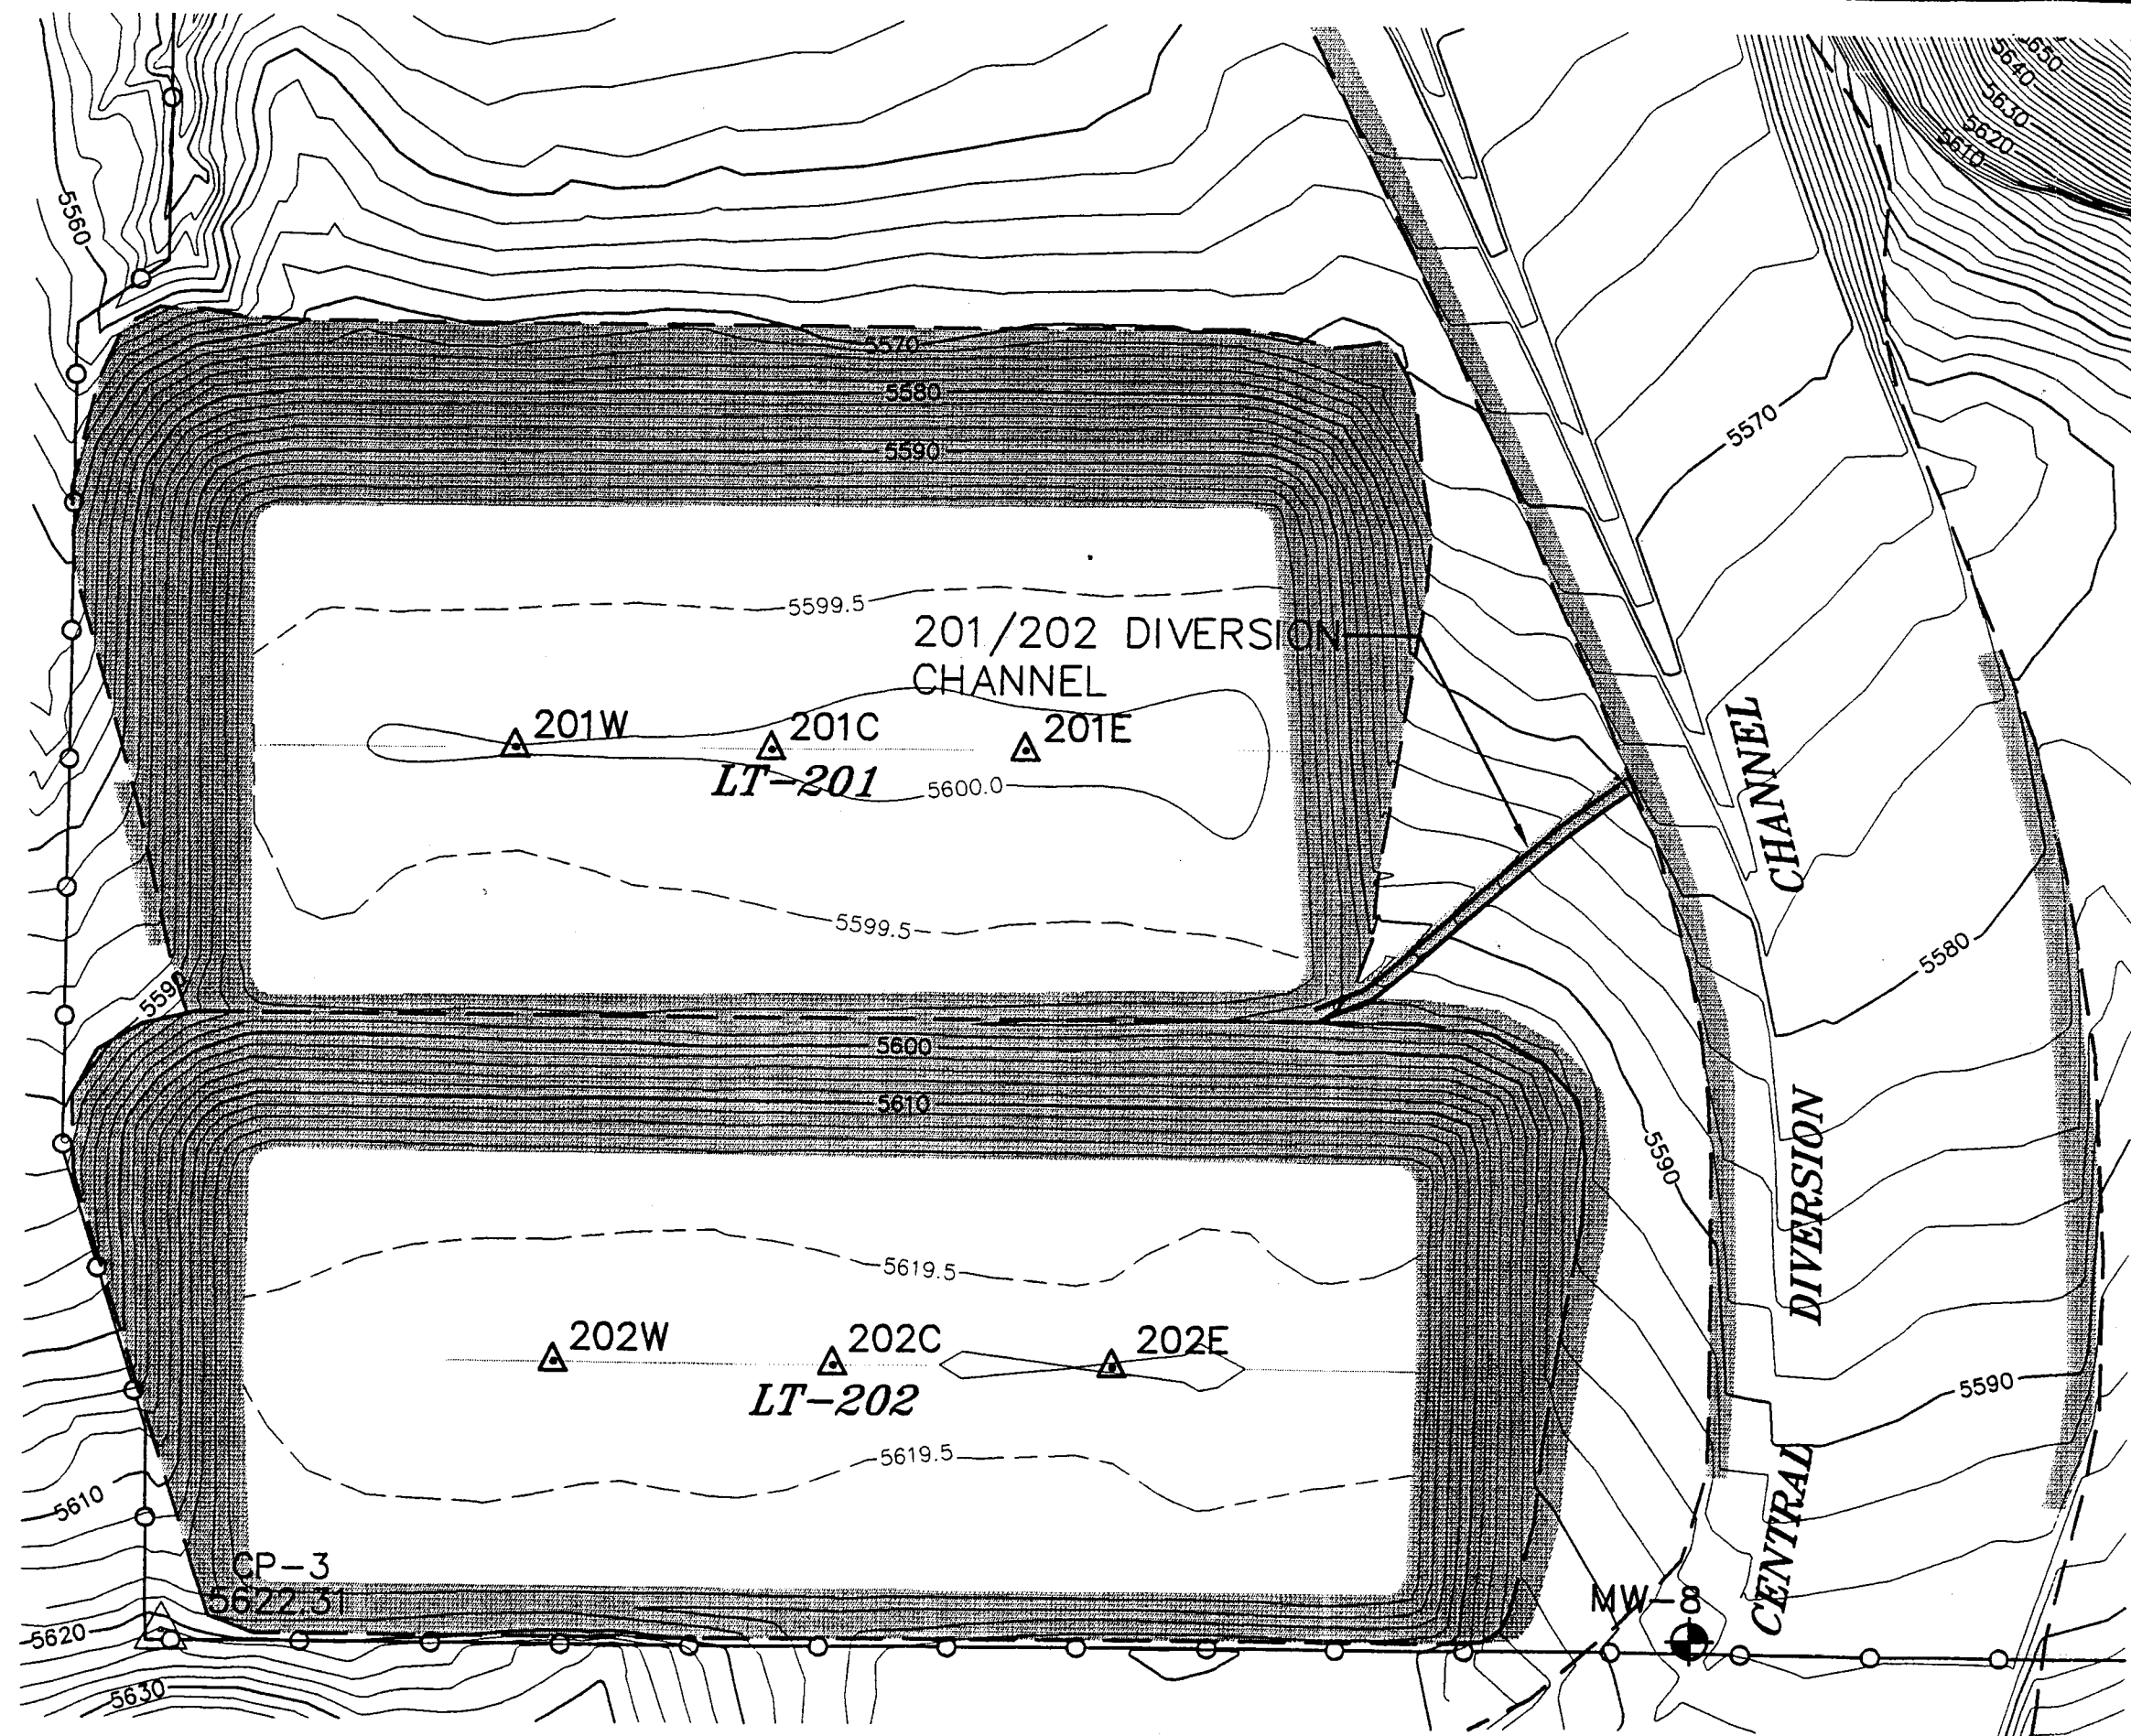
**FIGURE 3**  
**LT-201 / LT-202**  
**EROSION PROTECTION**  
**PLAN VIEW**  
 DURITA SITE RECLAMATION  
 FOR  
**HELCA MINING COMPANY**  
 DATE: 10/24/08 FILE: LTR03R-08  
 DRAWN BY: D.L.C. DW. NO.: 9328-08

The Leach Tank Stabilization Project was completed during 1998. All work was completed according to the specifications, and was verified and checked by Doug Gibbs and Del-Mont. 1998 work consisted of cutting, filling, and finish grading materials already in-place on tops of the three leach tanks. The work was necessary to fill in low areas (prevent ponding and infiltration) and provide for uniform (0.5% slopes), sheet flow off the tops of the tanks (protect against erosion). Reams utilized a laser level and full-time grade setter to ensure uniform slopes. Although the specified slopes were mainly achieved by cutting and filling, LT-202 contained excess cover soils placed during the last part of the 1995 construction season. These soils (less than 1,000 cubic yards) were removed and placed at the east toe of LT-202, between the toe of the leach tank and the Central Diversion. Figures 3 and 4 show the final configurations of all leach tanks as of June 12, 1998.

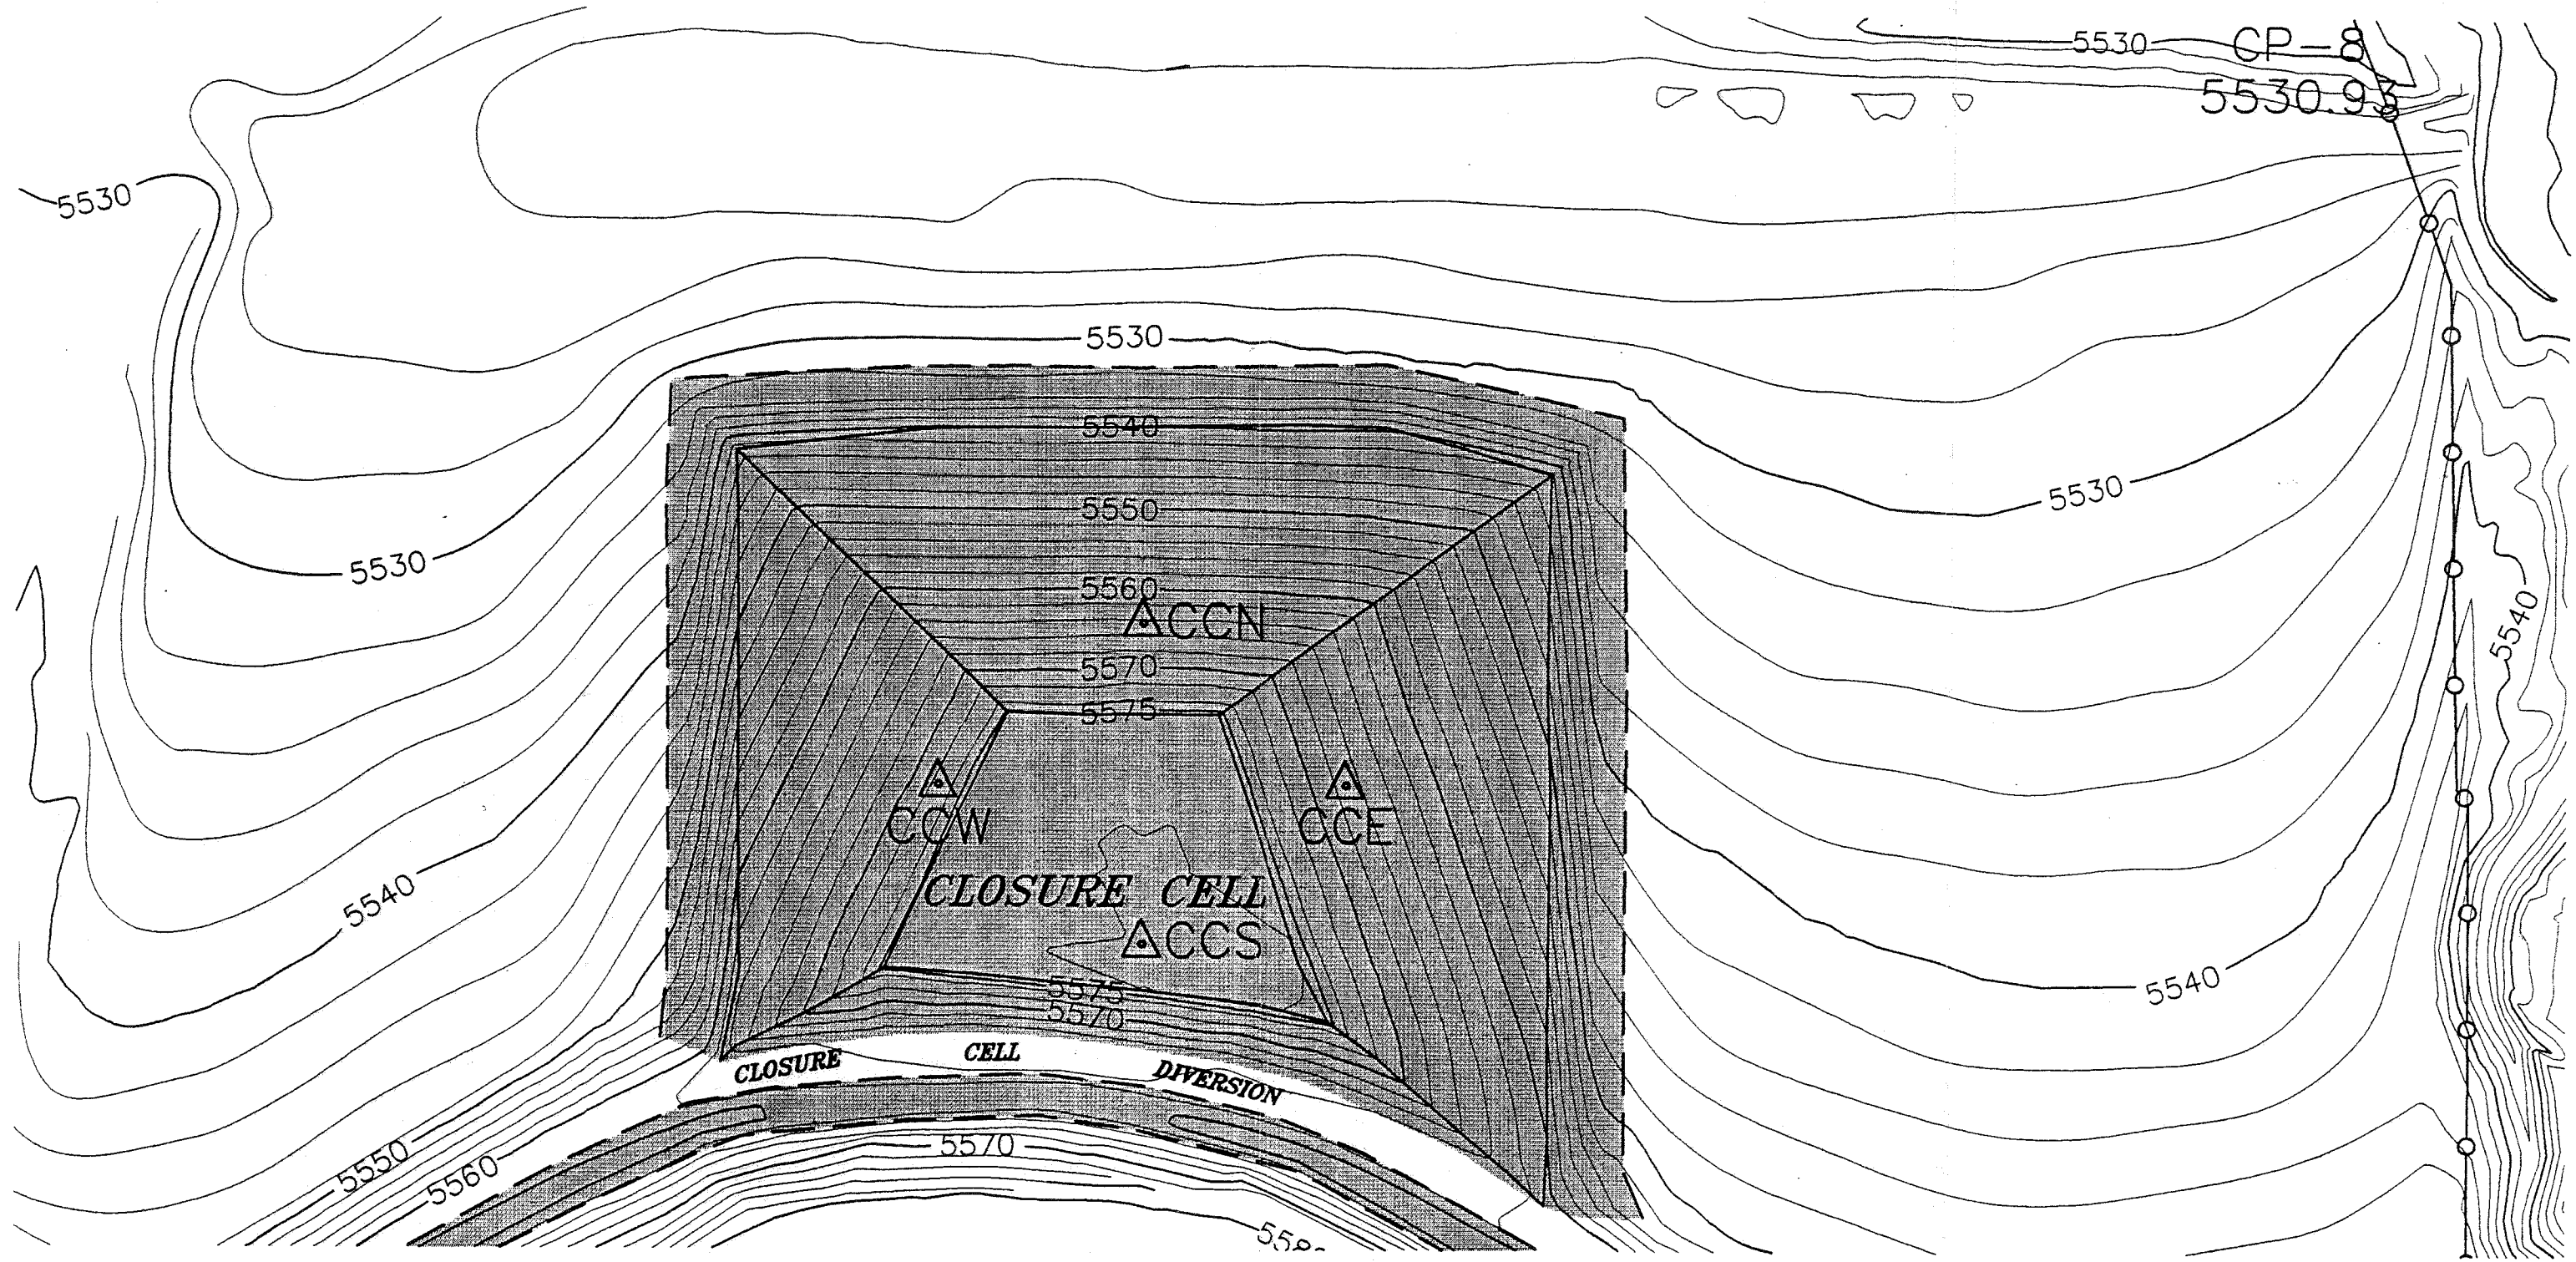
<b>FIGURE 5</b>	
<b>CLOSURE CELL EROSION PROTECTION PLAN VIEW</b>	
DURITA SITE RECLAMATION	
FOR HELCA MINING COMPANY	
DATE: 10/28/88	FILE: 00R00R-08
DRAWN BY: D.L.G.	DM NO.: 0022-08

- ▶ **Closure Cell Scour Protection** - A minimum of 12 inches of scour protection rock was placed along the Cell's west, north, and east outslope toes. Figure 5 shows a plan view of the completed facility and Figure 6 shows a cross section of the north side riprap and scour protection.

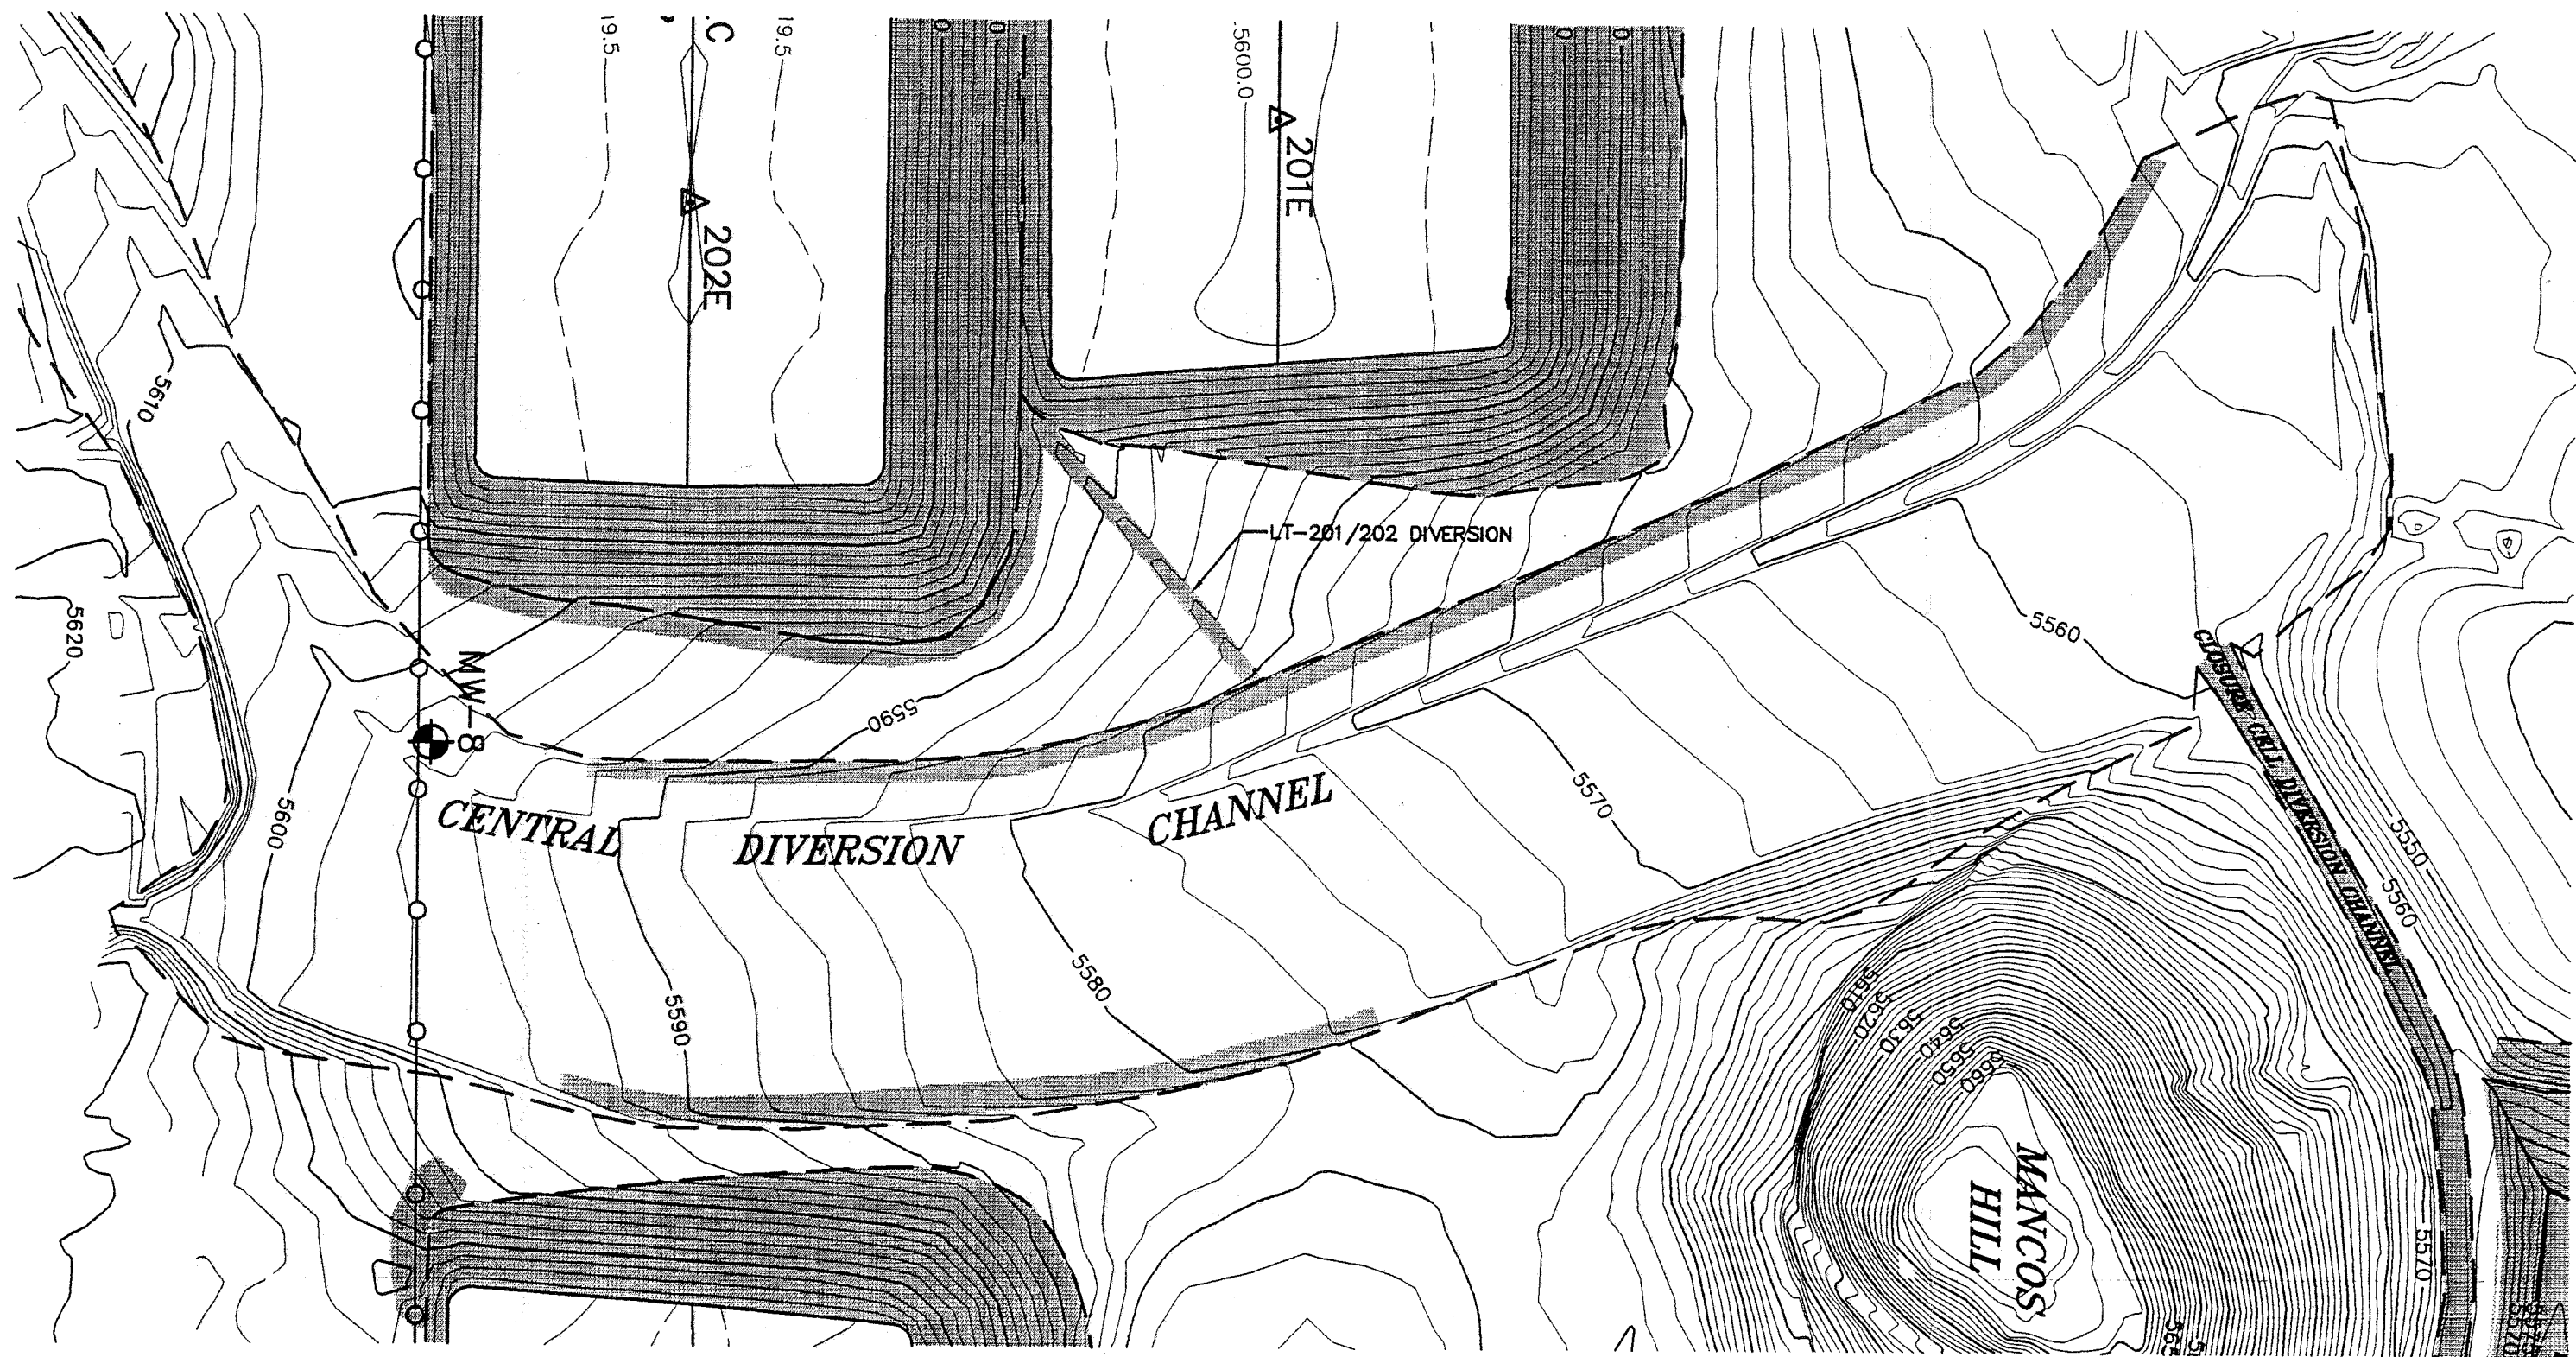
<b>FIGURE 8</b>	
<b>CENTRAL DIVERSION EROSION PROTECTION PLAN VIEW</b>	
DURITA SITE RECLAMATION	
FOR HELCA MINING COMPANY	
DATE: 10/28/04	FILE: 850600-04
DRAWN BY: D.L.C.	DM NO.: 9528-04

- ▶ **Main Diversion Riprap and Scour Protection** - Riprap and scour protection rock sizing varies based on location (station) within each of the diversions. In general, rock size decreases with increasing stationing (going downstream), as the width of the diversions increases, and as the slope decreases. Figure 7 shows a cross-section of in-place riprap and scour protection along the Central Diversion. Figures 8 and 9 show plan views of both the Central and East Diversions. Areas where riprap and scour protection were placed are identified on these two figures.
