2014 Annual Site Inspection and Monitoring Report for Uranium Mill Tailings Radiation Control Act Title II Disposal Sites

November 2014

Bluewater, New Mexico,
Disposal Site, 2014

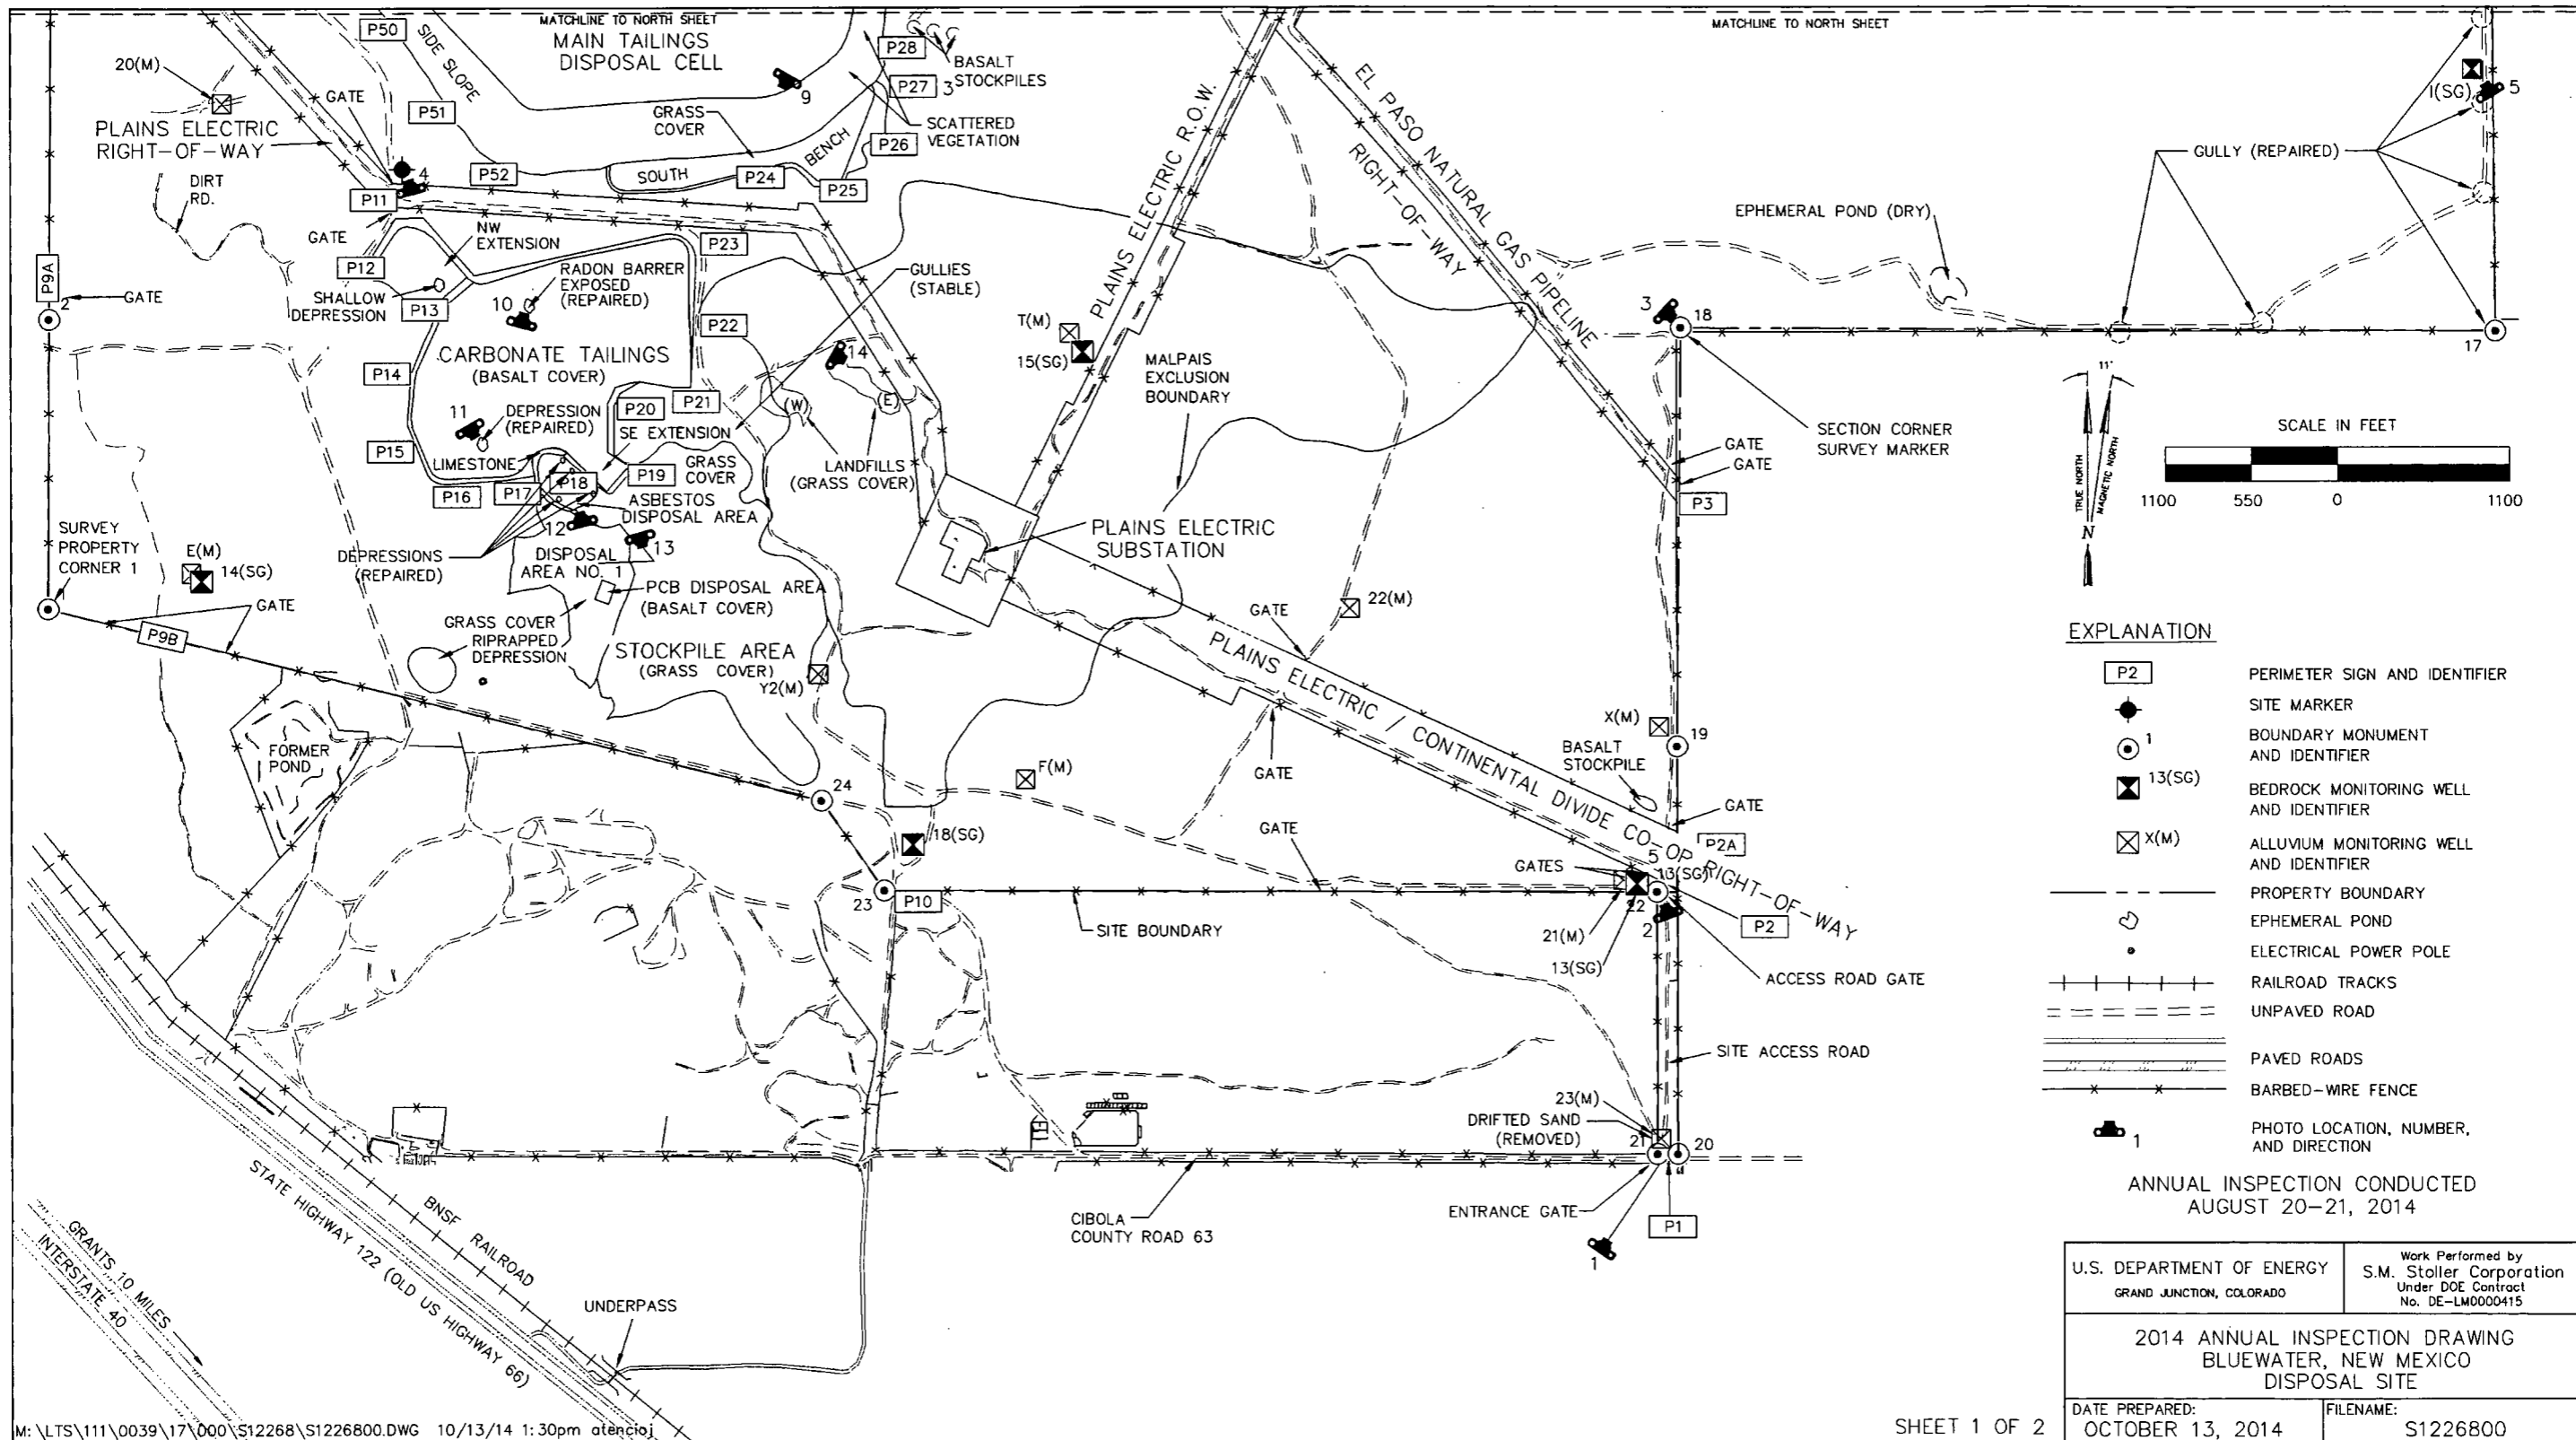
Figure 1-1. 2014 Annual Inspection Drawing for the Bluewater, New Mexico, Disposal Site (South Area)

Interior tertiary roads used to access DOE assets consist of a dirt track covered at places with crushed basalt. The roads are susceptible to erosion, and are repaired when they become impassable. Several locations were damaged from precipitation runoff and difficult to cross.

Fifty-five warning signs, referred to as perimeter signs, are mounted on steel posts along the site boundary and around the main and carbonate tailings disposal cells. Perimeter signs P3 and P10 have gunshot damage but are still legible. All other observed signs were in good condition (PL-2).

Twenty-four boundary monuments define the site boundary. These monuments are typically inside the perimeter fence and several feet inside the true corner or boundary line. The boundary monuments observed during the inspection were in good condition (PL-3). Some monuments tend to get covered by drifting sand, and metal t-posts have been driven at those locations to help inspectors find them.

1A These locations were repaired in September 2014.

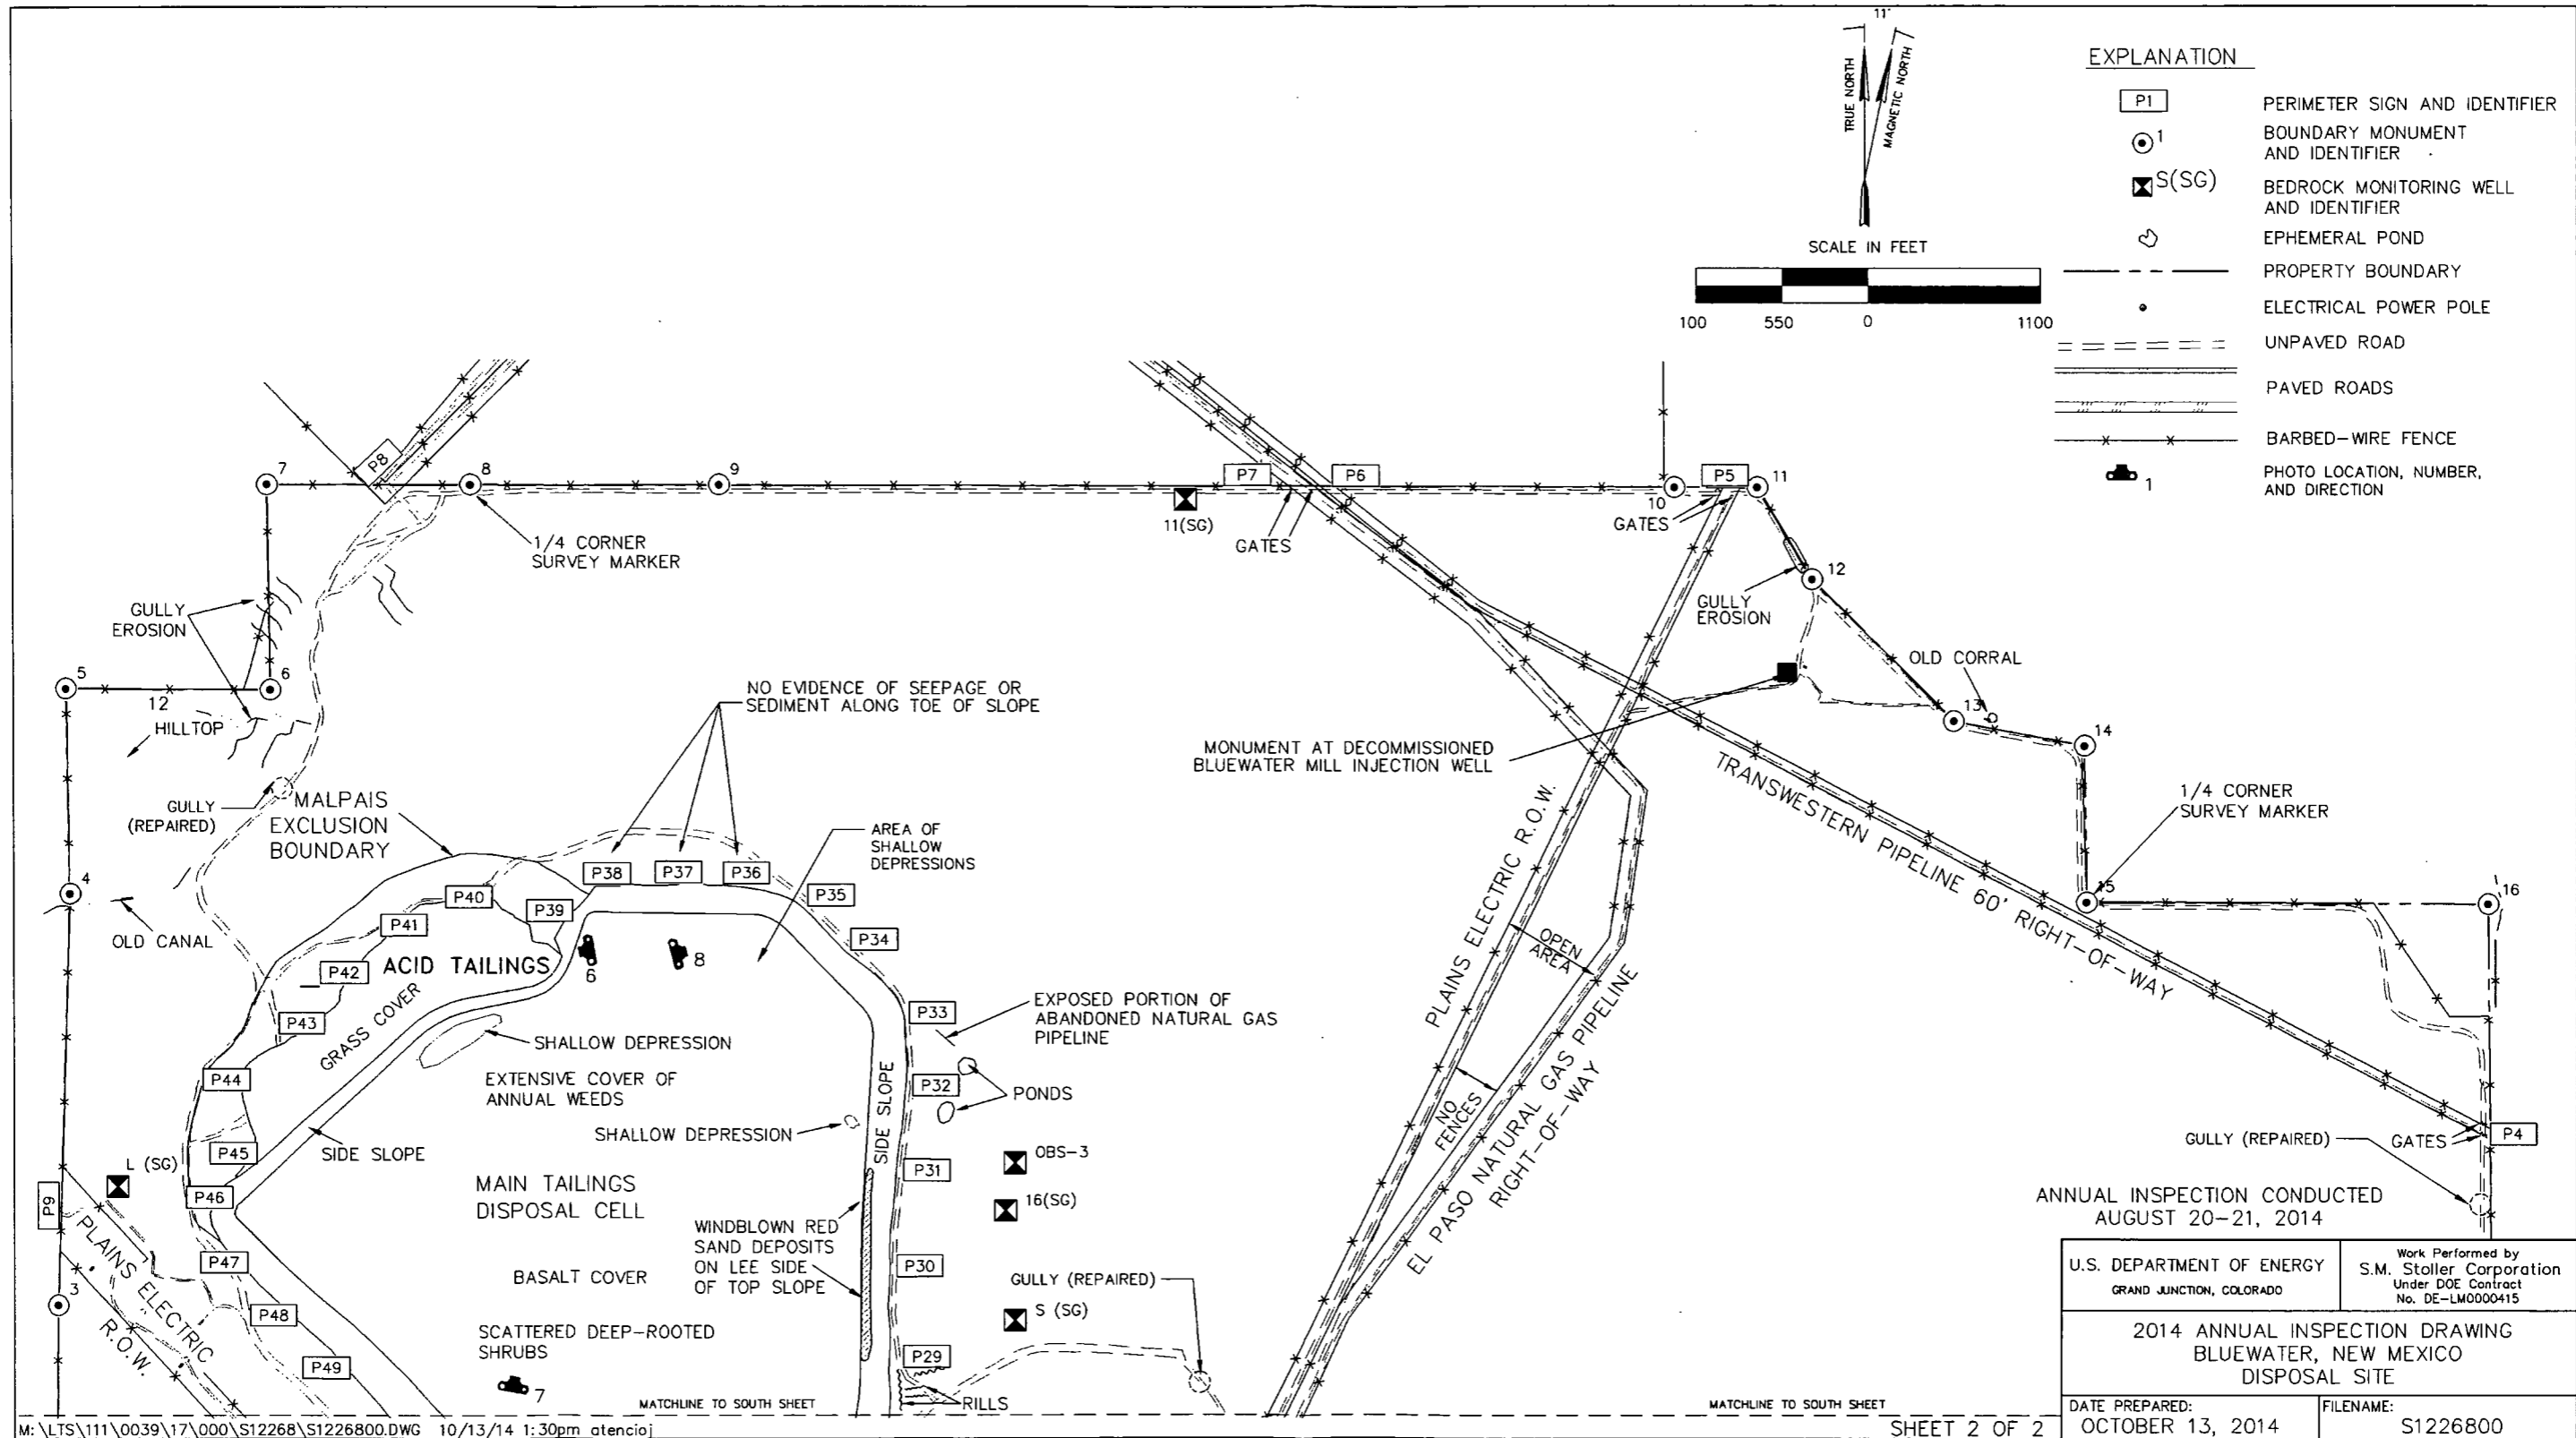
Figure 1-2. 2014 Annual Inspection Drawing for the Bluewater, New Mexico, Disposal Site (North Area)

Plant encroachment (annual weeds, perennial grasses and forbs, and scattered perennial shrubs) continues on the cell cover and side slopes (PL-7). Saplings of Siberian elm have been present on the cell cover and are periodically cut and their stumps are treated with herbicide; several saplings were observed during the inspection and were treated with herbicide.

Several shallow depressions exist on the relatively flat north end of the top slope of the main tailings disposal cell and along the east and northwest edges of the cover. Ponds often develop in the depressions after rainfall events, and some of the depressions had standing water at the time of the inspection (PL-8). Because of a concern that the ponds were degrading disposal cell performance, NRC requested DOE to evaluate the performance of the radon barrier. Radon flux measurements on top of the radon barrier in the area of depressions were collected in July 2013. All radon measurements were below the detection limit, indicating that the radon barrier in that portion of the disposal cell is performing as designed. Results of the investigation will be used to determine, in consultation with NRC, if additional monitoring or cover enhancements are necessary.

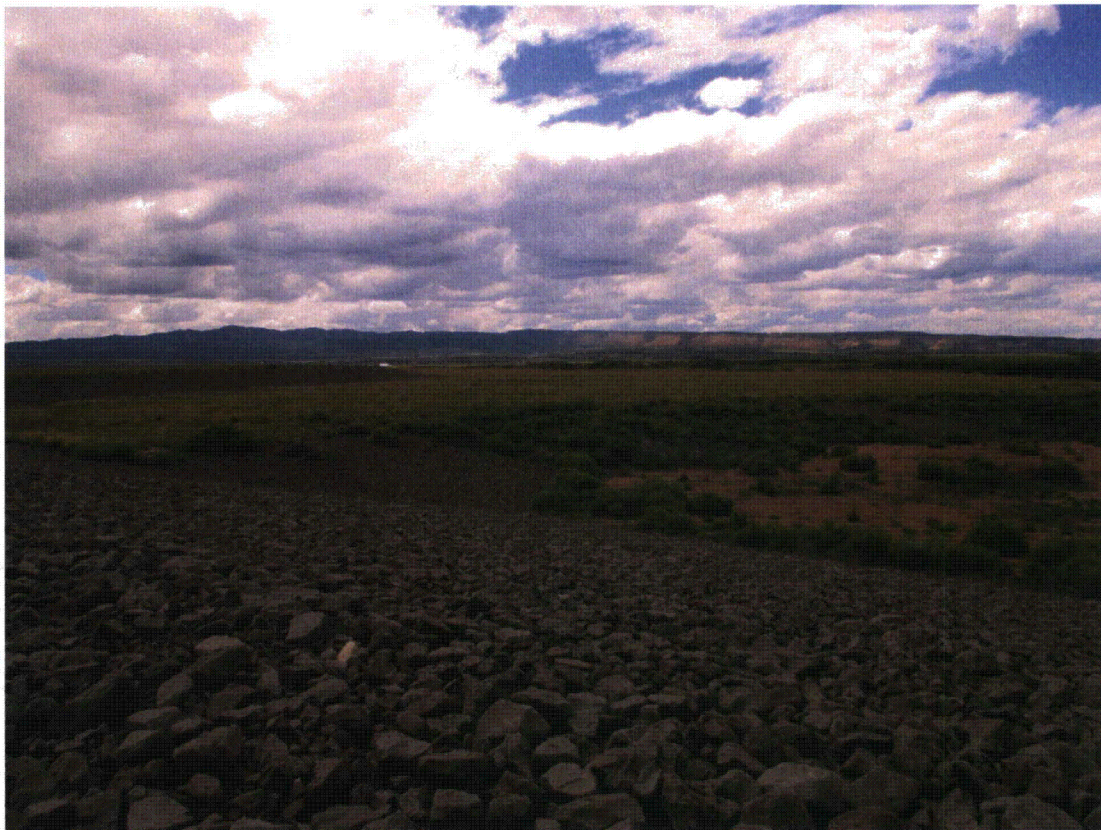
BLU 8/2014. PL-6. Acid tailings disposal area adjacent to main tailings disposal cell.

grade is 3 to 4 percent at the south end and decreases to less than 0.5 percent at the north end. The top slopes of the acid tailings (PL-6) and the south bench disposal areas are essentially flat and covered by healthy grass. Basalt riprap protects the side slopes of the three disposal areas. The riprap was in excellent condition.

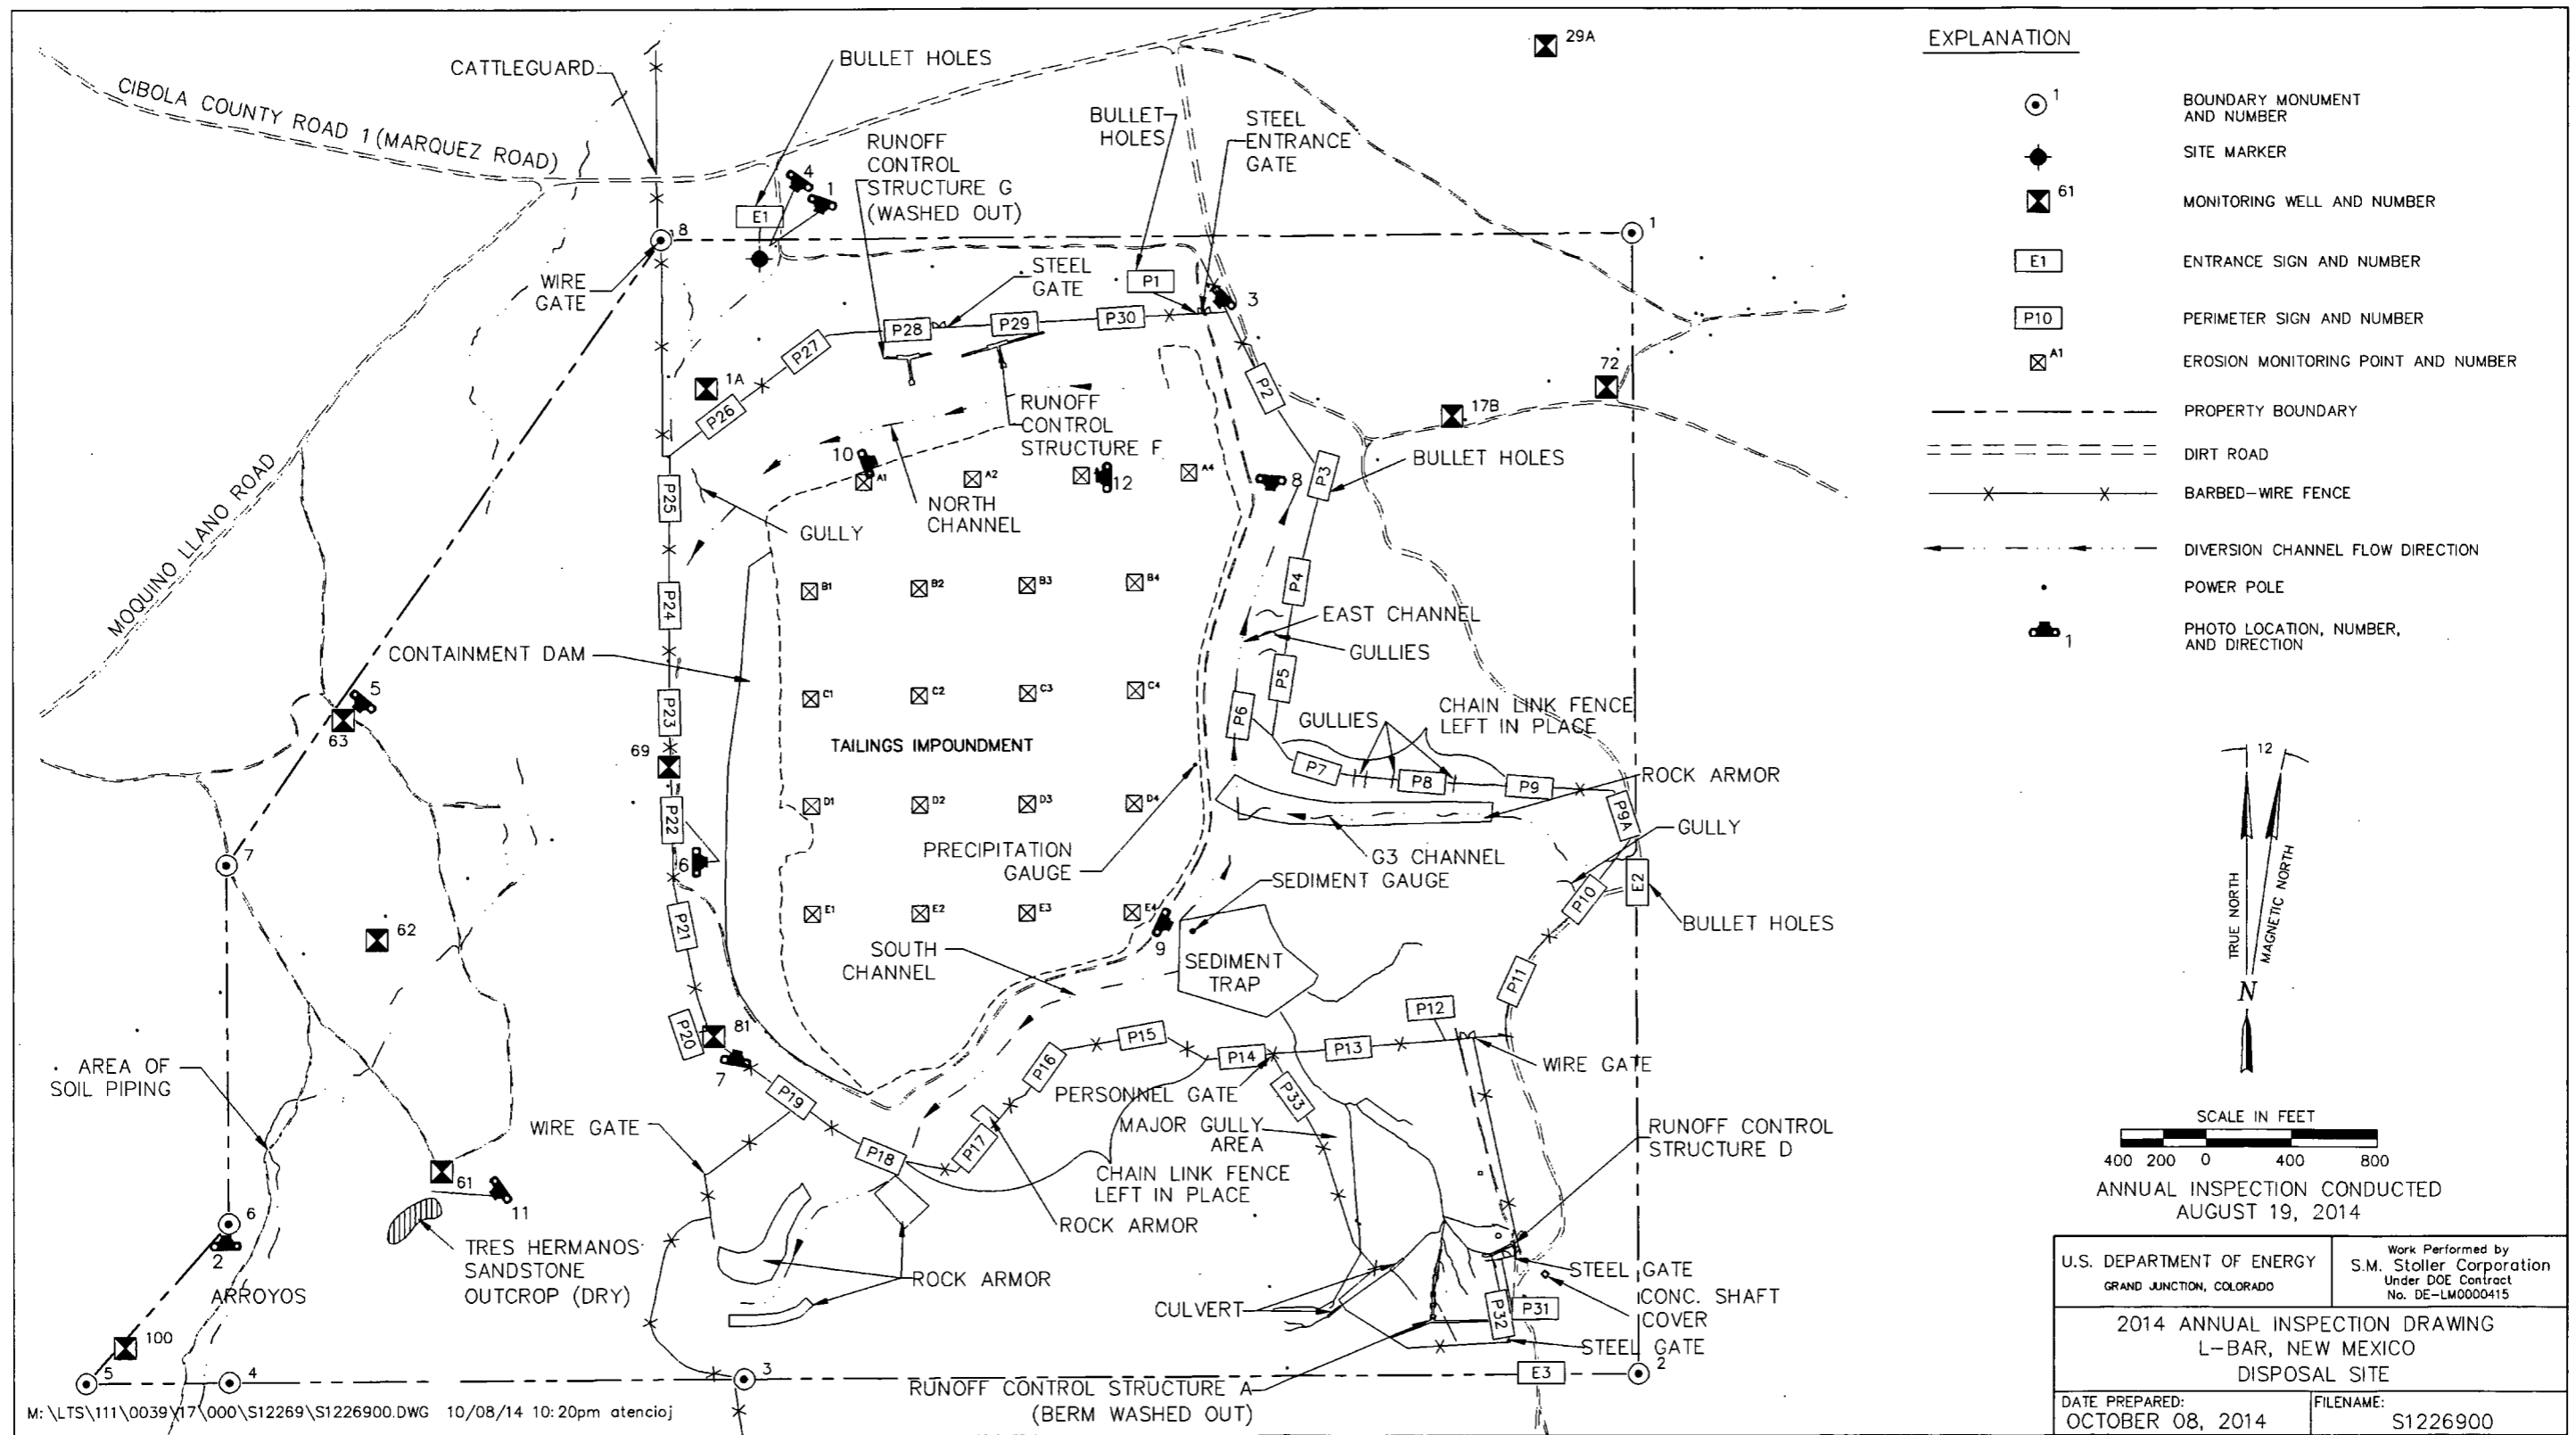
Figure 3-1. 2014 Annual Inspection Drawing for the L-Bar, New Mexico, Disposal Site

In accordance with the EMP, the former licensee installed a grid of 20 evenly spaced monitoring points on the cover in November 2003. These points are shown on Figure 3-1. The locations were initially measured in December 2003 to establish a baseline data set.

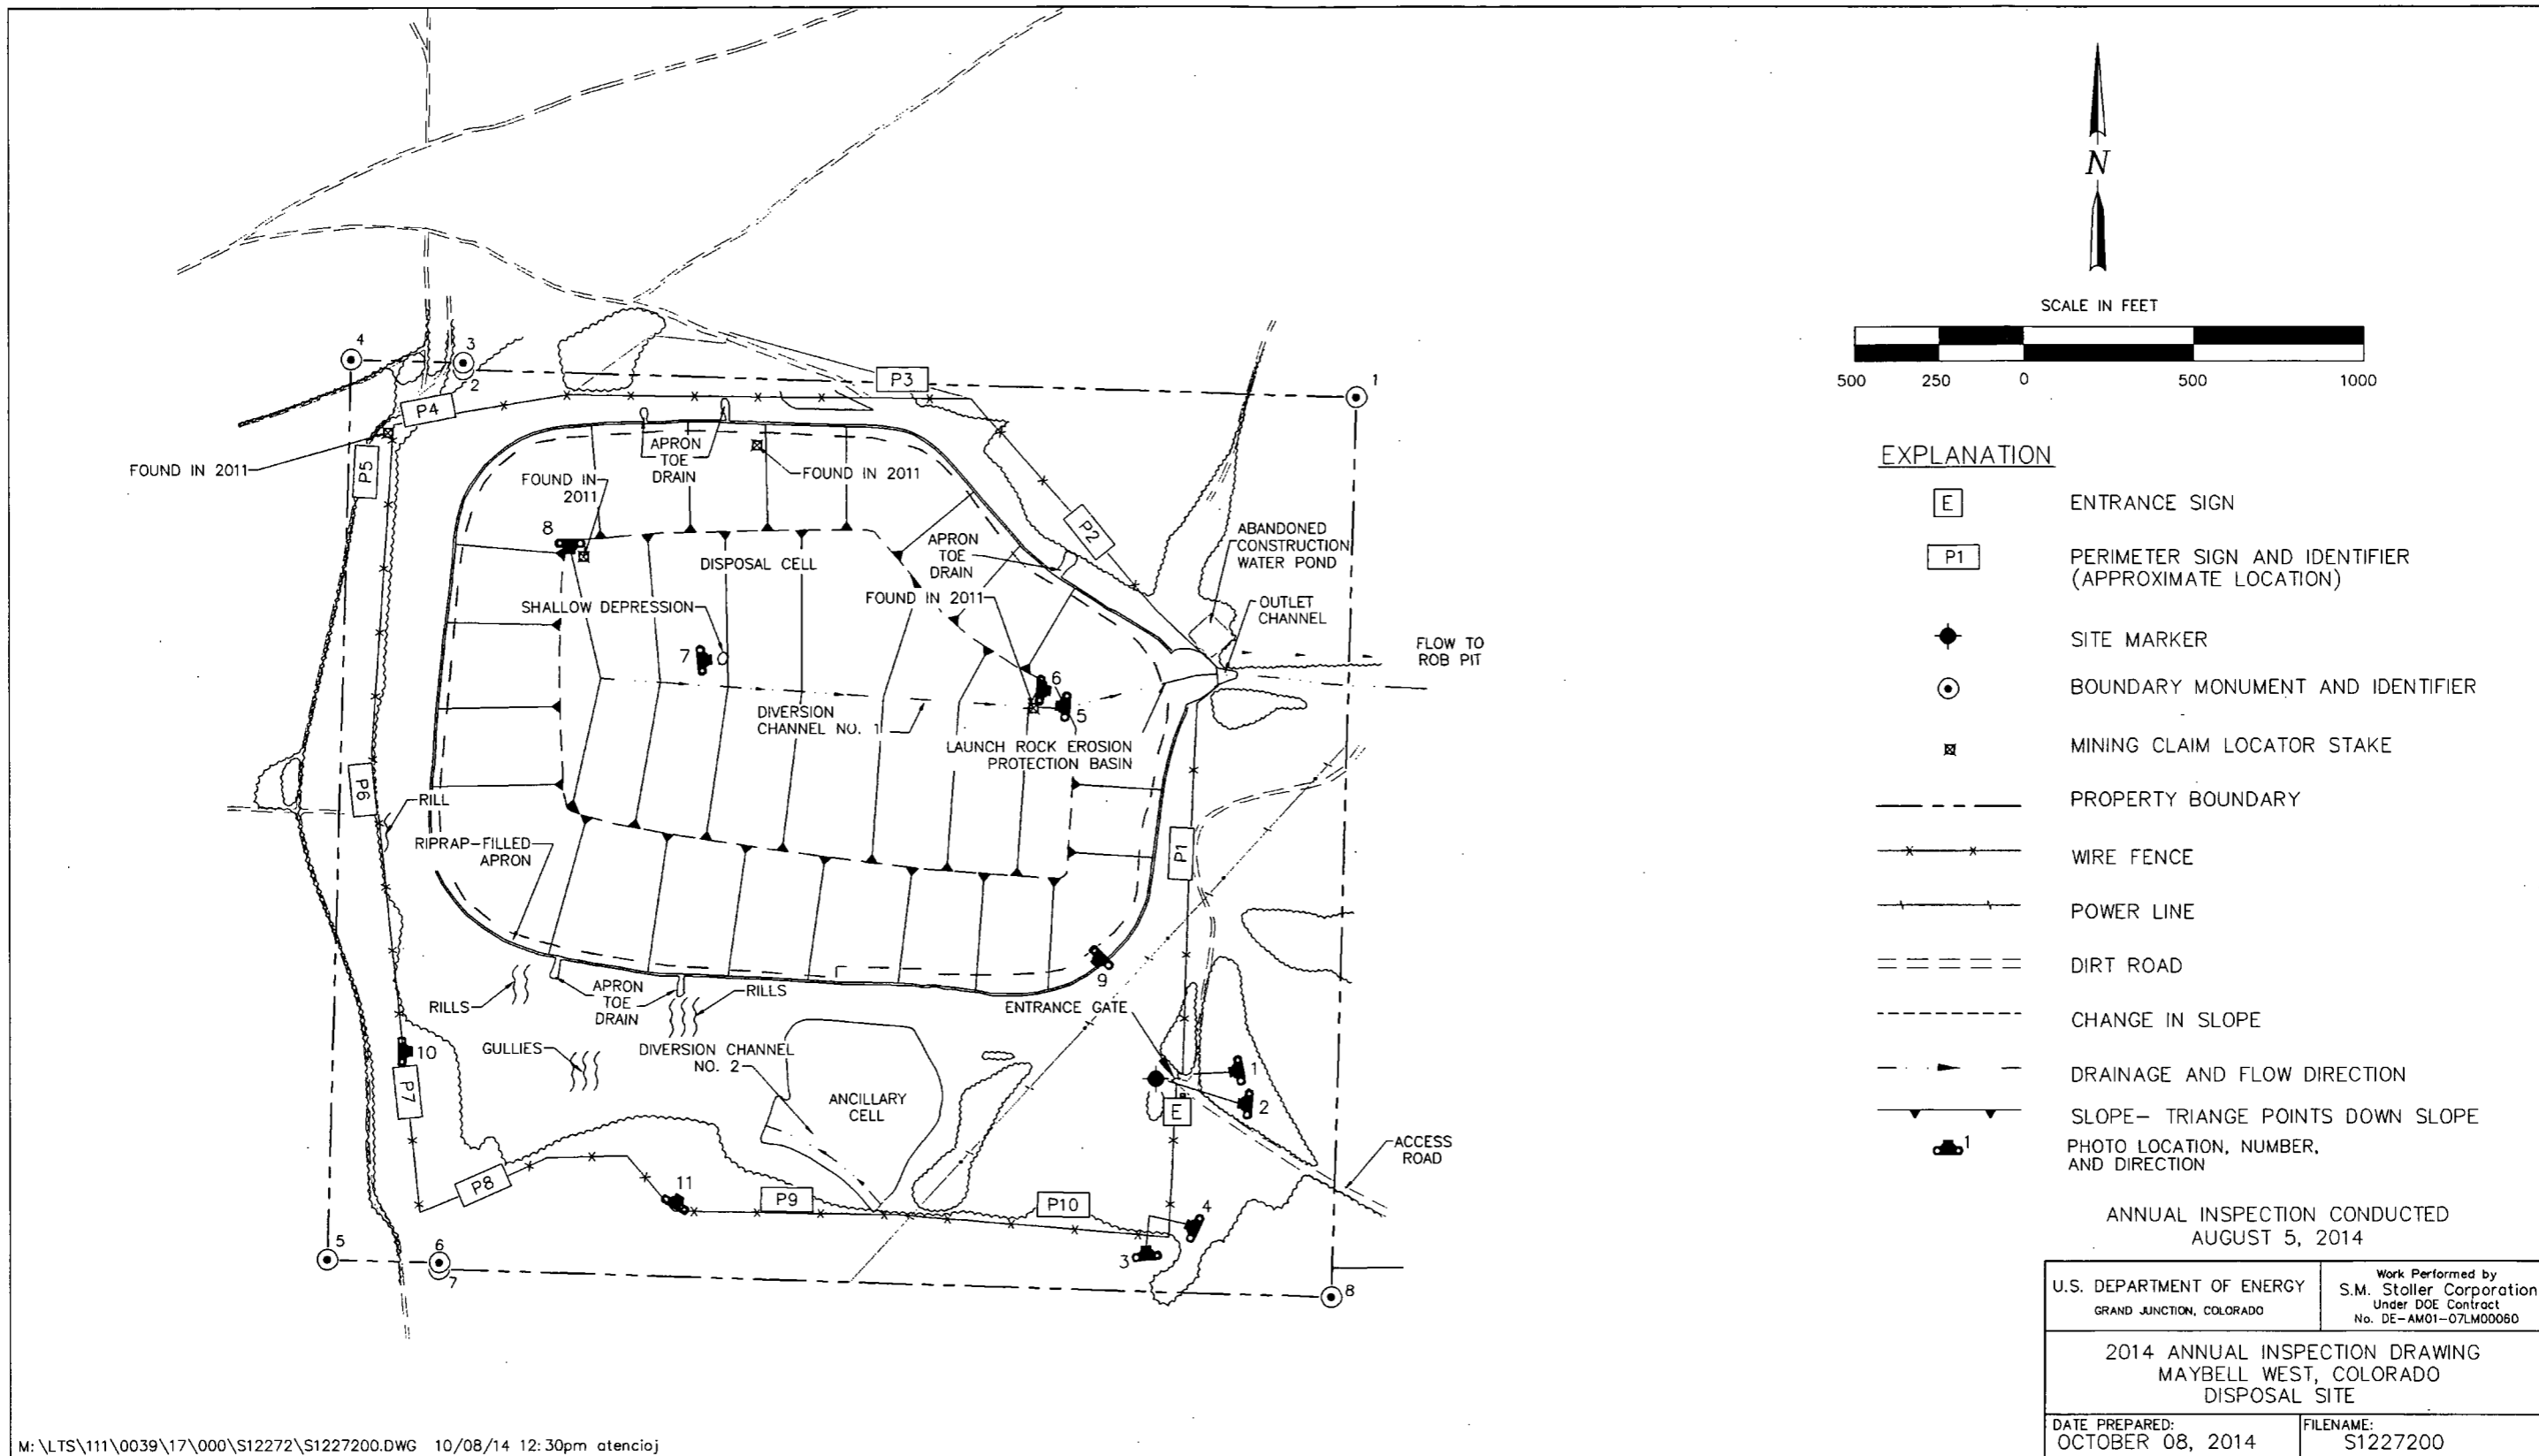
Figure 4-1. 2014 Annual Inspection Drawing for the Maybell West, Colorado, Disposal Site

The entrance sign is mounted on a perimeter fence metal t-post directly south of the entrance gate (PL-1). The entrance sign was in good condition.

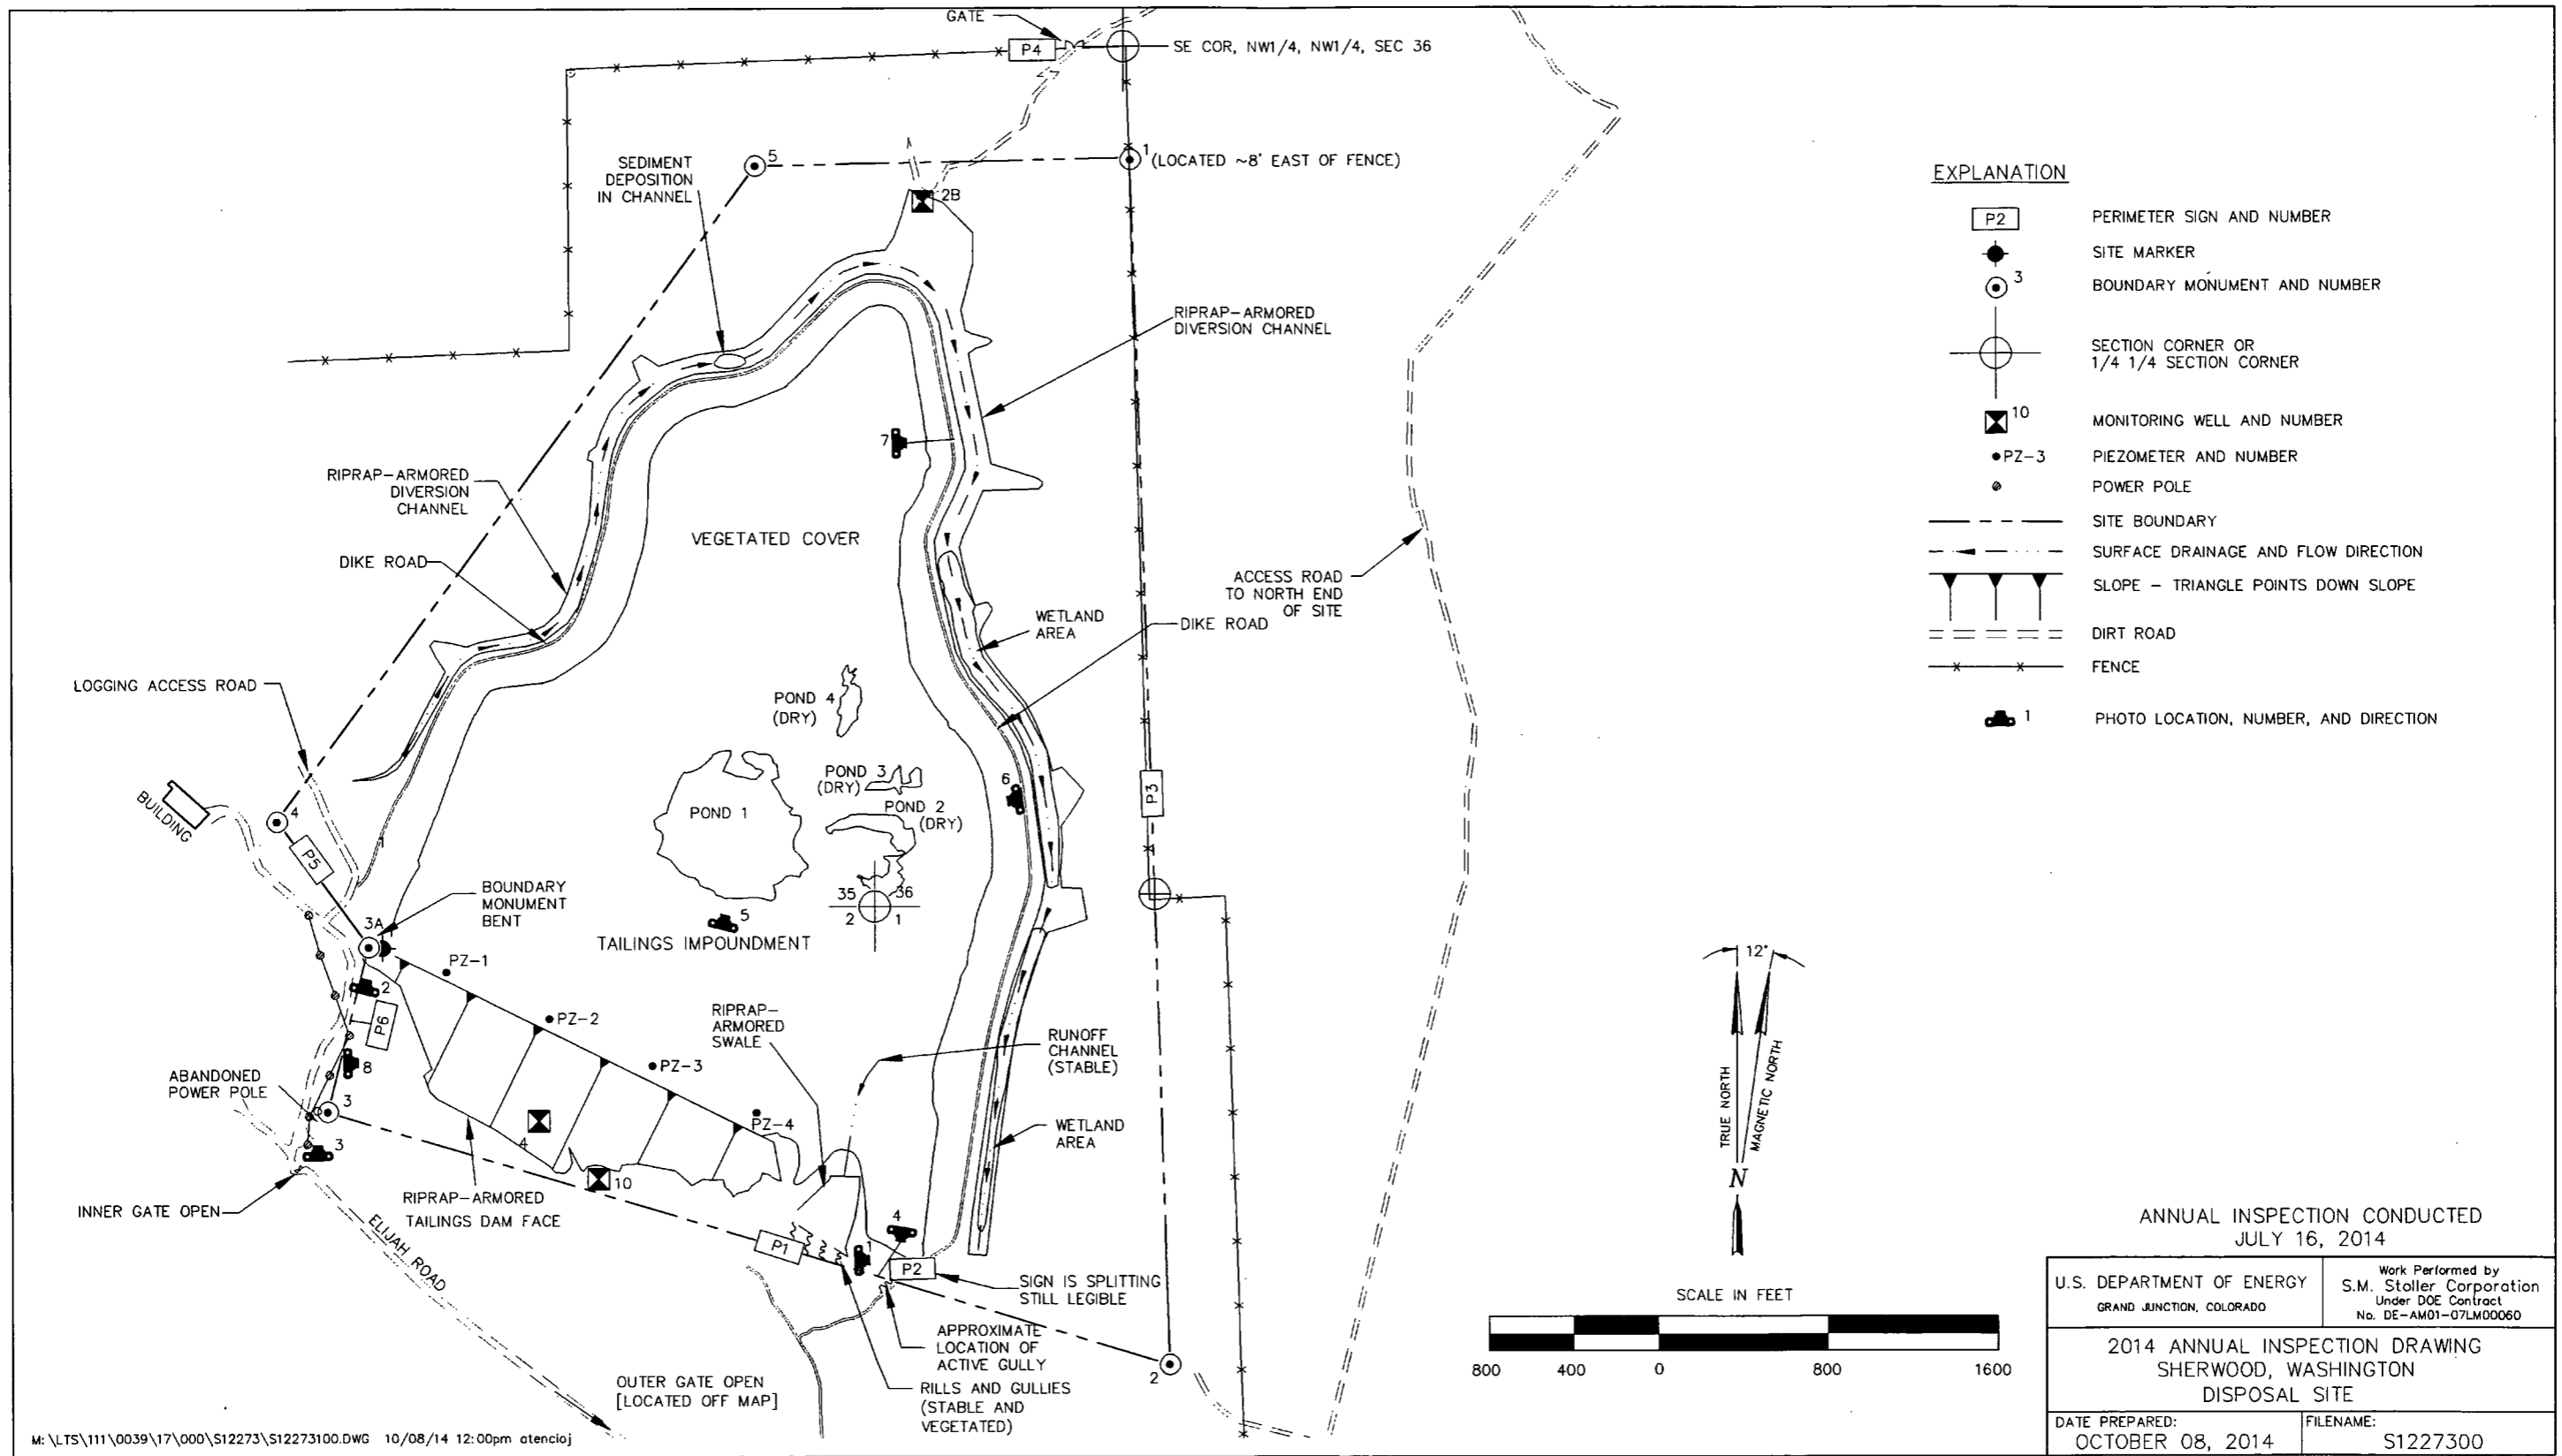
Figure 5-1. 2014 Annual Inspection Drawing for the Sherwood, Washington, Disposal Site

Three monitoring wells are located on the site and are designated wells 2B, 4, and 10. The wells were secure and in good condition.

As part of the dam safety inspection program, four piezometers, designated PZ-1 through PZ-4, were installed in November 2000 along the crest of the tailings dam at a depth equivalent to the base of the dam. All piezometers were secure and in good condition.
