2014 Annual Site Inspection and Monitoring Report for Uranium Mill Tailings Radiation Control Act Title II Disposal Sites

November 2014

Bluewater, New Mexico,
Disposal Site, 2014

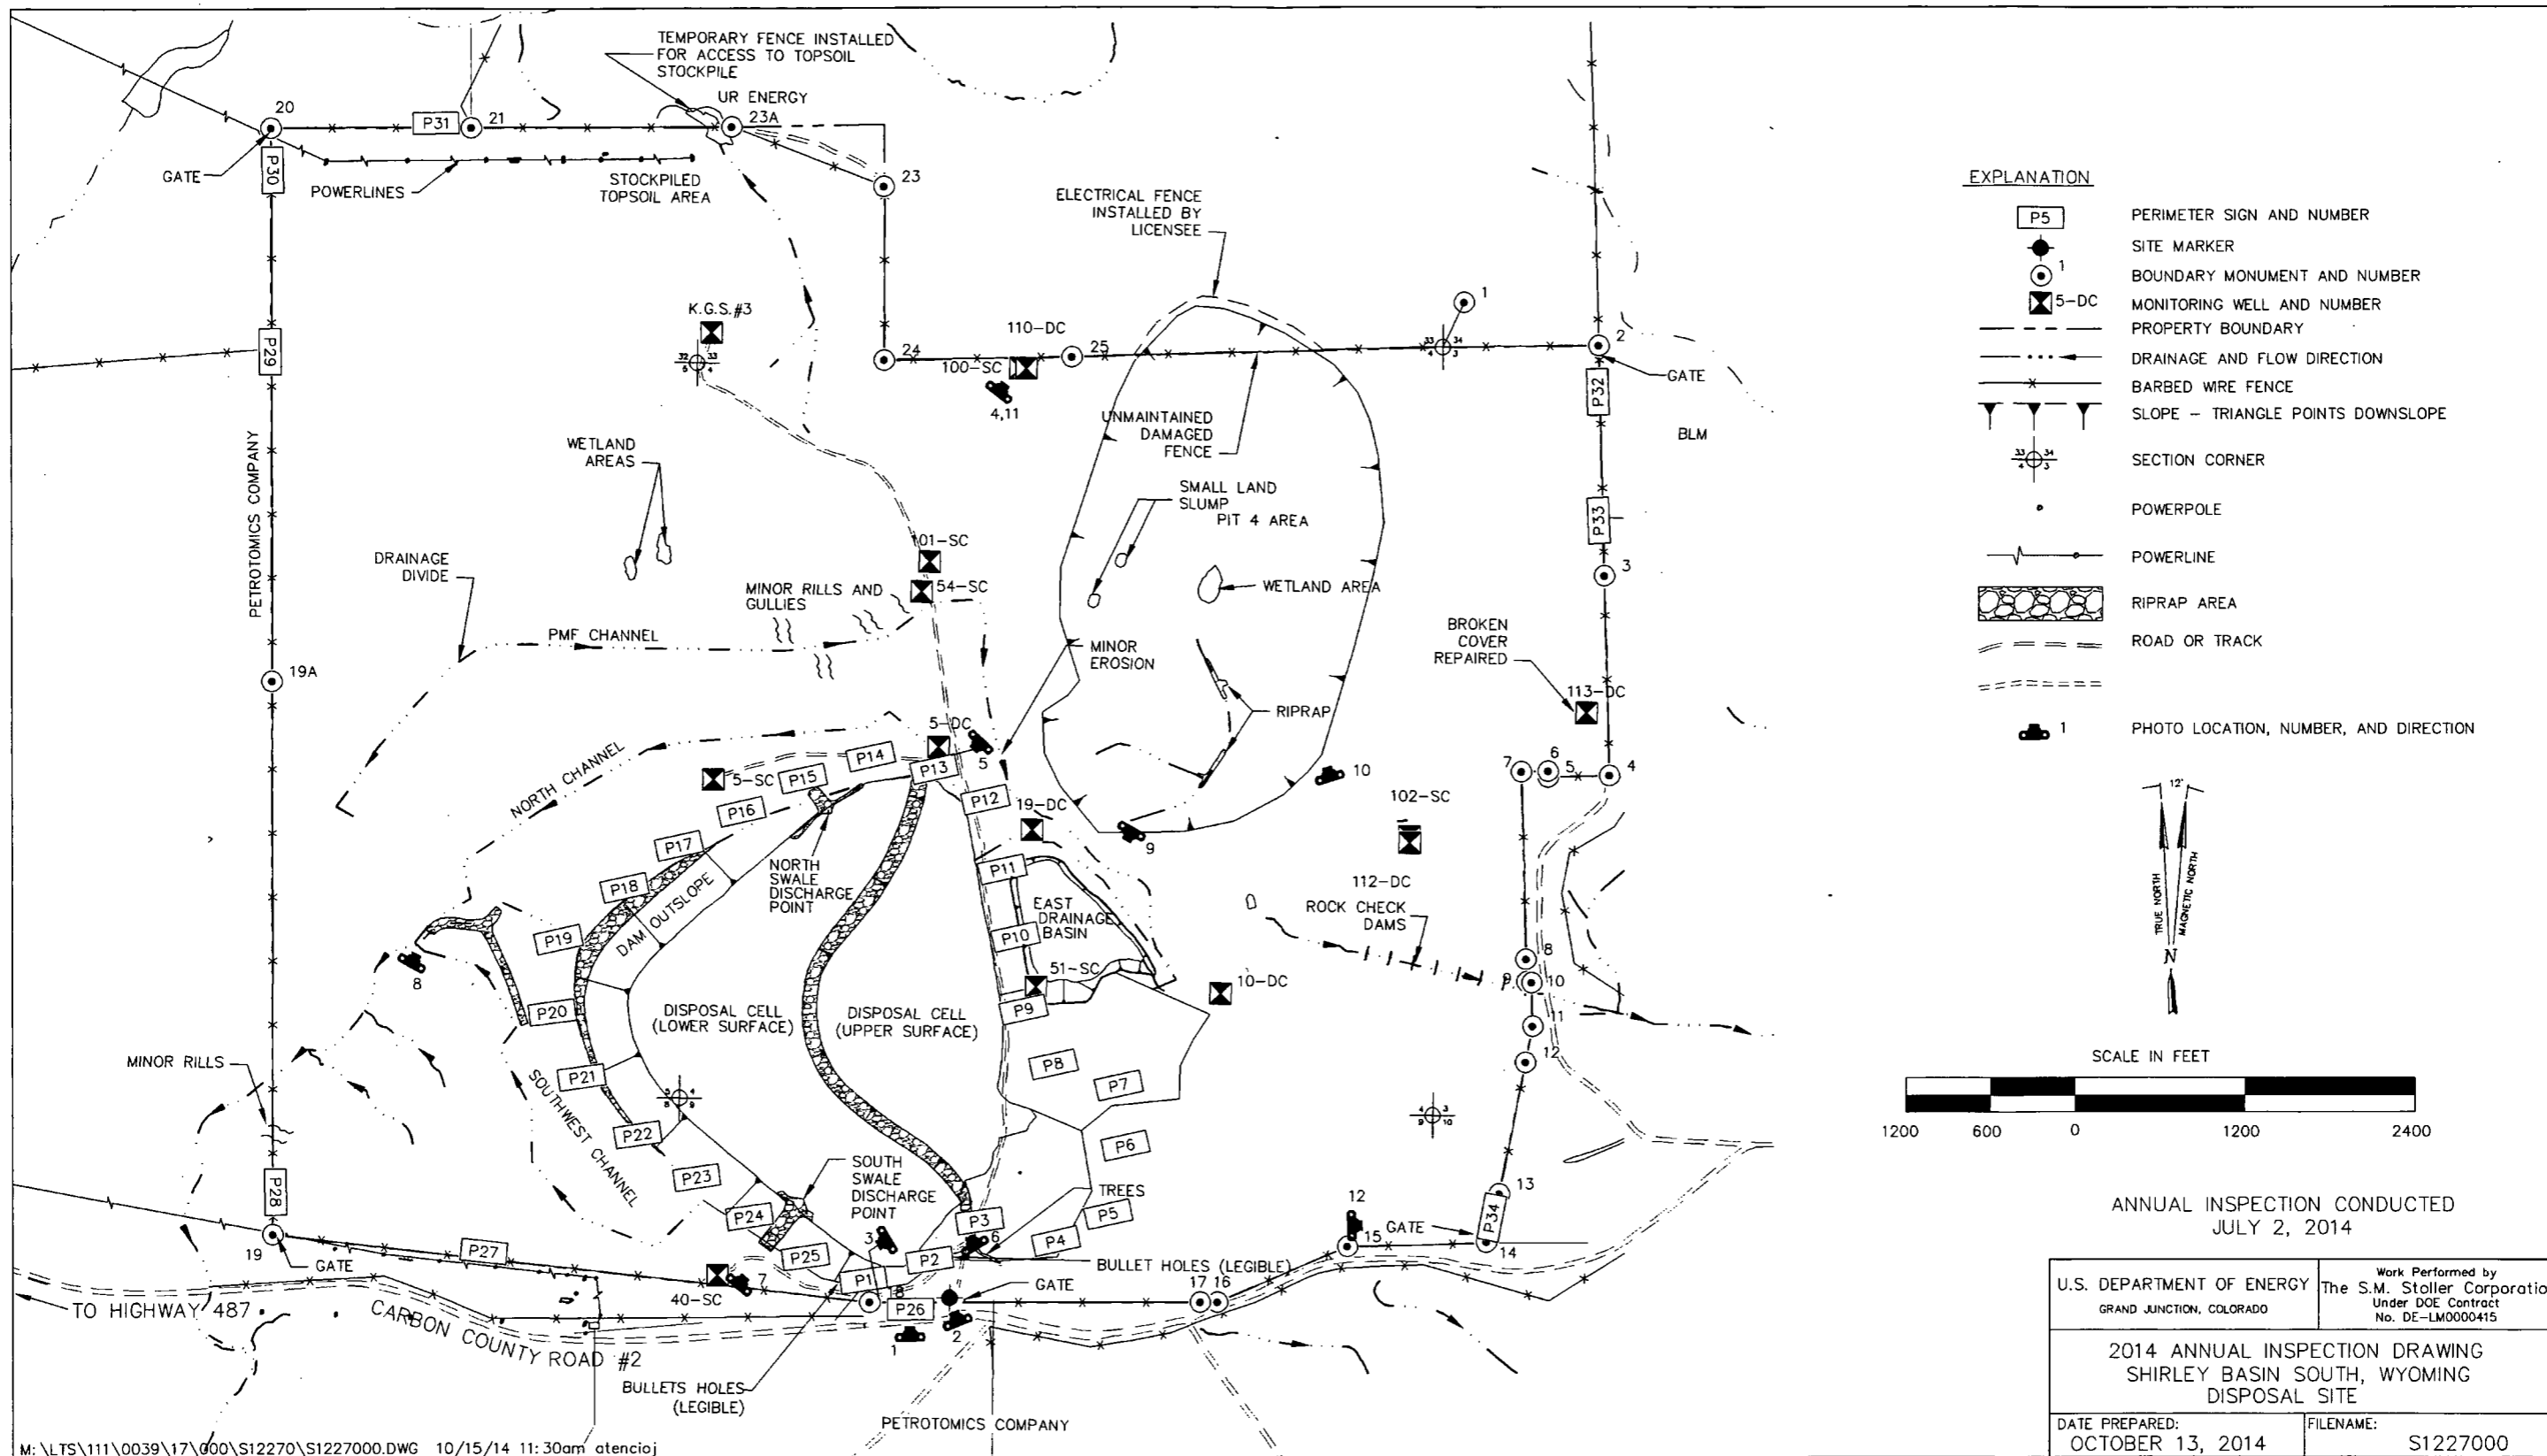
Figure 6-1. 2014 Annual Inspection Drawing for the Shirley Basin South, Wyoming, Disposal Site

The site groundwater monitoring network consists of 14 wells; six of these wells were installed downgradient of the disposal cell during fall 2008. The wells were in excellent condition (PL-4).

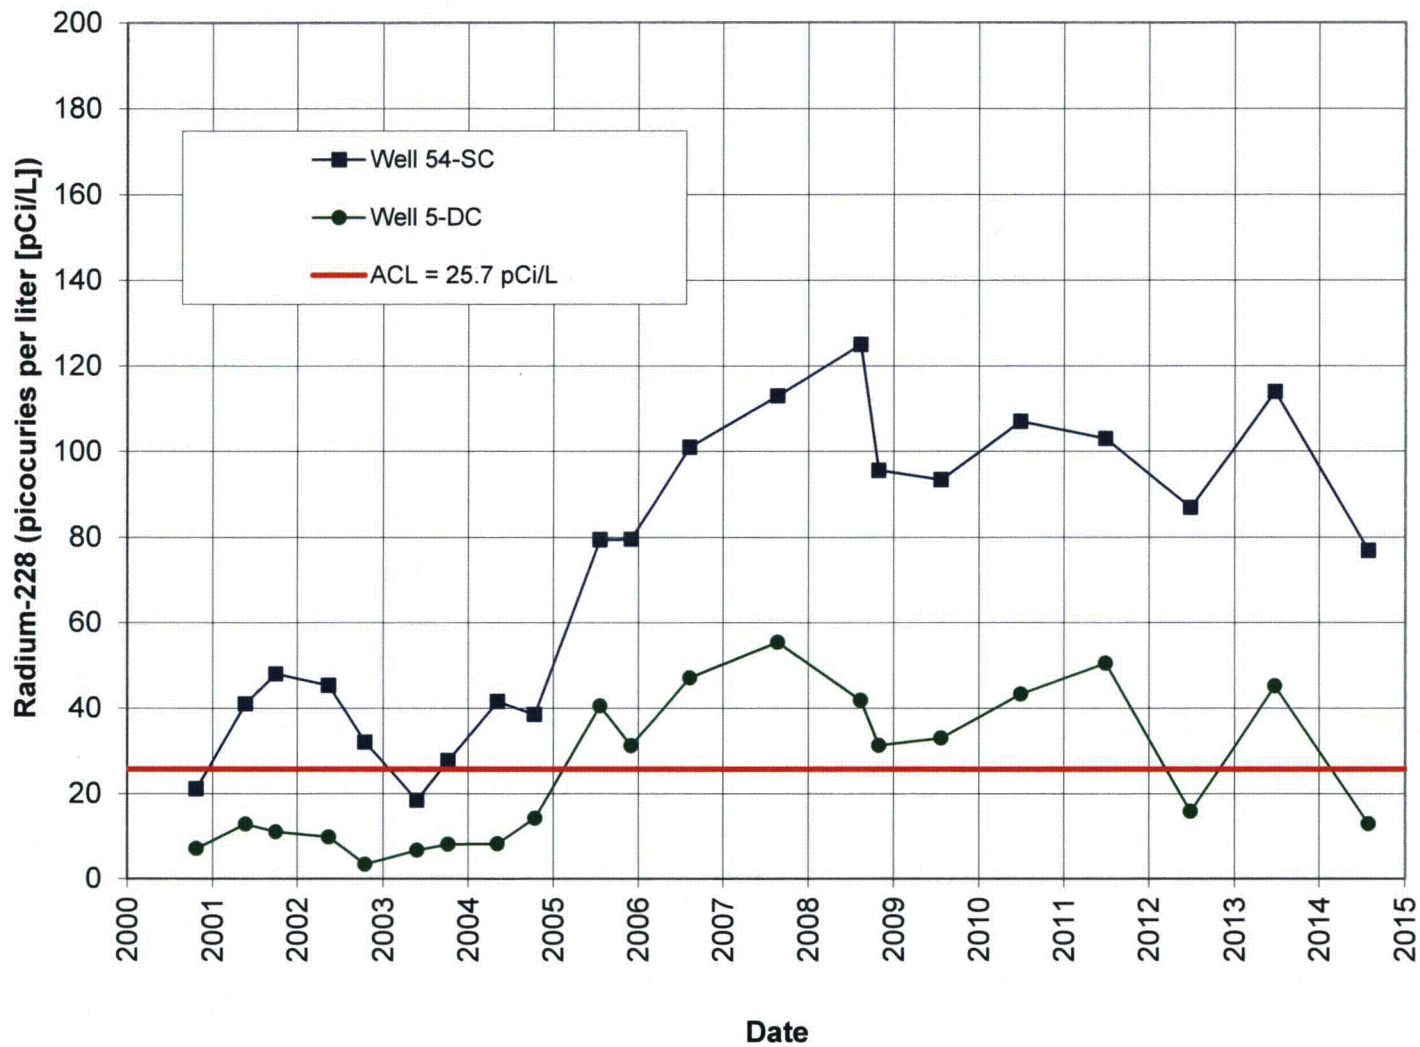
Figure 6-2. Radium-228 Concentrations in Wells 5-DC and 54-SC Since Completion of the Disposal Cell

6B The concentration for cadmium in well 5-SC remained below the ACL and has since 2005. Radium-228 continued to exceed the ACL in well 54-SC but dropped below the ACL in well 5-DC (Figure 6-2). Additionally, the ACL for radium-226 continues to be exceeded in well 110-DC (Figure 6-3).

Although radium-228 concentrations are elevated in two of the wells, they are less than the peak concentrations that occurred in these wells in the early 1990s during site groundwater remediation activities. Radium-228 is a decay product of thorium-232, which is highly immobile. Because the half-life of radium-228 is relatively short, the thorium-232 source must be near the wells of concern. DOE attributes the cause of elevated radium-226 and radium-228 in the site

6C wells to natural mineralization in the aquifers rather than evidence of diminished cell performance or contaminant plumes migrating offsite. NRC considers it possible that the elevated radium may represent leakage from the cell. However, NRC has concluded that additional evaluation of the cause of the elevated radium concentrations by DOE is not warranted at this time because there is no risk to human health and the environment. The groundwater is not a current or potential future source of drinking water, and the source of livestock water at the site is from an aquifer that is not impacted by former milling operations.

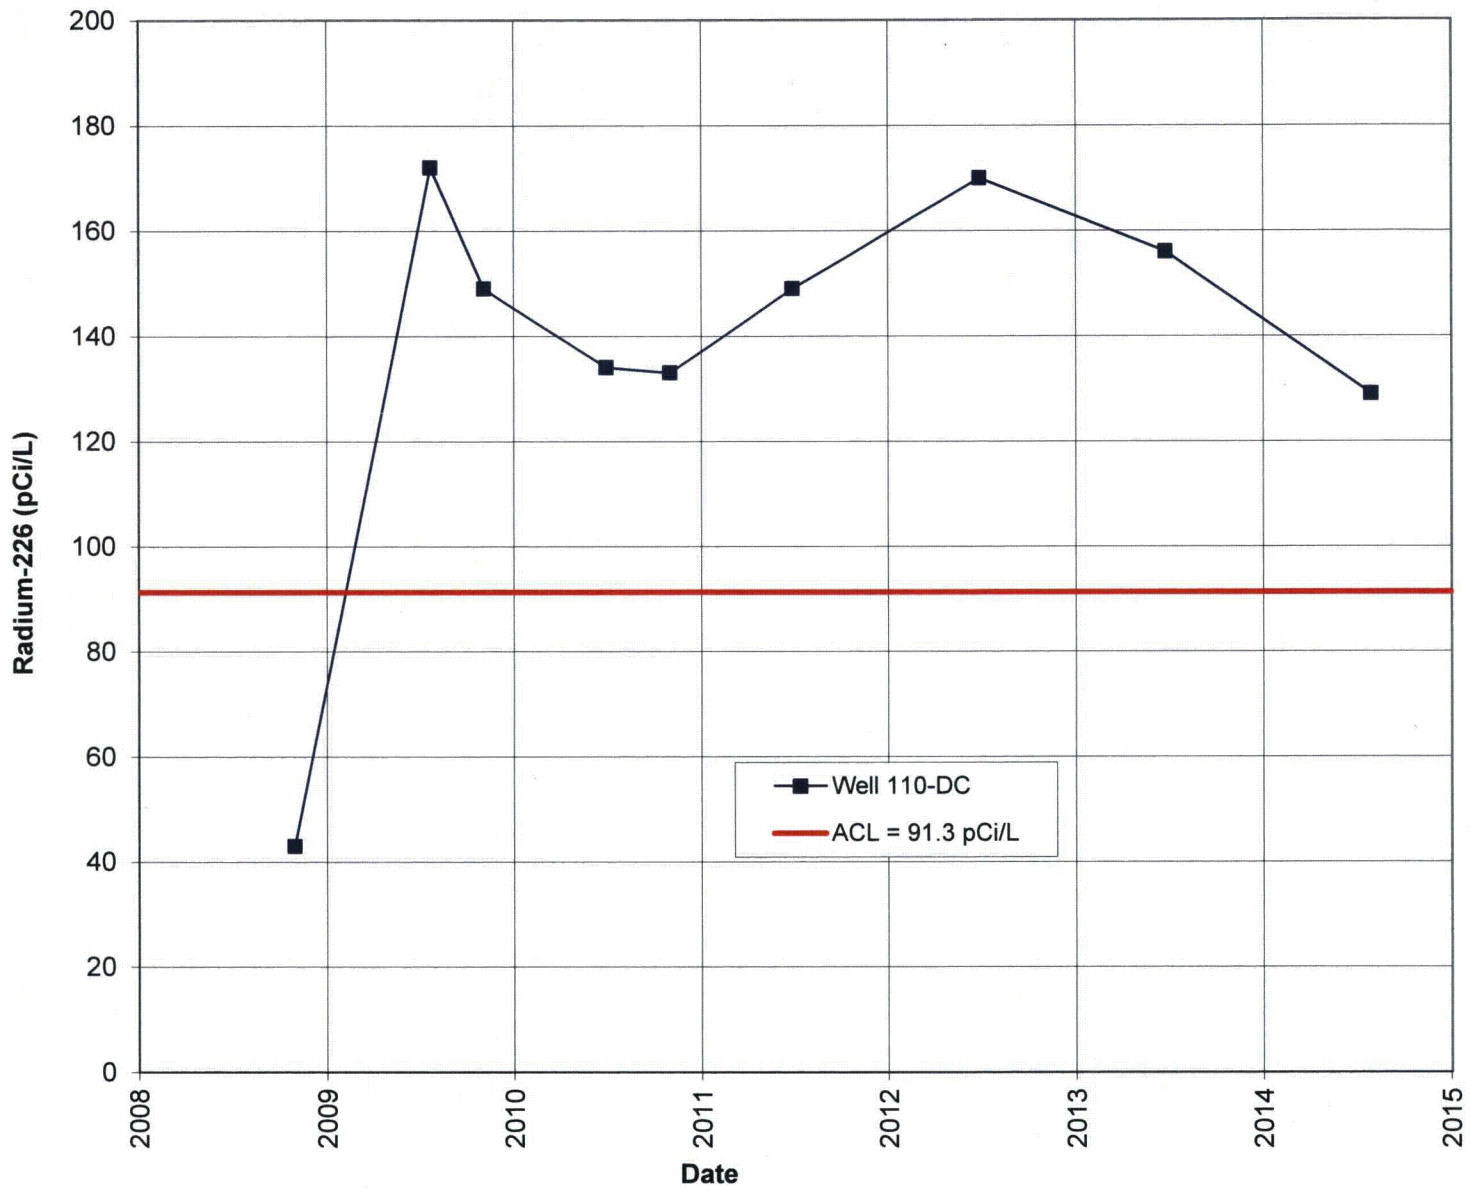
Figure 6-3. Radium-226 Concentrations in Well 110-DC

The second sampling event after installation of the new wells was conducted in July 2009 and indicated that radium-226 exceeded the ACL in new downgradient well 110-DC near the north site boundary. NRC and WDEQ were notified of the exceedance, and DOE began to evaluate the cause of the exceedance.

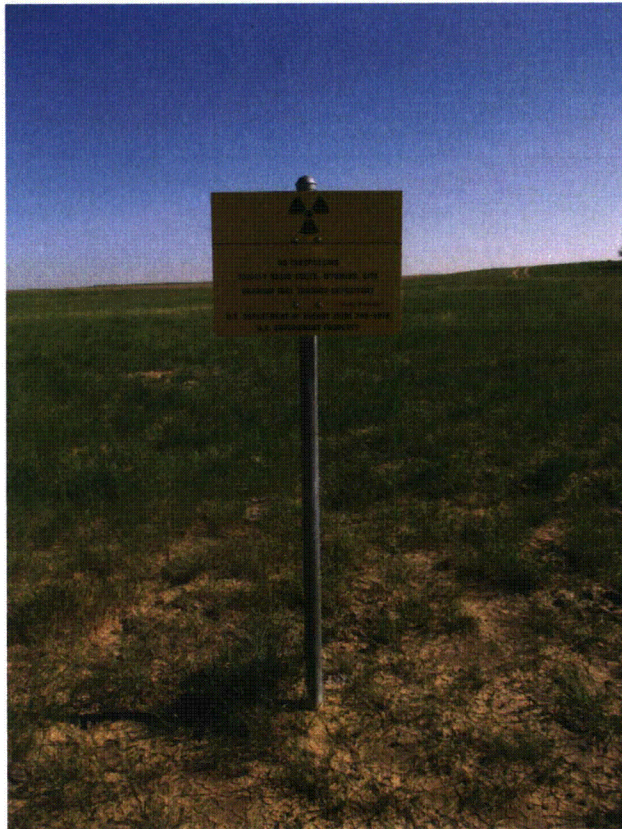
Nine perimeter signs (warning/no-trespassing signs) are along the site perimeter at potential points of access, and another 25 signs are positioned around the disposal cell (PL-1). Other than perimeter signs P1 and P2, which have bullet holes in them, the signs were in excellent condition.

SBS 7/2014. PL-1. Perimeter sign P26 at site entrance.

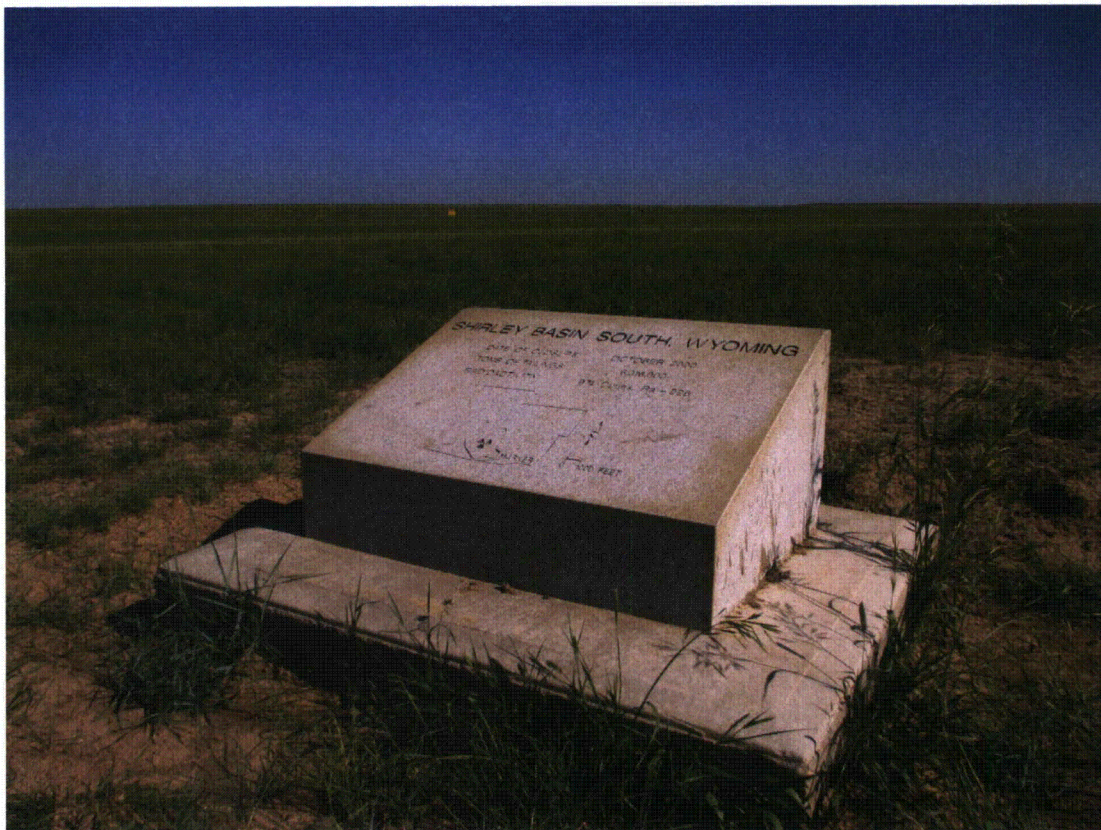
The granite site marker, which is located at the site entrance, was in excellent condition (PL-2). Twenty-six monuments delineate the site property boundary; the observed boundary monuments were in excellent condition (PL-3).

SBS 7/2014. PL-2. Site marker at site entrance.

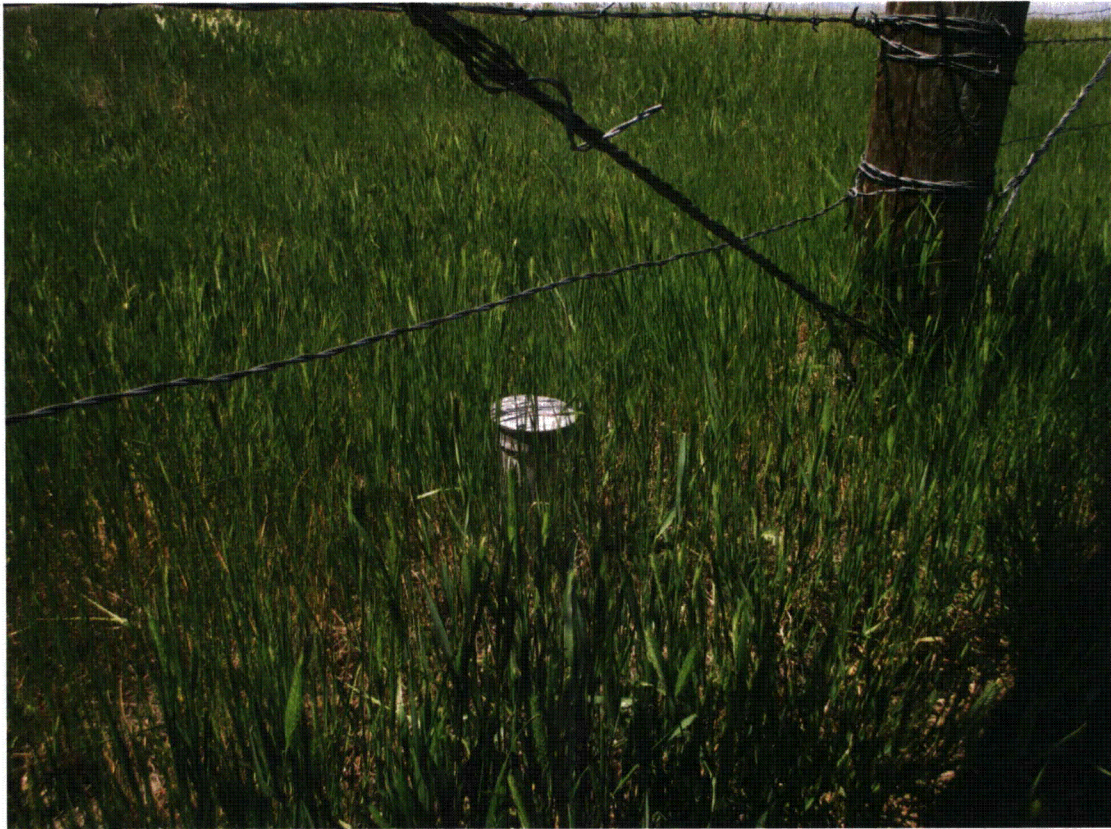
SBS 7/2014. PL-3. Boundary monument BM-18.

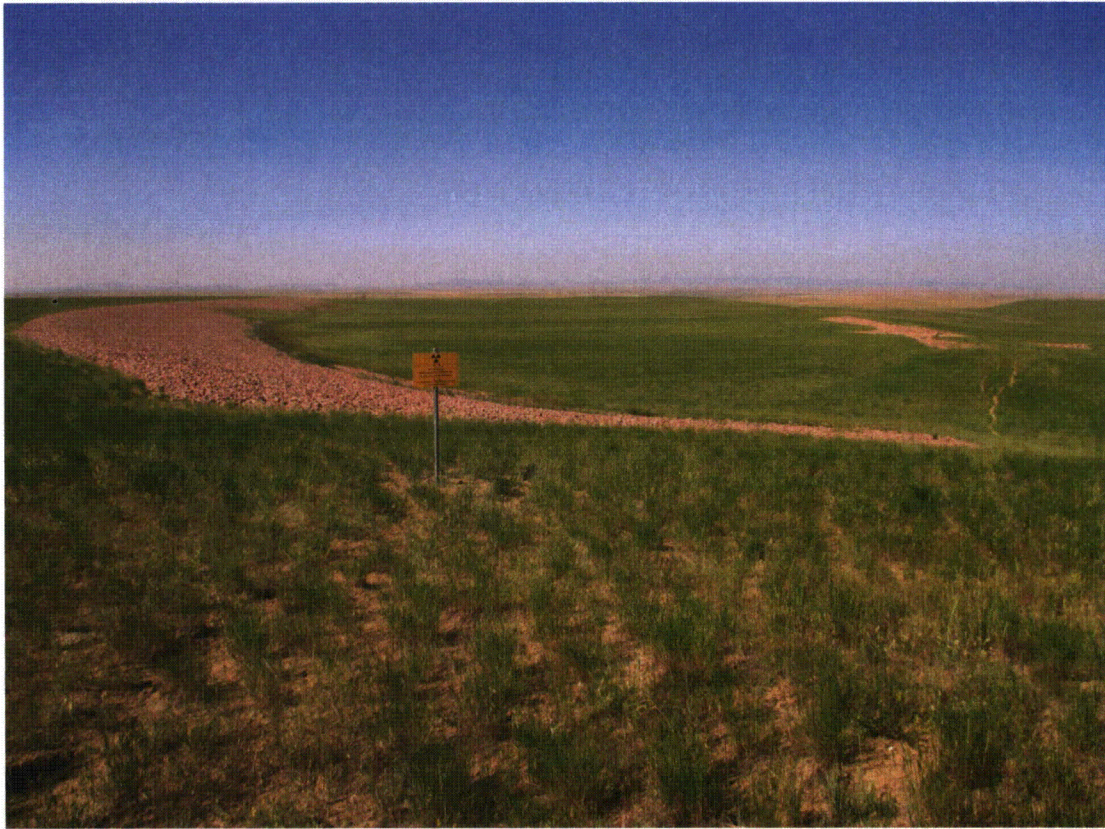
The eastern (upper) surface is contoured to drain into a basin east of the cell and west over the riprap-protected slope to the western (lower) surface. The lower surface drains to the north and south at riprap-armored discharge points; the discharge structures were in excellent condition (PL-7). The riprap dissipation basins of the discharge points usually hold snowmelt runoff water in spring and early summer; water was present at the time of the inspection.

SBS 7/2014. PL-5. Lower surface of disposal cell.

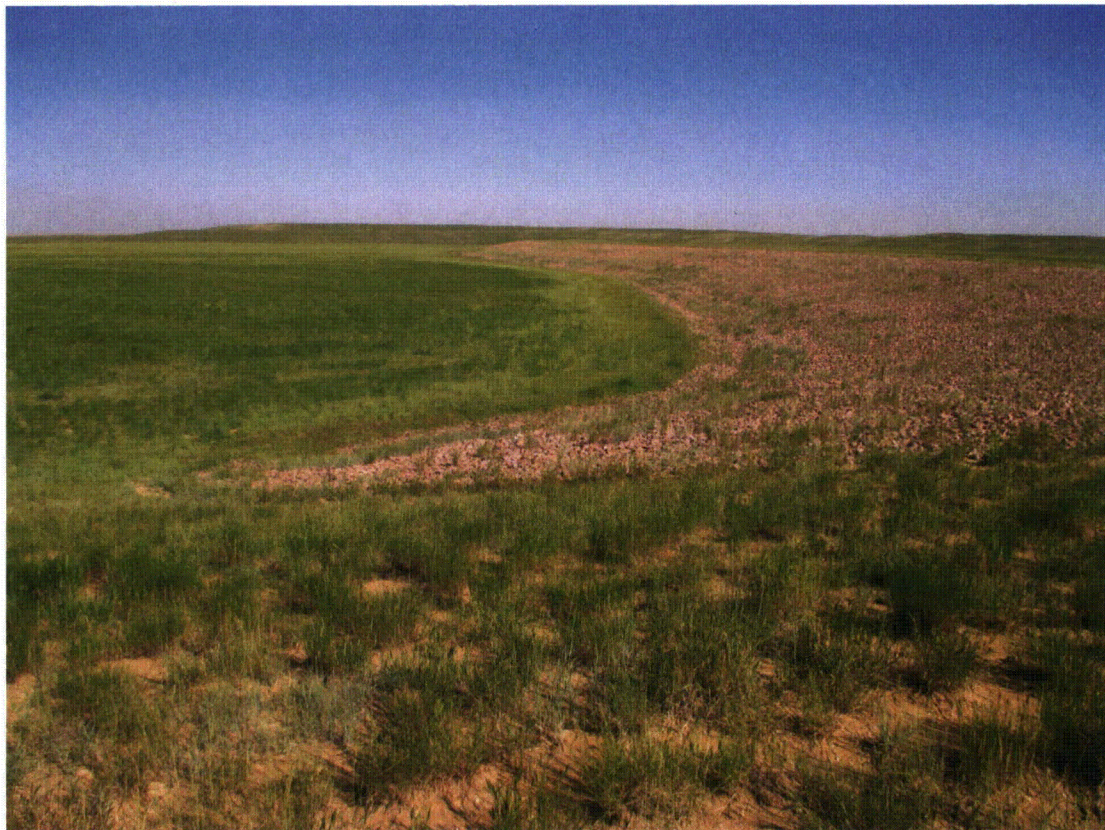
The tailings pile was reclaimed in place and was contained behind a horseshoe-shaped earthen dam. The containment dam is predominantly grass-covered, but the steeper portion (5:1 slope) of the dam is protected by riprap. The containment dam was in excellent condition; there were no indications of erosion, settlement, or other modifying processes that might affect the integrity of the dam. Vegetation is encroaching on the riprap surfaces, which enhances the stability of the slope.

SBS 7/2014. PL-6. Riprap-armored slope between disposal cell upper and lower surfaces.

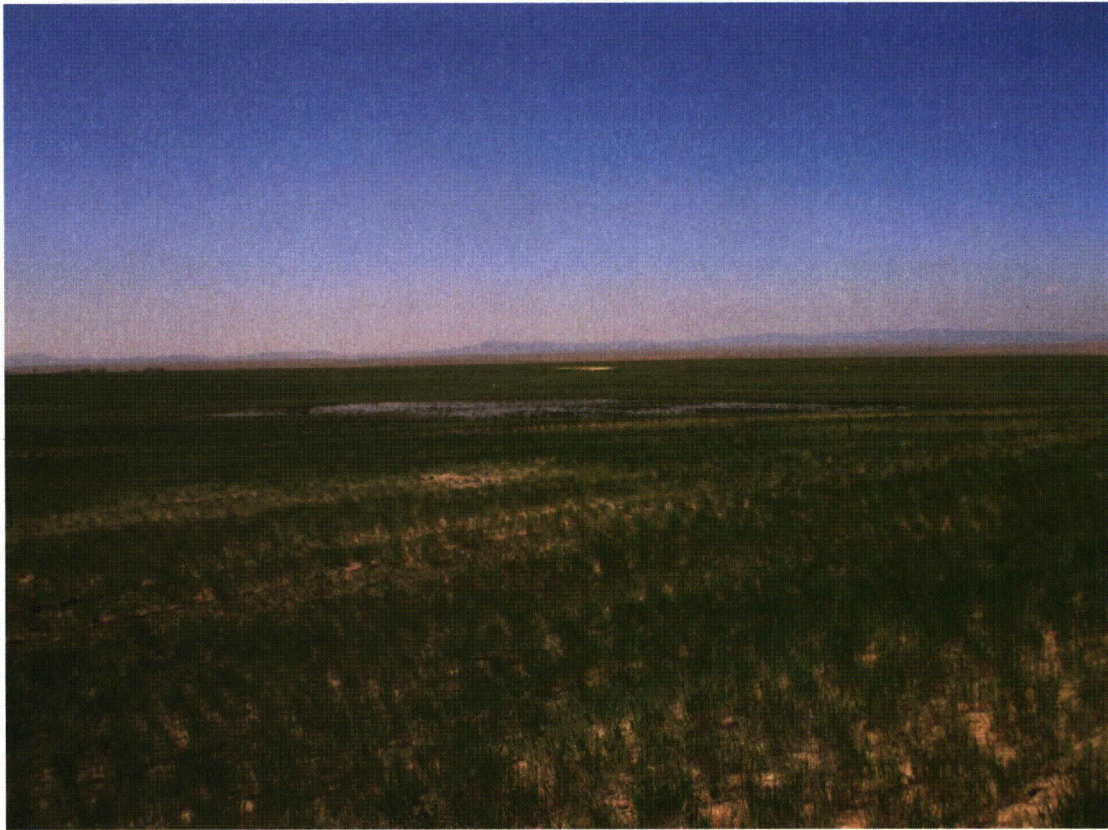
portion of the PMF channel that flows eastward and discharges into the east drainage basin captures a larger drainage area; this basin contained water at the time of the inspection (PL-9). These closed drainage basins are large enough to accommodate the PMF water volumes. The diversion channels were in excellent condition, and no active erosion was apparent in the channels.

SBS 7/2014. PL-9. Pond in east drainage basin.

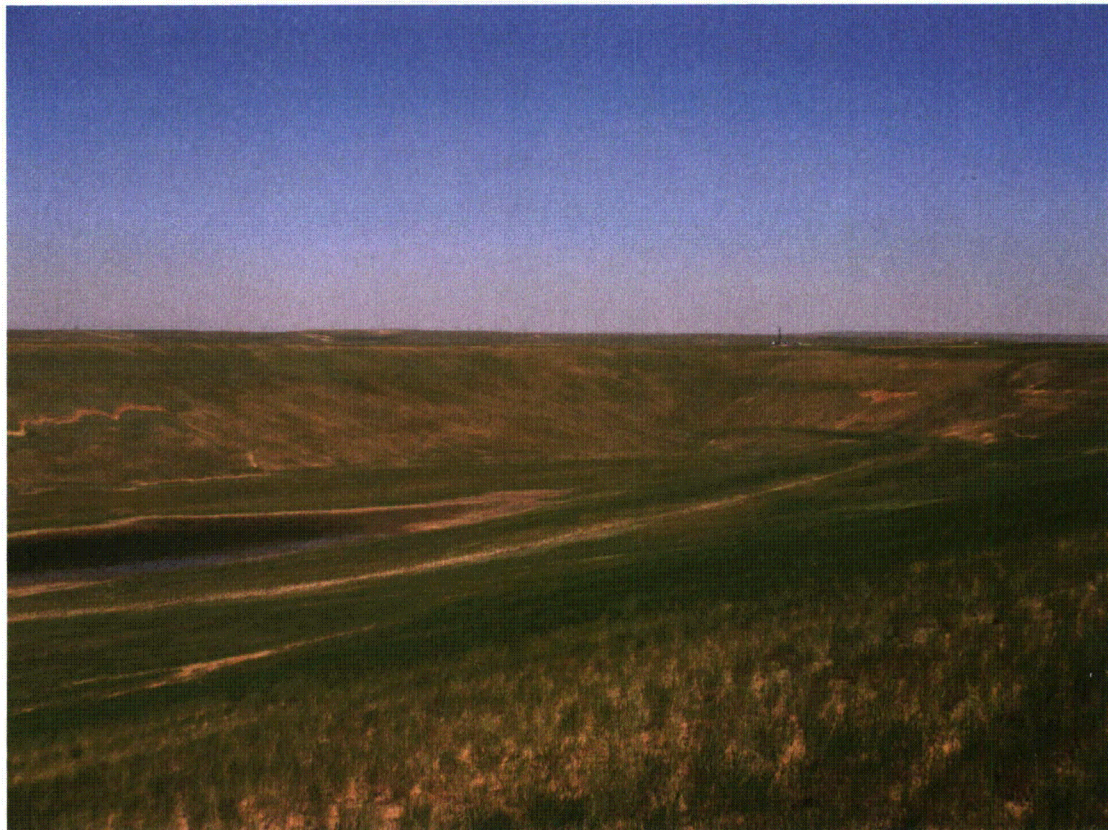
The other major feature on the site is reclaimed Pit 4, in the northeast portion of the site (PL-10). Reclamation activities included rounding the side slopes, partially backfilling the pit to an elevation above the local water table, revegetating the surfaces, and protecting potential erosion areas with riprap. Vegetation is well established, and a wetland area has formed at the bottom of the pit where standing water from runoff is often present; the surface of this area tends to dry out later in the summer. Overall, Pit 4 was in good condition, with some minor slumps and displacement features present on the west side slope of the pit.

SBS 7/2014. PL-10. North portion of reclaimed Pit 4.
