**UNITED STATES
NUCLEAR REGULATORY COMMISSION**
REGION IV
1600 E. LAMAR BLVD.
ARLINGTON, TX 76011-4511

**SUBJECT: FORT CALHOUN STATION – MANUAL CHAPTER 0350 INSPECTION REPORT
AND FINAL SIGNIFICANCE DETERMINATION OF WHITE FINDING AND
NOTICE OF VIOLATION; NRC INSPECTION REPORT NO. 05000285/2013018**

IR 05000285/2013018; 07/08/2013 – 10/15/2014; Fort Calhoun Station, Supplemental Inspection for Repetitive Degraded Cornerstones, Multiple Degraded Cornerstones, Multiple Yellow Inputs or One Red Input.

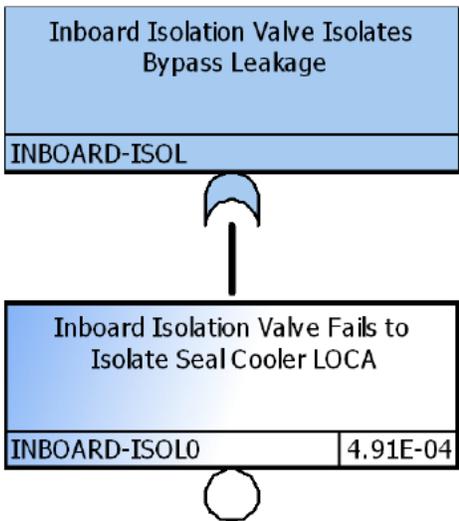
Figure 4
Failure to Isolate Group 6 Valves
Event Tree

2. Figure 4 shows the top event, "Inboard-Isol." This fault tree was created by the analyst and added to the event tree to account for the potential that operators fail to isolate the intersystem loss of coolant accident following the failure of the component cooling water system surge tank. The value provided was the single failure to close probability of an air-operated valve from the SPAR model. Upon failure the model transfers to the intersystem loss of coolant accident – shutdown cooling event tree, from the SPAR, as a surrogate to the operators' ability to diagnose and recover from the event.

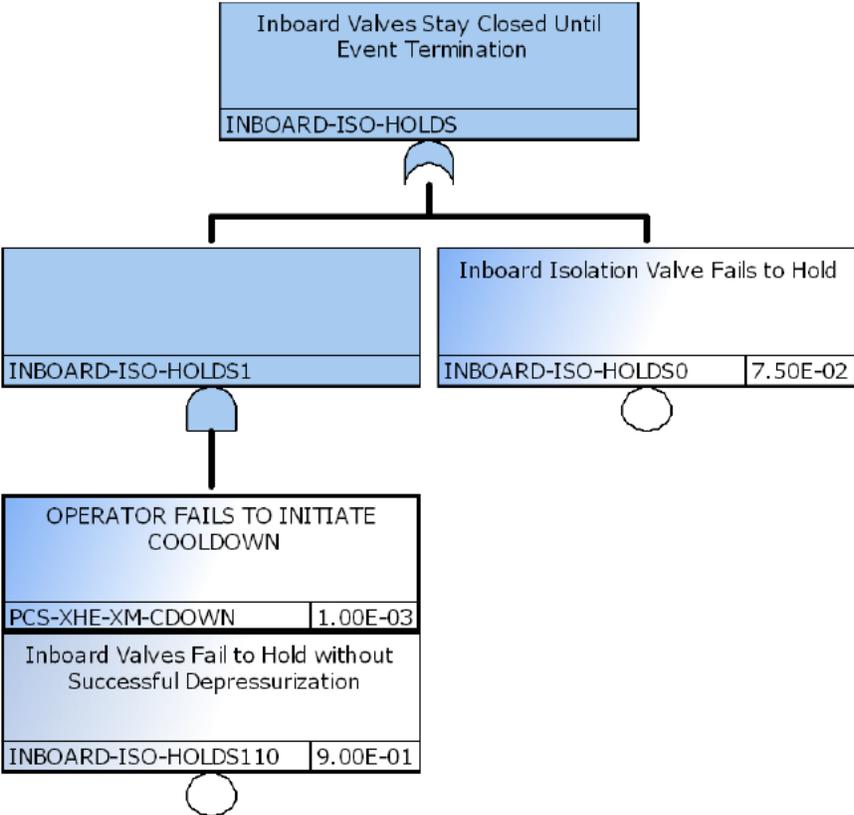
Figure 5
Failure of Outboard Group 6 Valves to Remain Closed
Event Tree

8. Figure 5 shows the top event, "Inboard-Iso-Holds." This fault tree was created by the analyst and added to the event tree to account for the potential that Valves HCV-438A and HCV-438C operators fail to remain closed in the containment environment created by a small-break loss of coolant accident. The failure of the valves as a result of the performance deficiency were modeled differently at high reactor coolant system pressures and following a reactor depressurization directed by the emergency operating procedures. The failure probabilities used were developed by the analyst using qualitative information provided by the licensee in a white paper entitled, "Overview of RCP Seal Cooler Containment Isolation Valve Elastomer Significance." The analyst noted that these valves would remain closed with a differential pressure of approximately 300 psig based on the design of the plug (See Figure 2).

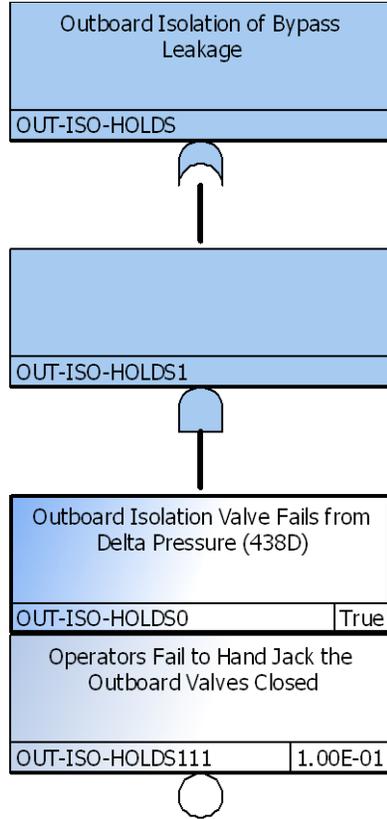
Figure 6
Failure of Inboard Group 6 Valves to Remain Closed
Event Tree

9. Figure 6 shows the top event, "Out-Iso-Holds." This fault tree was created by the analyst and added to the event tree to account for the potential that Valve Operators for HCV-438B and HCV-438D fail to remain closed against the differential pressure created when Valves HCV-438A and HCV-438C fail open following a break of one of four reactor coolant pump seal cooler helix coils. The analyst noted that the valves would fail open under differential pressures near 180 psig, indicating that the valves would most likely always fail open. However, Emergency Operating Procedure EOP-20, "Functional Recovery Procedure," Step 14.c.2 directs operators to manually close these valves with a hand jack. The analyst used a screening value of 0.1 as the human error probability for operators failing to close the outboard valves. This action requires depressurization of the reactor coolant system; an environment in Room 13 that would permit operator access; and access to necessary equipment.
