Alloy 152v2-LAS Dilution Zone PWSCC Testing

***Mychailo Toloczko, Matt Olszta,
Nicole Overman and Steve Bruemmer***
Pacific Northwest National Laboratory

Research Supported by
U.S. Nuclear Regulatory Commission
NRC Project Manager
Greg Oberson

Alloy 690/52/152 PWSCC Research Collaboration Meeting
December 2-5, 2014 Tampa, FL

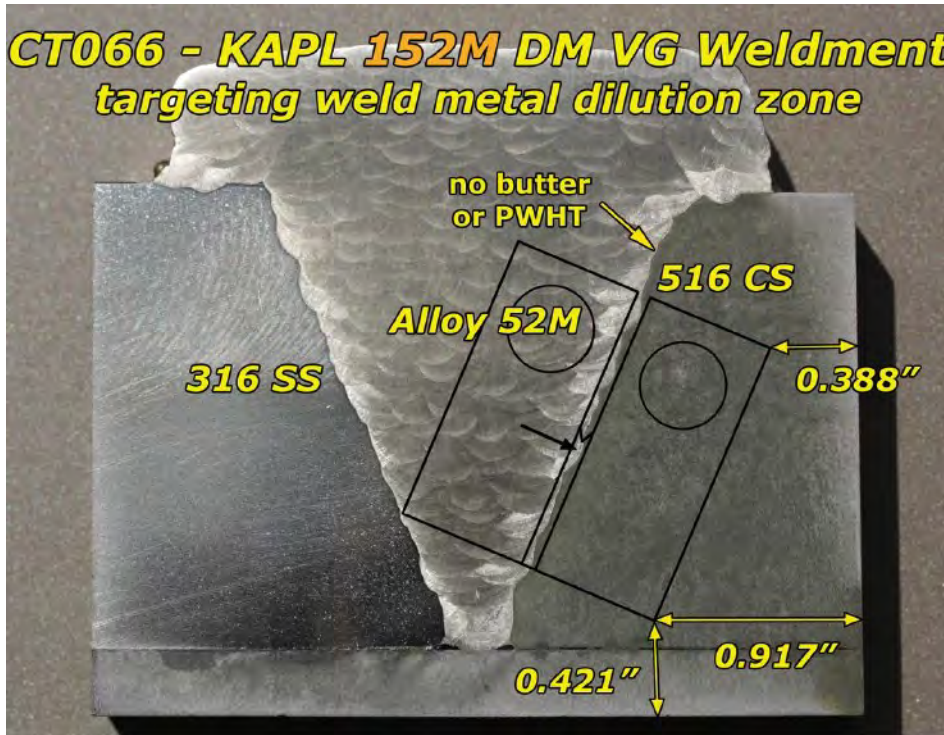
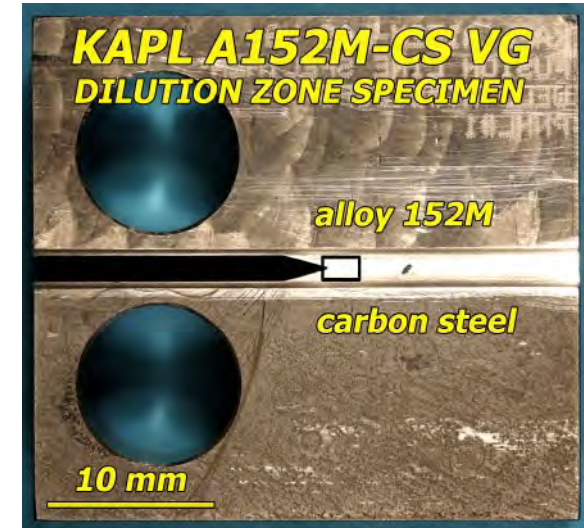
CT066 - KAPL 152M DM VG Weldment targeting weld metal dilution zone

Goal was to measure weld dilution zone response ~0.5-1 mm from fusion line.

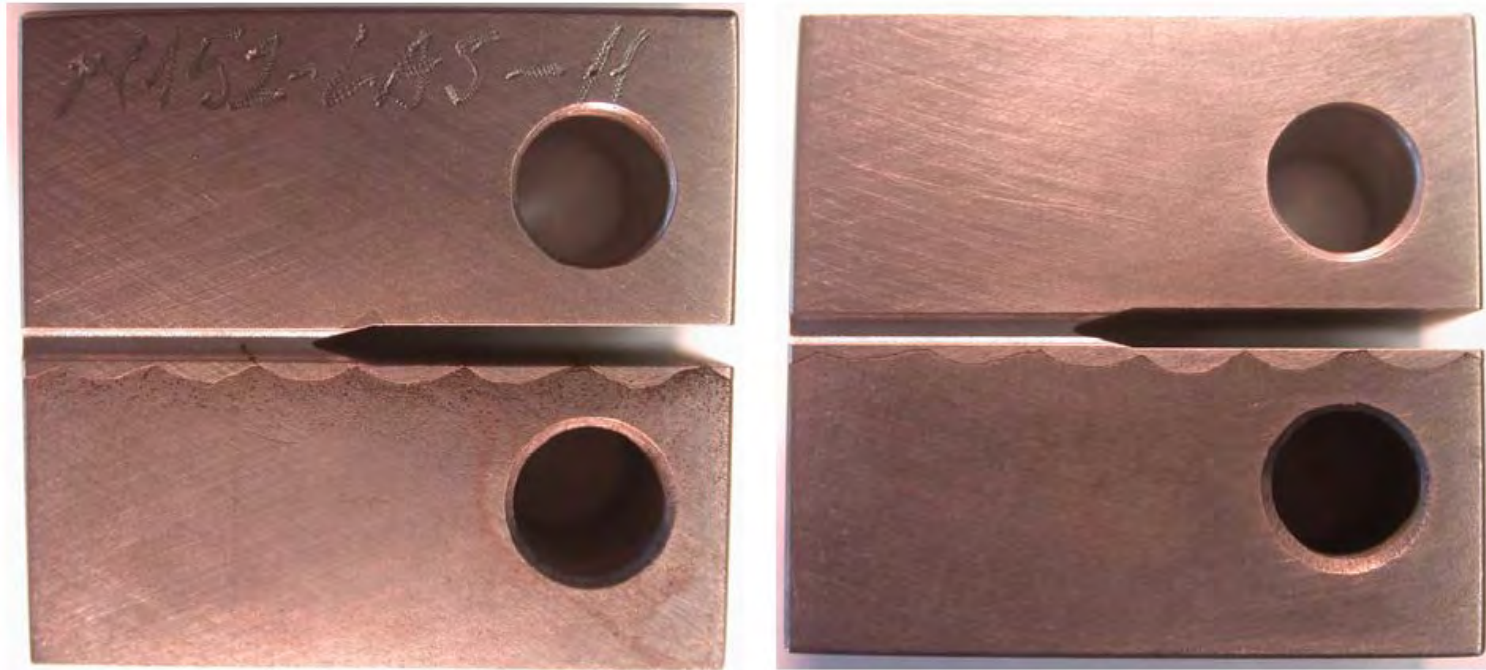
Both sides of the specimen

- ▶ *Roughly similar alignment as for the KAPL alloy 152M-CS dilution zone specimen tested at PNNL.*

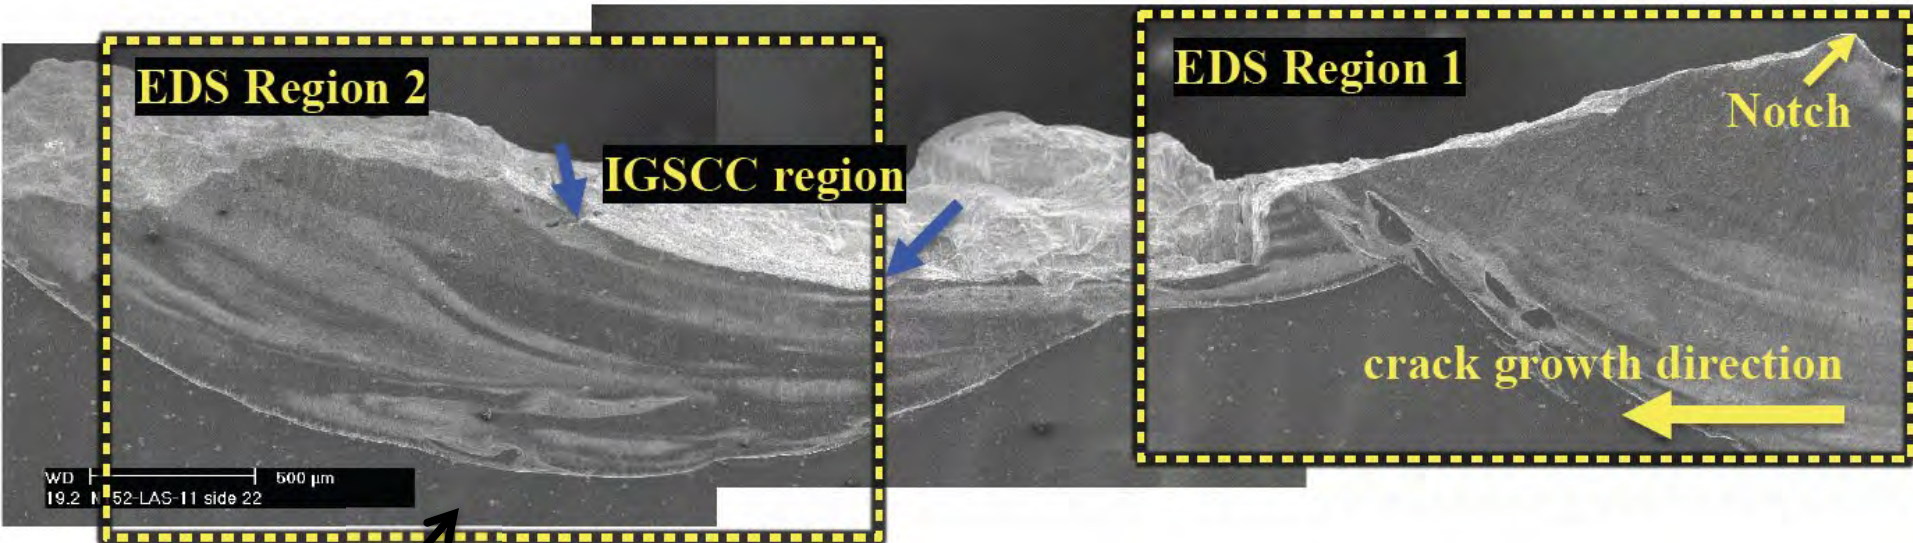
Region of interest near that contains constant load crack extension

- ▶ *Specimen has been fractured, so only one side of the specimen shown here in cross section.*

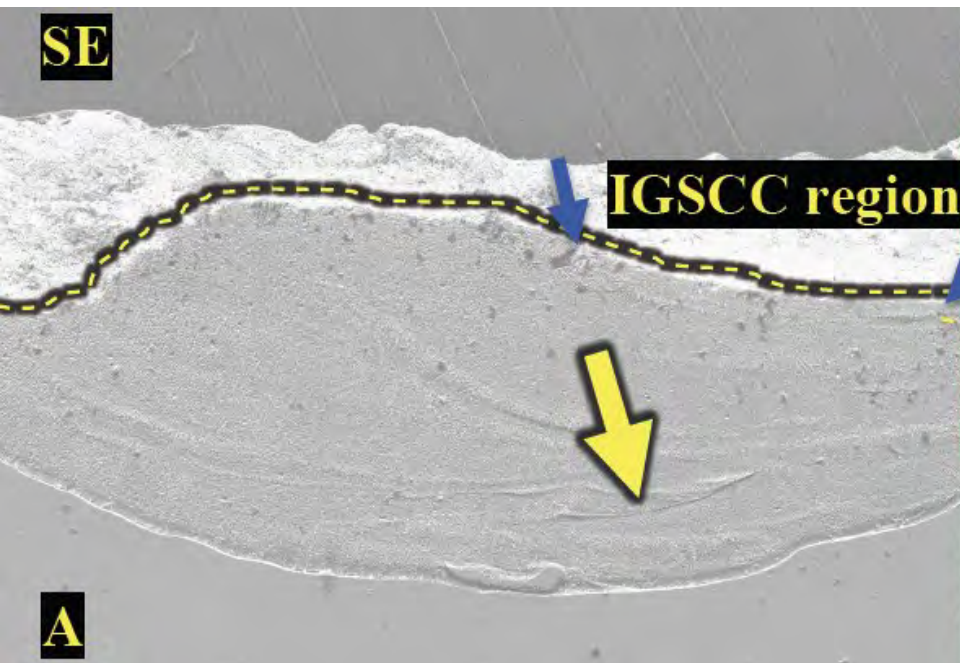
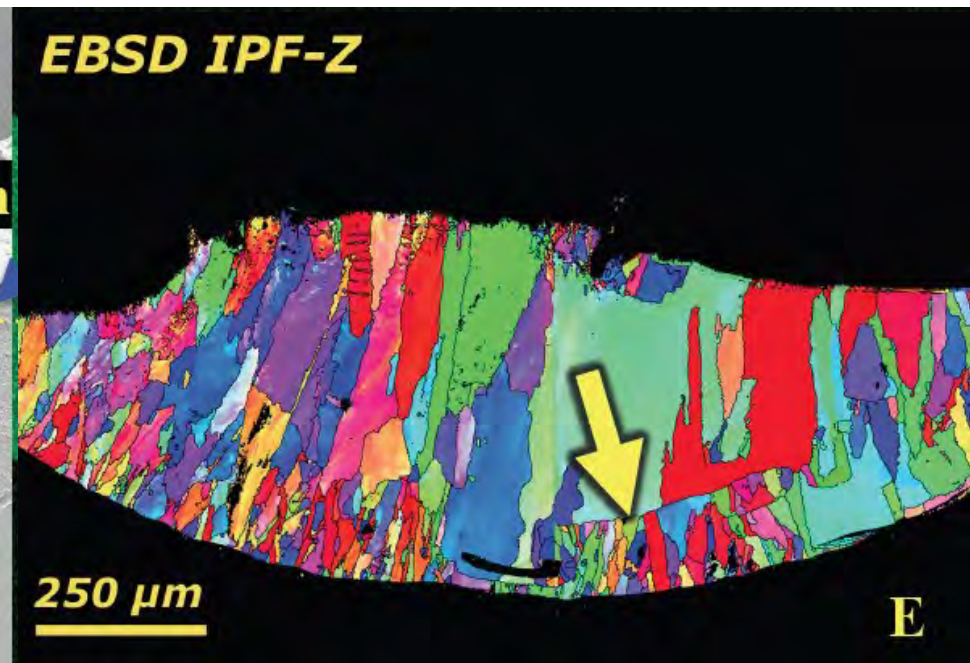
- ▶ SCC tested at ANL. Additional exams performed at PNNL.
- ▶ High constant load crack growth rates were observed.
- ▶ Crack path not well aligned to weld grain boundaries.
- ▶ Crack surface had an IG appearance.
- ▶ No strong weld dilutions in cross section of one side of crack.
- ▶ Unusual boundary that could explain SCC crack path.

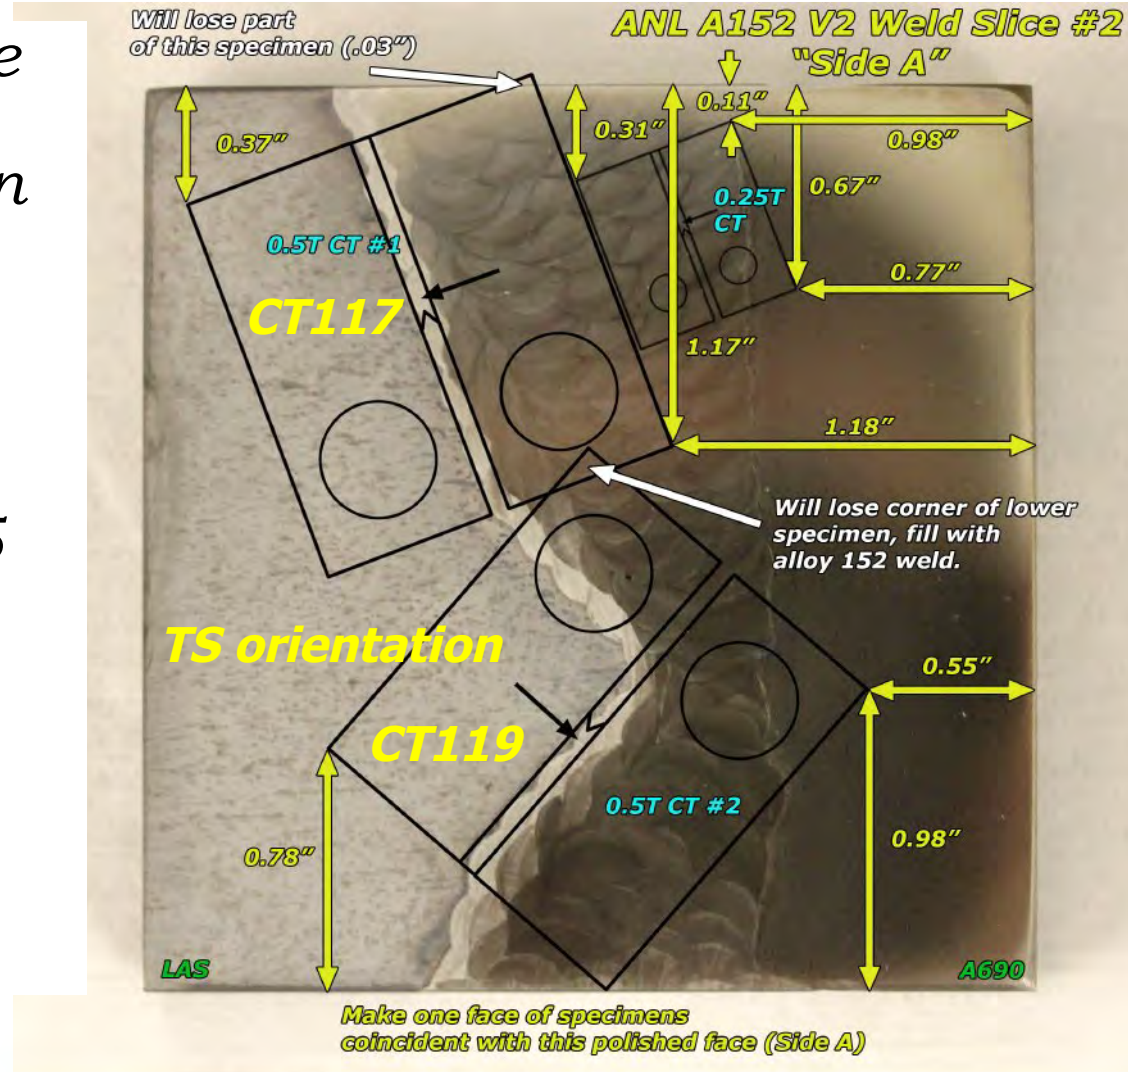
- ▶ CT117 aligned to same region of weld as ANL N152-LAS-11 specimen tested at ANL.
- ▶ Tested separately.
- ▶ Tested at 360°C PWR primary water with 25 cc/kg dissolve H₂.
- ▶ No resistivity drift correction used.

- ▶ *First weld pass has dilution near interpass boundary as indicated by etching contrast.*
- ▶ *Second pass has dilution near the same interpass boundary.*
- ▶ *Current crack front location indicated by hash marks. In a region of dilution in first weld pass.*
