2CAN021502

SUBJECT: Anti-Vibration Bar Positioning and Sludge Evaluation Information
Concerning the Spring 2014 Steam Generator Inspections
Arkansas Nuclear One – Unit 2
Docket No. 50-368
License No. NPF-6

**ANTI-VIBRATION BAR POSITIONING AND DEPOSIT LOADING INFORMATION
BASED ON THE SPRING 2014 STEAM GENERATOR INSPECTIONS**

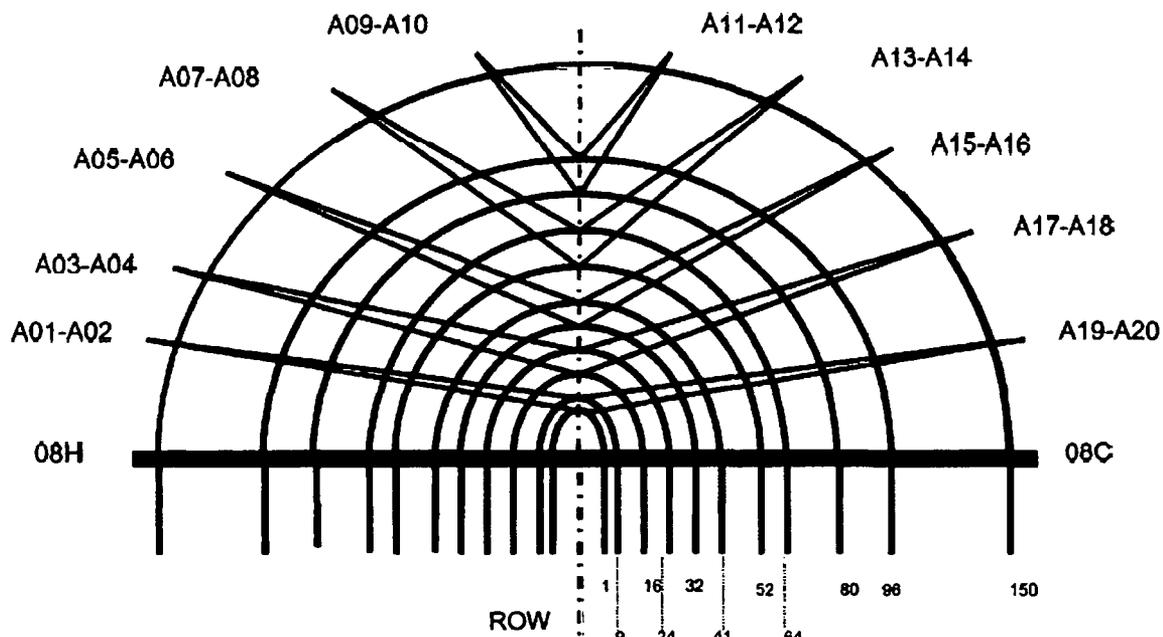
Figure 1
AVB Assemblies

- There are 10 AVB assemblies labeled A01-A20, A02-A19 through A10-A11 as shown in Figure 1.
- Pairs of AVB assemblies such as A01-A20 / A02-A19 originate from the same point at the outer periphery of the tube bundle as shown in Figure 1.

This design results in AVBs being very close to each other in certain areas of the U-bend making AVB locating and labeling challenging.

- All anti-vibration bars are installed.
- The depth of insertion for most of the bars is in accordance with the design information relative to the typical row where the AVB should intersect the tube. Minor differences between columns were noted to exist when locating a specific bar. Overall, the AVB bundle is uniform. It does not show any particular unexpected pattern and it is similar or better when compared with other SGs analyzed.
