5.0 Falls City, Texas, Disposal Site

5.1 Compliance Summary

6.0 Grand Junction, Colorado, Disposal Site

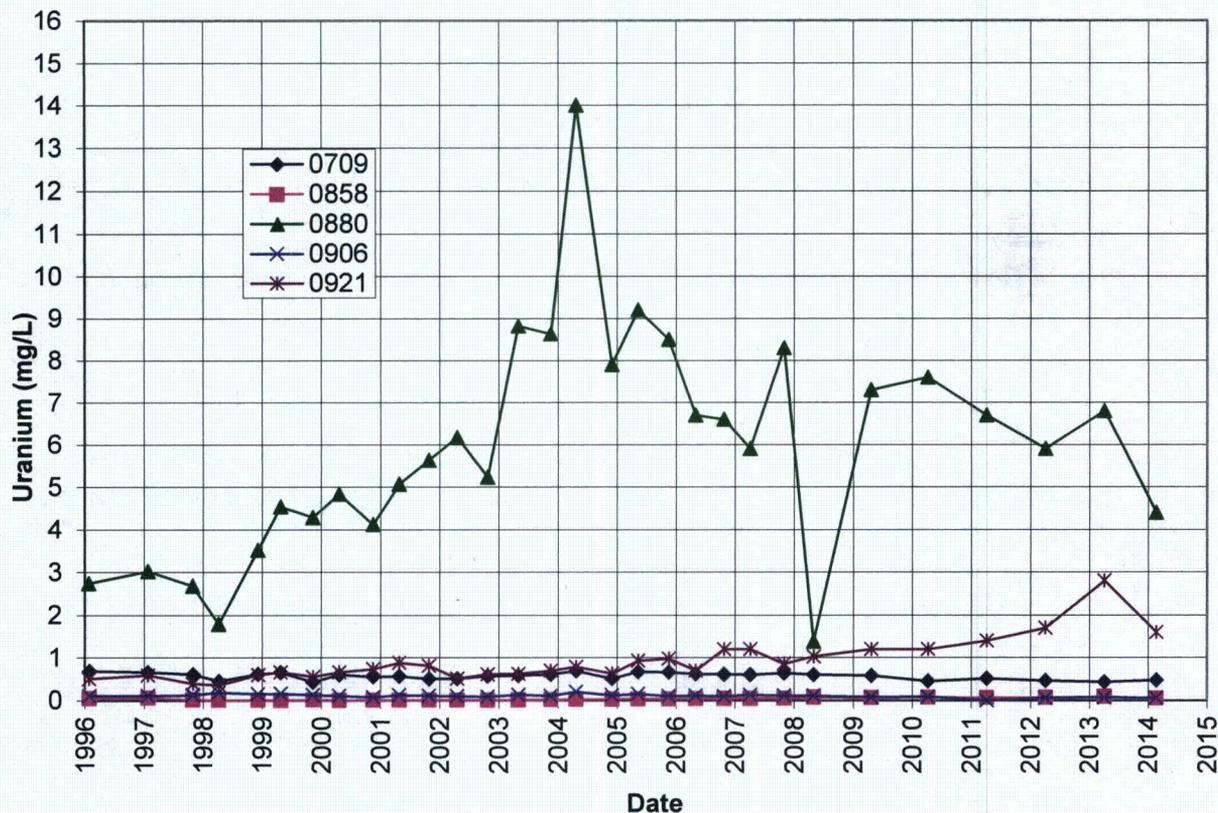
Figure 5-5. Uranium in Groundwater at Cell Performance Monitoring Locations at the Falls City Disposal Site

Uranium—Uranium concentrations in the cell performance wells remained within the historical range (Figure 5-5). Though the concentration in well 0921 decreased from the 2013 result, an overall upward trend has occurred since 2002. A downward trend has occurred in well 0880 since 2004. At well 0880, uranium concentrations have varied considerably, ranging from a low of 1.38 milligrams per liter (mg/L) in 2008 to a high of 14 mg/L in 2004. Wells 0908 and 0916 are not shown in Figure 5-5 because these wells have been dry since 1996.

Uranium concentrations in cell performance well 0880 have varied considerably (Figure 5-5). The pH at this location is lower than at other locations in the cell performance monitoring network. Water levels are also declining at well 0880 (Figure 5-7). These results suggest that the interaction among the disposal cell, the legacy groundwater mound, and processing plumes is still equilibrating. However, monitoring results do not indicate that the disposal cell is contributing to the degradation of the uppermost aquifer. The cause of the anomalously high uranium concentrations in groundwater compliance well 0891 since 2008 (Figure 5-6) has not been determined.

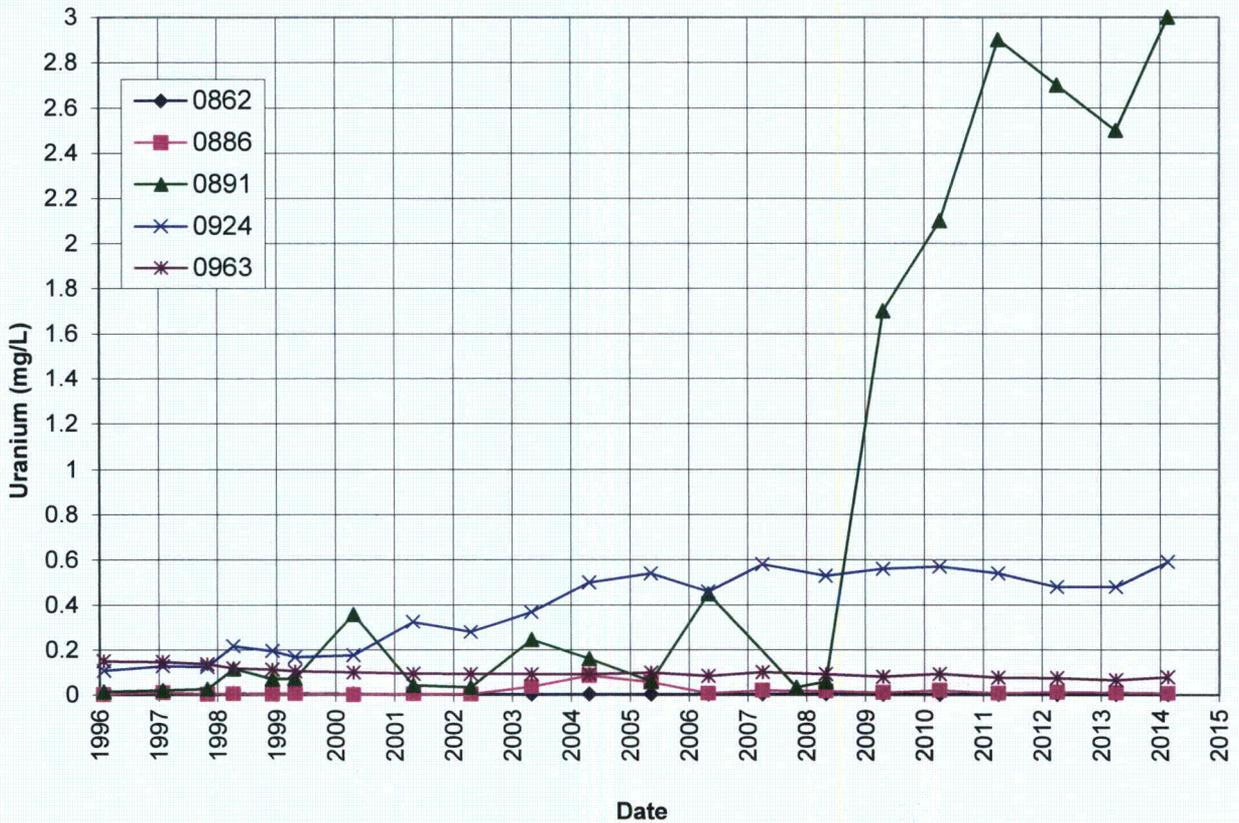
Figure 5-6. Uranium in Groundwater at Compliance Monitoring Locations at the Falls City Disposal Site

The concentration of uranium in groundwater within the compliance monitoring network shows that the uranium concentrations at monitoring wells 0862, 0886, and 0963 remain stable at low levels (<0.2 mg/L) (Figure 5-6). The uranium concentration in well 0924 has been relatively stable since 2004, fluctuating between 0.4 mg/L and 0.6 mg/L. Since 2008, the uranium concentrations measured at well 0891 have been significantly higher than the other wells. The 2014 result (3.0 mg/L) is the highest measured in the well to date and equals the maximum concentration reported for the aquifer, which is also the value used in the risk assessment for the Dilworth groundwater (3.04 mg/L).

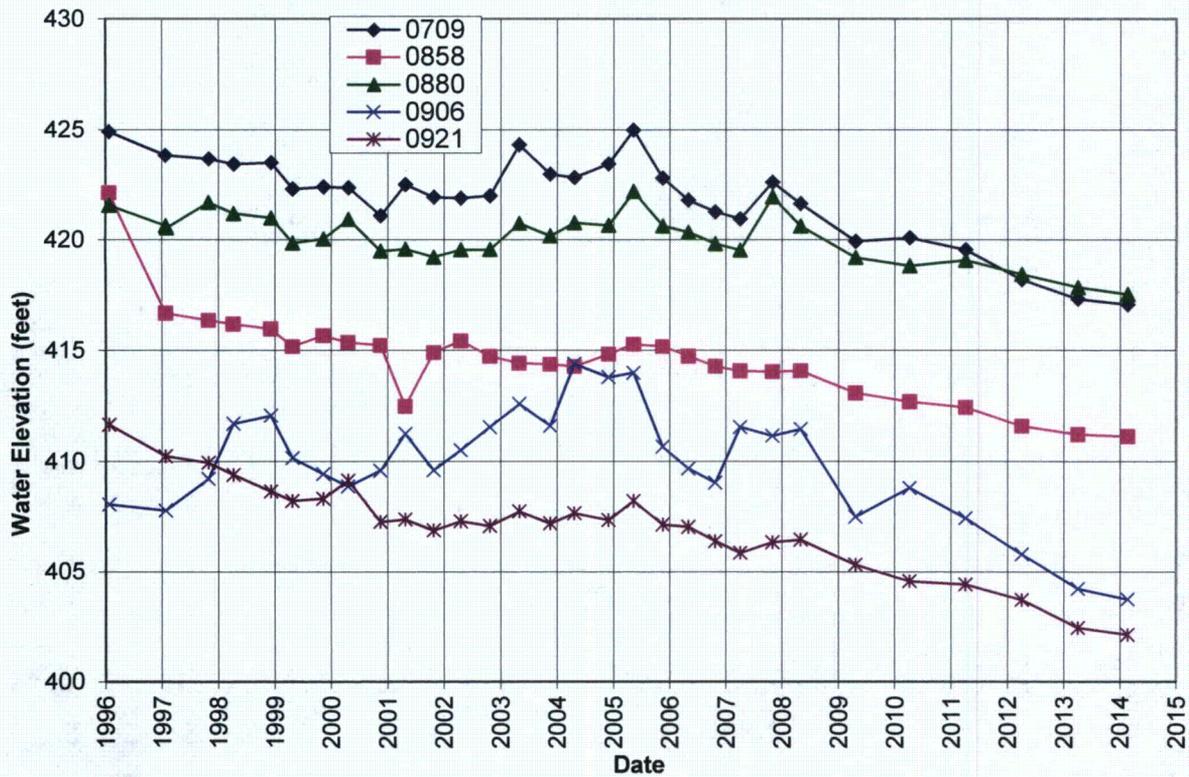
Figure 5-7. Water-Level Measurements at Cell Performance Monitoring Locations at the Falls City Disposal Site

Water levels measured in 2014 in the disposal cell performance network are new lows for each well (Figure 5-7). Since 1996, groundwater levels in the disposal cell performance network wells have all decreased, ranging from approximately 5 feet to 11 feet lower than 1996 levels. The water level in monitoring well 0906 has fluctuated more than levels in the other wells. This well is directly downslope of the disposal cell, and the historical fluctuation may be the result of the infiltration of water that is shed by and conveyed away from the disposal cell, reflecting variations in annual precipitation. Other contributors that may influence local groundwater levels include: (1) the dissipation of the processing-site-related groundwater mound beneath the disposal cell, and (2) the reduction of transient drainage from the disposal cell. Wells 0908 and 0916 are not shown in Figure 5-7 because these wells, completed in an unsaturated zone of the Conquista Sandstone, have been dry since 1996.

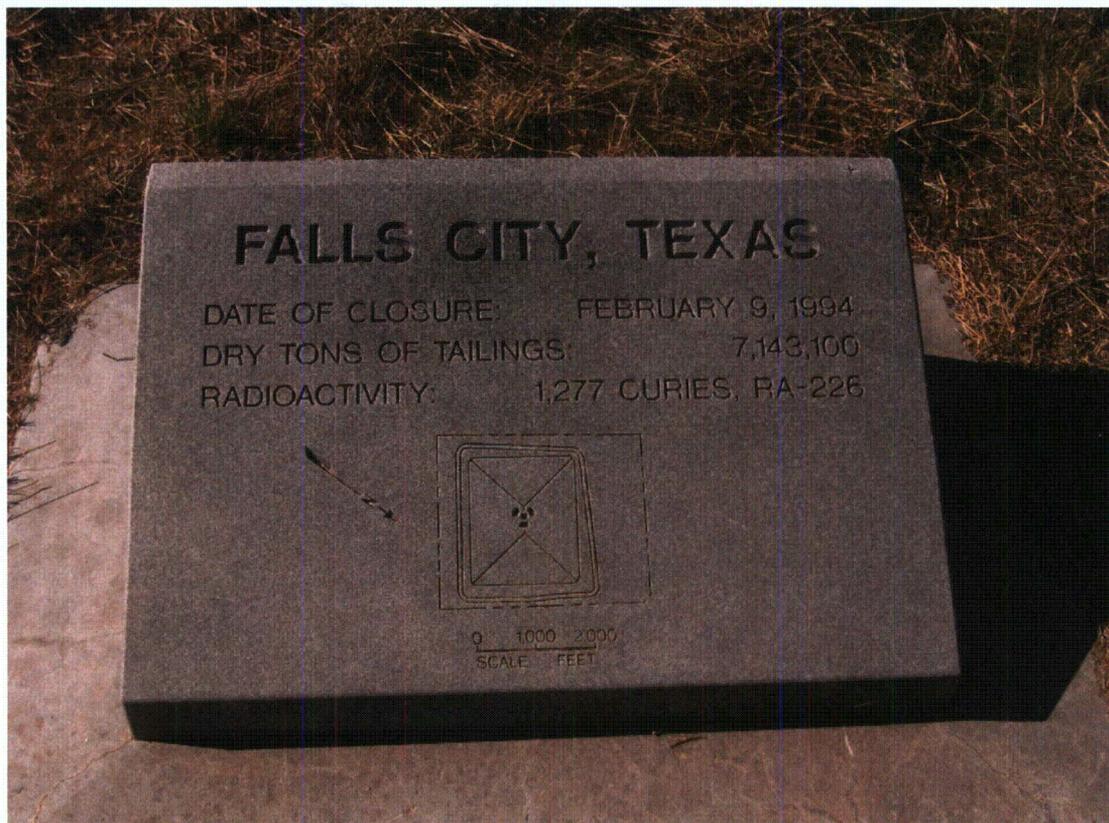
There are two site markers. The marker on top of the disposal cell (SMK-2) was in excellent condition (PL-1). The marker at the main entrance gate (SMK-1) was also in excellent condition (PL-2), but the corners of the concrete base that the marker sits on are cracked. The cracks appear to be unchanged from last year, and repairs are not needed at this time.

FCT 1/2014. PL-2. Site marker SMK-1.

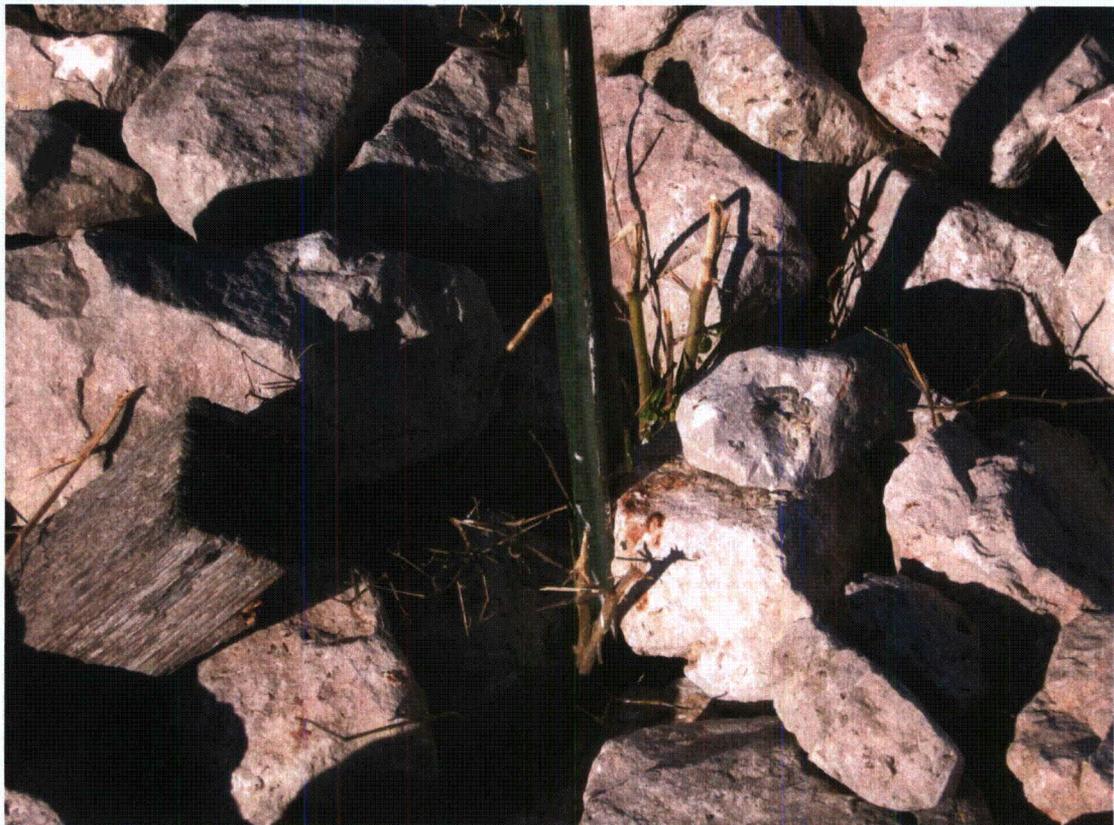
In 2007, inspectors noted a possible slight slumping of riprap at the toe of the south corner of the side slope. Three t-posts were installed in a straight line running at an orientation of 317 degrees in 2008. Each post was installed at a vertical pitch of 90 degrees. These three posts provide

FCT 1/2014. PL-6. Riprap at base of Post 4.

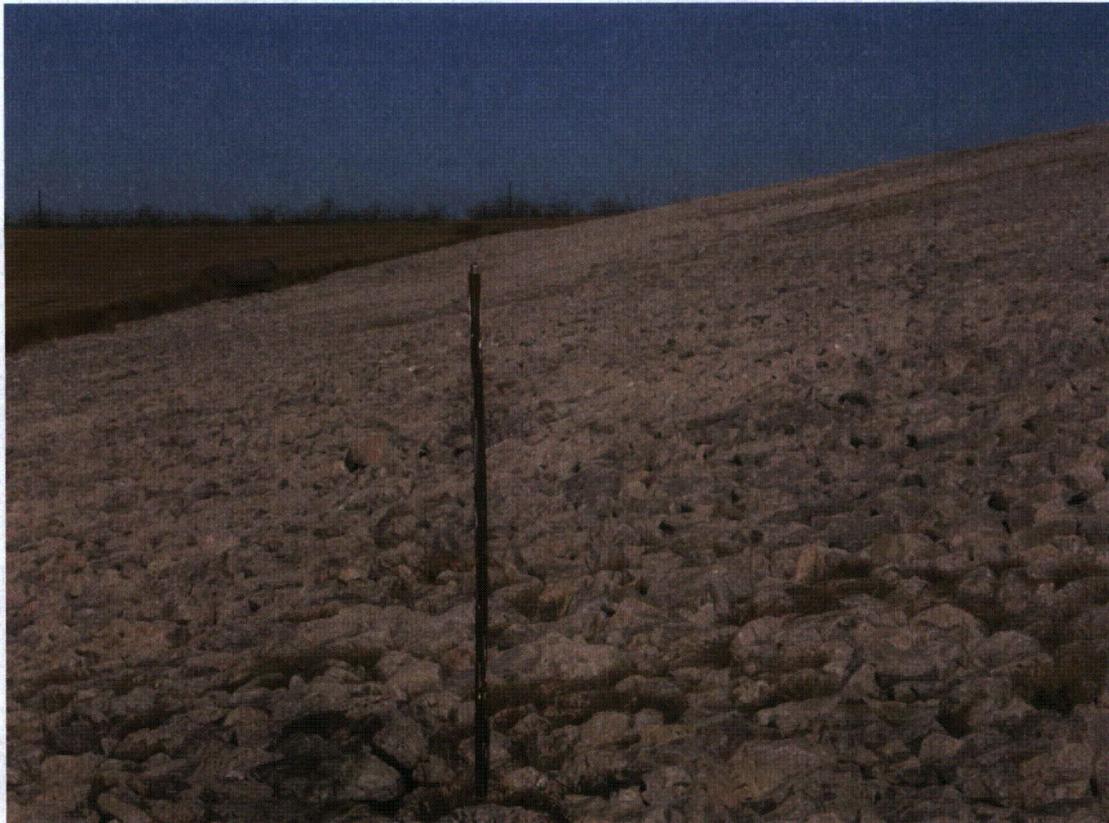
FCT 1/2014. PL-7. Line of slope stability indicator posts at south corner of cell.

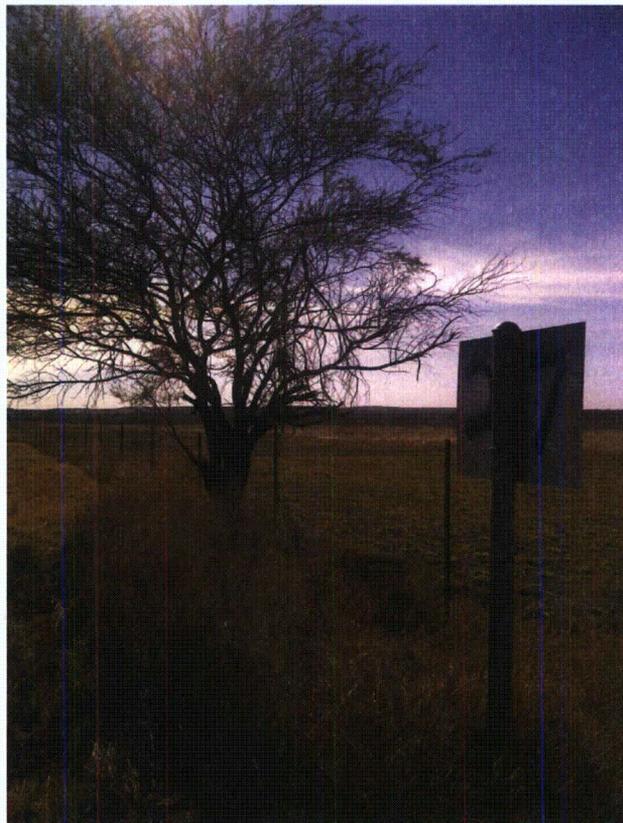
FCT 1/2014. PL-10. Huisache tree.

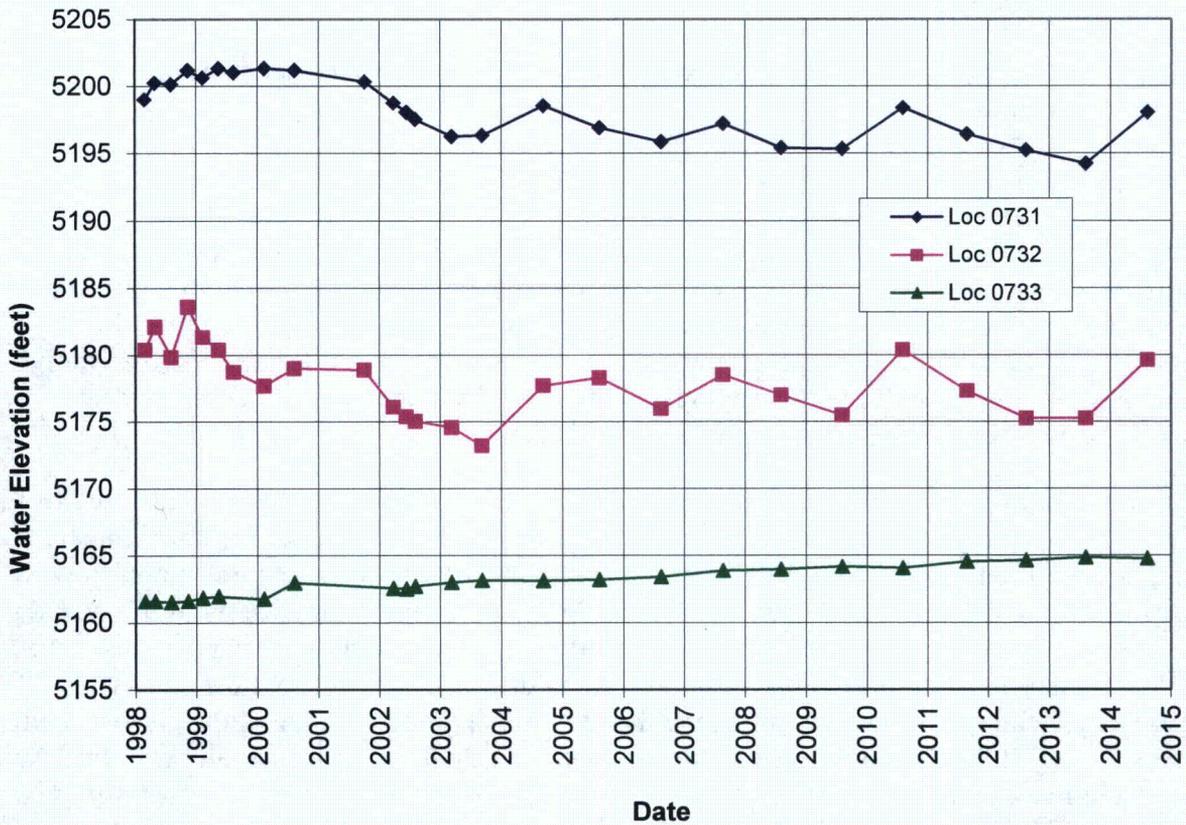
Figure 6-2. Water Level Measurements at the Grand Junction Disposal Site

Since 1998, the water level in disposal cell well 0733 has apparently stabilized over the last few years and has remained substantially lower than the water levels in paleochannel monitoring wells 0731 and 0732 (Figure 6-2). Water levels within the two paleochannel monitoring wells continue to fluctuate and are currently near 1998 levels. The water levels verify that groundwater at the base of the disposal cell at well 0733 has not risen to an elevation where it could potentially migrate into paleochannel groundwater at wells 0731 and 0732.

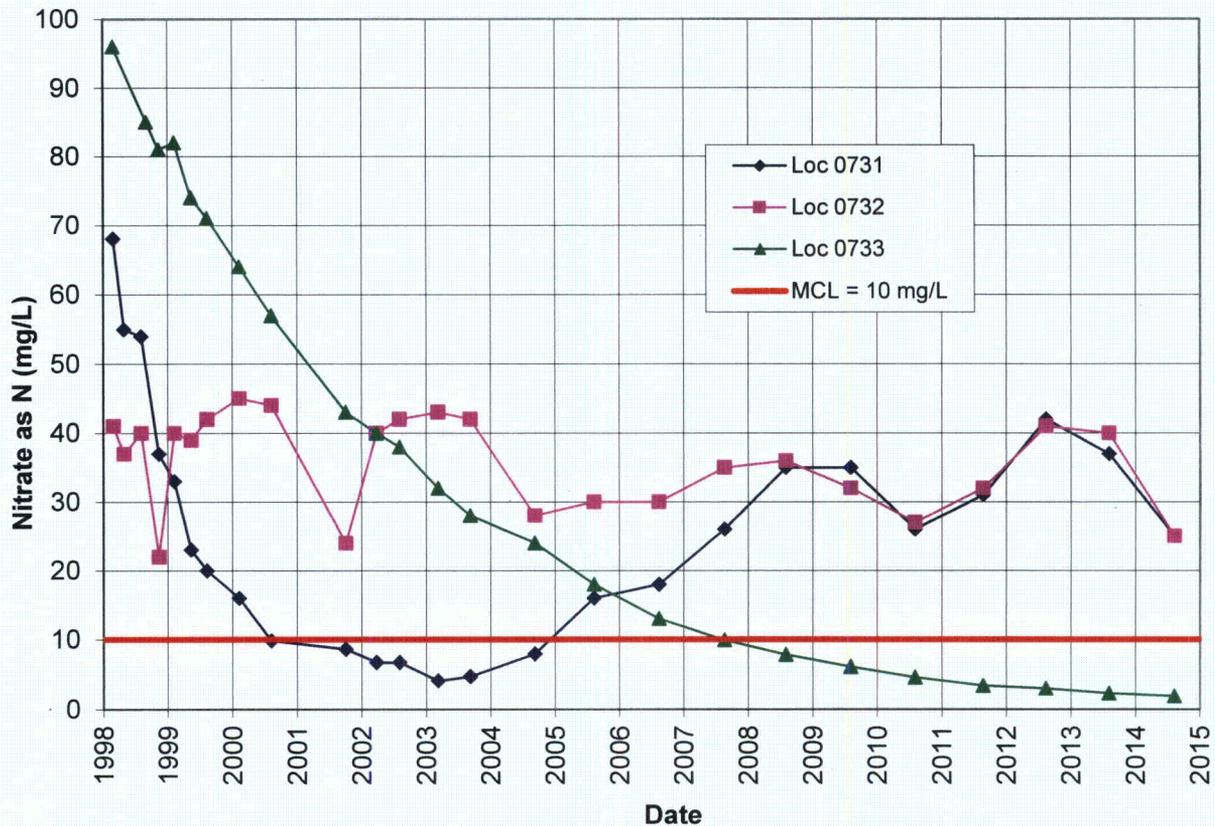
Figure 6-3. Time-Concentration Plots of Nitrate (as Nitrogen) in Groundwater at the Grand Junction Disposal Site

Nitrate (as nitrogen) concentrations in groundwater continued to exceed the MCL of 10 mg/L in the paleochannel monitoring wells (0731 and 0732) in 2014 (Figure 6-3). Concentrations in these wells have varied substantially since 1998 with no overall trend. Nitrate concentrations in disposal cell well 0733 have shown a continuous downward trend since 1999 and reached a low of 1.9 mg/L in 2014. There is no apparent correlation of nitrate concentrations between the paleochannel wells and the disposal cell well.

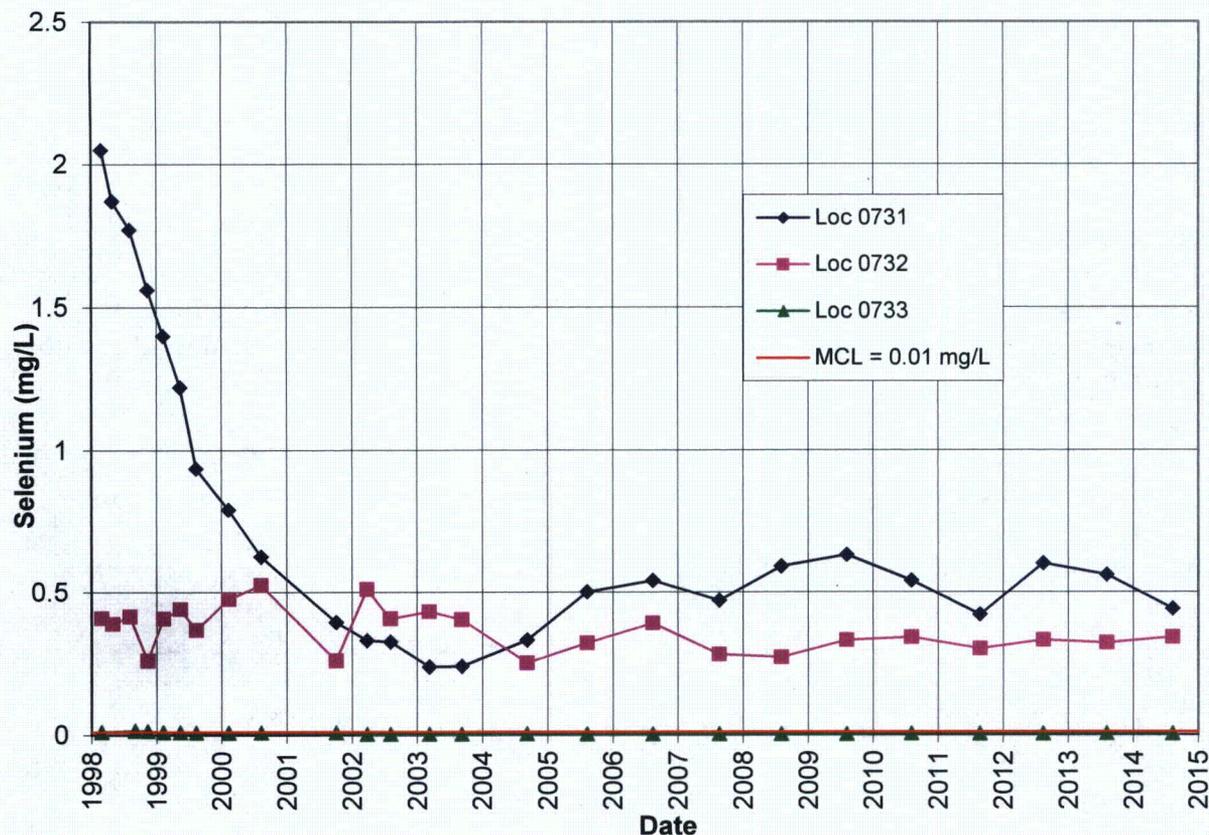
Figure 6-4. Time-Concentration Plots of Selenium in Groundwater at the Grand Junction Disposal Site

Selenium concentrations continued to exceed the MCL of 0.01 mg/L in the paleochannel monitoring wells (0731 and 0732), with no apparent trend in either well since 2001 (Figure 6-4). Selenium occurs naturally in the Mancos Shale deposits that underlie the disposal cell, and it

may be the cause of the elevated concentrations reported in both paleochannel monitoring wells. In well 0733, the selenium concentration of 0.0038 mg/L remained well below the MCL, with no trend evident. There is no apparent correlation of selenium concentrations between the paleochannel wells and the disposal cell well.

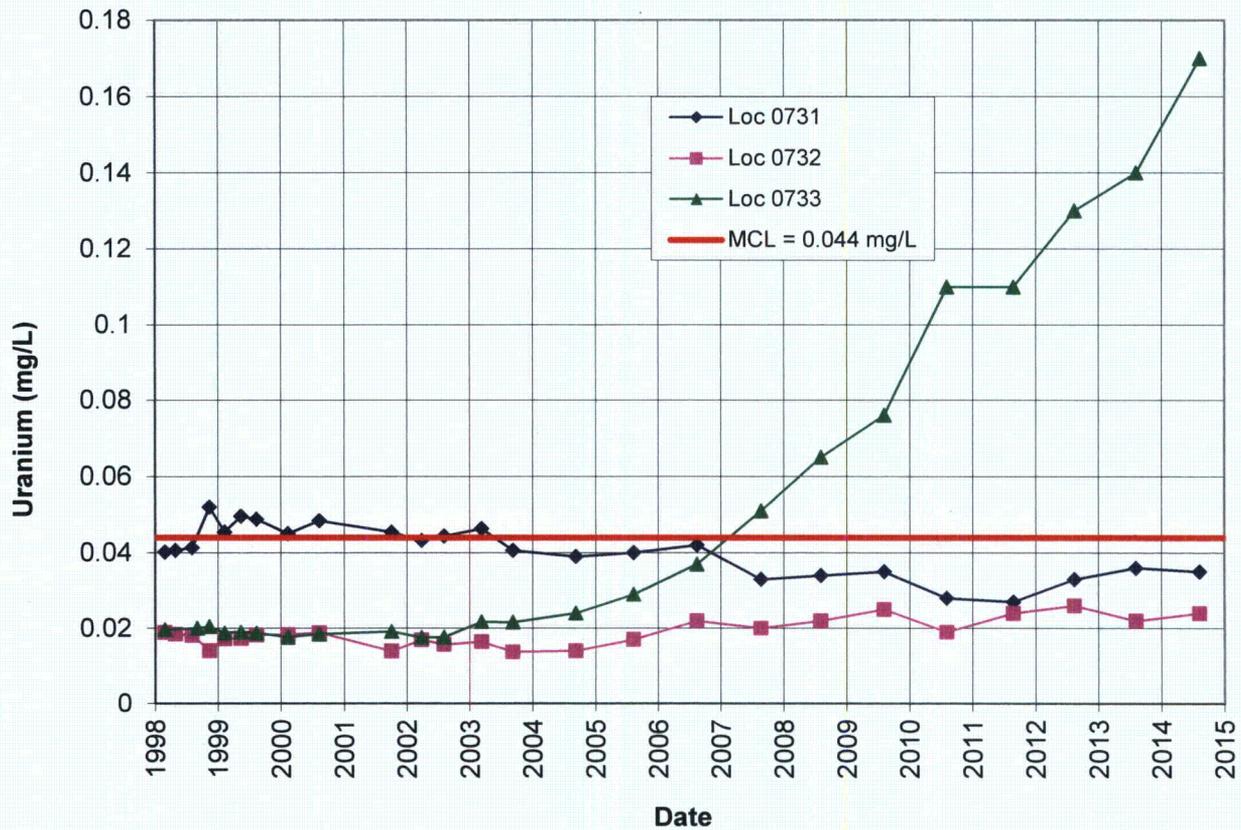
Figure 6-5. Time-Concentration Plots of Uranium in Groundwater at the Grand Junction Disposal Site

Uranium concentrations in groundwater continued to be below the MCL of 0.044 mg/L in wells 0731 and 0732, showing no apparent trend since 2007 (Figure 6-5). The uranium concentration in well 0733 continued to be above the MCL and continued an upward trend; the 2014 concentration was 0.17 mg/L. There is no apparent correlation of uranium concentrations between the paleochannel wells and the disposal cell well.

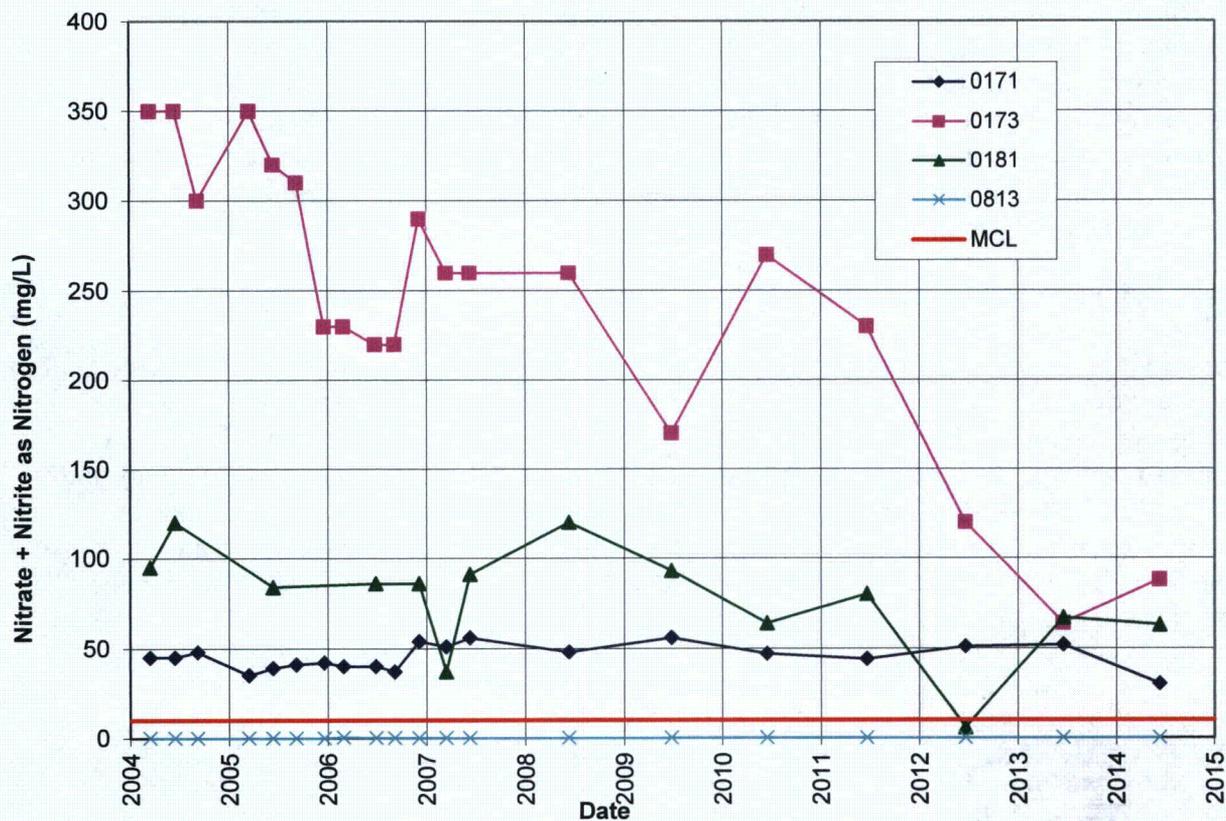
Figure 7-2. Time-Concentration Plots of Nitrate in Groundwater at the Green River Disposal Site

Nitrate concentrations have been measured as nitrate plus nitrite reported as nitrogen since early 2004 (before then, nitrate was reported as NO₃). Concentrations continued to exceed the LTSP limits in wells 0171 and 0173, but they are considerably below the proposed ACL of 1,000 mg/L. 2014 nitrate concentrations in the wells are similar to previous measurements, with an overall decreasing trend in well 0173 (Figure 7-2).

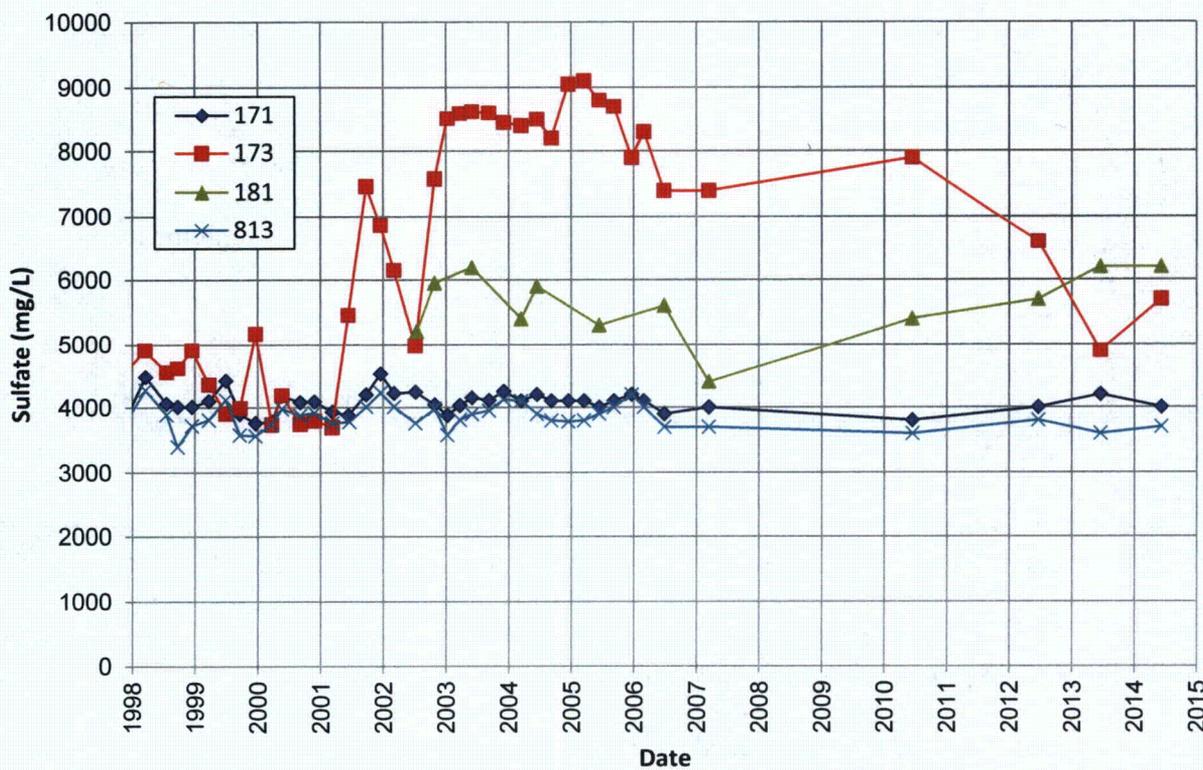
Figure 7-3. Time-Concentration Plot of Sulfate in Groundwater at the Green River Disposal Site

Sulfate concentrations continue to exceed the LTSP limits in all POC wells except 0813. The 2014 concentrations were within historical results, showing a downward trend in well 0173 since 2004 and an upward trend in well 0181 since 2006 (Figure 7-3).

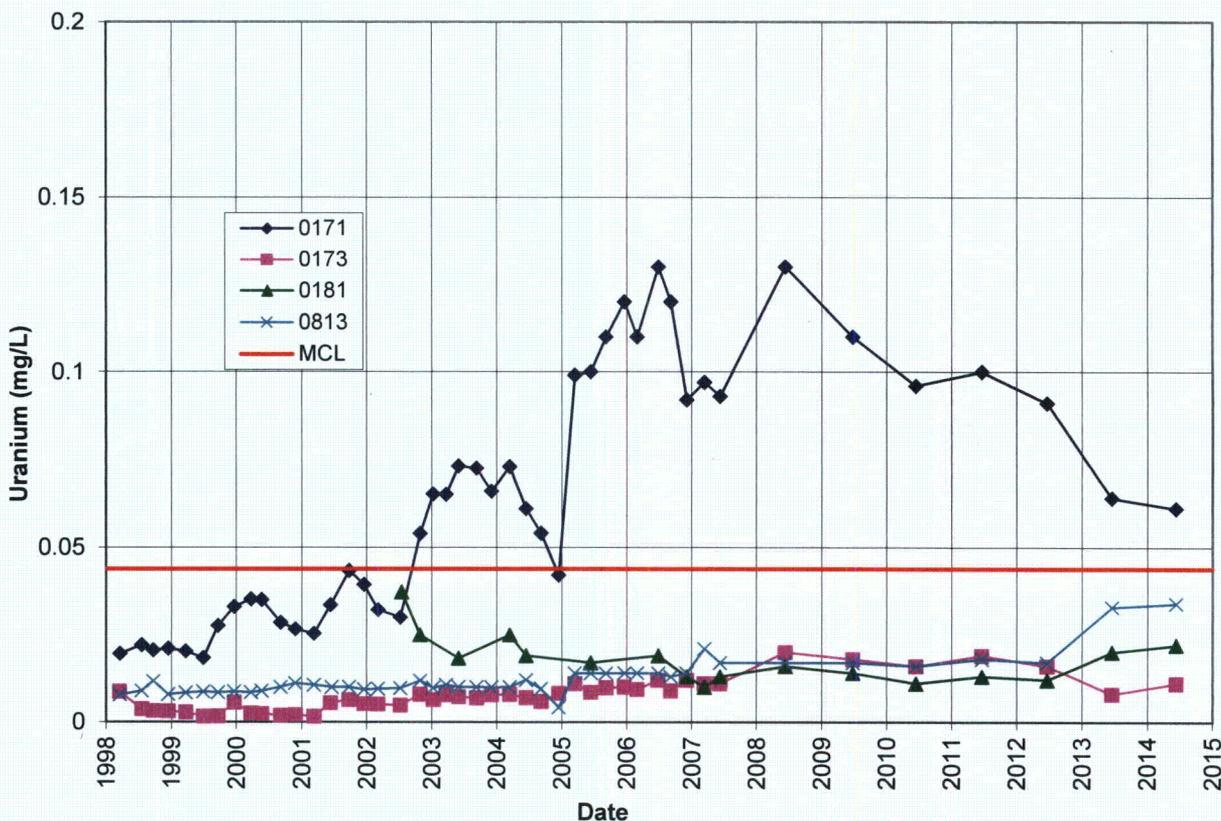
Figure 7-4. Time-Concentration Plot of Uranium in Groundwater at the Green River Disposal Site

Uranium concentrations in groundwater remain below the LTSP limits in all POC wells except well 0171, and remain considerably below the proposed ACL of 4.4 mg/L in all POC wells (Figure 7-4). Uranium concentrations at well 0171 have varied considerably, ranging from a low of 0.0184 mg/L in 1999 to a high of 0.13 mg/L in 2006 and again in 2008. Concentrations have steadily decreased since 2008 to a 2014 concentration of 0.061 mg/L. No conclusions regarding the variability of uranium concentrations in well 0171 have been reached.

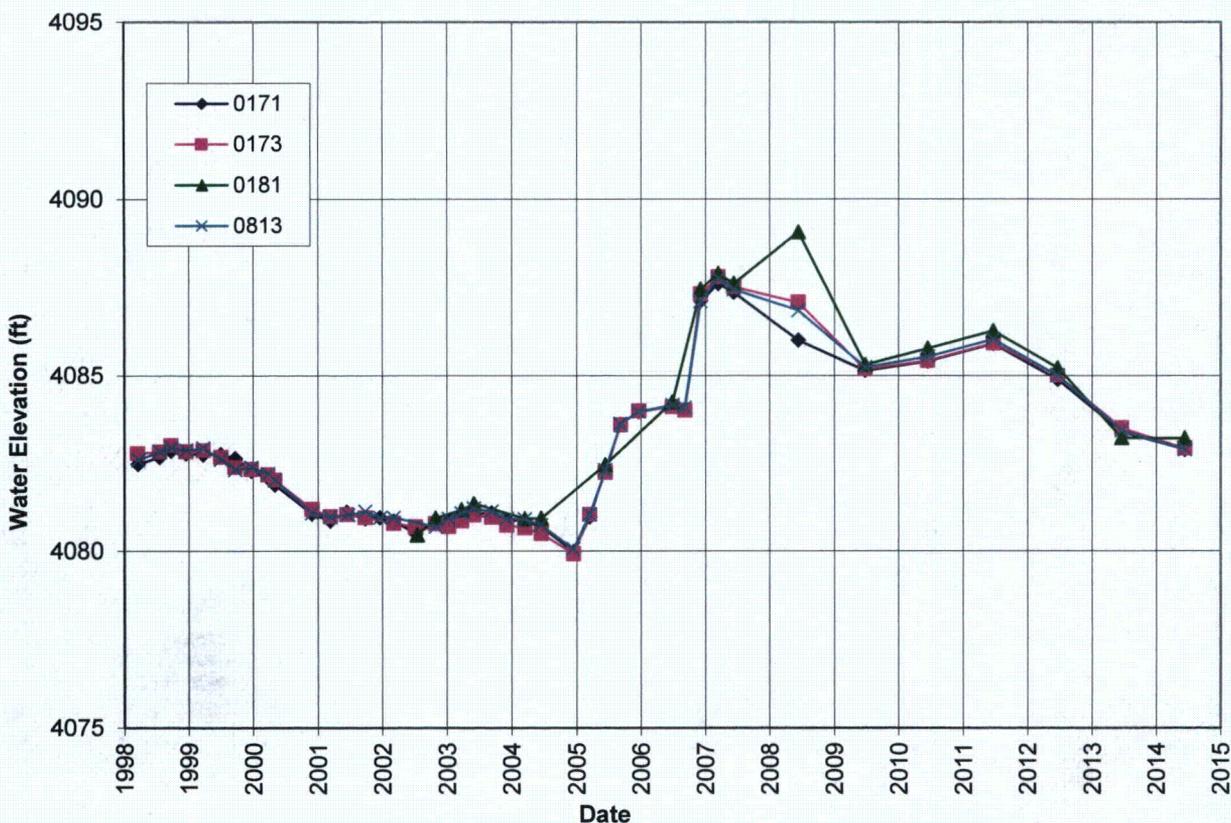
Figure 7-5. Groundwater Elevations at the Green River Disposal Site

Water level hydrographs of the POC wells, completed in the middle sandstone aquifer, indicate that the groundwater elevation decreased approximately 3 feet overall from 1998 through 2004, and then increased approximately 8 feet between 2004 and 2007. Water levels have decreased approximately 4 to 5 feet since 2007 (Figure 7-5). Historically, rainfall measurements recorded

at a precipitation gauge near well 0171 did not correlate with water level changes in the POC wells, so the uppermost aquifer is not being directly recharged by rainfall in the disposal cell watershed. Therefore, this relationship is no longer being evaluated.
