8.0 Gunnison, Colorado, Disposal Site

8.1 Compliance Summary

The Gunnison, Colorado, Uranium Mill Tailings Radiation Control Act (UMTRCA) Title I Disposal Site was inspected on June 11, 2014. The disposal cell and all associated surface water diversion and drainage structures were in excellent condition and functioning as designed. Six riprap test areas on the cell apron and diversion ditches were visually inspected; no rock degradation was noted when compared to 2012 photos. Inspectors identified no maintenance needs or cause for a follow-up inspection.

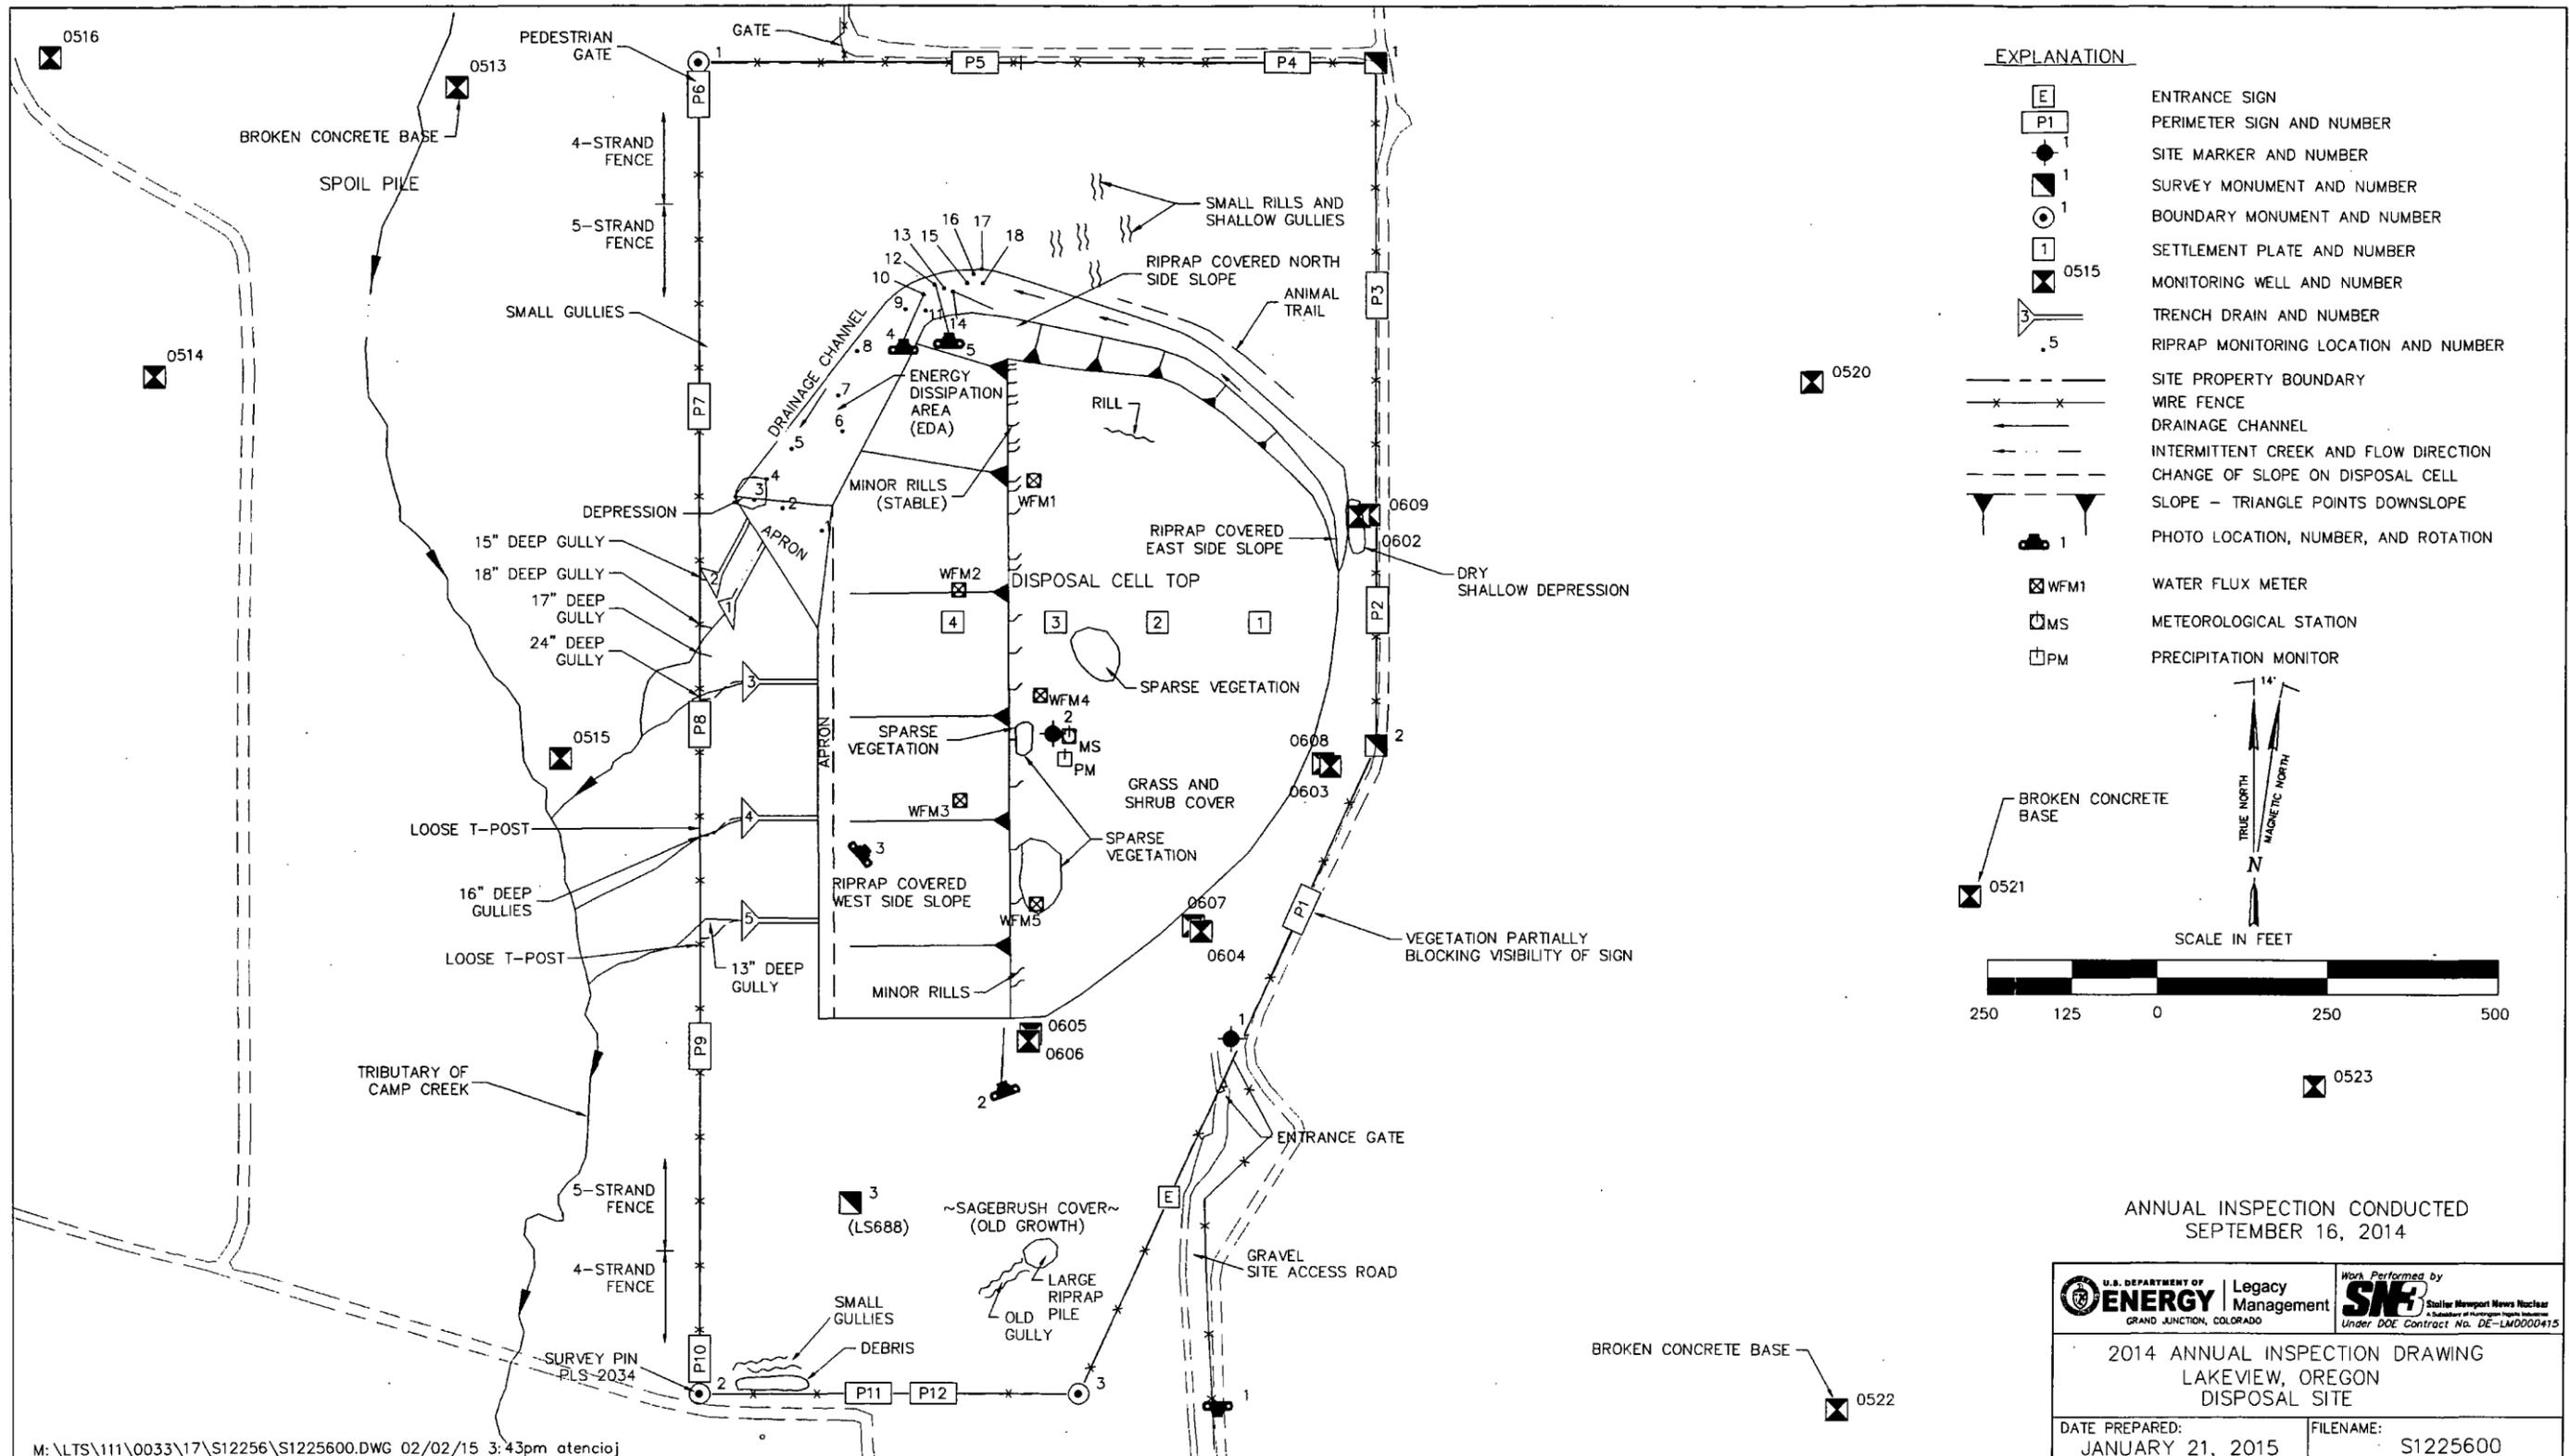
Figure 9-1. 2014 Annual Inspection Drawing for the Lakeview Disposal Site

The locations of site surveillance features are shown on Figure 9-1. Inspection results and recommended maintenance activities associated with site surveillance features are included in the following subsections. Photographs to support specific observations are identified in the text and on Figure 9-1 by photograph location (PL) numbers.

The two site markers, SMK-1 near the site entrance and SMK-2 on top of the disposal cell, were in good condition.

The three survey monuments and three boundary monuments were in good condition.

The groundwater monitoring network comprises eight onsite point-of-compliance (POC) wells located east and south of the cell and one upgradient well located offsite to the west of the disposal site. All nine wells were inspected and were locked, labeled, and in good condition.

Seven additional DOE-owned monitoring wells exist on privately owned property near the site but are not part of the groundwater compliance monitoring network. These wells were also inspected and were locked, labeled, and in fair condition. Of the five offsite wells with concrete surface pads, three of the pads were cracked or broken and had some soil undercutting from water and wind erosion.

Riprap was observed through the soil on the top slope in numerous small areas during the inspection. The areas ranged in size from approximately 4 inches to 2.5 feet. These areas are intermittently located across the top slope and are likely caused by the infilling of the soil into the riprap-void spaces below. No structural or cell performance concerns are associated with the riprap becoming visible on the top slope.

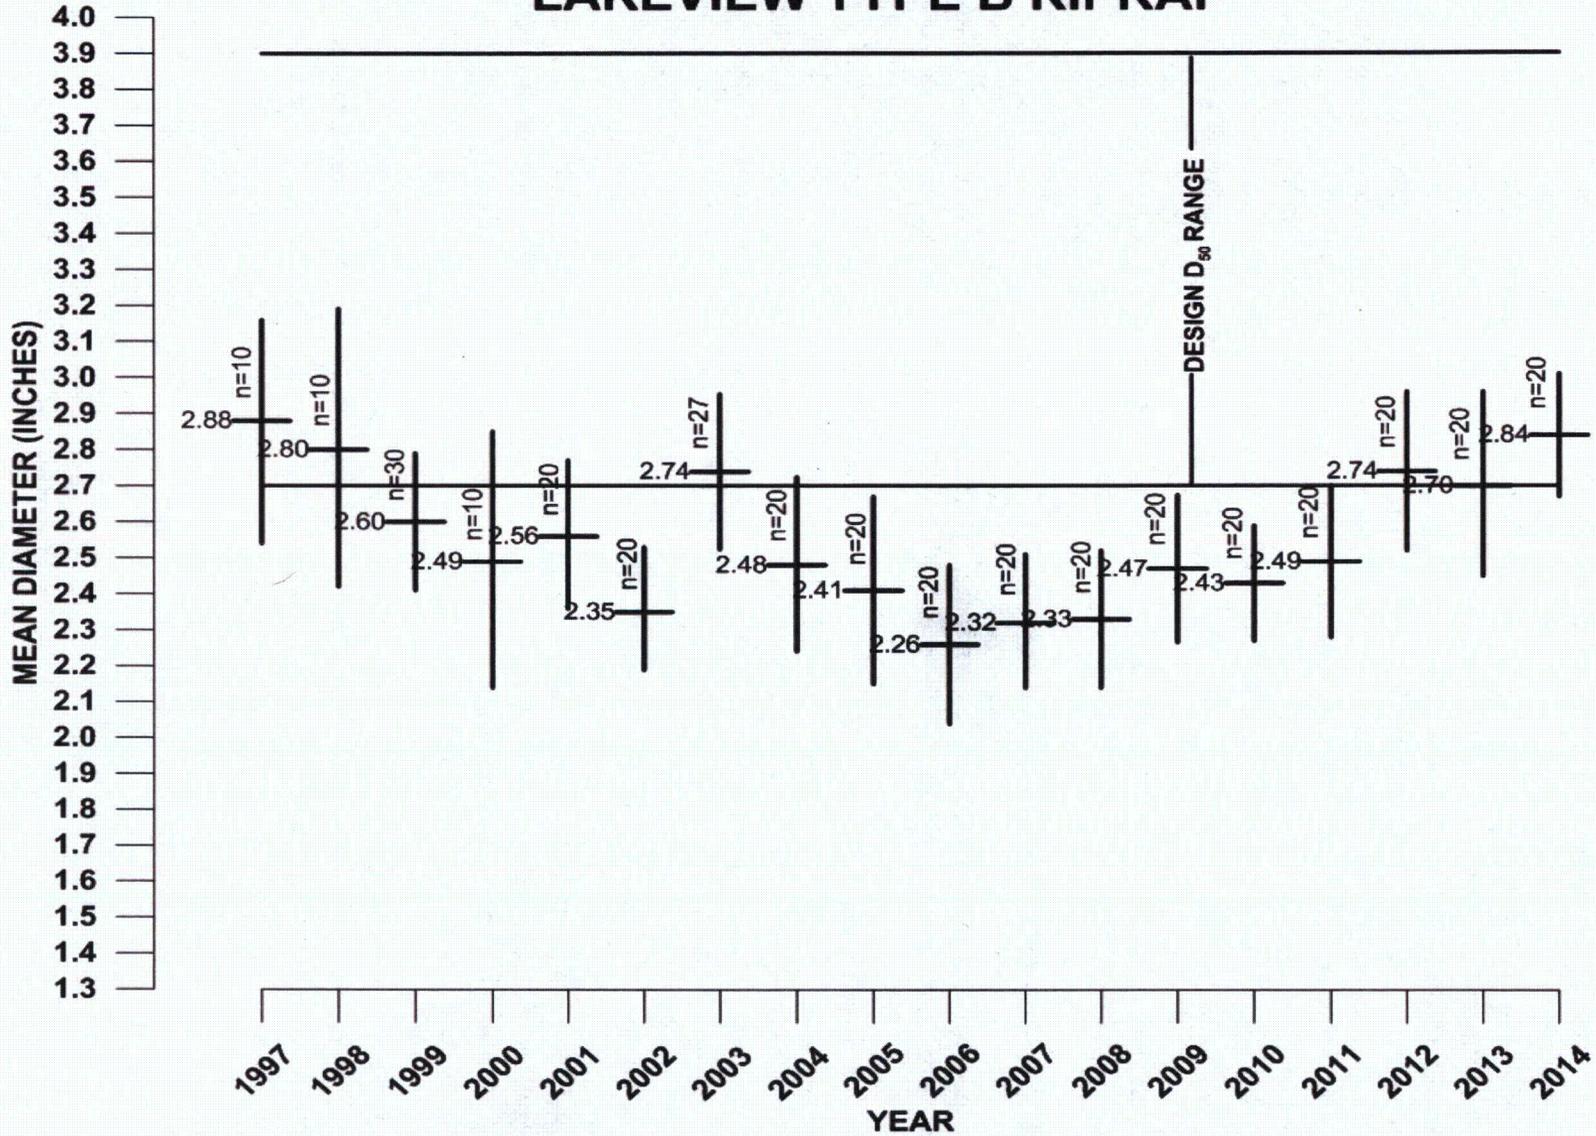
Figure 9-2. Riprap Gradation Monitoring

- 9A In 2014, the gradation monitoring was performed for the 18th consecutive year. Figure 9-2 is a graph that shows the results of the gradation monitoring since 1997. Using the results shown in Figure 9-2, the average D_{50} value for the 18-year period of monitoring is 2.55 inches. An evaluation of the 2014 rock size measurement data indicates that the west side slope riprap D_{50} is 2.84 inches with a 95 percent confidence interval between 2.67 and 3.01 inches. The D_{50} value is 0.14 inch larger than the value of 2.70 inches measured during the 2013 gradation monitoring. The west side slope is shown in photo PL-2 and monitoring is shown in photo PL-3.

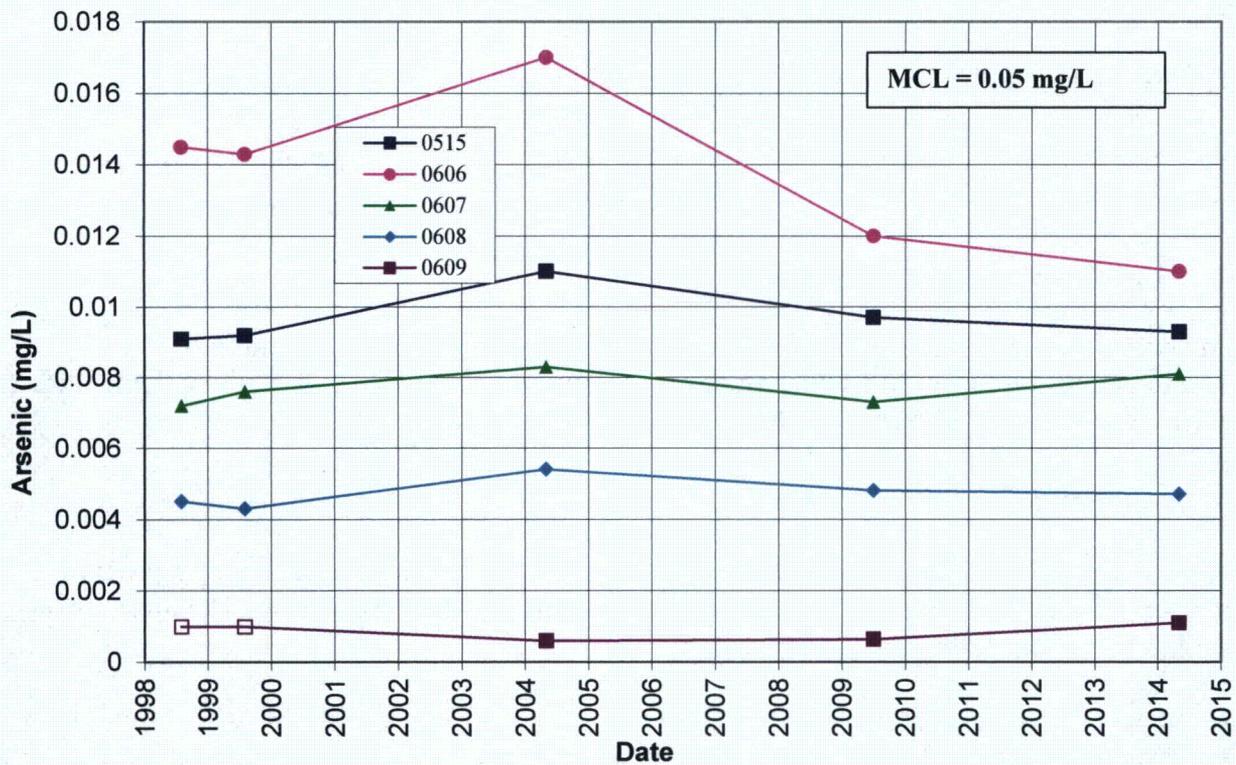
Figure 9-3. Time-Concentration Plot of Arsenic in Groundwater at the Lakeview Disposal Site

Constituents analyzed every 5 years include arsenic, cadmium, and uranium. Their maximum concentration limits (MCLs), established by the U.S. Environmental Protection Agency in Table 1 to Subpart A of 40 CFR 192, are 0.05 milligram per liter (mg/L) for arsenic, 0.01 mg/L for cadmium, and 0.044 mg/L for uranium. Concentrations of these constituents continued to remain significantly below their respective limits in 2014. Arsenic concentrations were similar to the 2009 results (Figure 9-3), all but one cadmium concentration result were below the laboratory detection limit of 0.00012 mg/L (Figure 9-4), and uranium concentrations remained stable or slightly increased (Figure 9-5). Based on the monitoring results to date, there is no indication of any degradation of groundwater near the site. The next cell performance monitoring is scheduled for 2019.

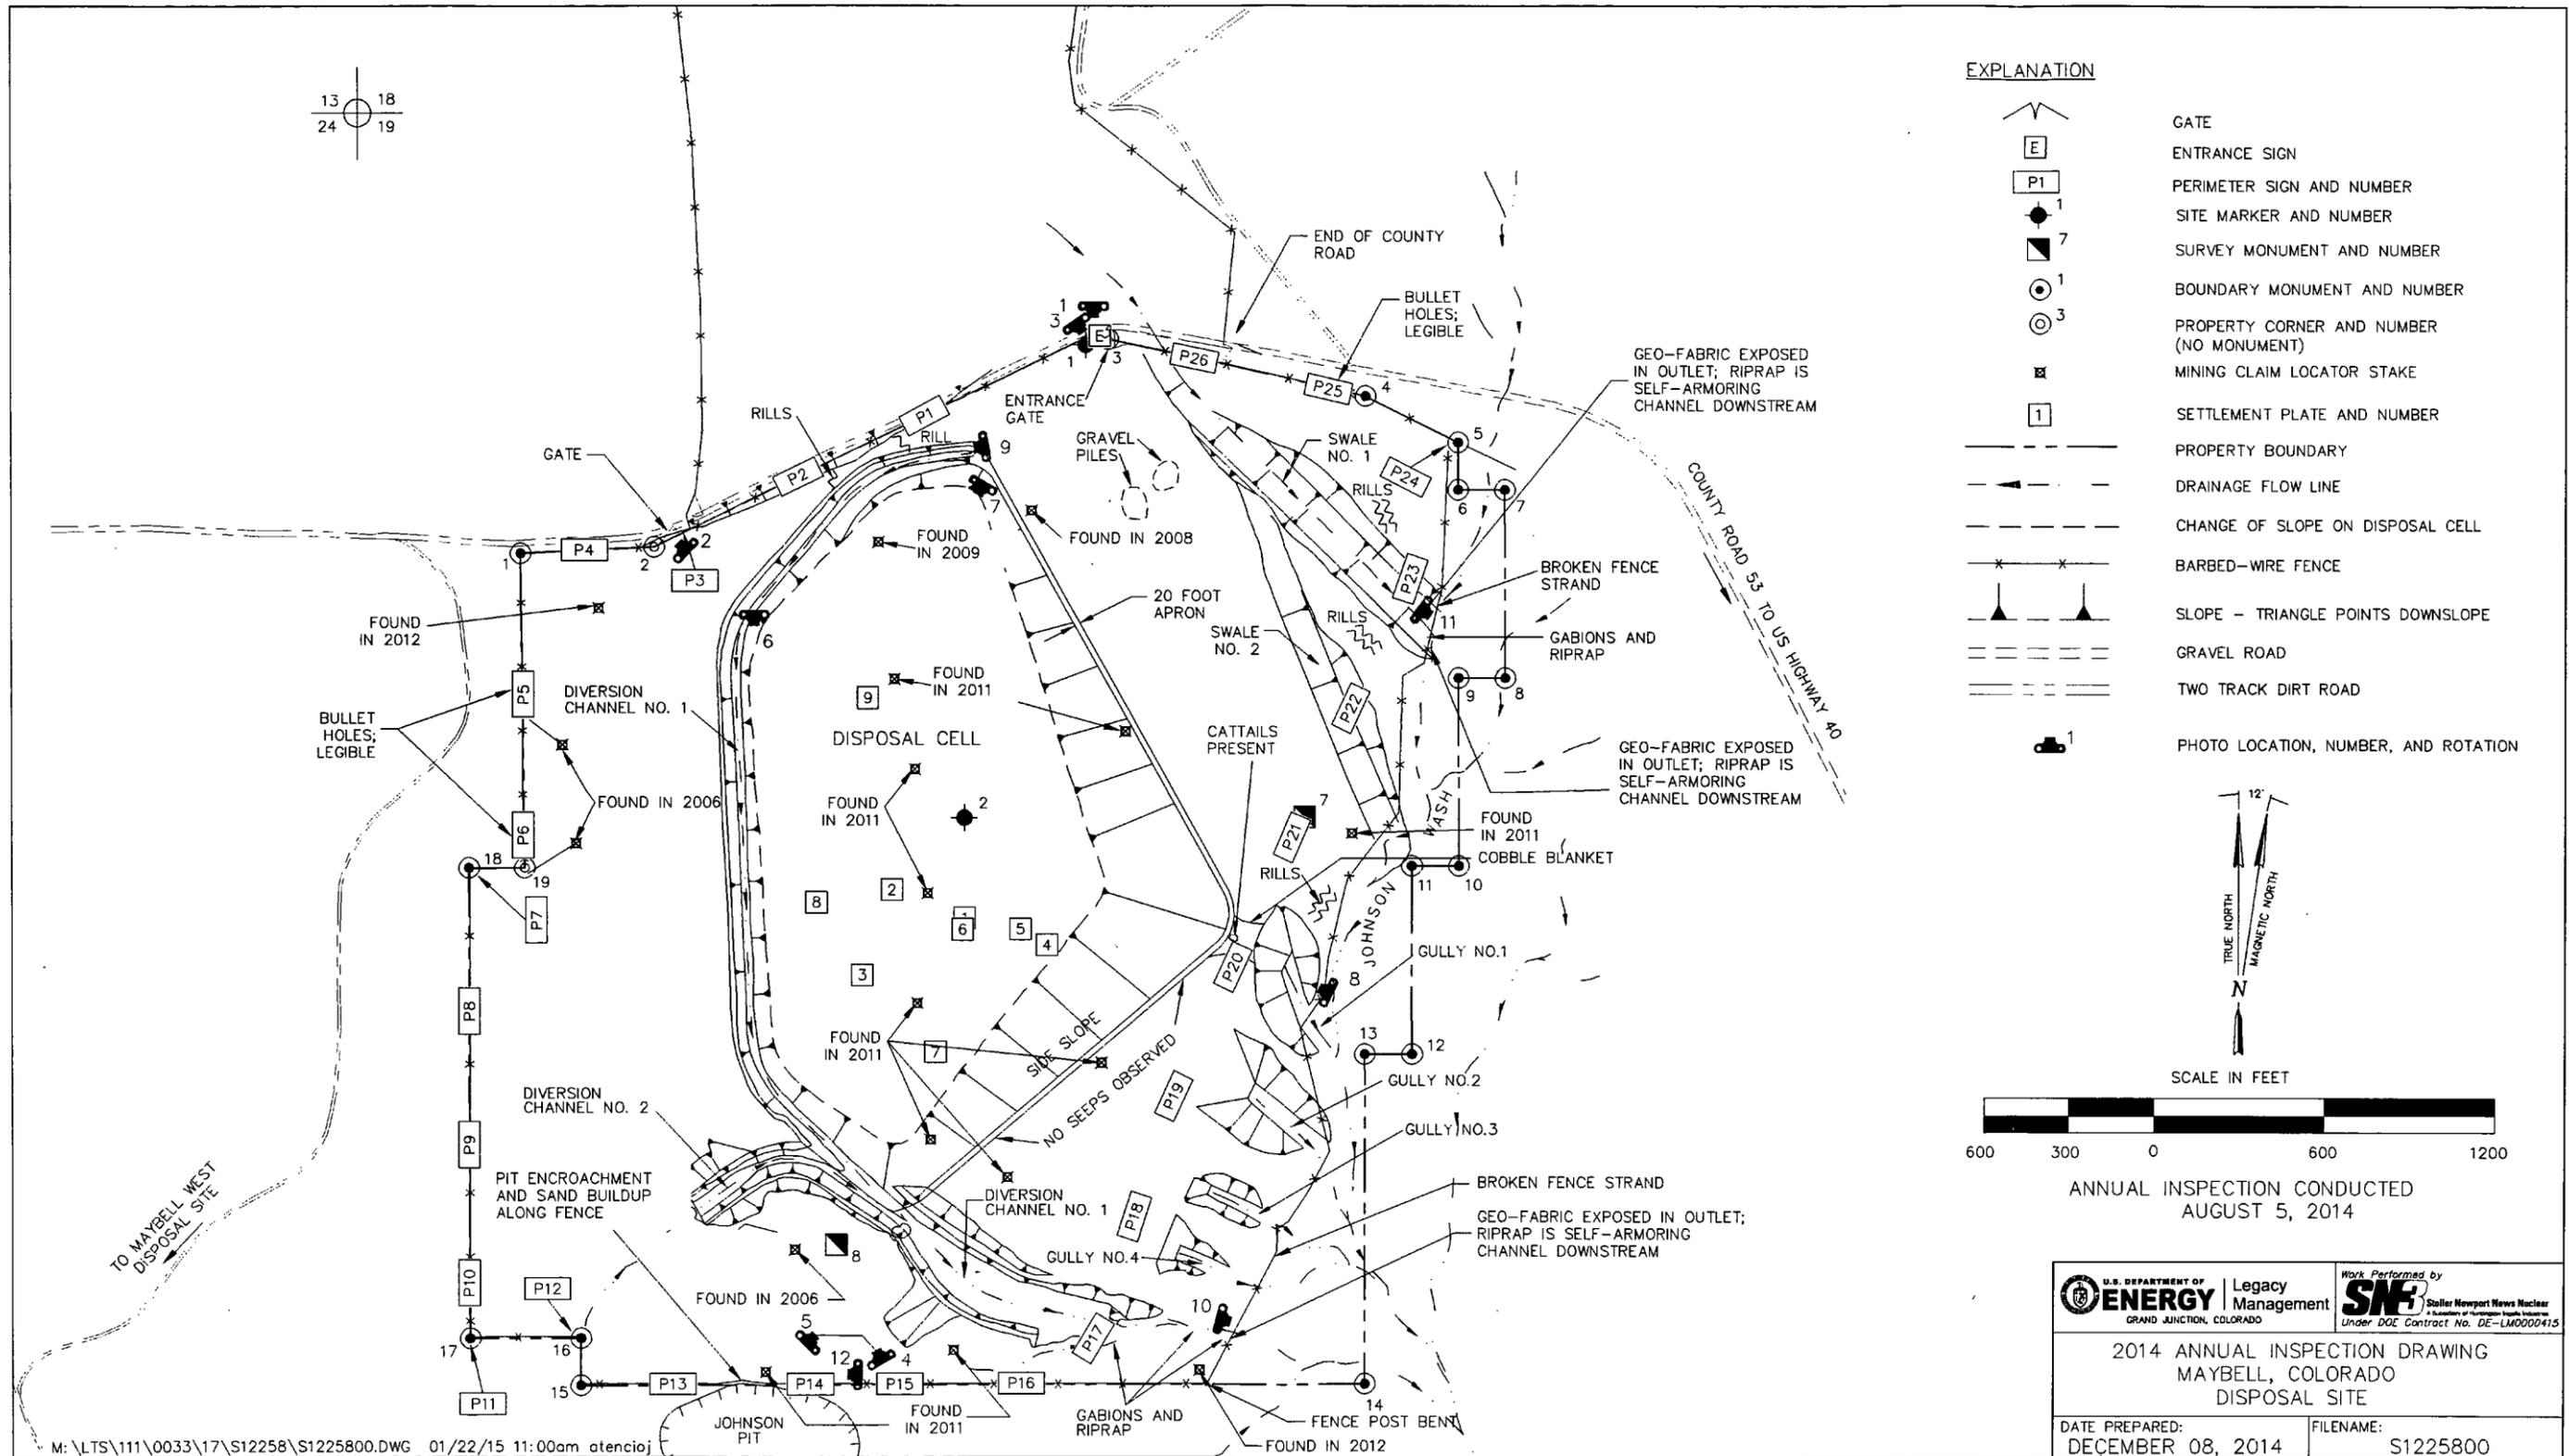
Figure 11-1. 2014 Annual Inspection Drawing for the Maybell Disposal Site

Two gates are located in the perimeter fence along the north boundary of the site. One is considered the site entrance gate and is located adjacent to the site marker and entrance sign (PL-1). The second gate is located directly west of perimeter sign P3 in the northwest corner of the property (PL-2). Both gates are standard tubular metal stock gates and were locked and in good condition.

A standard four-strand barbed-wire stock fence surrounds the disposal cell and drainage structures. The site is located in wintering grounds frequented by big game animals (primarily pronghorn, deer, and elk) and is also surrounded by open range used to graze cattle. As a result, minor damage to the perimeter fence occurs periodically. With the exception of broken top strands at two locations, the fence was in good condition. Repairs of these broken strands will occur when more significant repairs are needed.

11B Originally, four boundary monuments had been installed along the property boundary. These four monuments, however, did not adequately represent the site property boundary. Therefore, additional monuments were installed in September 2002. A 2008 real property assessment noted that the 2002 land survey did not match the legal description included in the BLM permanent withdrawal for the site. BLM confirmed that the perimeter fence along the north and northwest sides of the site corresponds to the actual site boundary and that nine of the new boundary monuments outside the fence in that area were located outside the property boundary. BLM recommended in 2014 that DOE leave those nine monuments in place to avoid the cost of removing them. Figure 11-1 shows the correct boundary monuments and property corners. All boundary monuments observed during the inspection were in good condition.
