12.0 Mexican Hat, Utah, Disposal Site

12.1 Compliance Summary

The Mexican Hat, Utah, Uranium Mill Tailings Radiation Control Act (UMTRCA) Title I Disposal Site was inspected on April 15, 2014. The disposal cell was in excellent condition. A broken perimeter fence strand was repaired. No additional maintenance needs or cause for a follow-up inspection was identified.

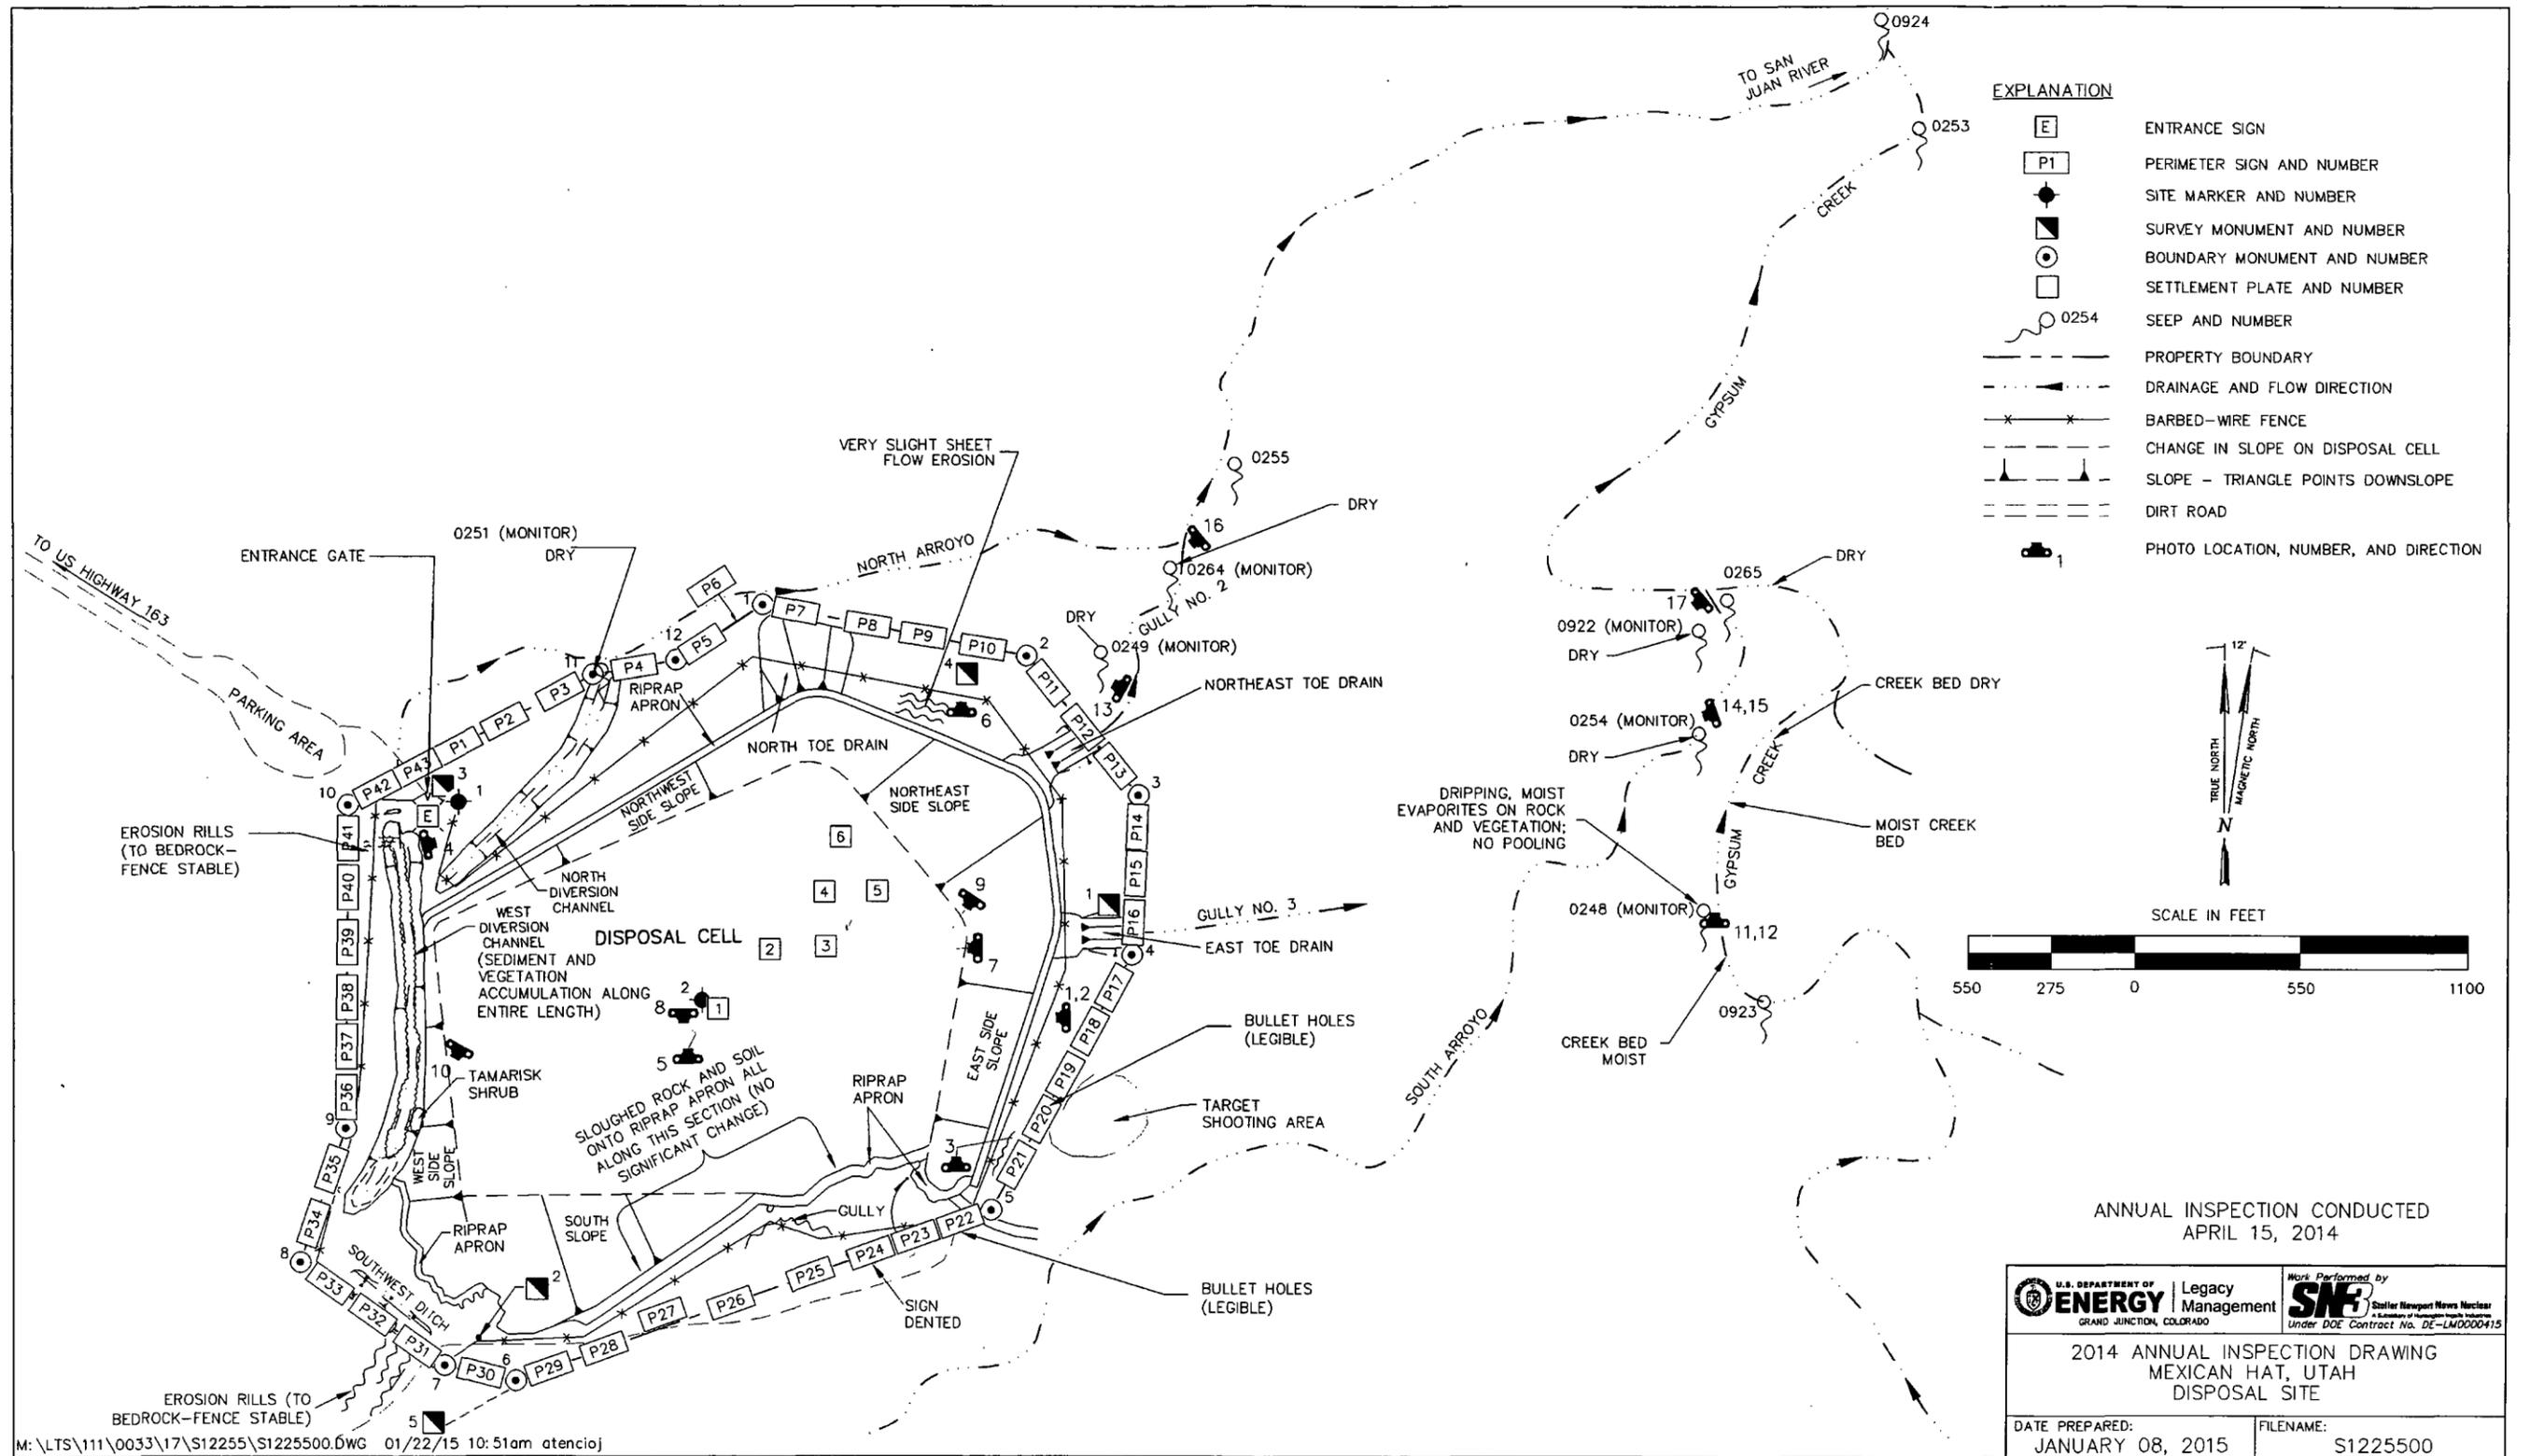
Figure 12-1. 2014 Annual Inspection Drawing for the Mexican Hat Disposal Site

The locations of site surveillance features are shown on Figure 12-1. Inspection results and recommended maintenance activities associated with site surveillance features are included in the following subsections. Photographs to support specific observations are identified in the text and on Figure 12-1 by photograph location (PL) numbers.

Twelve boundary monuments mark the site boundary. Five survey monuments were installed for survey control during cell construction. All of the monuments were in good condition (PL-6).

The top slope of the disposal cell was in excellent condition (PL-7 and PL-8). Inspectors found no evidence of differential settling, cracking, erosion, or burrowing. All visible components of the riprap-armored disposal cell top and side slopes were functioning as designed.

The disposal cell toe drains and diversion channels were in excellent condition and functioning as designed. Upgradient offsite areas continue to erode and transport sediment onto the site and into the west diversion channel (PL-10). The sediment accumulation has promoted the growth of vegetation in the channel, including perennial grasses and annual weeds; however, the sediment and vegetation are not affecting the performance of the diversion channel.

Minor erosion continues to occur in upgradient areas along the west and southwest portions of the site. This is an expected natural process and a result of the site coming to equilibrium with the outlying areas. Erosion in these areas will continue to be monitored, but it is not a concern unless it damages the perimeter fence or impacts the performance of the west diversion channel.

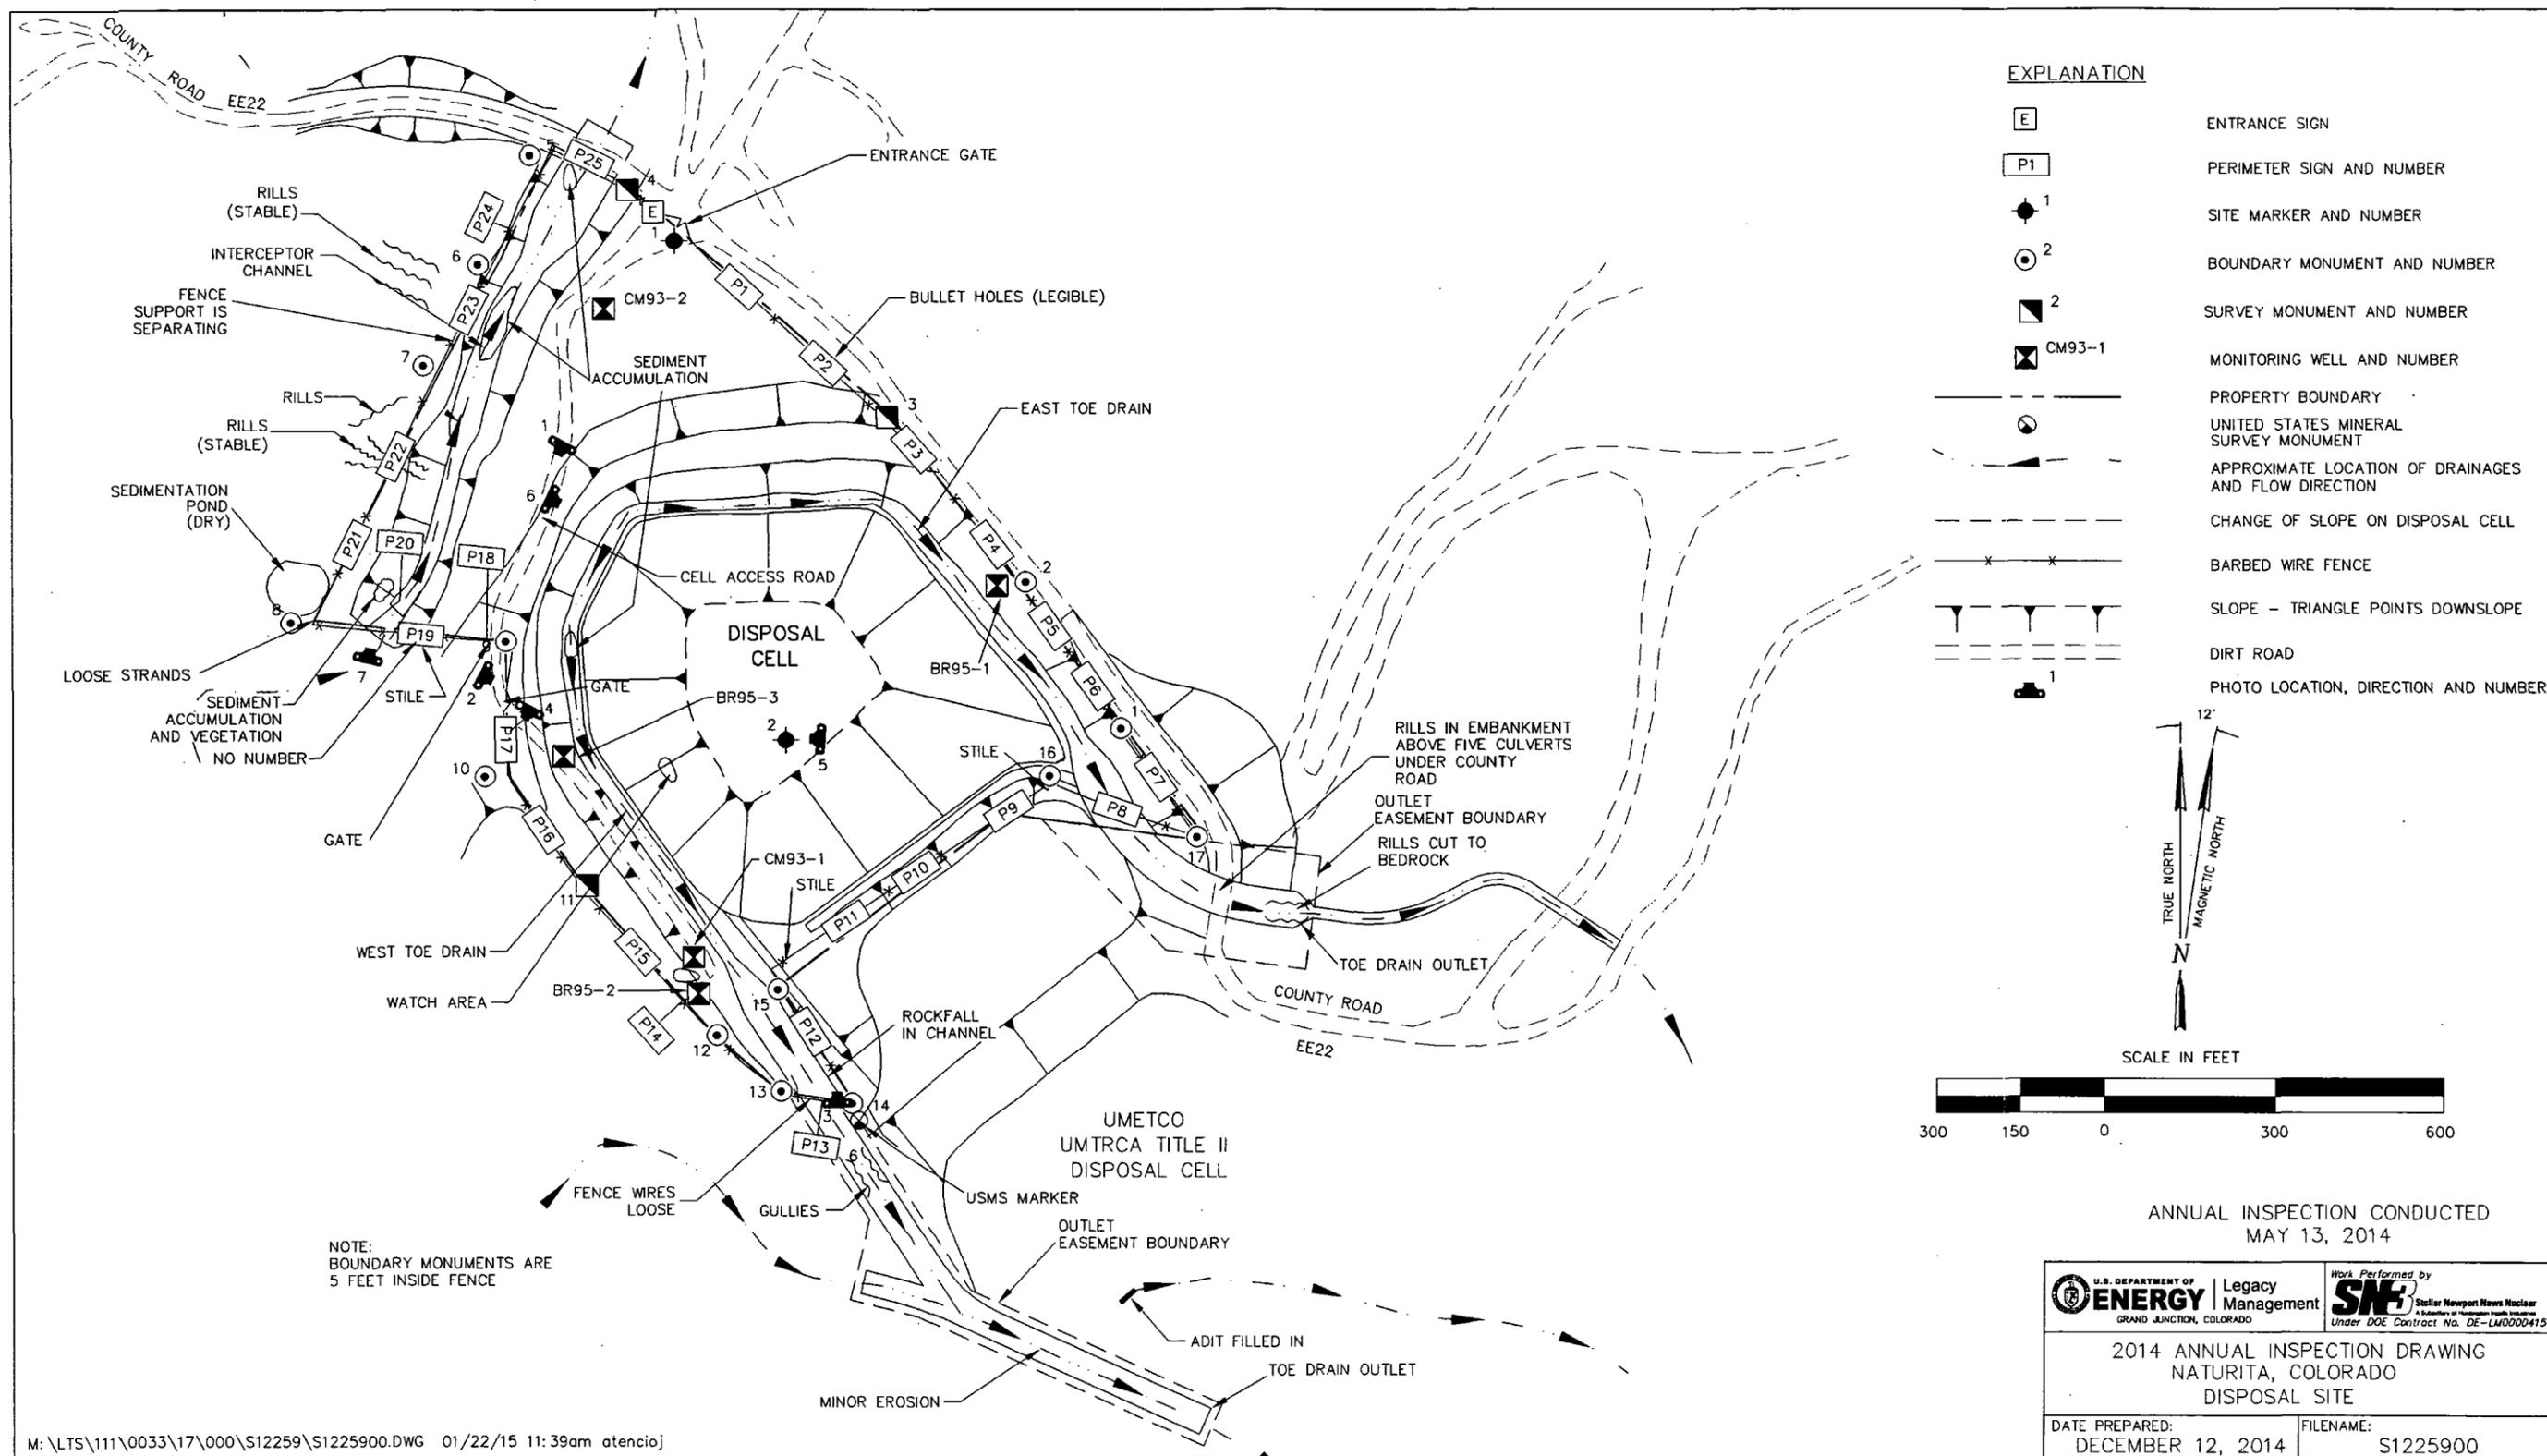
Figure 13-1. 2014 Annual Inspection Drawing for the Naturita Disposal Site

Figure 13-1 shows the locations of site surveillance features. Inspection results and recommended maintenance activities associated with site surveillance features are included in the following subsections. Photographs to support specific observations are identified in the text and in Figure 13-1 by photograph location (PL) numbers.

Survey and boundary monuments mark the boundary of the site. The survey monuments were installed during site construction for survey control, and the boundary monuments were installed after completion of construction. The 17 survey and boundary monuments were undisturbed and in good condition.

Rock covers the 2-acre top of the disposal cell and the approximate 8 acres of side slopes (PL-6). The rock is rounded, with larger rock on the side slopes than on the top. The rock-covered surfaces were in excellent condition. A small area on the southwest side of the disposal cell was noted during the 2013 inspection as being slightly higher than the surrounding cell sides (shown as an area to be watched in Figure 13-1). This area, which may be a feature left from final rock placement, was inspected in 2014 but no change was evident. No degradation or significant vegetation was identified on the cell.
