14.0 Rifle, Colorado, Disposal Site

14.1 Compliance Summary

Figure 14-1. 2014 Annual Inspection Drawing for the Rifle Disposal Site

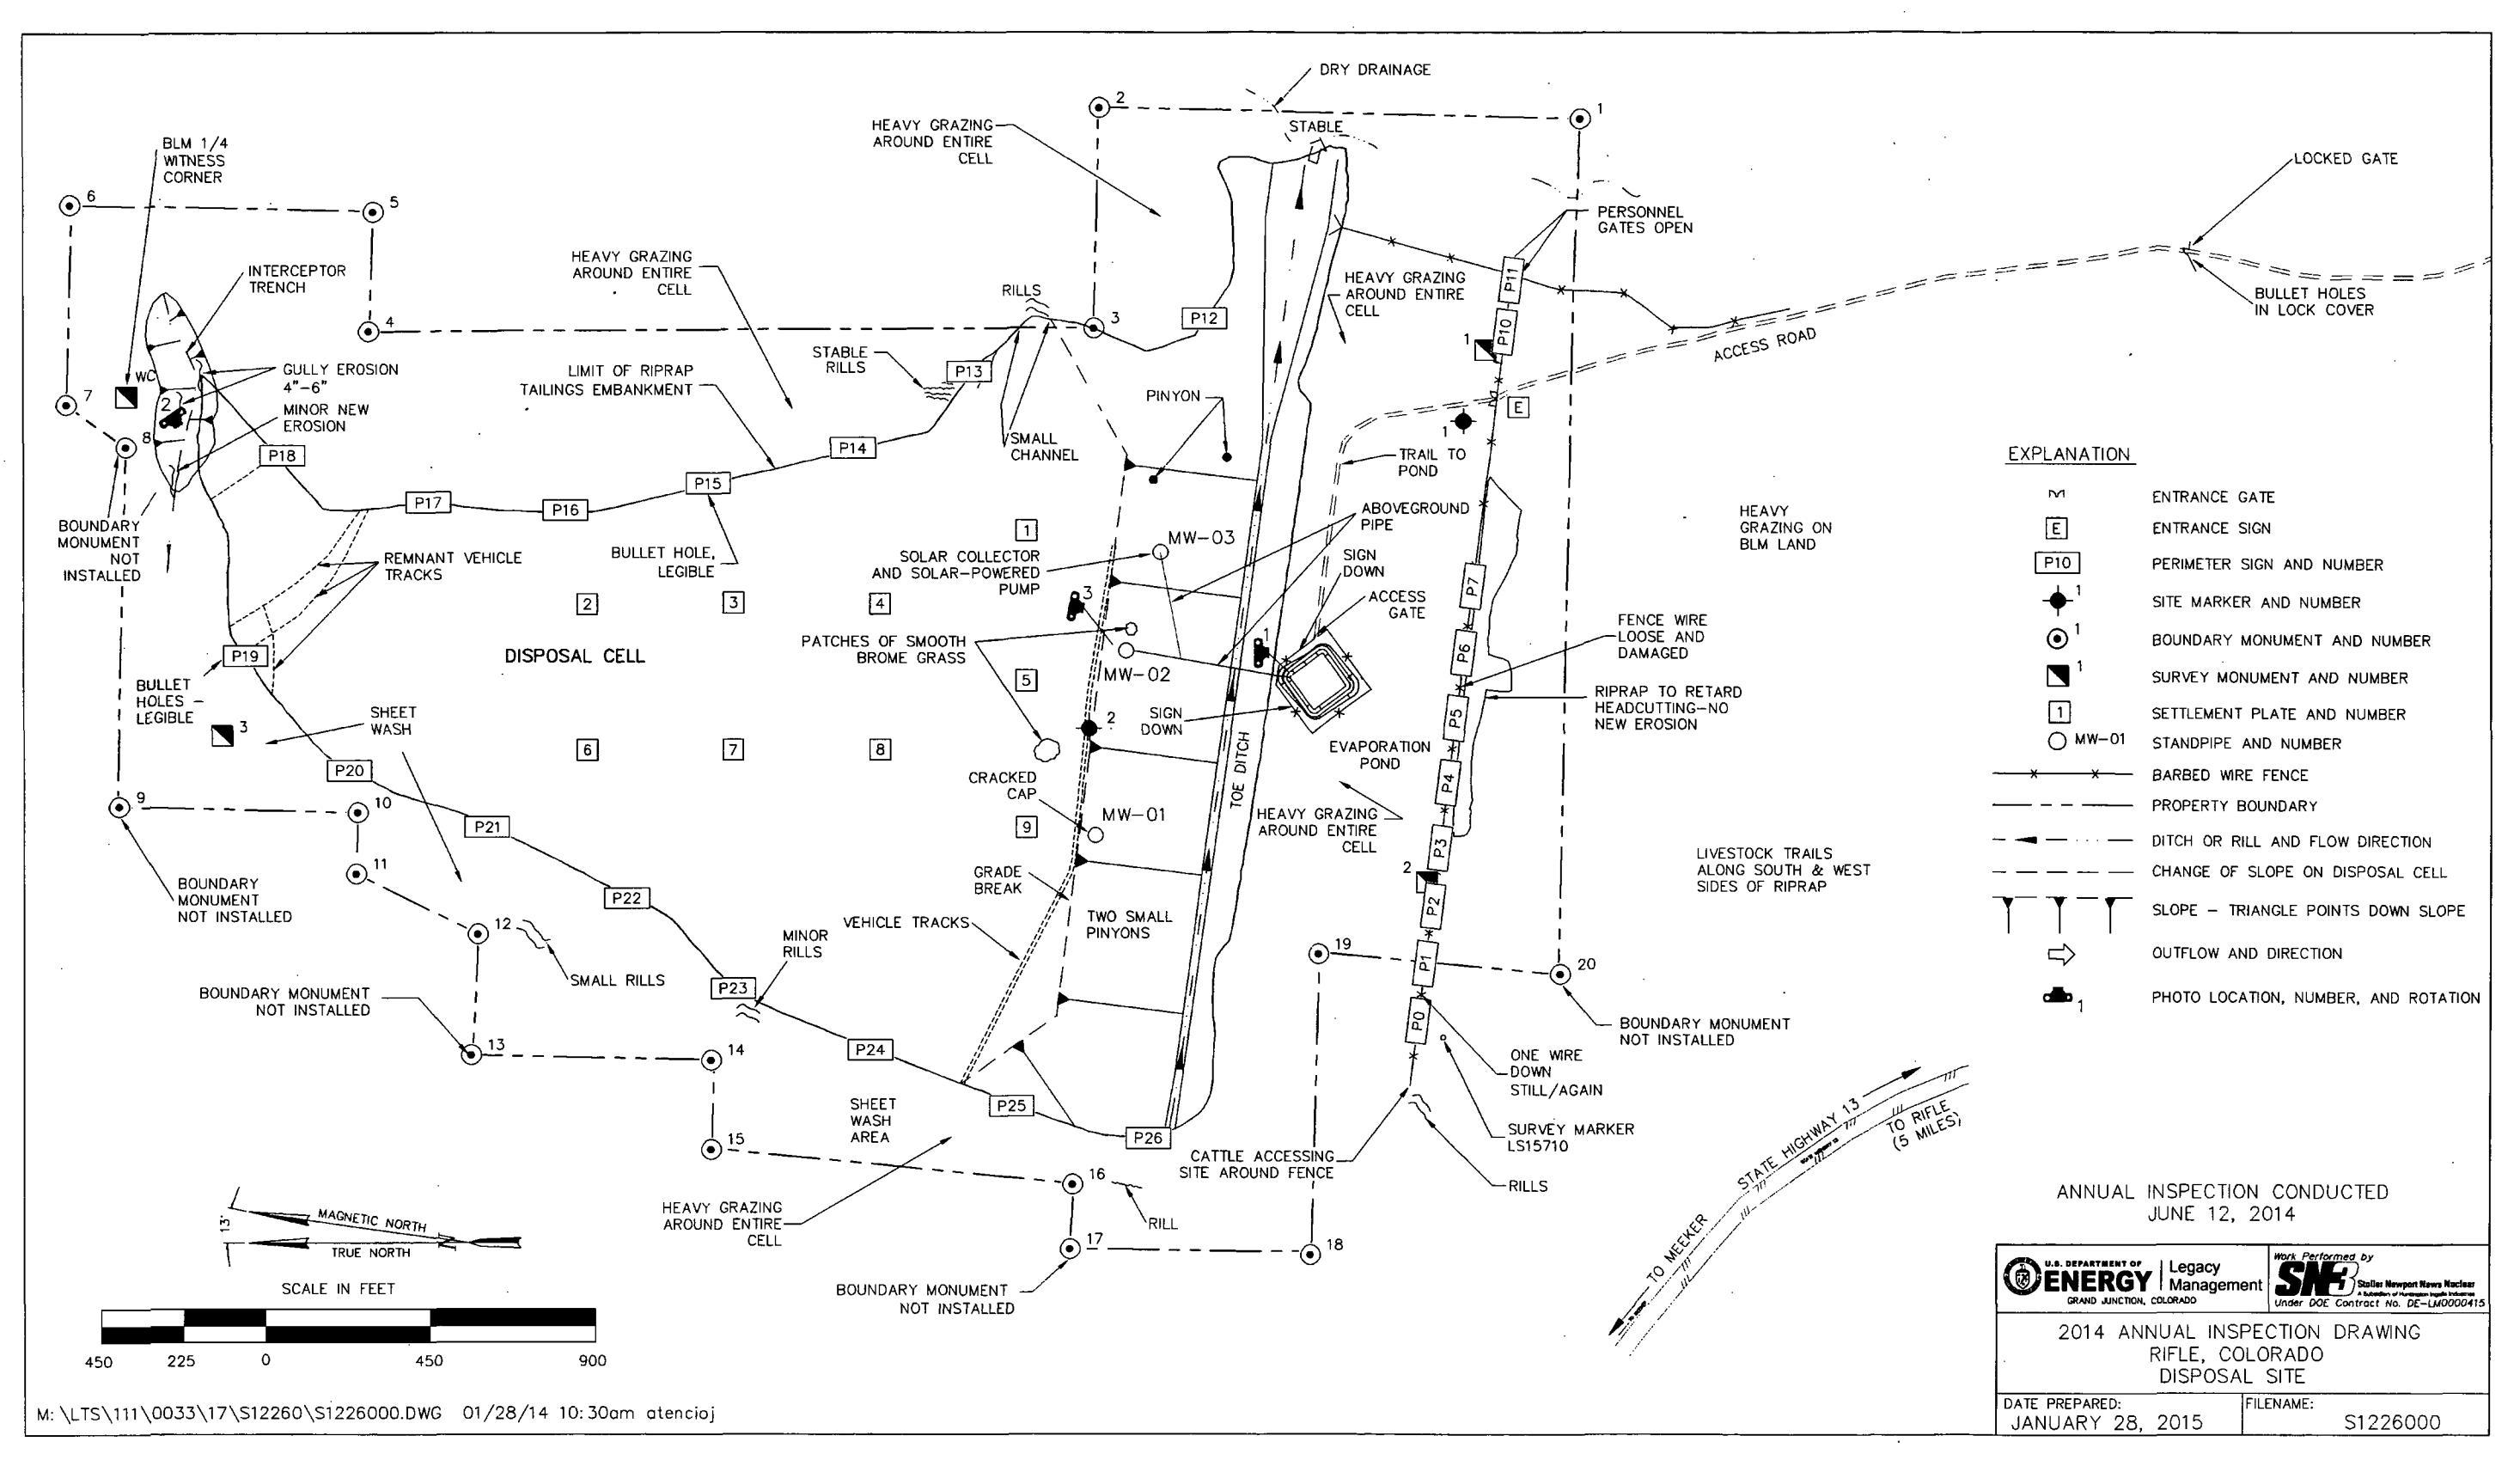
Figure 14-1 shows the locations of site surveillance features. Inspection results and recommended maintenance activities associated with site surveillance features are included in the following subsections. Photographs to support specific observations are identified in the text and on Figure 14-1 by photograph location (PL) numbers.

Two granite site markers, one just inside and left of the entrance gate (SMK-1) and the other on the disposal cell (SMK-2), were in good condition.

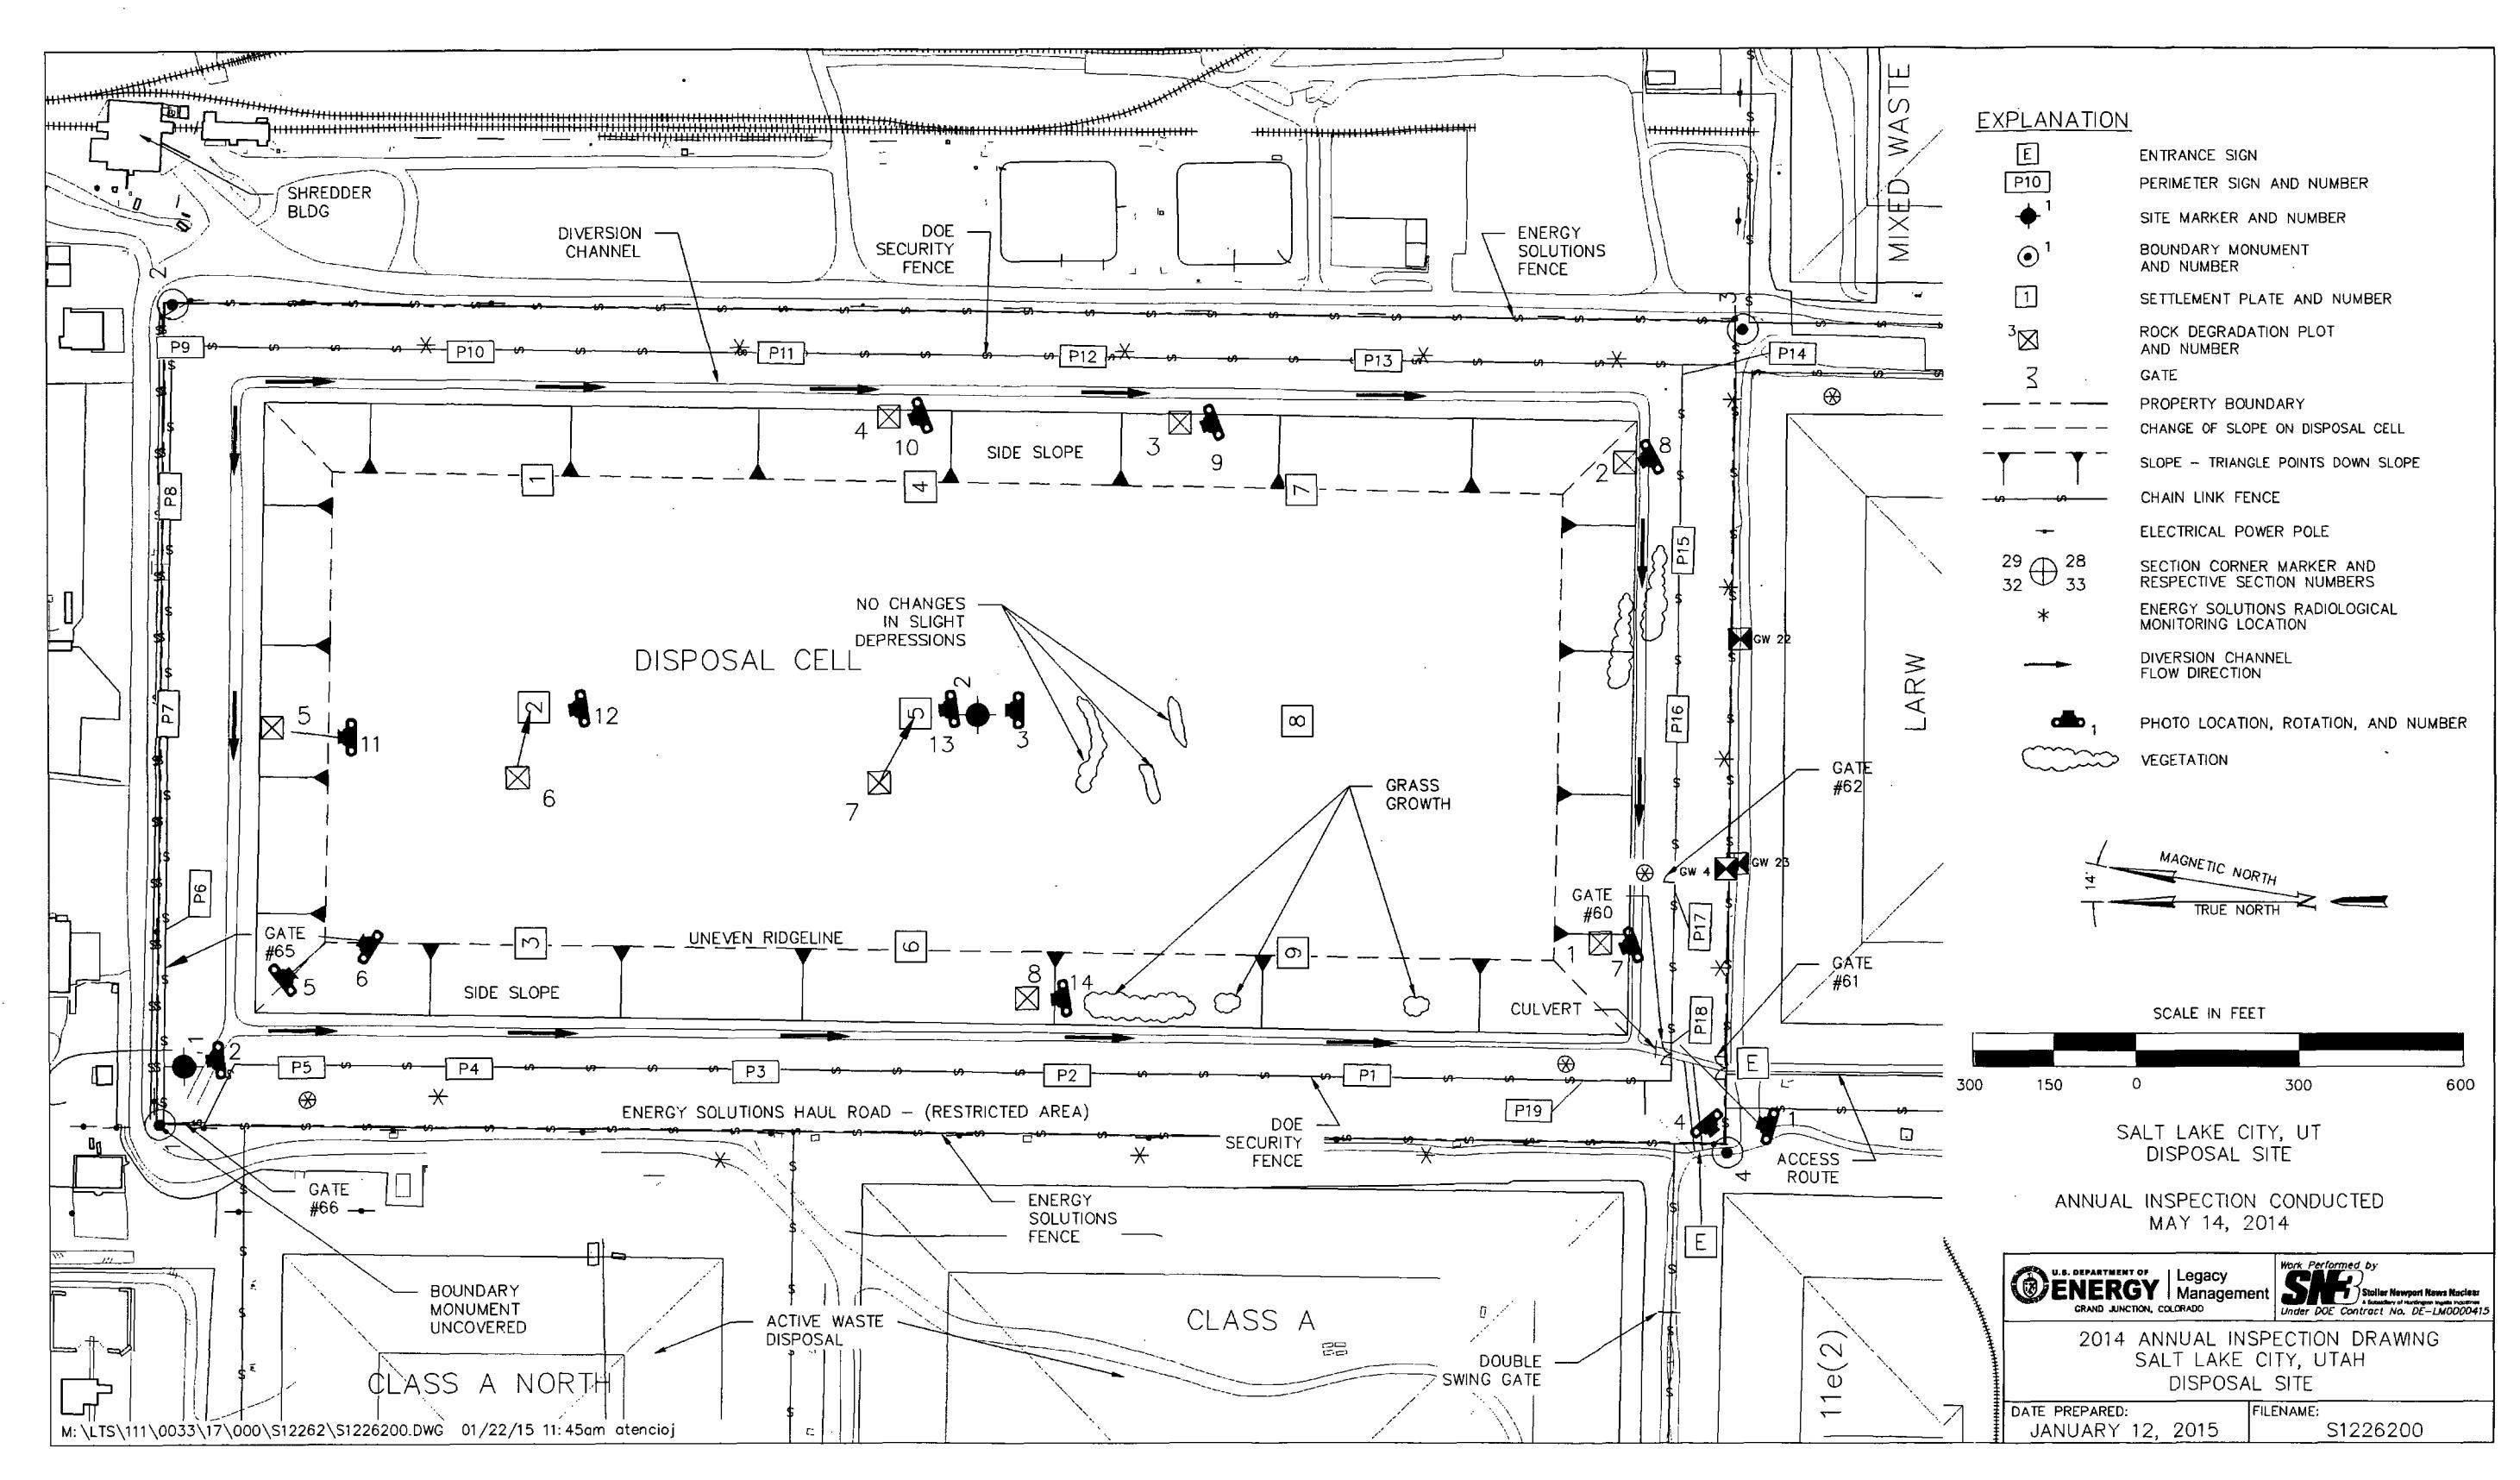
Figure 15-1. 2014 Annual Inspection Drawing for the Salt Lake City Disposal Site

Figure 15-1 shows the locations of site surveillance features. Inspection results and recommended maintenance activities associated with site surveillance features are included in the following subsections. Photographs to support specific observations are identified in the text and on Figure 15-1 by photograph location (PL) numbers.

Two chain-link fences are at the site. The exterior EnergySolutions perimeter fence, located along the site boundary, and the interior DOE security fence (PL-1) were in good condition. Nineteen perimeter signs are attached to the DOE fence, and all of the signs were in good condition.

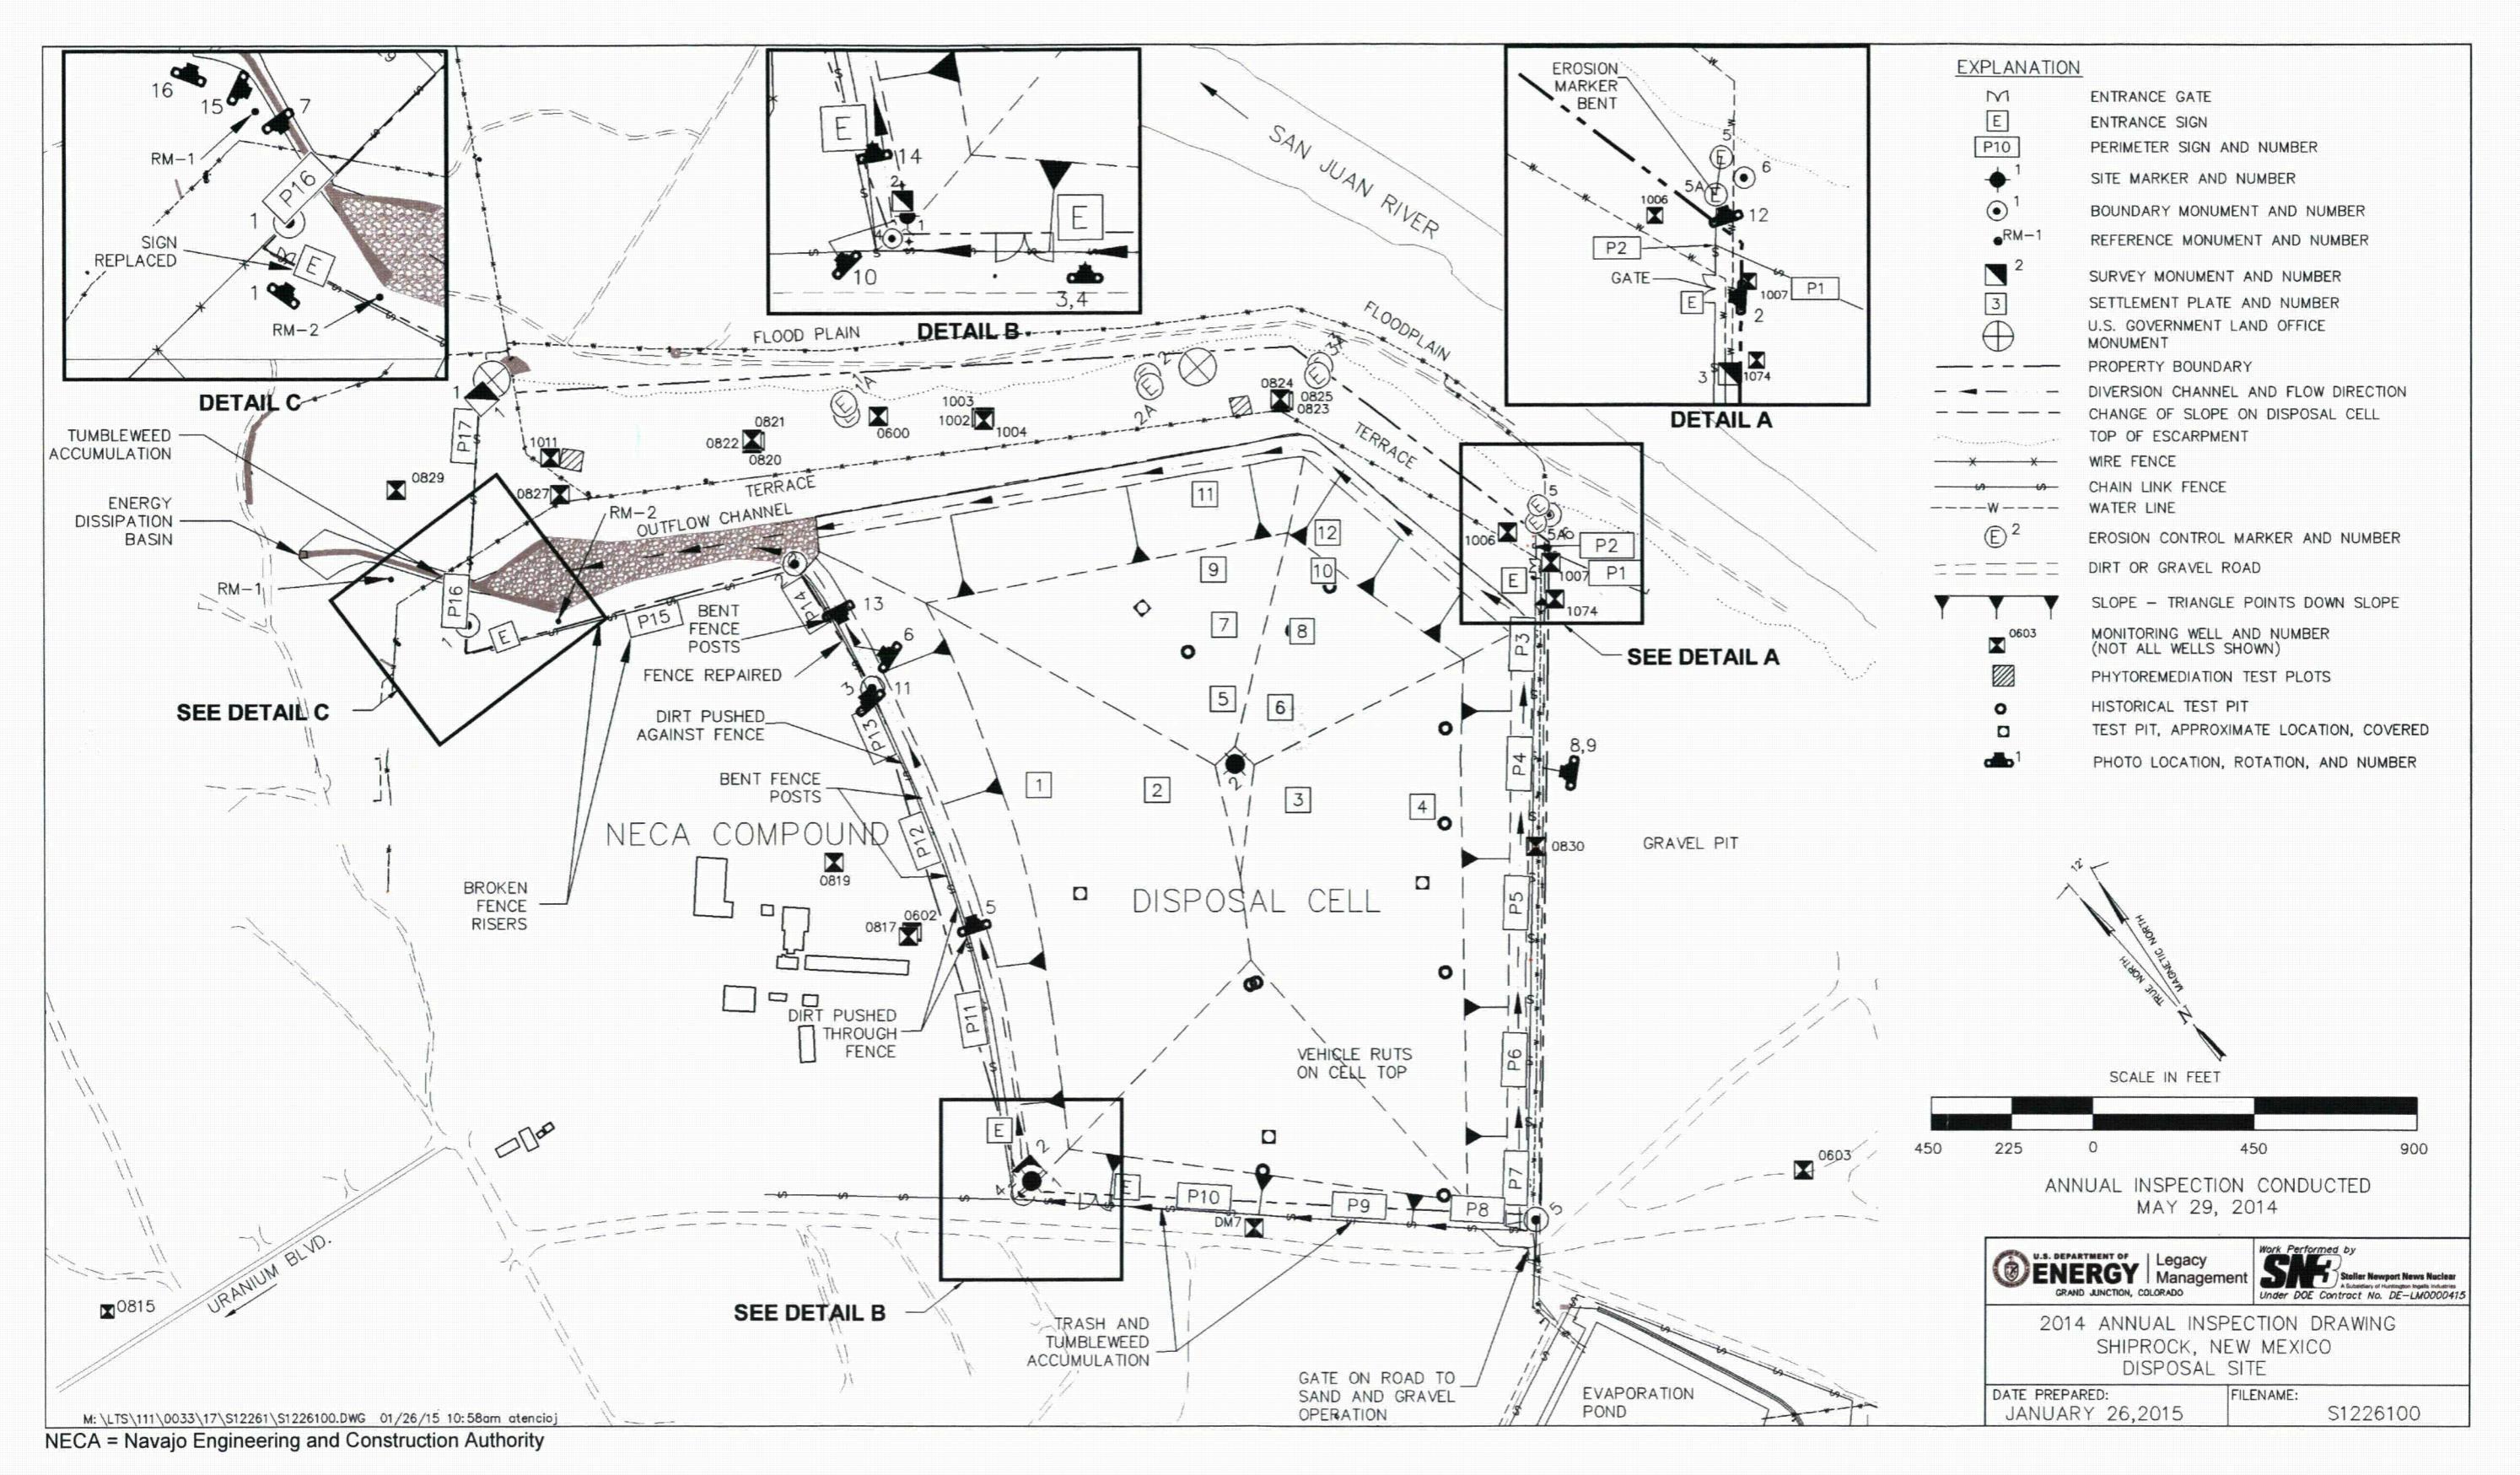
Figure 16-1. Annual Inspection Drawing for the Shiprock Disposal Site

Figure 16-1 shows the locations of site surveillance features. Inspection results and recommended maintenance activities associated with site surveillance features are included in the following subsections. Photographs to support specific observations are identified in the text and on Figure 16-1 by photograph location (PL) numbers.

Trash and tumbleweeds continually accumulate in many places along the perimeter fence, particularly along the southwest fence line and a section of fence across the outflow channel (PL-7). Accumulations large enough to represent a fire hazard or increase the possibility of damage to the fence will be removed. During the inspection, inspectors picked up trash along the inside of the perimeter fence and also placed rocks in several gaps beneath the fence that were potentially large enough to allow site access.

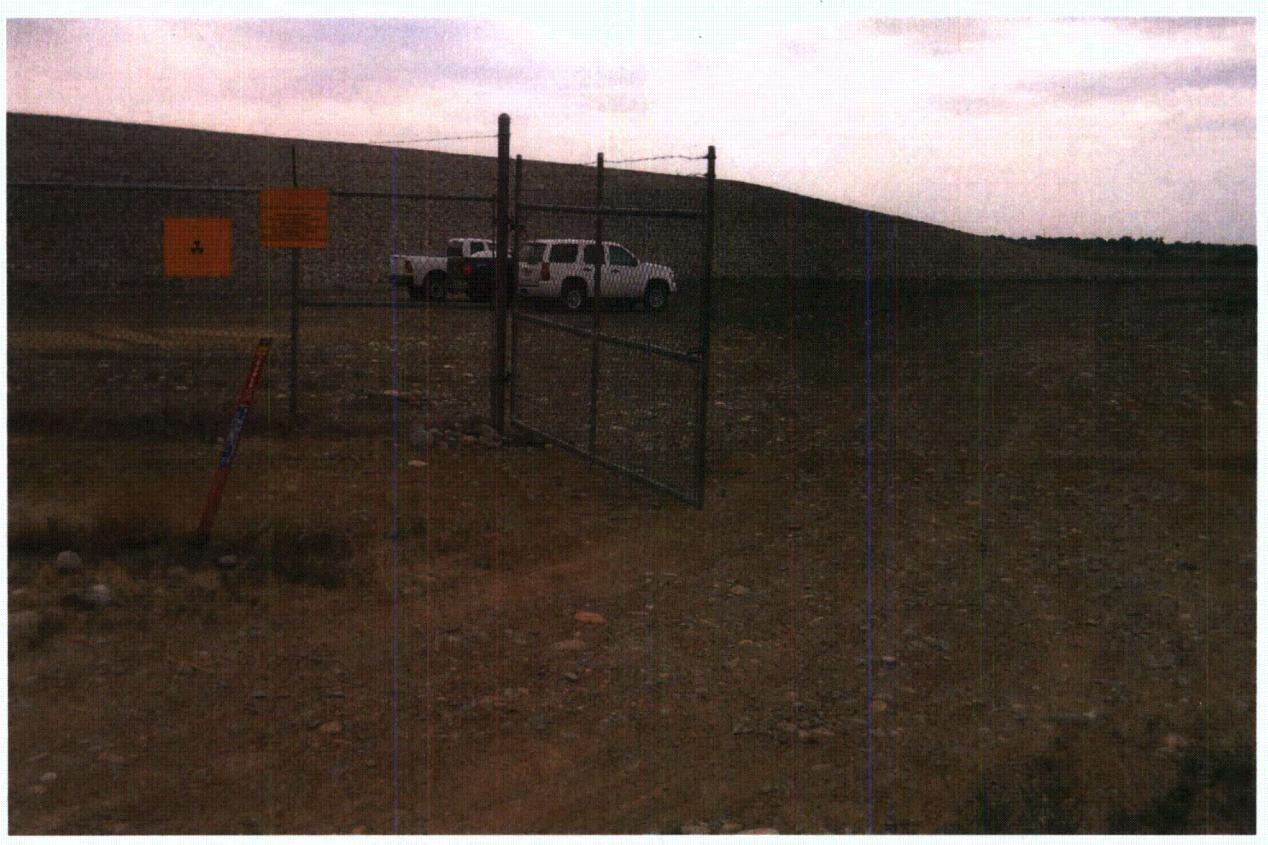
SHP 5/2014. PL-2. Main (east) entrance gate.

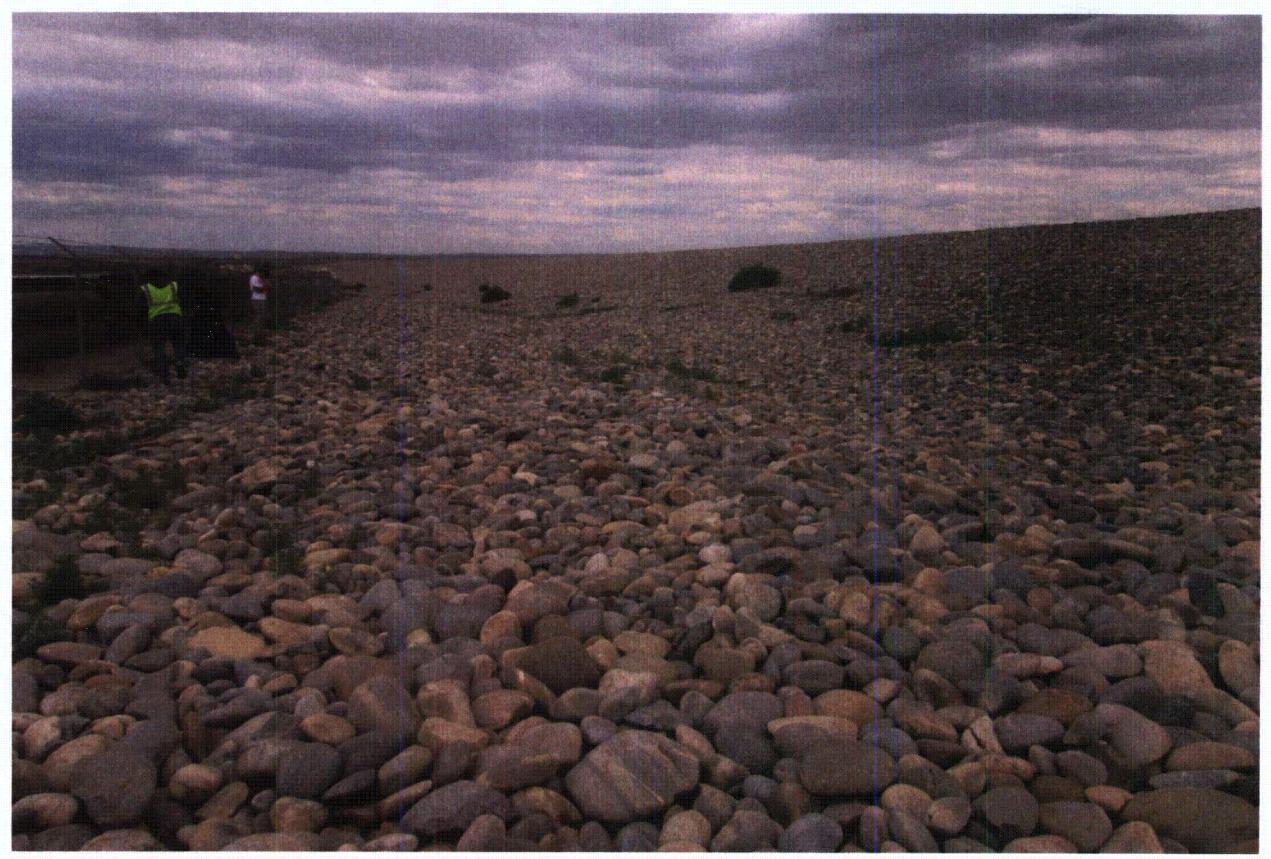
SHP 5/2014. PL-14. Diversion ditch and northwest side slope of disposal cell.
