17.0 Slick Rock, Colorado, Disposal Site

17.1 Compliance Summary

The Slick Rock, Colorado, Uranium Mill Tailings Radiation Control Act (UMTRCA) Title I Disposal Site was inspected on May 13, 2014. The site was in good condition. A damaged perimeter sign was replaced. Inspectors identified no other maintenance needs or cause for a follow-up inspection.

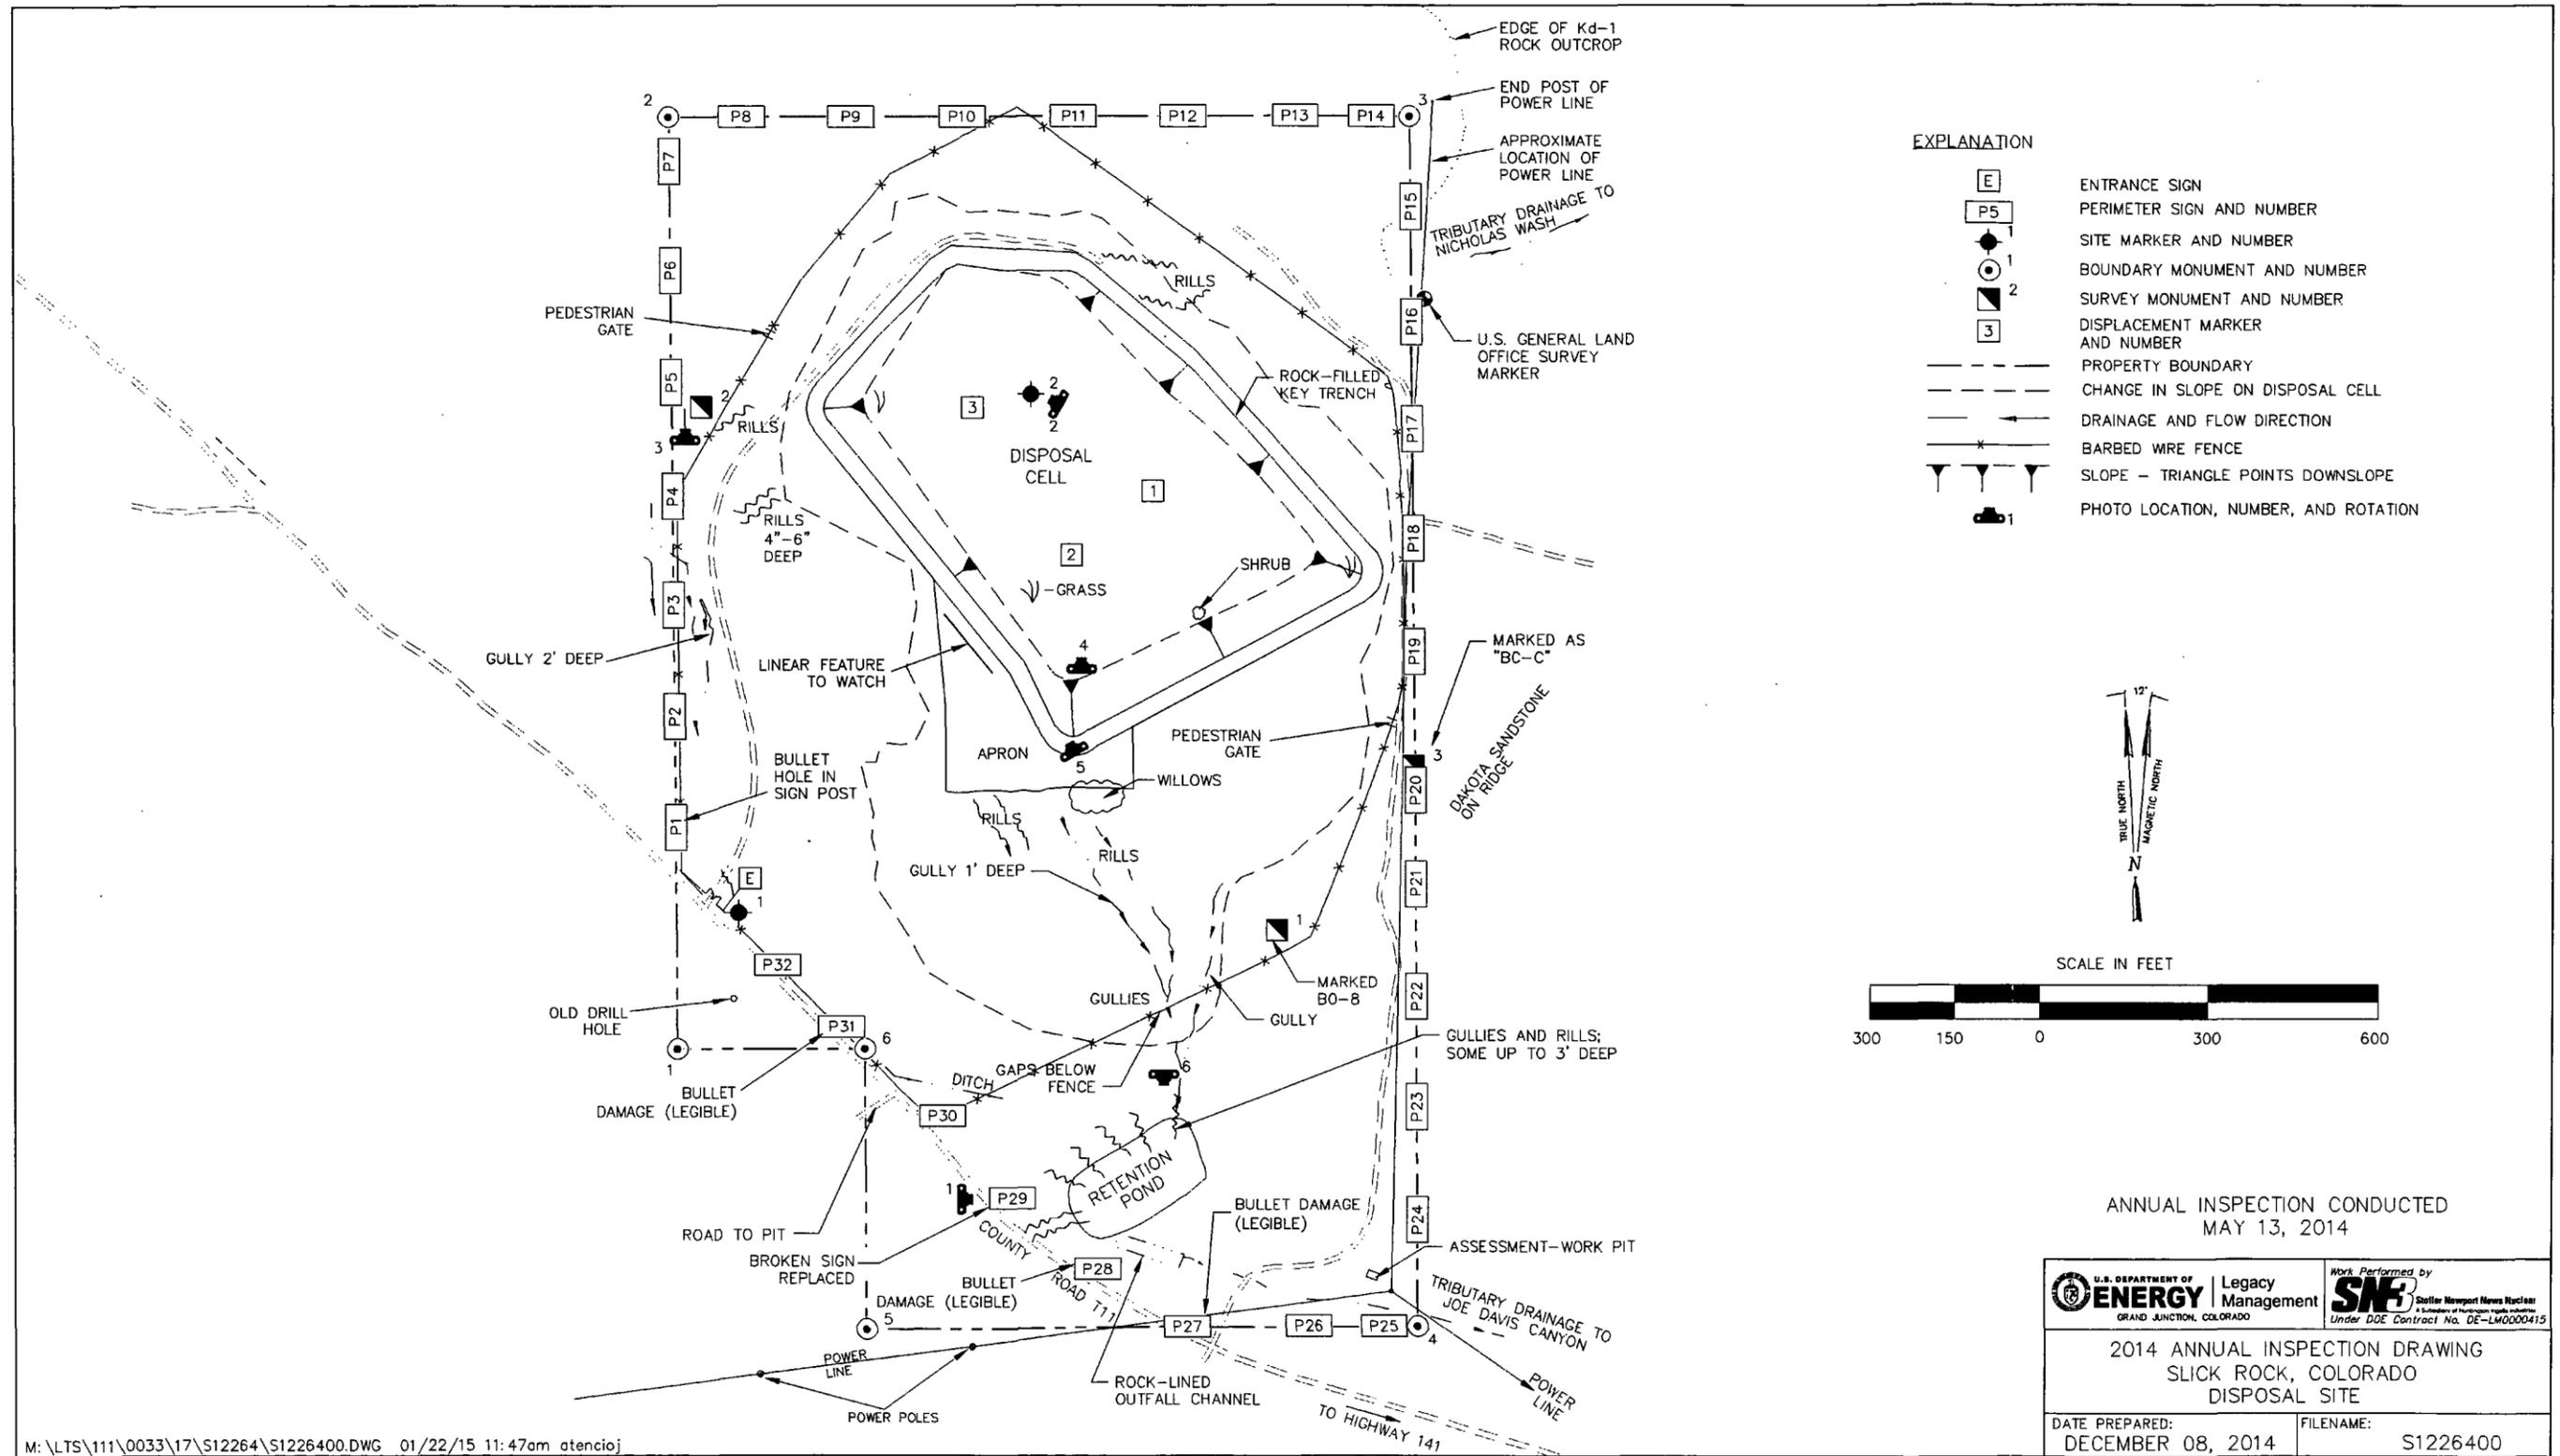
Figure 17-1. 2014 Annual Inspection Drawing for the Slick Rock Disposal Site

Figure 17-1 shows the locations of site surveillance features. Inspection results and recommended maintenance activities associated with site surveillance features are included in the following subsections. Photographs to support specific observations are identified in the text and on Figure 17-1 by photograph location (PL) numbers.

Erosion rills and gullies are present in several areas of the site (Figure 17-1) but do not impact the disposal cell or any site features. They appear to be stabilizing but will continue to be monitored. Vegetation in the reclaimed areas was healthy. Noxious weeds are controlled to comply with state and county requirements.

Damaged perimeter sign P29 was replaced. No other maintenance needs were identified.

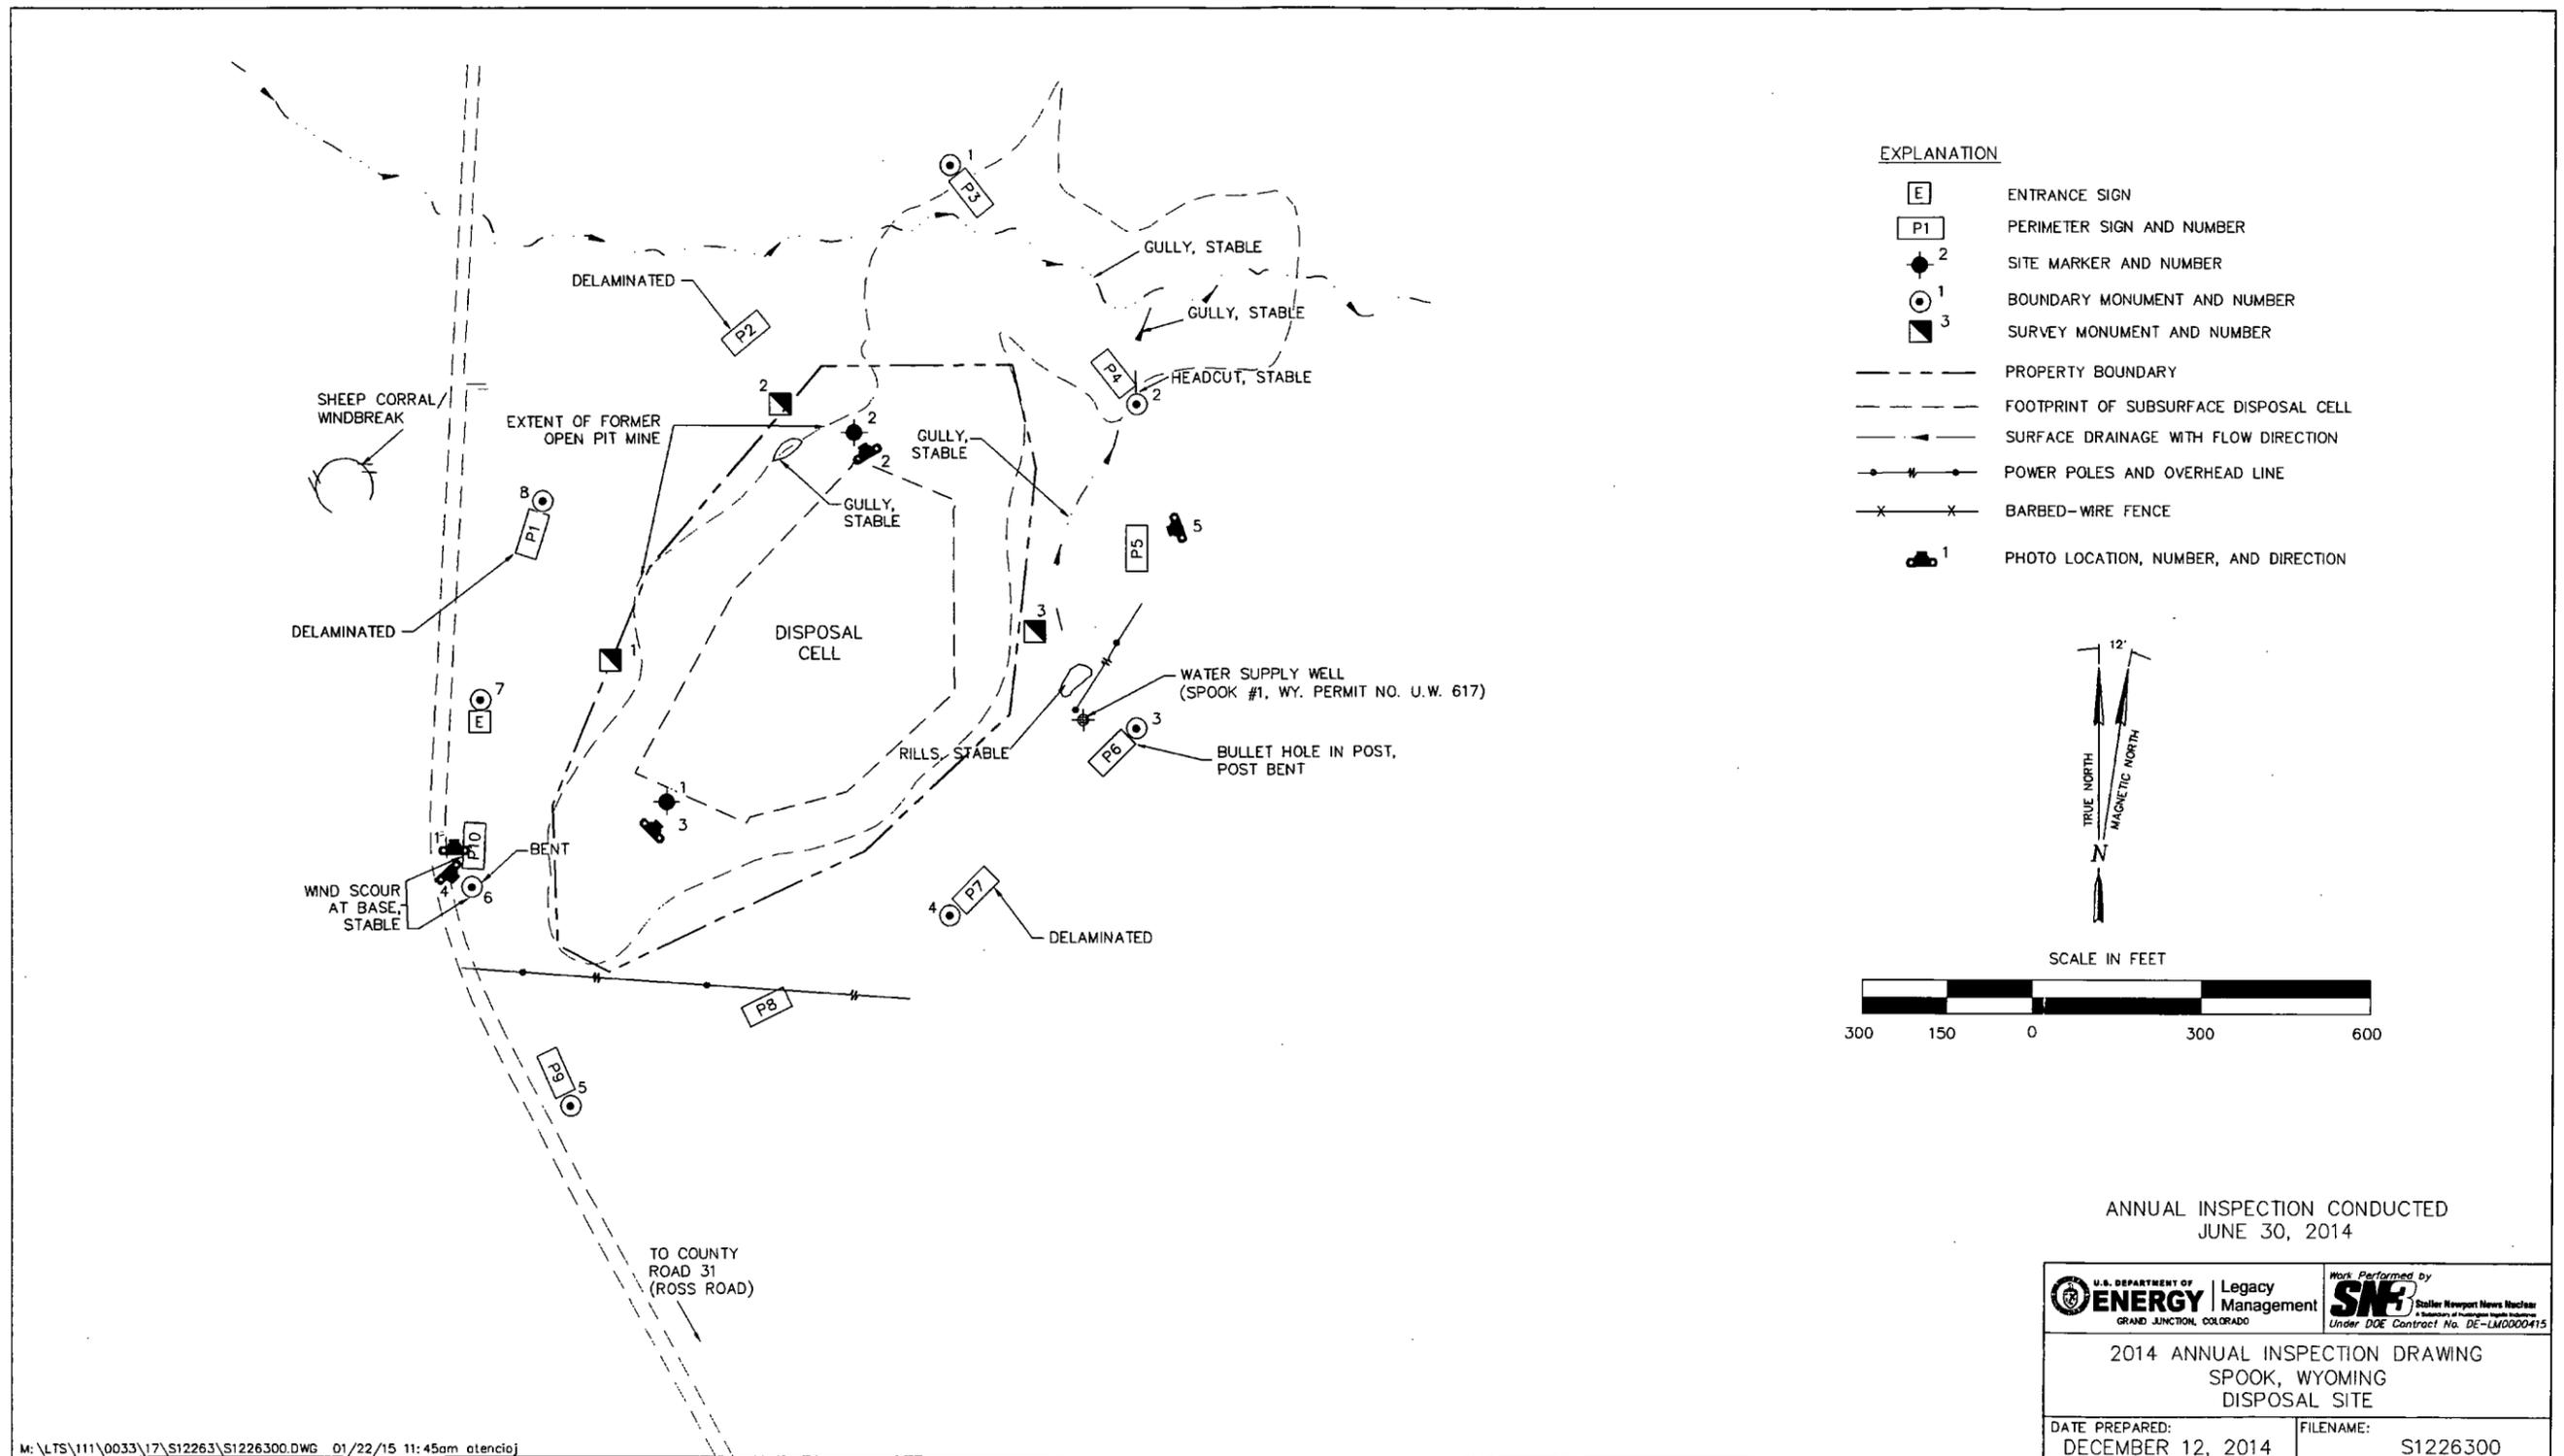
Figure 18-1. 2014 Annual Inspection Drawing for the Spook Disposal Site

Figure 18-1 shows the locations of site surveillance features. Inspection results and recommended maintenance activities associated with site surveillance features are included in the following subsections. Photographs to support specific observations are identified in the text and in Figure 18-1 by photograph location (PL) numbers.

Eight boundary monuments and three survey monuments are present at the site. Wind erosion has exposed the concrete base for boundary monument BM-6 (PL-4). During this inspection that monument was noted as being bent. It may have been inadvertently damaged by a vehicle when covered by snow. A t-post will be installed to mark its location. Even though bent, it was stable and repair is not warranted. The other monuments were in excellent condition.

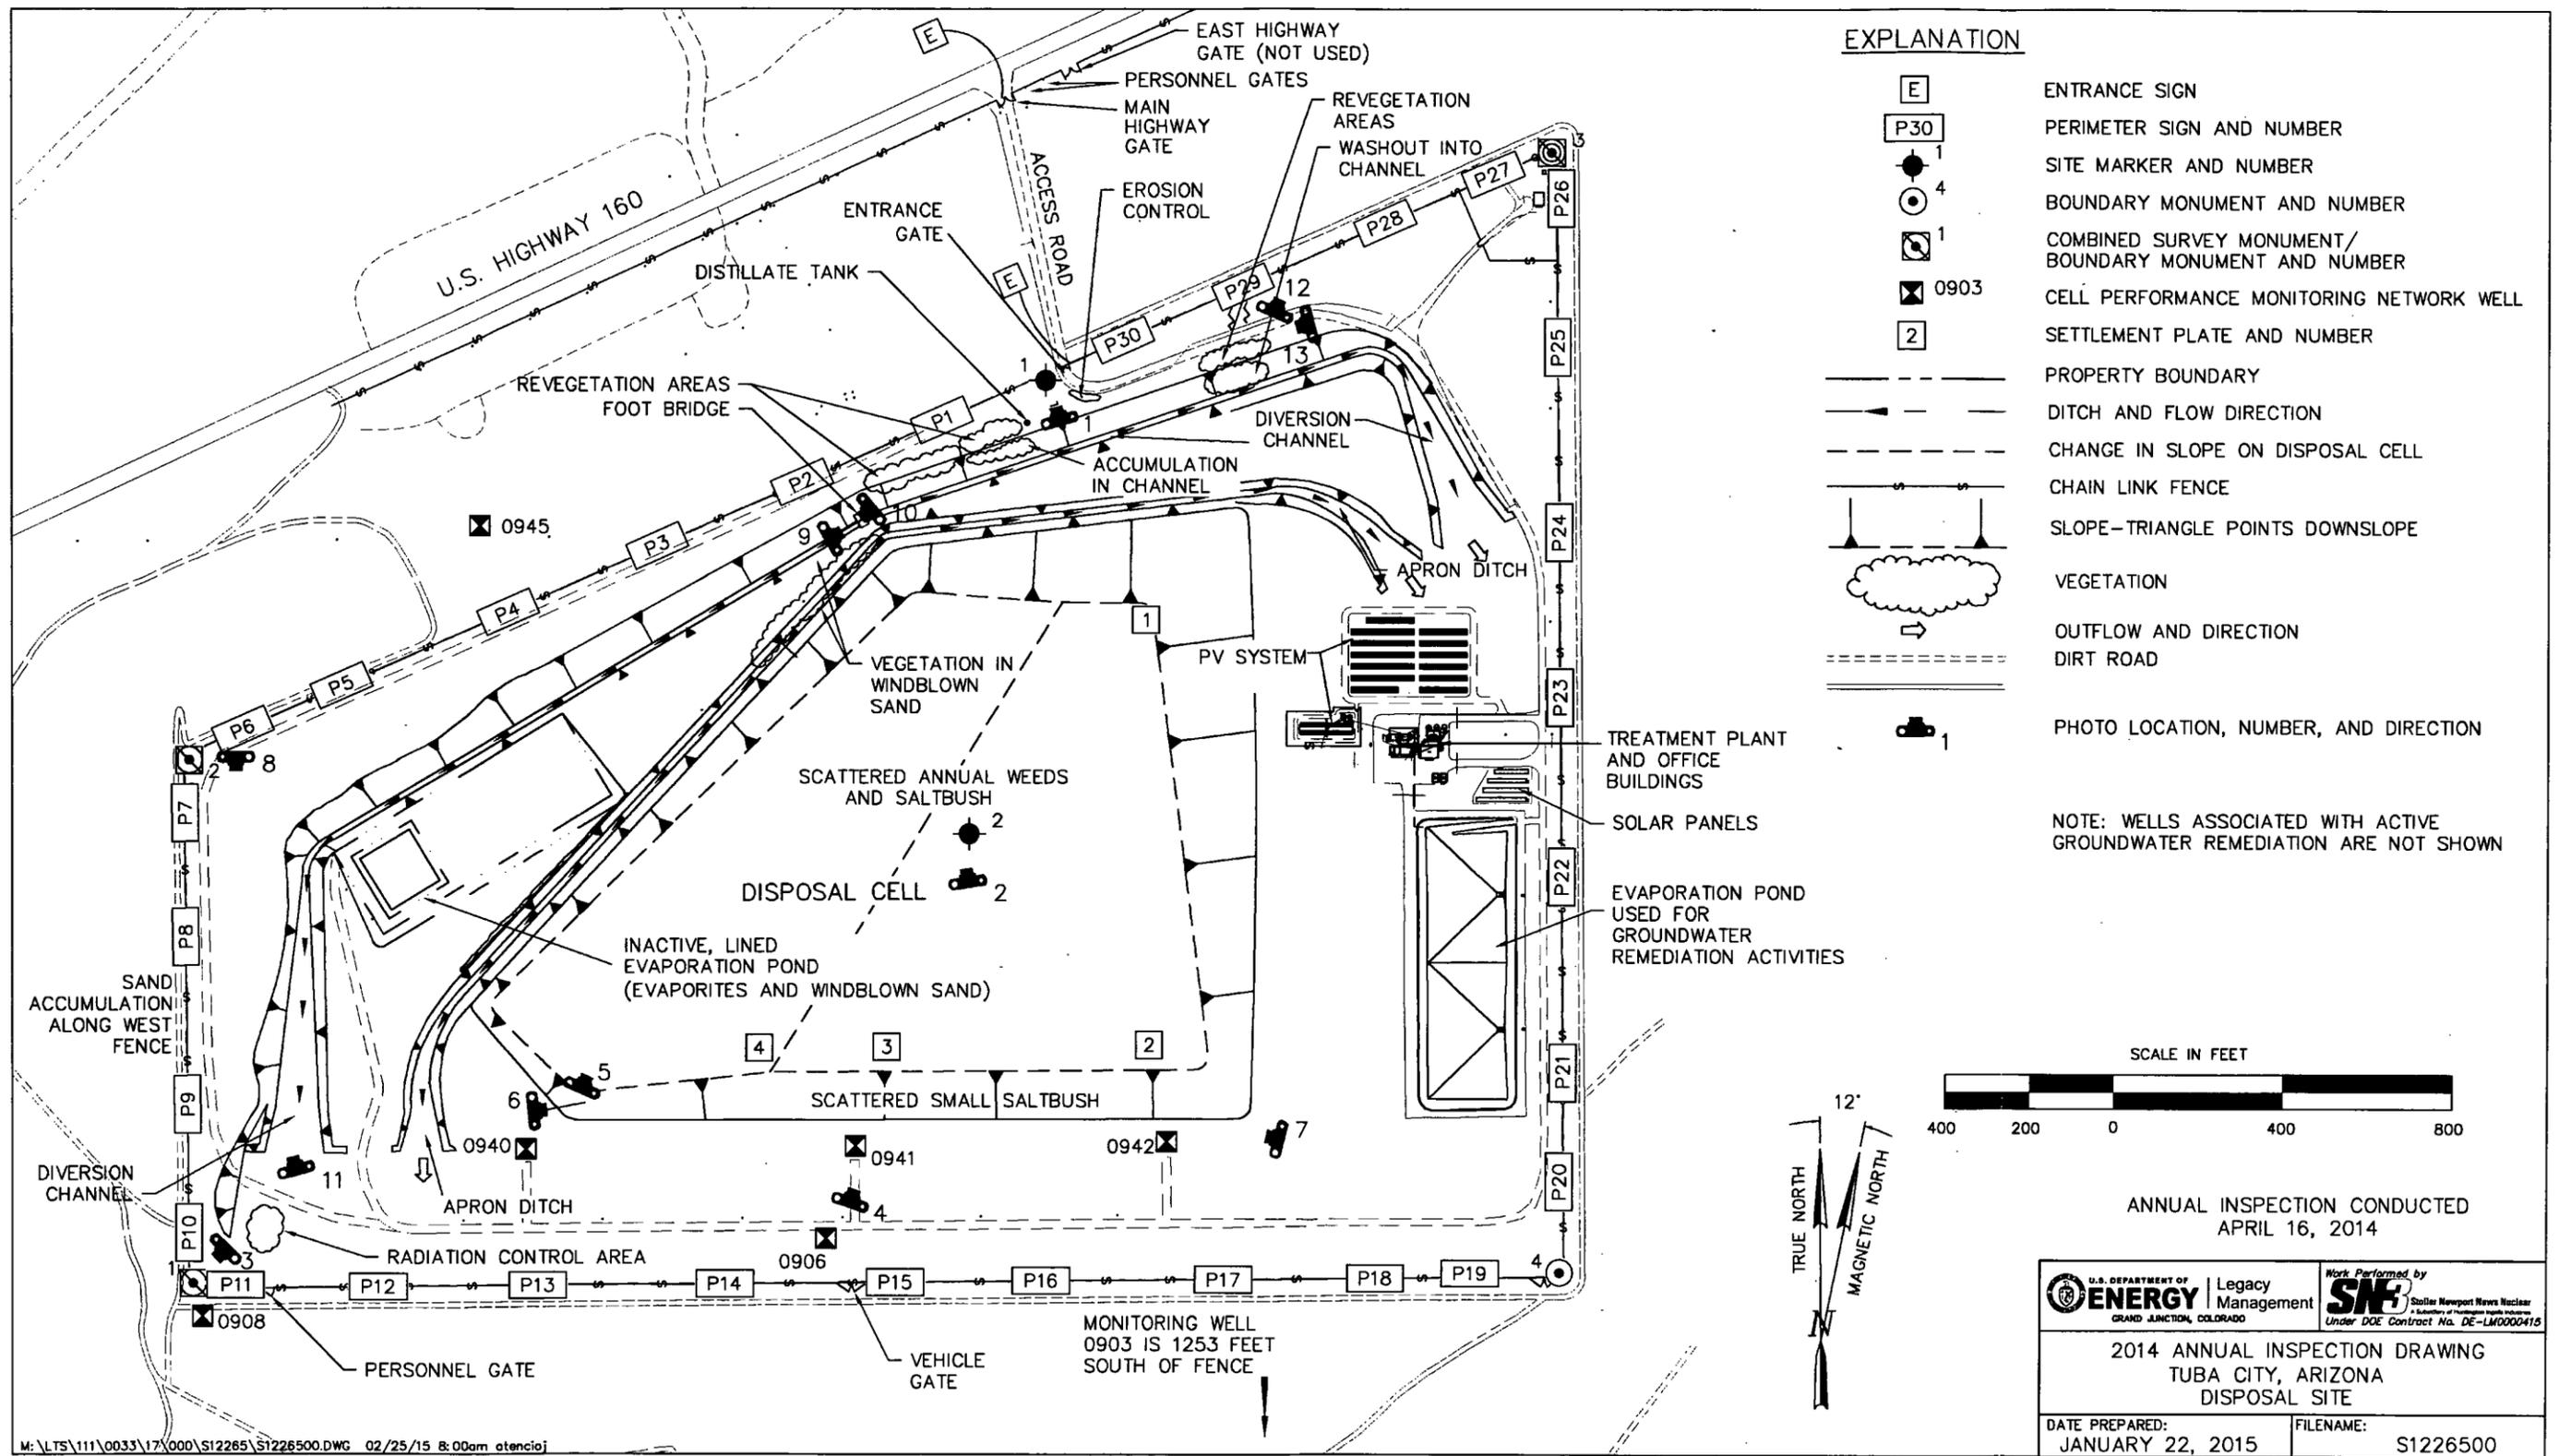
Figure 19-1. 2014 Annual Inspection Drawing for the Tuba City Disposal Site

Figure 19-1 shows the locations of site surveillance features. Inspection results and recommended maintenance activities associated with site surveillance features are included in the following subsections. Photographs to support specific observations are identified in the text and in Figure 19-1 by photograph location (PL) numbers.
