Edwin I. Hatch Nuclear Plant – Unit 2 Inservice Inspection Program Owner's Activity Report for Outage 2R23

SNC and SI Evaluation Core Shroud Axially Oriented Flaw

Edwin I. Hatch Nuclear Plant – Unit 2 Technical Justification Regarding Scope Expansion of ASME Code Section XI B-N-2 Components

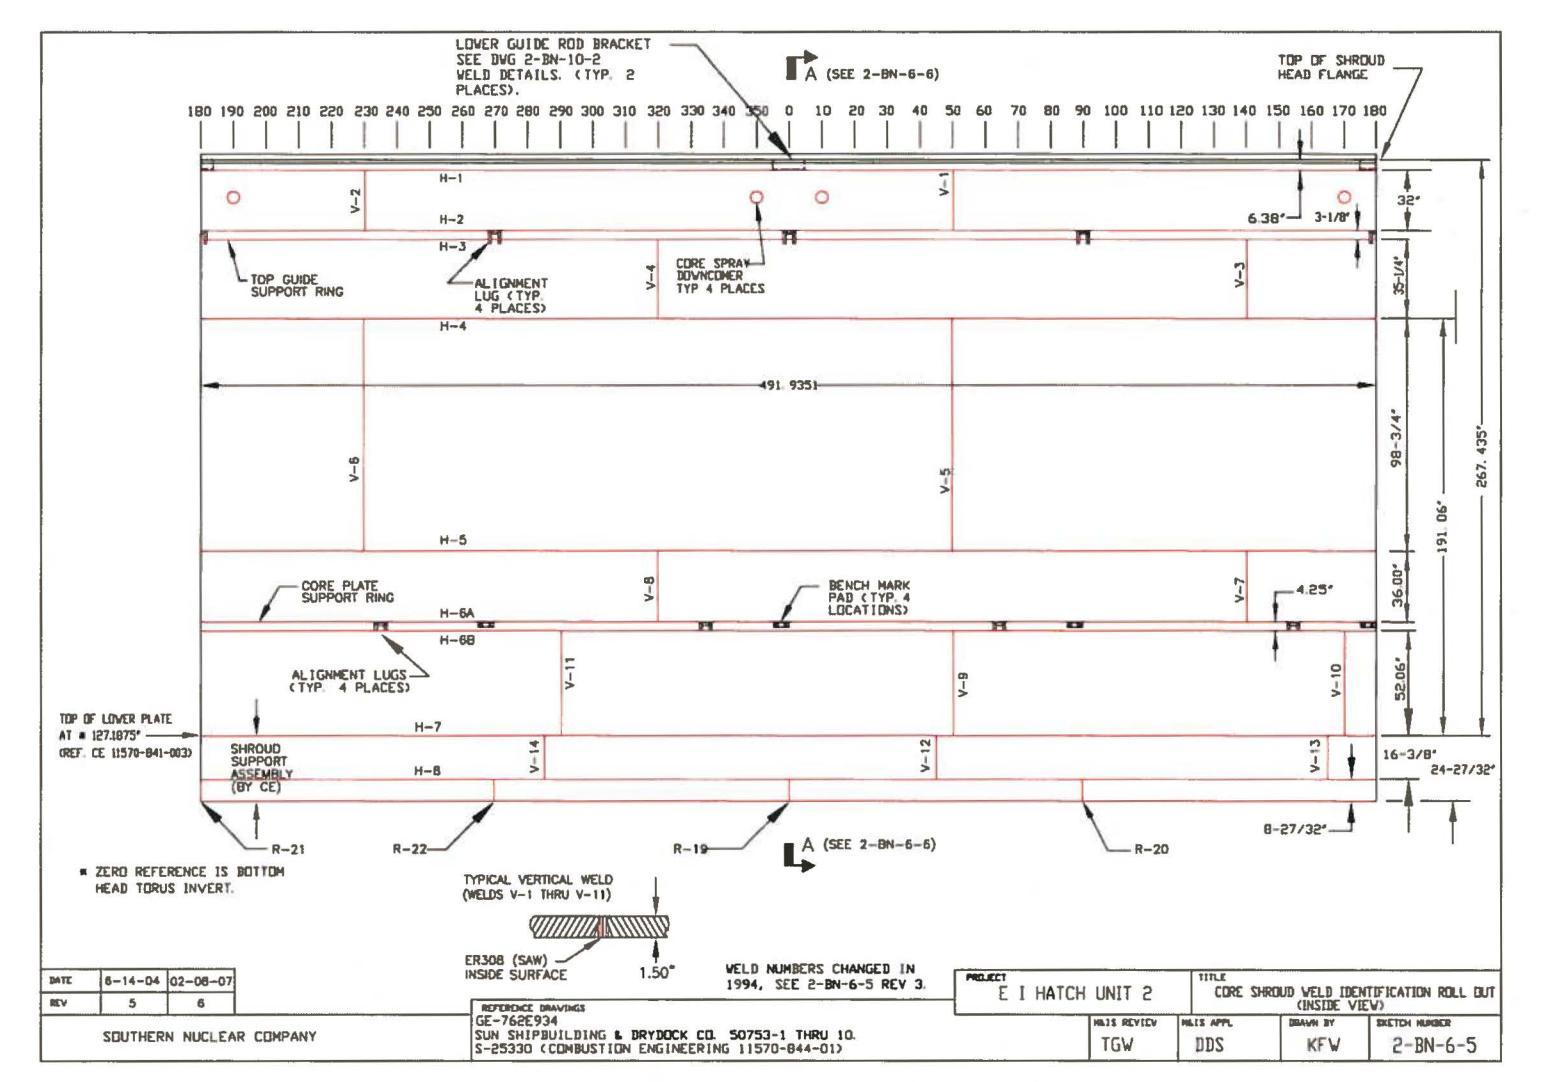
Figure 1. HNP2 Core Shroud Configuration [11]

Figure 1 illustrates the HNP2 core shroud configuration and weld locations, while Figure 2 illustrates the locations and sizes of reported indications, based on 2R23 inspection results [1].

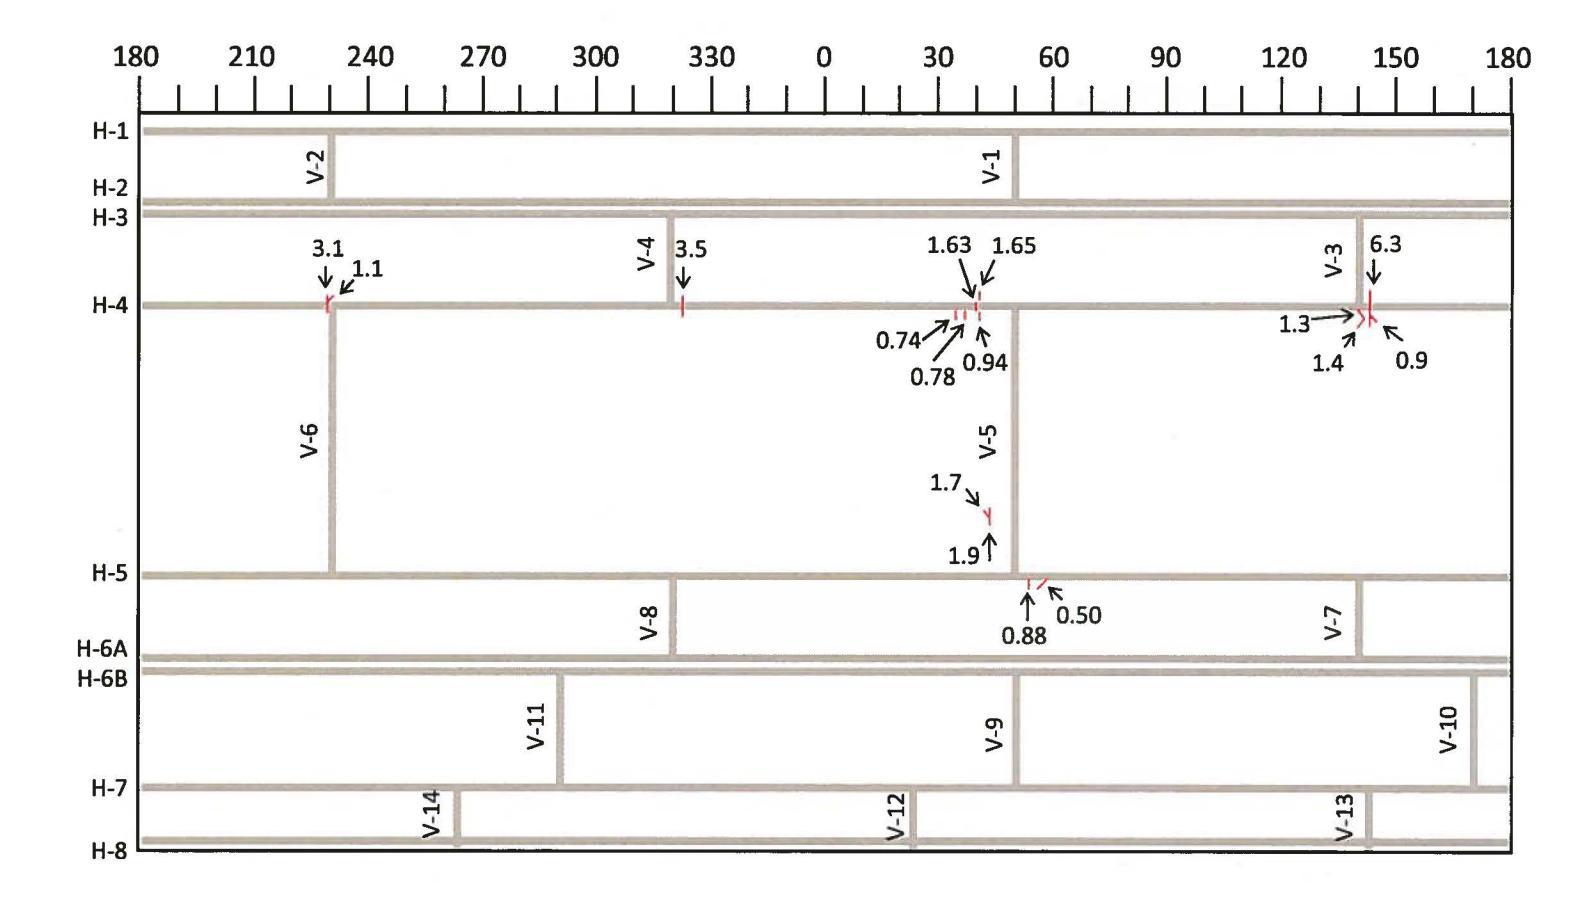
Table 2 presents the results of the axial flaw LEFM evaluation. The 10-year, end of interval, bounding flaw size is **15.5 inches**. This flaw bounds all reported axially oriented indications. The final flaw size is determined by adding to the reported flaw size the inspection uncertainty and projected 10-year crack growth at each crack tip:

The calculated allowable **operating interval** for the reported indications is approximately **44 years** using the bounding IGSCC crack growth rate. No re-inspection interval greater than 10 years is currently allowed in BWRVIP-76 [3].
