SUBJECT: Forwards response to 820623 request for addl info re damage,  
 repair & replacement of auxiliary feedwater header. *586 RPT*

Subject: Oconee Nuclear Station  
Docket No. 50-287

ATTACHMENT A  
DUKE POWER COMPANY  
OCONEE NUCLEAR STATION  
UNIT 3  
AUXILIARY FEEDWATER HEADER  
DAMAGE, REPAIR AND REPLACEMENT

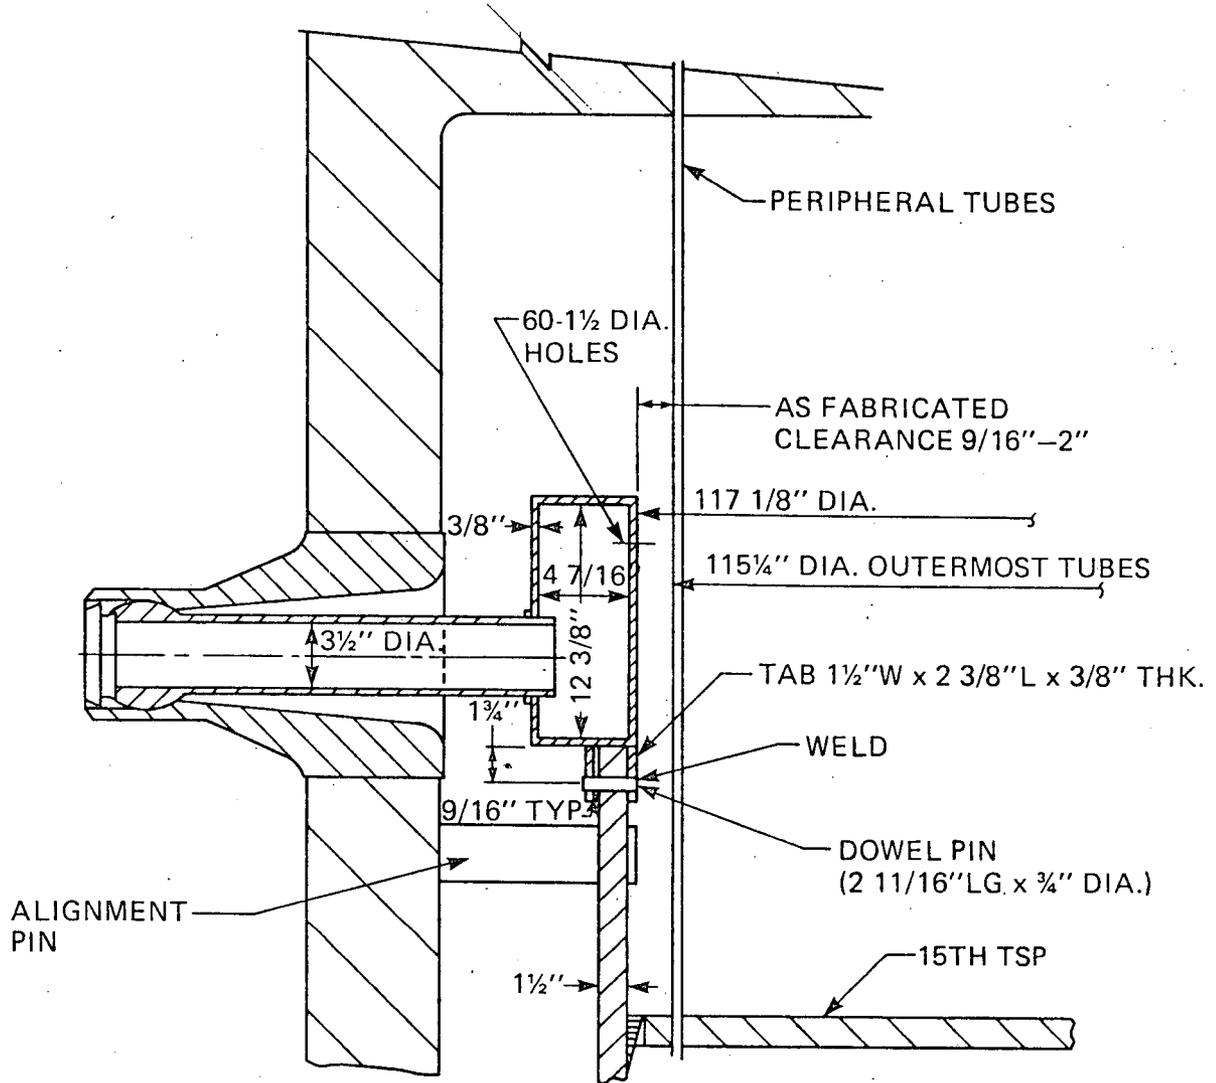
A single 3 1/2 inch diameter AFW nozzle delivers water to the header via a thermal sleeve which slip fits into the header (See Fig. 1-7). Water leaves the header through 60 - 1 1/2 inch diameter flow holes near the top of the inner header wall. The flow holes are equally spaced around the circumference. There are 8 - 1/4 inch diameter drain holes near the bottom of the inner vertical wall (See Fig. 1-2 and 1-4).

It should be noted that although Figure 1-2 indicates a possible nominal clearance of 9/16" to 2" in the original header design, there was no minimum clearance criteria defined. No minimum dimension was specified.

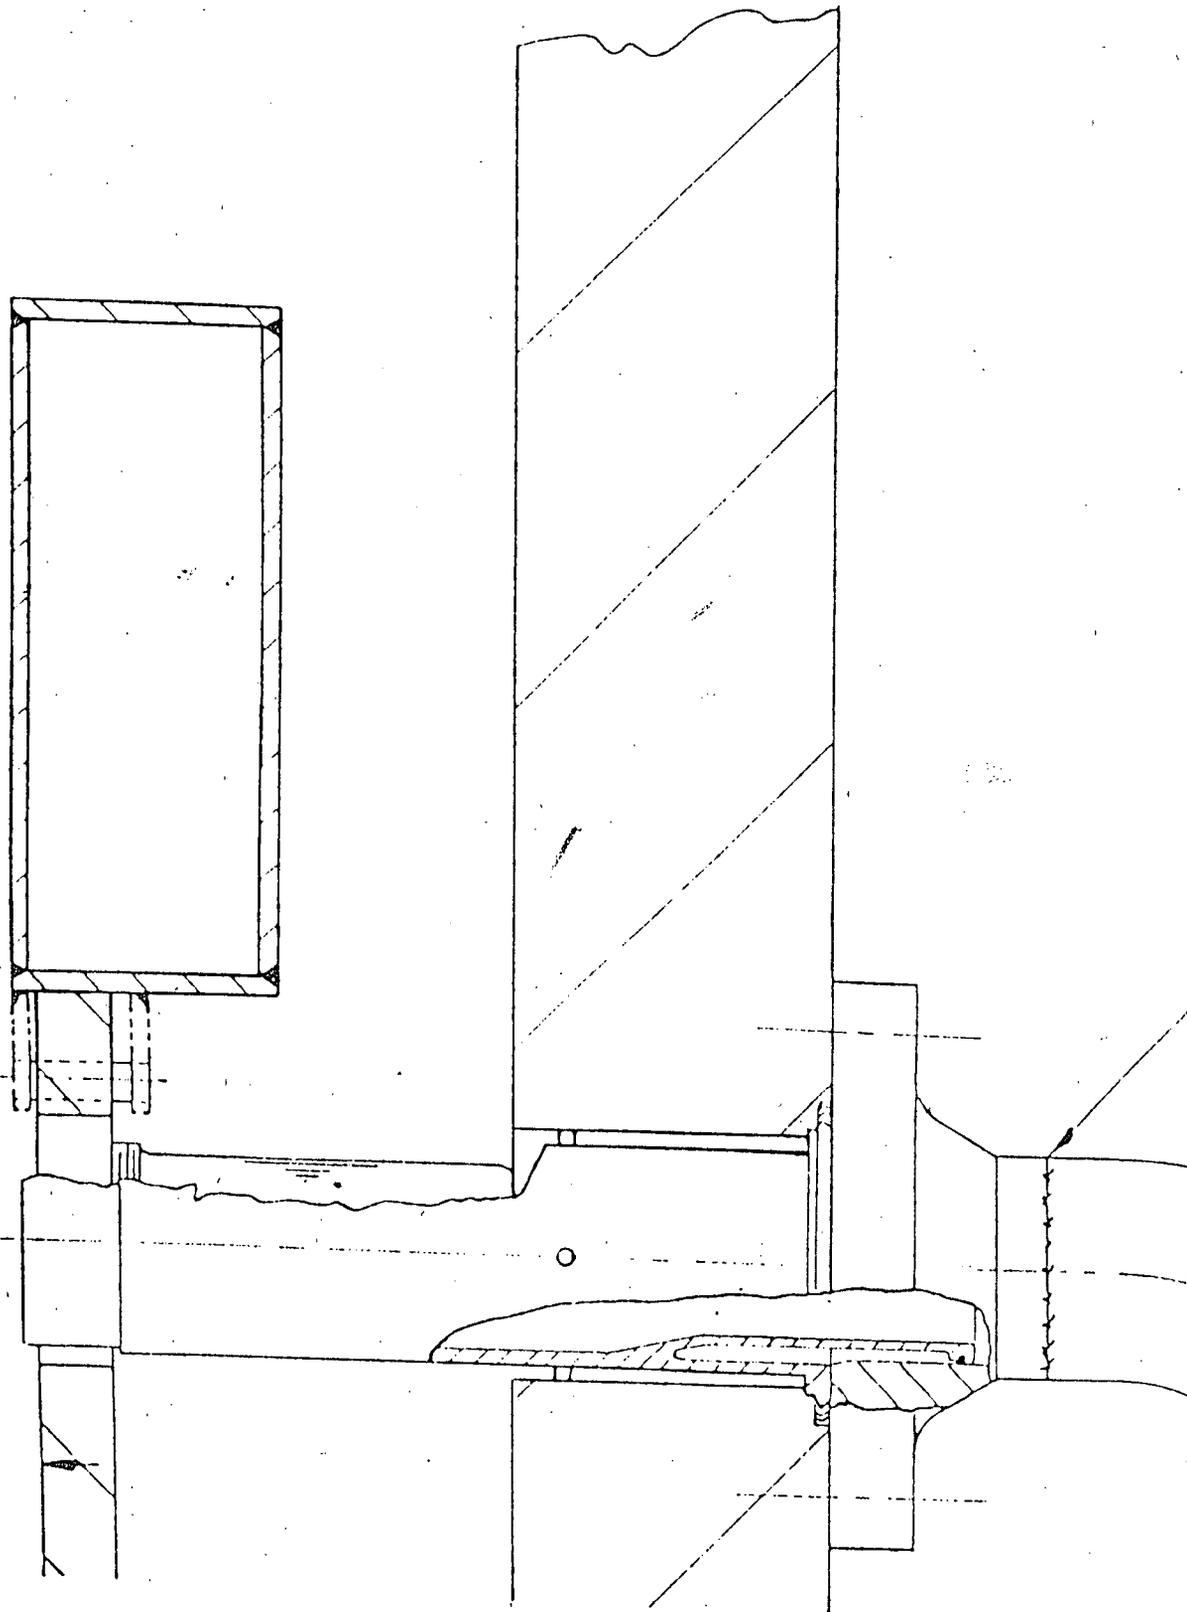
During the preparations to rotate the A header to allow the hole in the bottom plate to be cut out for analysis, a crack was discovered in the lower inner corner weld of the header. Fiberscope inspections located 180 degrees apart while the header was rotated 180 degrees allowed a 360 degree inspection of the lower-inner corner weld. Visual and UT inspections were made of the lower-outer corner weld. Visual inspections were made on the majority of the upper inner weld. The upper outer weld was inspected visually in a few areas; however, the difficulty in inspecting this weld resulted in less than full inspection. (Due to the other weld cracks, the very conservative approach of assuming all corner welds were fully cracked was taken in the stabilization analysis and thus saved the additional radiation exposure which would have been required for full inspection of all welds prior to repair.) Figure 2-6 shows the as-designed header with the corner construction welds. Figure 2-7 through 2-10 show the areas of weld degradation on the A header. Figure 2-11 shows photographs of two weld samples cut from the A header showing the lack of fusion, lack of full penetration, and lack of lower plate weld prep. While construction drawings required a "V" shaped weld prep at the interface of the vertical and horizontal walls, the analyses show that only the vertical walls were prepped which resulted in an inconsistent weld pattern with areas of lack of fusion and lack of full penetration when the fit up was less than ideal. Those areas of these welds were simply inadequate to withstand the loads generated when the header was deformed during AFW initiations.

Corner  
Weld  
(Typical for  
each Corner).
