# **Chernobyl Disaster 25<sup>th</sup> Anniversary RBMK Reactor & Sequence of Events**

**Dr. Brian Sheron, Director  
Office of Nuclear Regulatory Research  
April 26, 2011**

## **CHERNOBYL – 25 YEARS LATER**

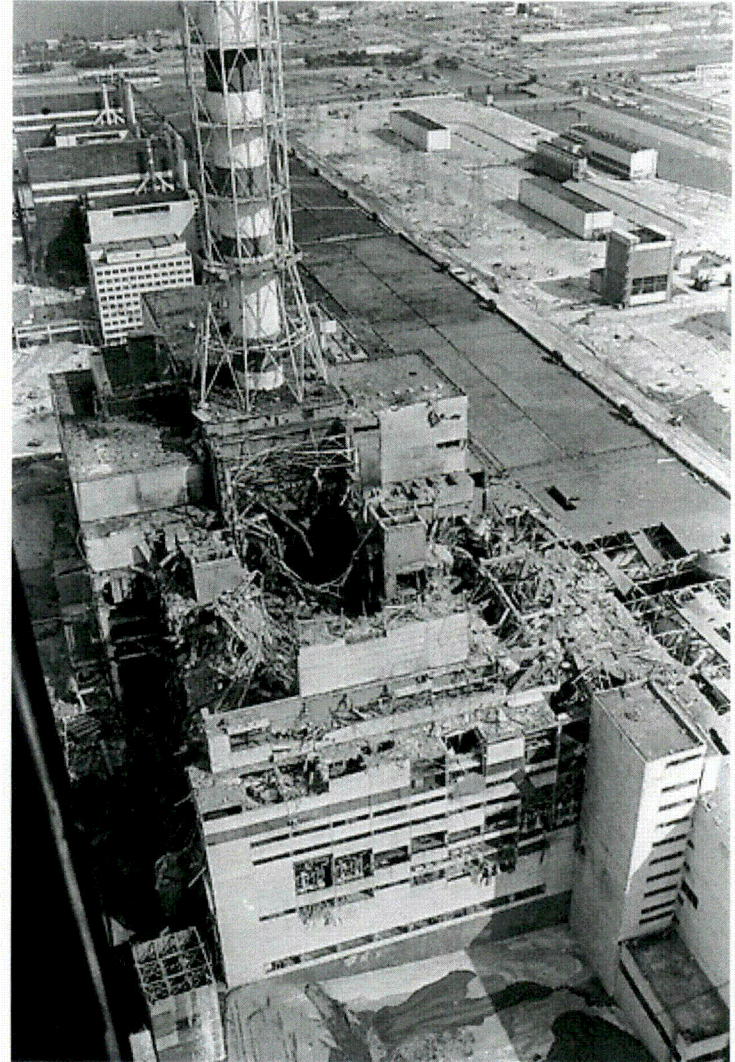
- Initial explosion
  - Prompt critical reactivity excursion
  - Power level exceeded 100 times full power
  - Fuel pellet temperature – 3,000 degrees C – fuel melted and expanded causing cladding failure
  - Massive energy release to coolant, along with particles of destroyed fuel
  - Massive steam explosion
- Second explosion 3 to 4 seconds later
  - Possible hydrogen and carbon monoxide explosion
  - Blew roof off of reactor building, and started 30 fires
- Graphite fires burned for 10 days

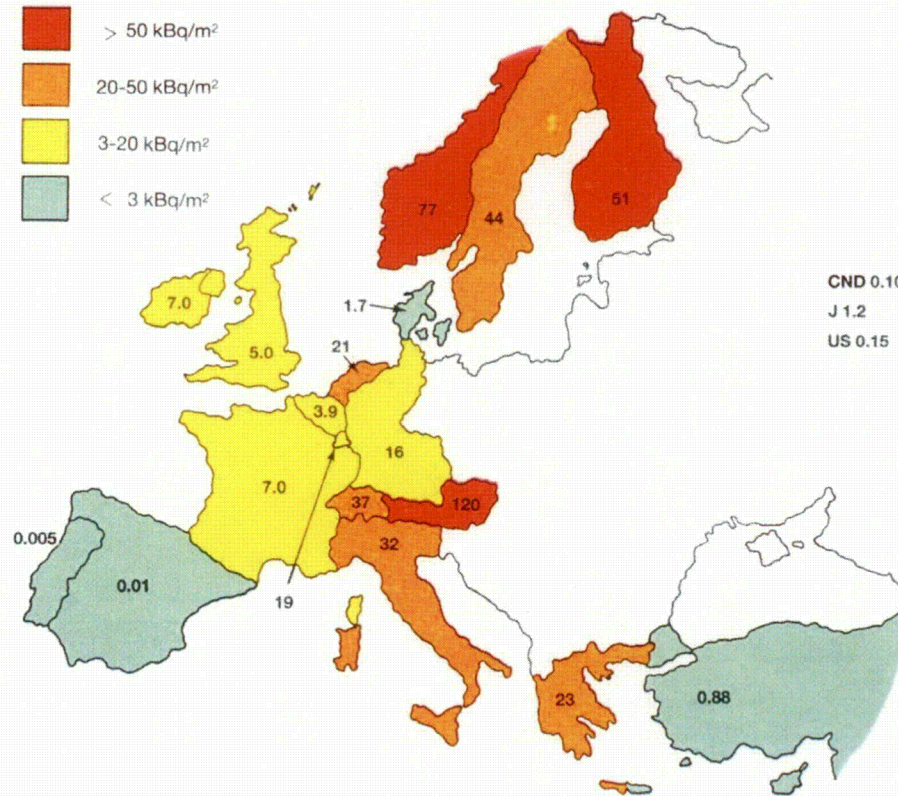
Figure 4. . AVERAGE VALUES OF THE TOTAL DEPOSITION OF IODINE-131  
FOLLOWING THE ACCIDENT  
(kBq/m<sup>2</sup>)

**I-131 SPREAD OVER WIDE  
AREA  
SIMILAR DISTRIBUTION FOR  
CESIUM 134 & 137**

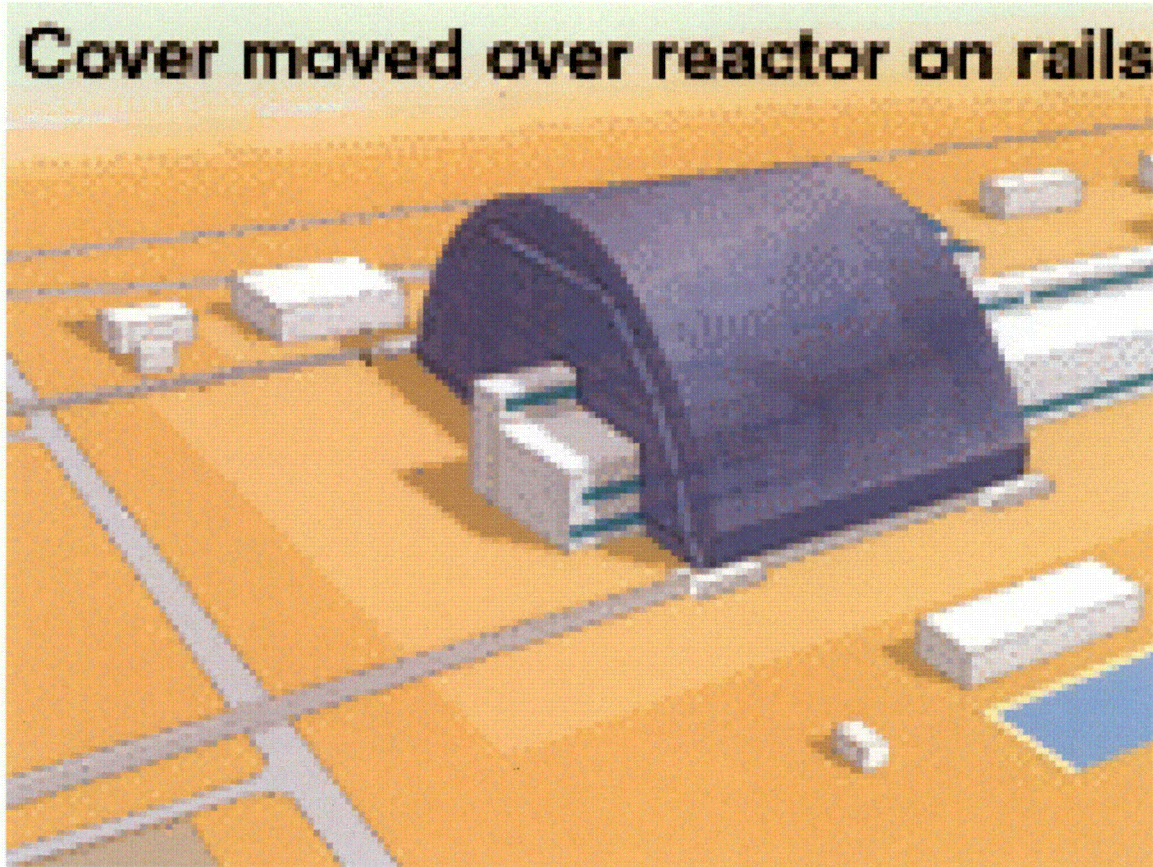
## **ARTIST RENDERING OF FUTURE SARCOPHOGUS**

**THE CURRENT BUILDING SURROUNDING CHERNOBYL 4 IS CRUMBLING.  
REPLACEMENT EXPECTED WITHIN NEXT FOUR YEARS**

**Cover moved over reactor on rails**
