Susquehanna Siphon and Vent Block Leak

John Wise
Division of Spent Fuel Management
Regulatory Conference
November 18-19, 2015

Susquehanna spent fuel loading campaign – Nov. 2014

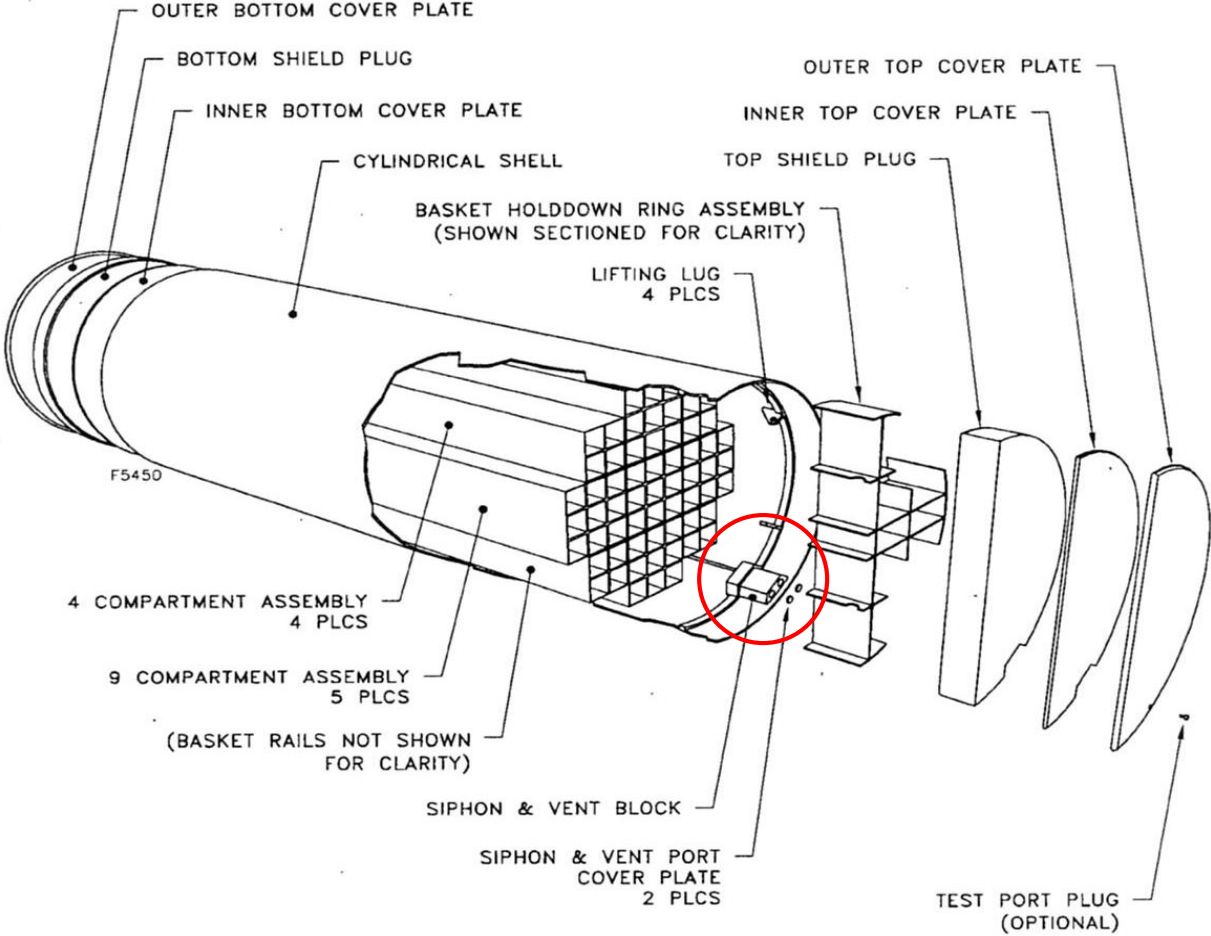
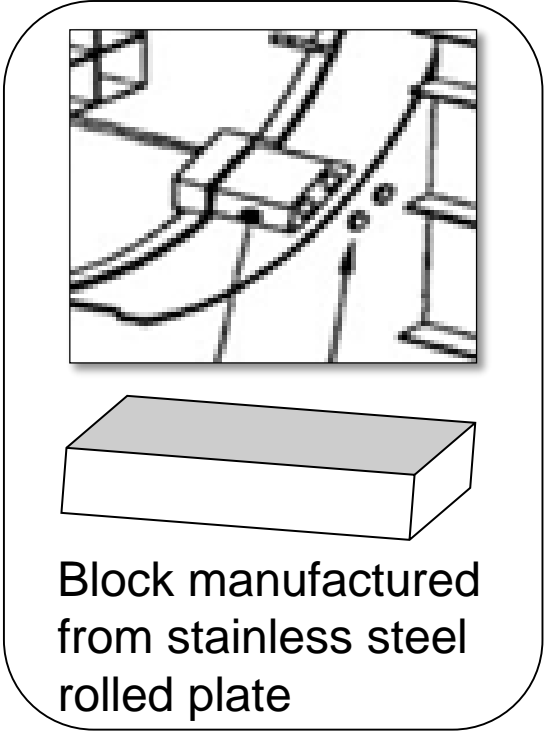
NUHOMS 61BTH Type 1 DSC

- NUHOMS 61BTH Type 1 dry shielded canisters (DSCs)
- During closure operations on one DSC, a liquid penetrant examination of a closure weld identified indications in the base metal of the syphon and vent block
