PNNL-SA-115353

Non-destructive Evaluation of Butt-fusion Joint Integrity in High Density Polyethylene Piping

INDUSTRY/NRC NDE TECHNICAL INFORMATION EXCHANGE
PUBLIC MEETING

JANUARY 21, 2016

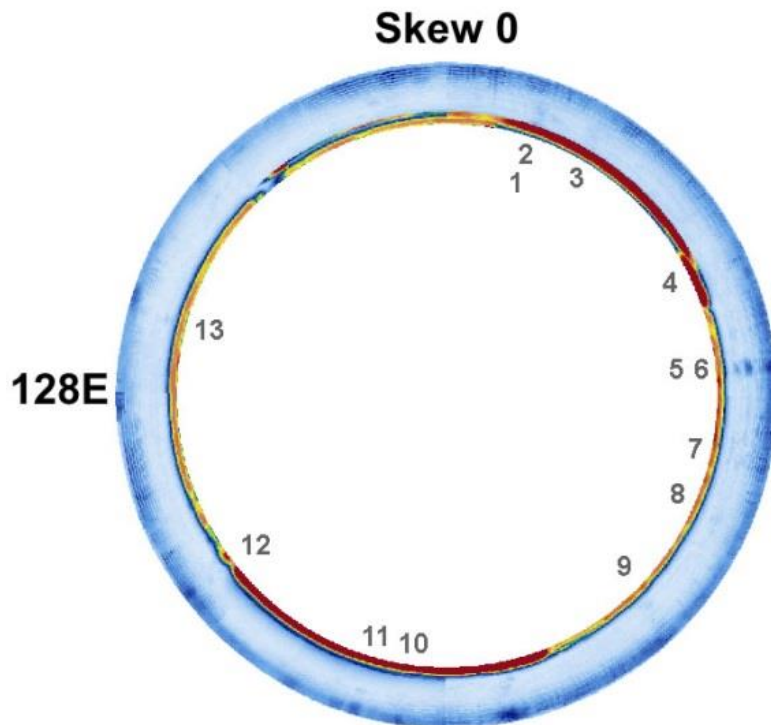
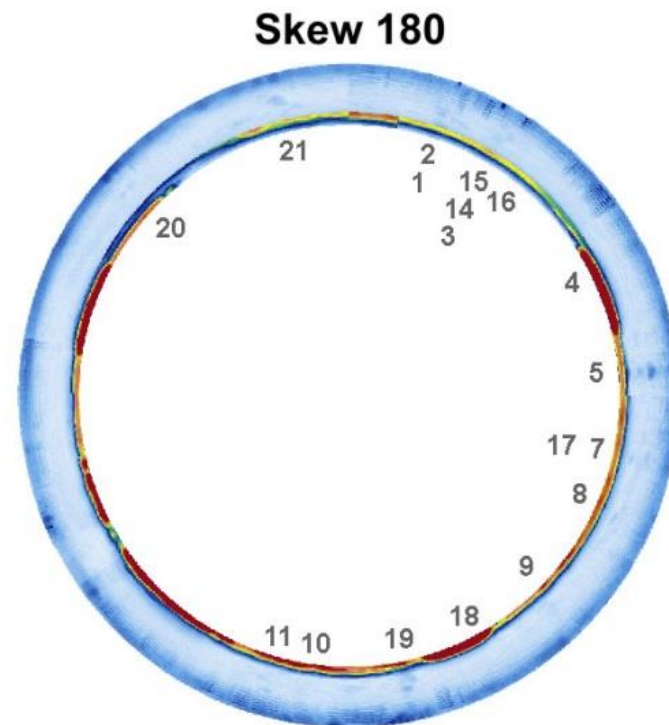
- ▶ Implanted “coarse” particulate contamination
 - 118-micron PSD d50
- ▶ Pre-fab: Applied OD to ID across circumference
- ▶ Fabricated per ASME Code

- ▶ RT confirms particulate is in the fusion joint
- ▶ Appears PA-UT/TRL can detect at a certain concentration level
 - Require better understanding of actual concentration across wall and circumference
