OCONEE NUCLEAR STATION

UNIT 3

REACTOR BUILDING

END ANCHORAGE SURVEILLANCE

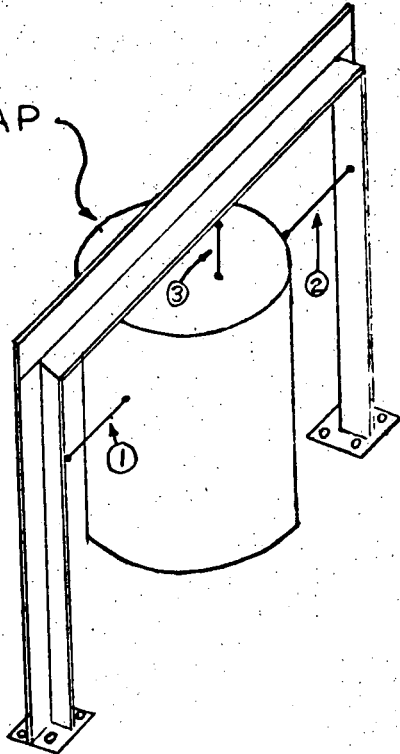
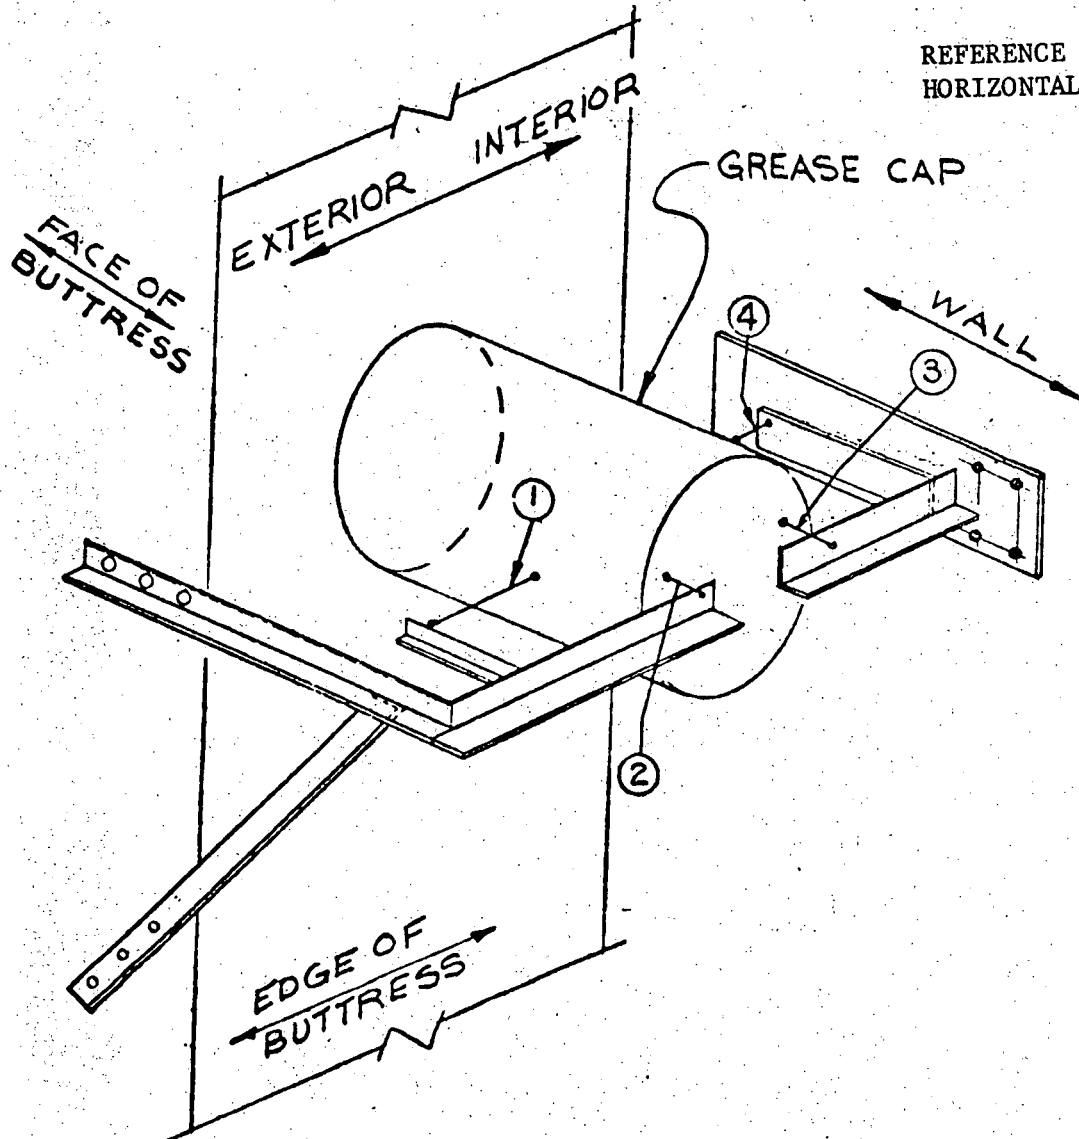
FIGURE 8

Position measurements for seven of the tendon anchors were made during the Reactor Building Structural Integrity Test and at the two other periods as stated above. Results of these measurements are given in Table 1. Details of the demountable reference frames and the location of measurements are shown in Figure 8.
