## 5.0 Falls City, Texas, Disposal Site

### 5.1 Compliance Summary

The Falls City, Texas, Uranium Mill Tailings Radiation Control Act (UMTRCA) Title I Disposal Site was inspected on January 20, 2015. The site was in excellent condition. Some perimeter signs are discolored and becoming illegible; these will be replaced. Inspectors identified no other maintenance needs or cause for a follow-up inspection.

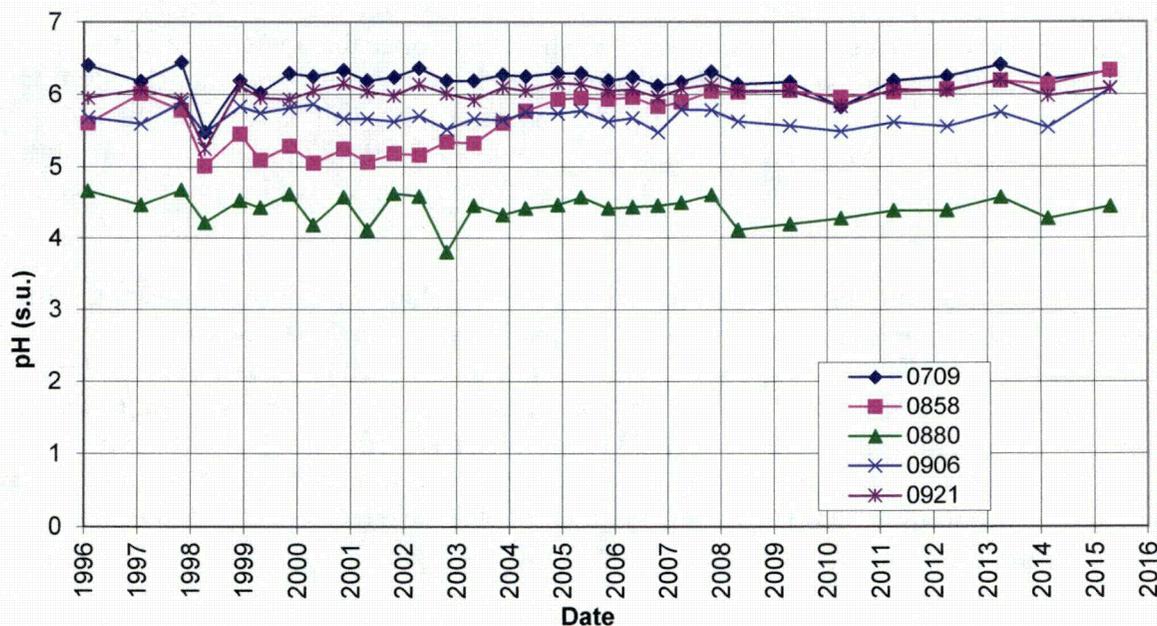
Figure 5-3. pH in Groundwater at Cell Performance Monitoring Locations at the Falls City Disposal Site

**pH:** At the cell performance monitoring wells, pH levels historically have been higher than the pH in tailings pore fluids (pH level of 2.93), with no significant upward or downward trends. In 2015, the pH levels for the cell performance wells continued to increase slightly (Figure 5-3) as would be expected as the pore fluids dissipate with time. Wells 0908 and 0916 are not shown in Figure 5-3 because those wells have been dry since 1996.

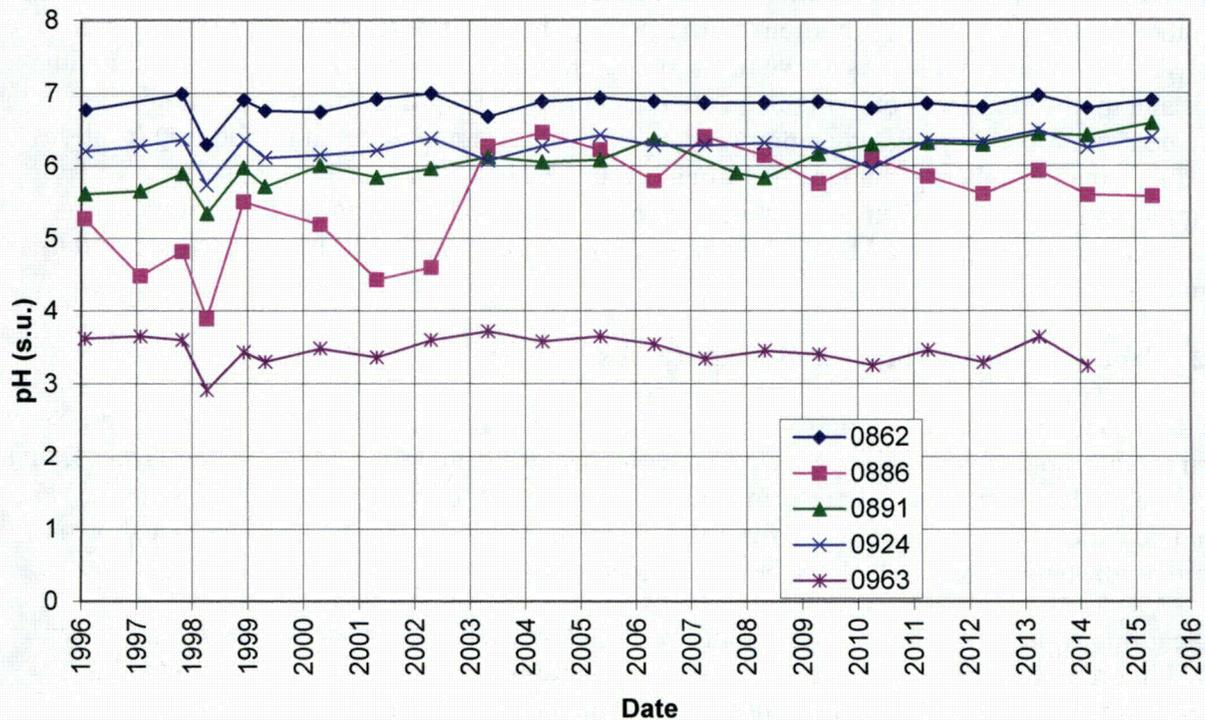
Figure 5-4. pH in Groundwater at Compliance Monitoring Locations at the Falls City Disposal Site

At the groundwater compliance monitoring wells, pH levels have historically been higher than the pH in groundwater contaminated by processing activities, with no significant upward or downward trends. The pH levels for these wells remained within the historical range (Figure 5-4). The pH in well 0963 historically has been lower than at the other locations but, in 2014 at a level of 3.24, it remains higher than the pH in the tailings pore fluids. This location was not accessible in 2015 due to high water in a gravel pit, and was therefore not sampled.<sup>1</sup>

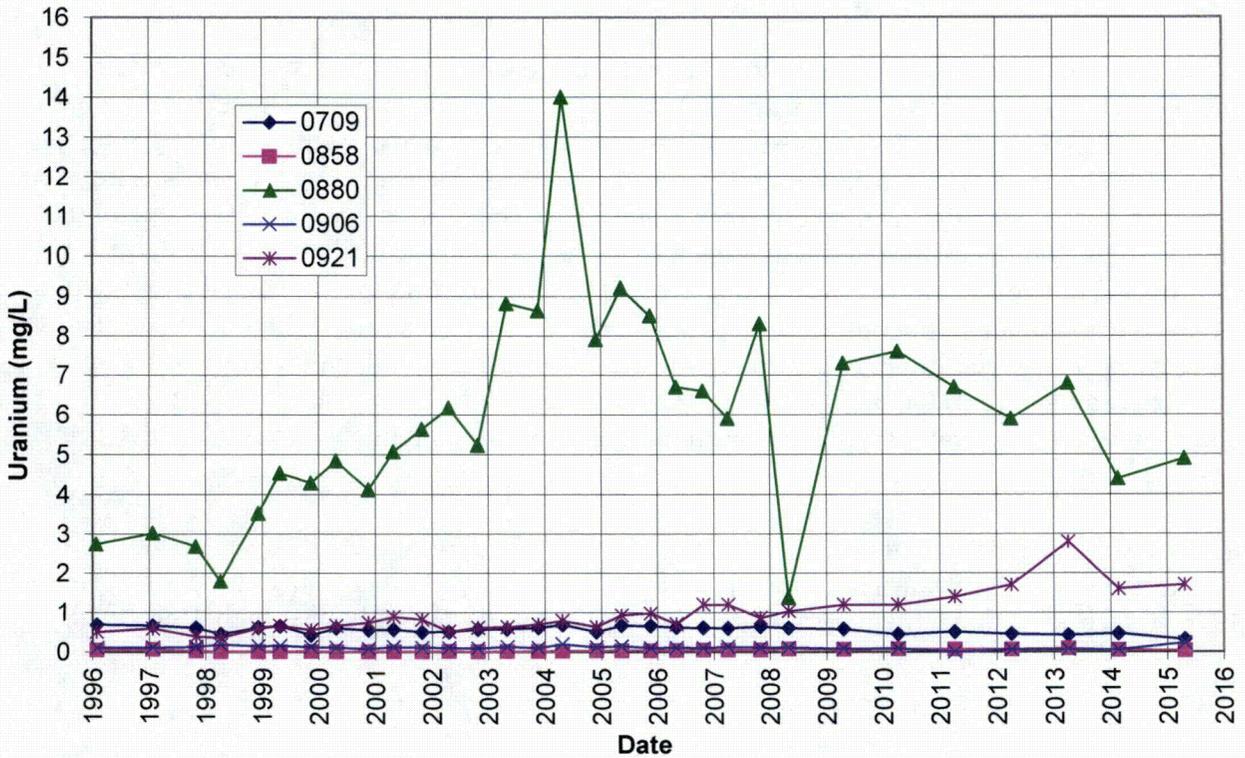
Figure 5-5. Uranium in Groundwater at Cell Performance Monitoring Locations at the Falls City Disposal Site

**Uranium:** Uranium concentrations in the cell performance wells remained within the historical range (Figure 5-5). The concentration in well 0921 showed a noticeable increase in 2013 following a gradual increase since 2002, but the 2015 result showed no significant change from 2014. A downward trend has occurred in well 0880 since 2004. At well 0880, uranium concentrations have varied considerably, ranging from a low of 1.38 milligrams per liter (mg/L) in 2008 to a high of 14 mg/L in 2004. Wells 0908 and 0916 are not shown in Figure 5-5 because those wells have been dry since 1996.

Uranium concentrations in cell performance well 0880 have varied considerably since 1996, but the 2015 results show little change from 2014 (Figure 5-5). The pH at this location is lower than at other locations in the cell performance monitoring network. Water levels are also declining at well 0880 (Figure 5-7). These results suggest that the interaction among the disposal cell, the legacy groundwater mound, and processing plumes is still equilibrating. However, monitoring results do not indicate that the disposal cell is contributing to the degradation of the uppermost aquifer. The cause of the anomalously high uranium concentrations in groundwater compliance well 0891 since 2008 (Figure 5-6) has not been determined.

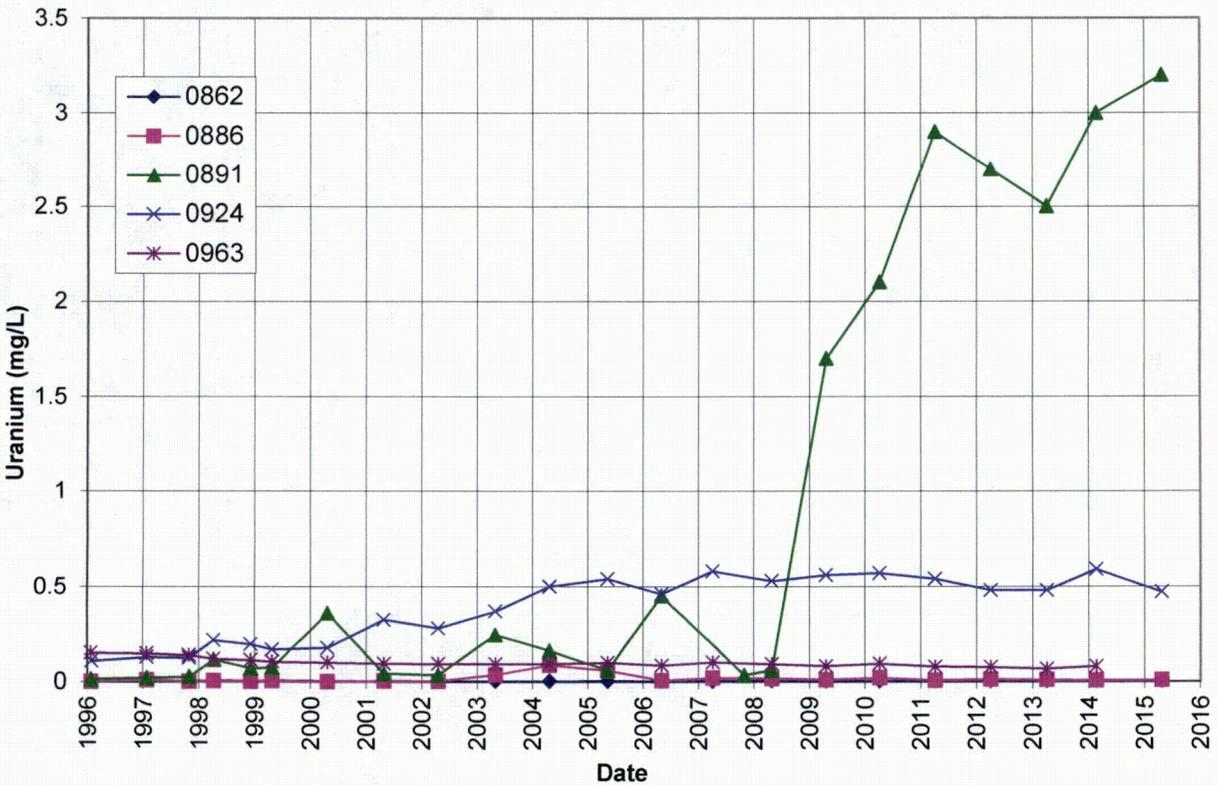
Figure 5-6. Uranium in Groundwater at Compliance Monitoring Locations at the Falls City Disposal Site

The concentration of uranium in groundwater within the compliance monitoring network shows that the uranium concentrations at monitoring wells 0862, 0886, and 0963(not sampled in 2015) remain stable at low levels (<0.2 mg/L) (Figure 5-6). The uranium concentration in well 0924 has been relatively stable since 2004, fluctuating between 0.4 mg/L and 0.6 mg/L. Since 2008, the uranium concentrations measured at well 0891 have been significantly higher than the other wells. The 2015 result (3.2 mg/L) is the highest measured in the well to date and is slightly above the maximum concentration reported for the aquifer, which is also the value used in the risk assessment for the Dilworth groundwater (3.04 mg/L).

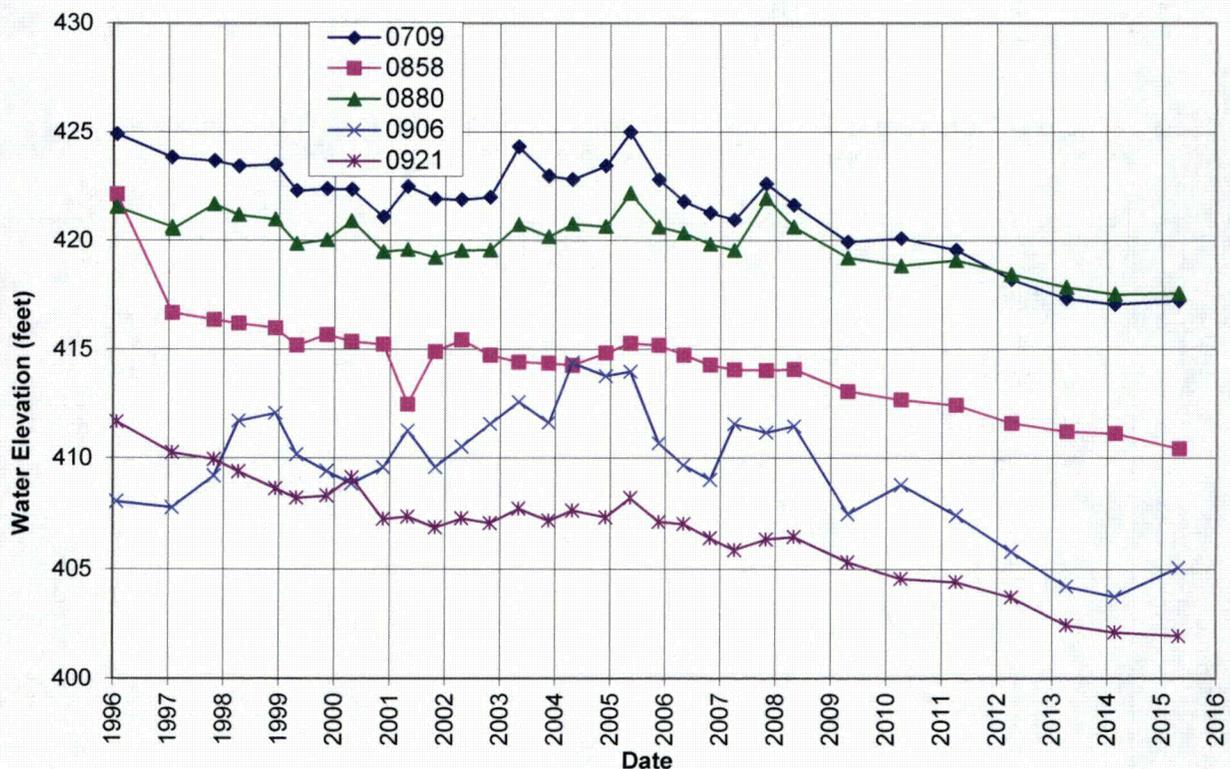
Figure 5-7. Water-Level Measurements at Cell Performance Monitoring Locations at the Falls City Disposal Site

Water levels in the disposal cell performance network reached new lows for every well in 2014, and the changes from 2014 to 2015 were varied but not large (Figure 5-7). Since 1996, groundwater levels in the disposal cell performance network wells have all decreased, ranging from approximately 2 feet to 12 feet lower than 1996 levels. The water level in monitoring well 0906 has fluctuated more than levels in the other wells. This well is directly downslope of the disposal cell, and the historical fluctuation may be the result of the infiltration of water that is shed by and conveyed away from the disposal cell, reflecting variations in annual precipitation. Other contributors that may influence local groundwater levels include: (1) the dissipation of the processing-site-related groundwater mound beneath the disposal cell, and (2) the reduction of transient drainage from the disposal cell. Wells 0908 and 0916 are not shown in Figure 5-7 because these wells, completed in an unsaturated zone of the Conquista Sandstone, have been dry since 1996.

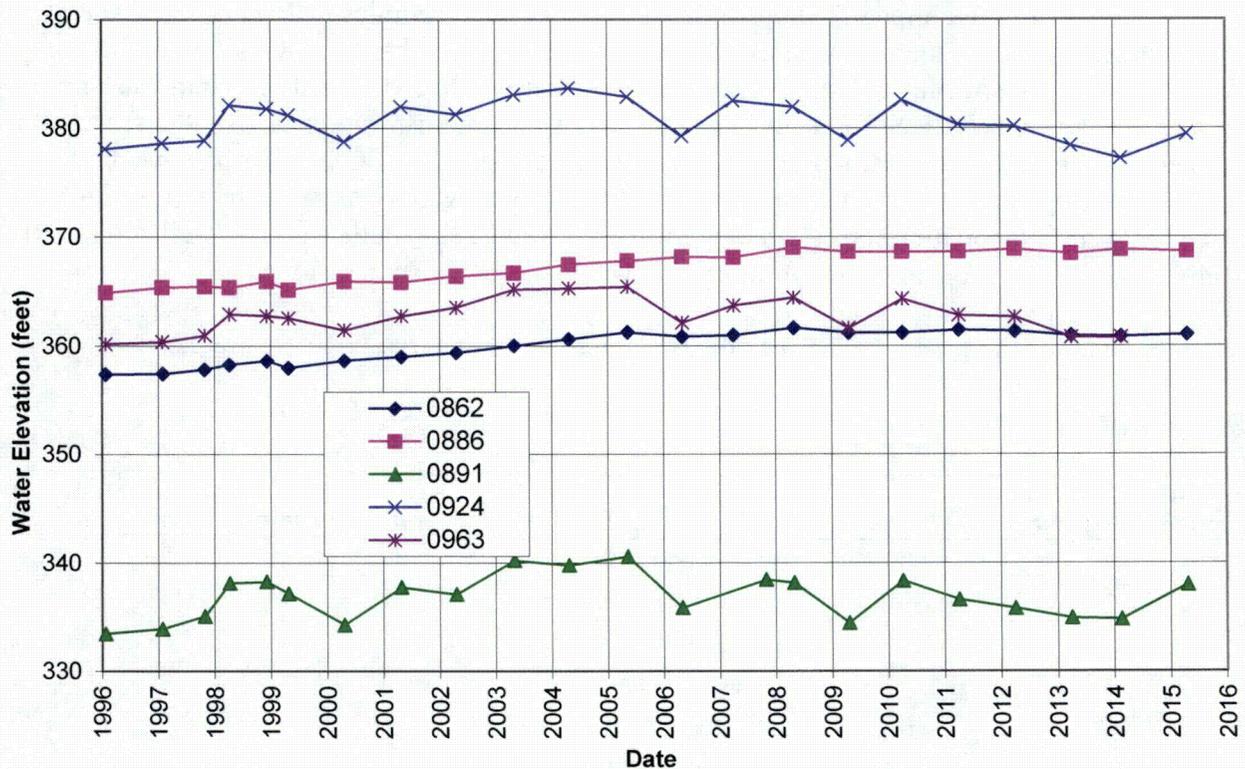
Figure 5-8. Water-Level Measurements at Compliance Monitoring Locations at the Falls City Disposal Site

Water level trends vary in the groundwater compliance monitoring network wells (Figure 5-8). Levels show a slight upward trend in wells 0862, 0886, and 0891 increasing about 4 feet since 1996. Water levels have fluctuated in the other wells and are currently near their 1996 levels.

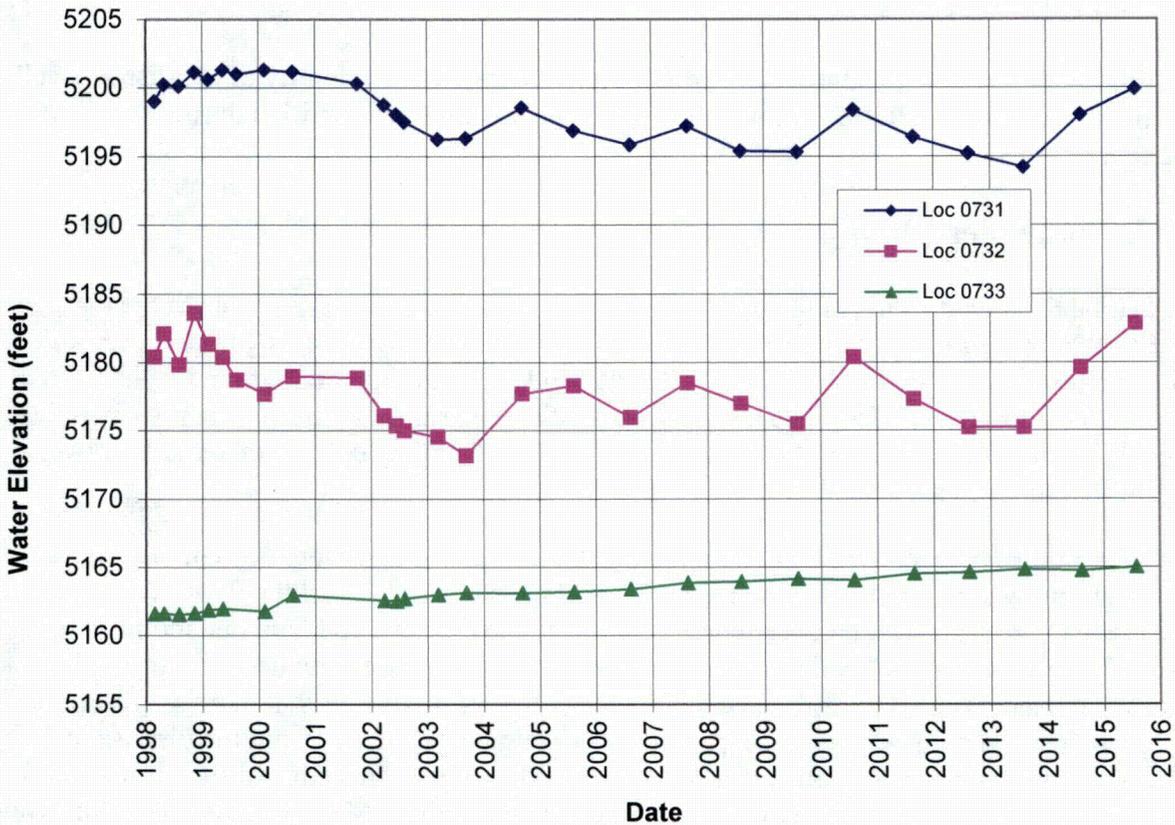
Figure 6-2. Water Level Measurements at the Grand Junction Disposal Site

Since 1998, the water level in disposal cell well 0733 has stabilized. It has risen only an estimated 4 feet over the last few years, and it has remained substantially lower than the water levels in paleochannel monitoring wells 0731 and 0732 (Figure 6-2). Water levels within the two paleochannel monitoring wells continue to fluctuate and in 2015 were near 1998 levels. The water levels verify that groundwater at the base of the disposal cell at well 0733 has not risen to an elevation where it could potentially migrate into paleochannel groundwater at wells 0731 and 0732.

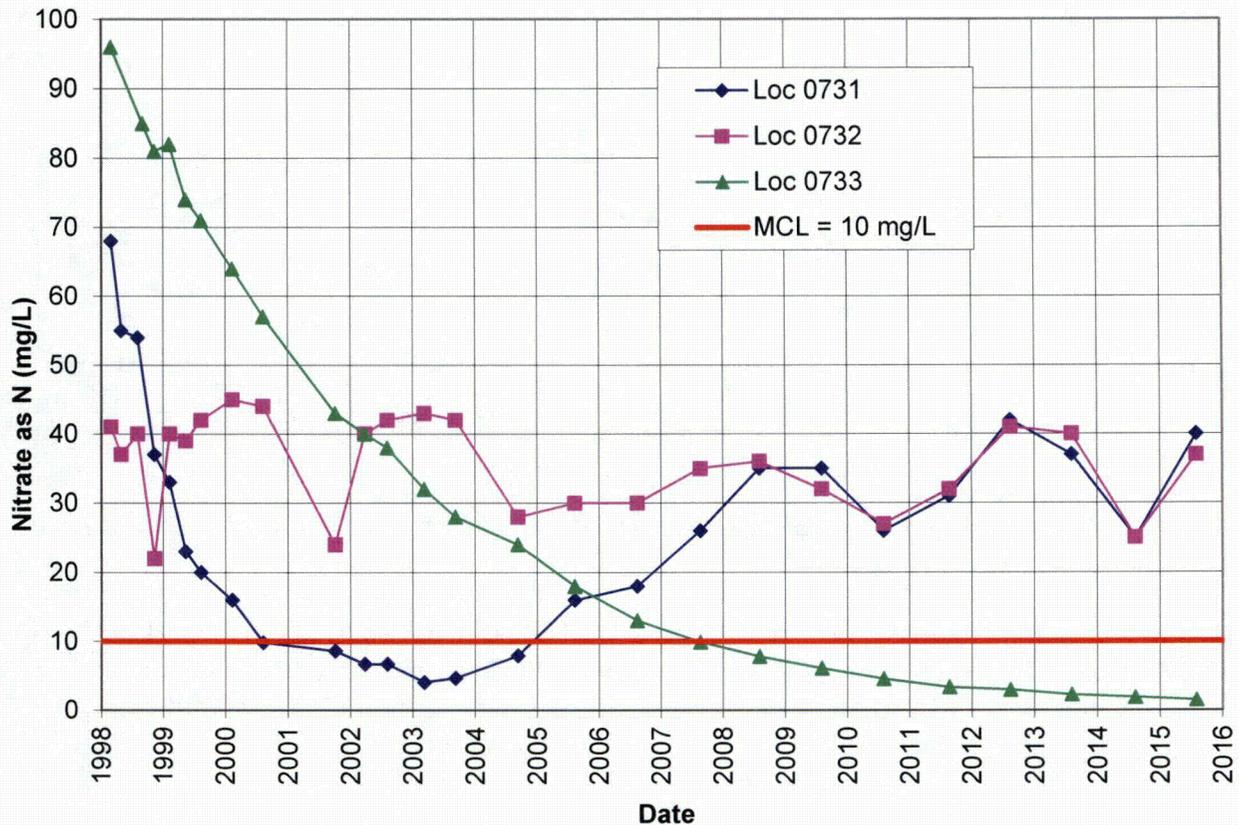
Figure 6-3. Time-Concentration Plots of Nitrate (as Nitrogen) in Groundwater at the Grand Junction Disposal Site

Nitrate (as nitrogen) concentrations in groundwater continued to exceed the MCL of 10 mg/L in the paleochannel monitoring wells (0731 and 0732) in 2015 (Figure 6-3). Concentrations in these wells have varied substantially since 1998 with no overall trend. Nitrate concentrations in disposal cell well 0733 have shown a continuous downward trend since 1999 and reached a low of 1.5 mg/L in 2015. There is no apparent correlation of nitrate concentrations between the paleochannel wells and the disposal cell well.

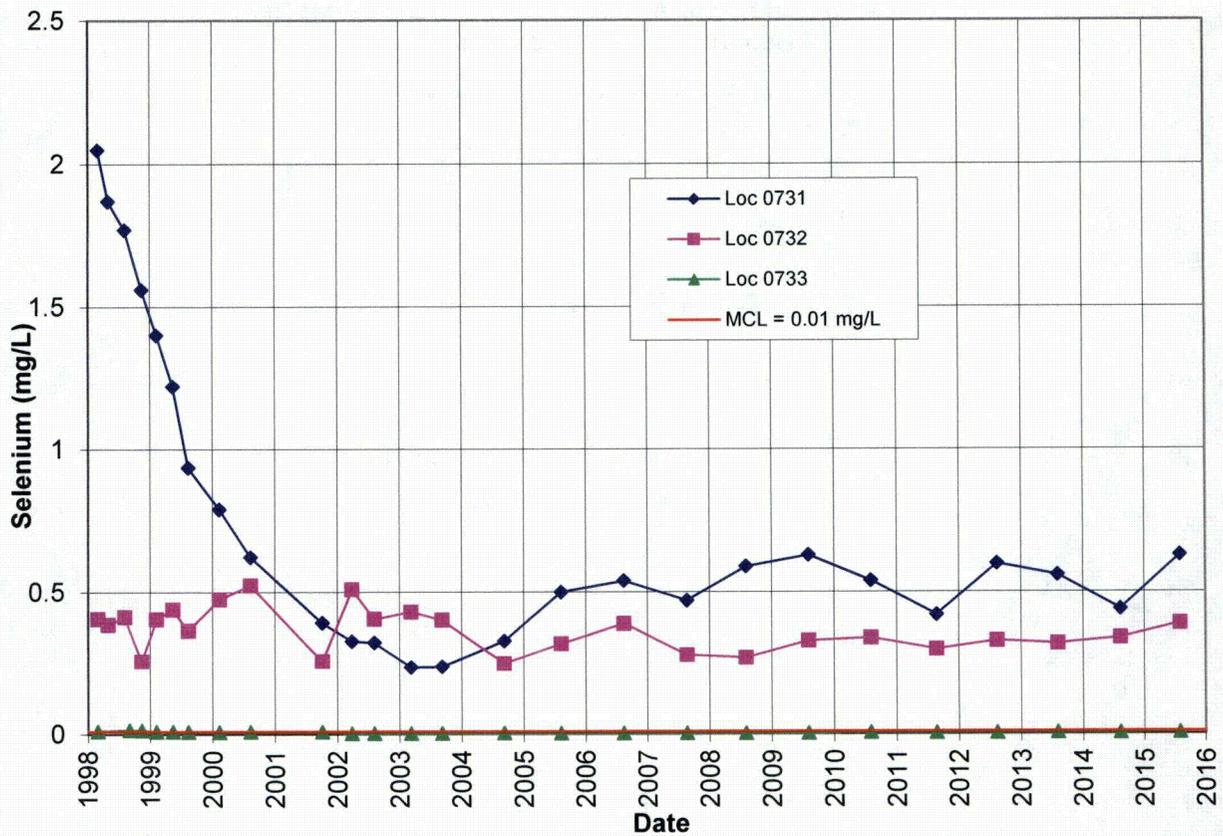
Figure 6-4. Time-Concentration Plots of Selenium in Groundwater at the Grand Junction Disposal Site

Selenium concentrations continued to exceed the MCL of 0.01 mg/L in the paleochannel monitoring wells (0731 and 0732), with no apparent trend in either well since 2001 (Figure 6-4). Selenium occurs naturally in the Mancos Shale deposits that underlie the disposal cell, and it might be the cause of the elevated concentrations reported in both paleochannel monitoring wells. In well 0733, the selenium concentration of 0.0052 mg/L in 2015 remained well below the MCL, with no trend evident. There is no apparent correlation of selenium concentrations between the paleochannel wells and the disposal cell well.

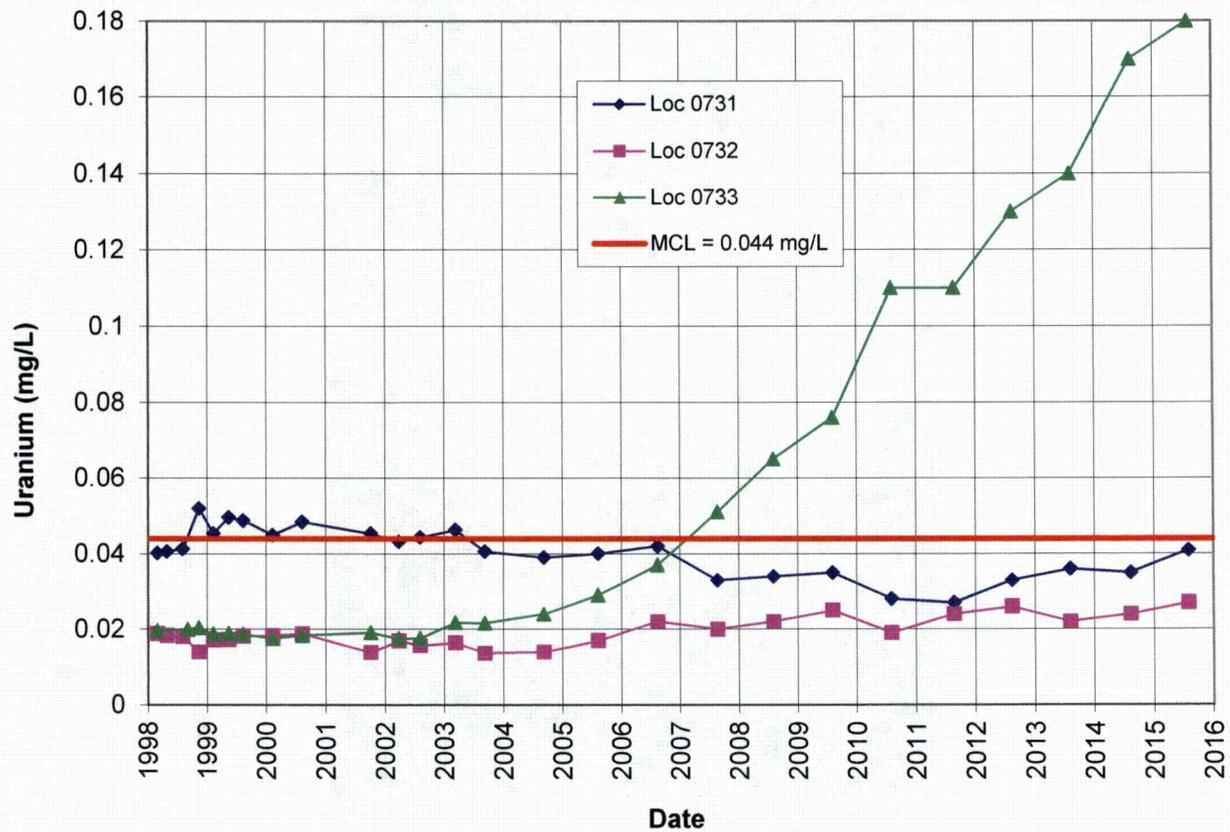
Figure 6-5. Time-Concentration Plots of Uranium in Groundwater at the Grand Junction Disposal Site

Uranium concentrations in groundwater continued to be below the MCL of 0.044 mg/L in wells 0731 and 0732, showing no apparent trend since 2007 (Figure 6-5). The uranium concentration in well 0733 continued to be above the MCL and continued an upward trend; the 2015 concentration was 0.18 mg/L. There is no apparent correlation of uranium concentrations between the paleochannel wells and the disposal cell well.

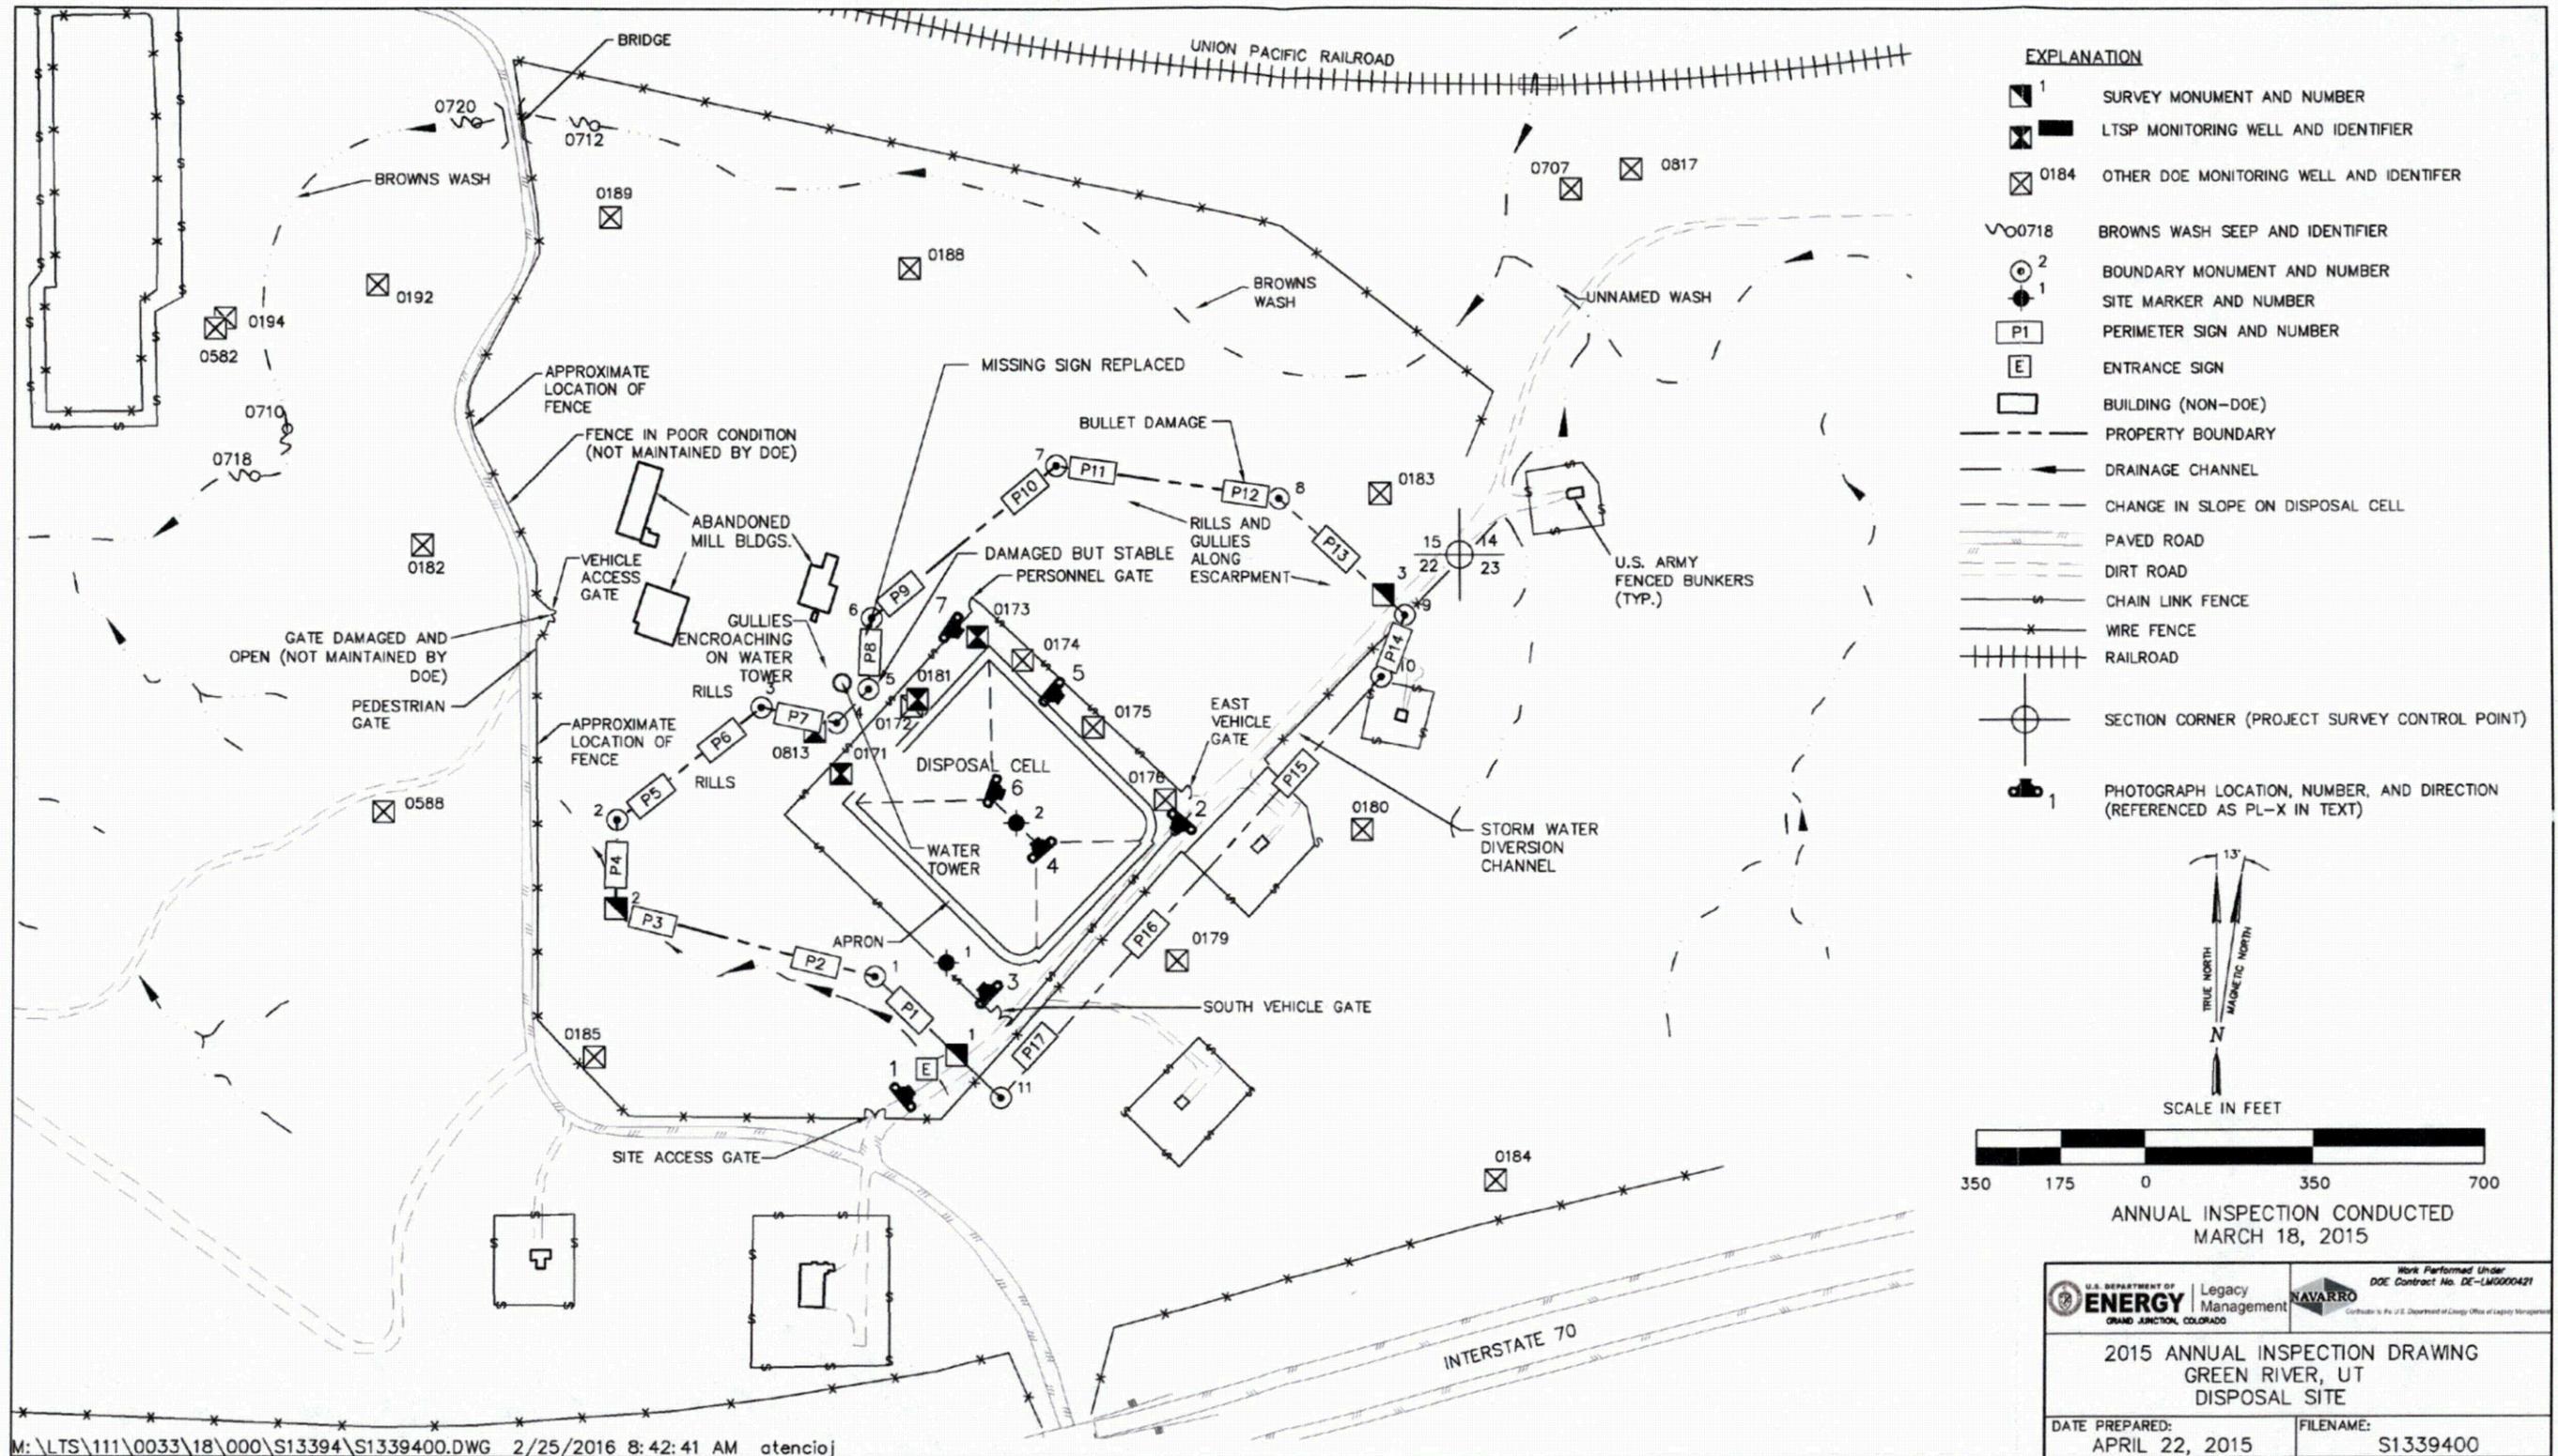
Figure 7-1. 2015 Annual Inspection Drawing for the Green River Disposal Site

Eleven boundary monuments and three survey monuments are along the site perimeter. The monuments were in excellent condition with the exception of boundary monument BM-5, which was bent but remains stable.

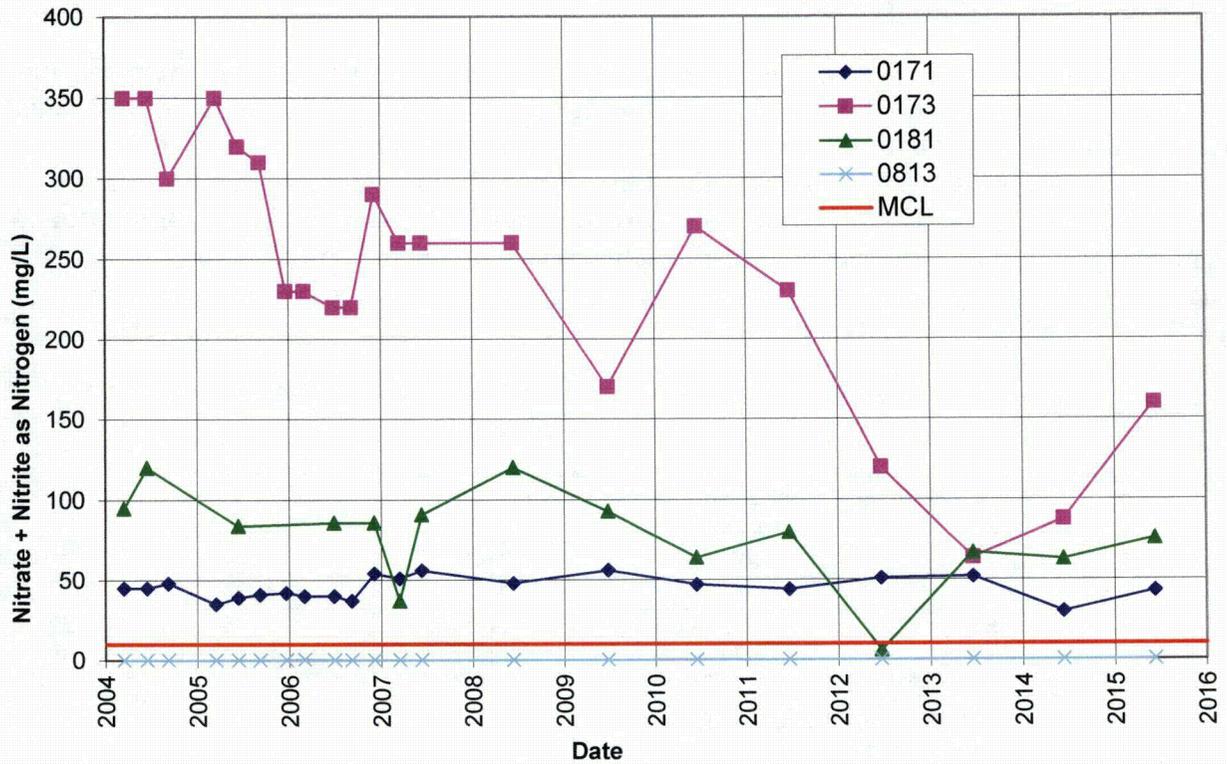
Figure 7-2. Time-Concentration Plots of Nitrate in Groundwater at the Green River Disposal Site

Nitrate concentrations have been measured as nitrate plus nitrite reported as nitrogen since early 2004 (before then, nitrate was reported as NO<sub>3</sub>). Concentrations continued to exceed the LTSP limits in wells 0171 and 0173, but they are considerably below the proposed ACL of 1,000 milligrams per liter (mg/L). Concentrations of nitrate for 2015 in the POC wells are similar to previous measurements (Figure 7-2).

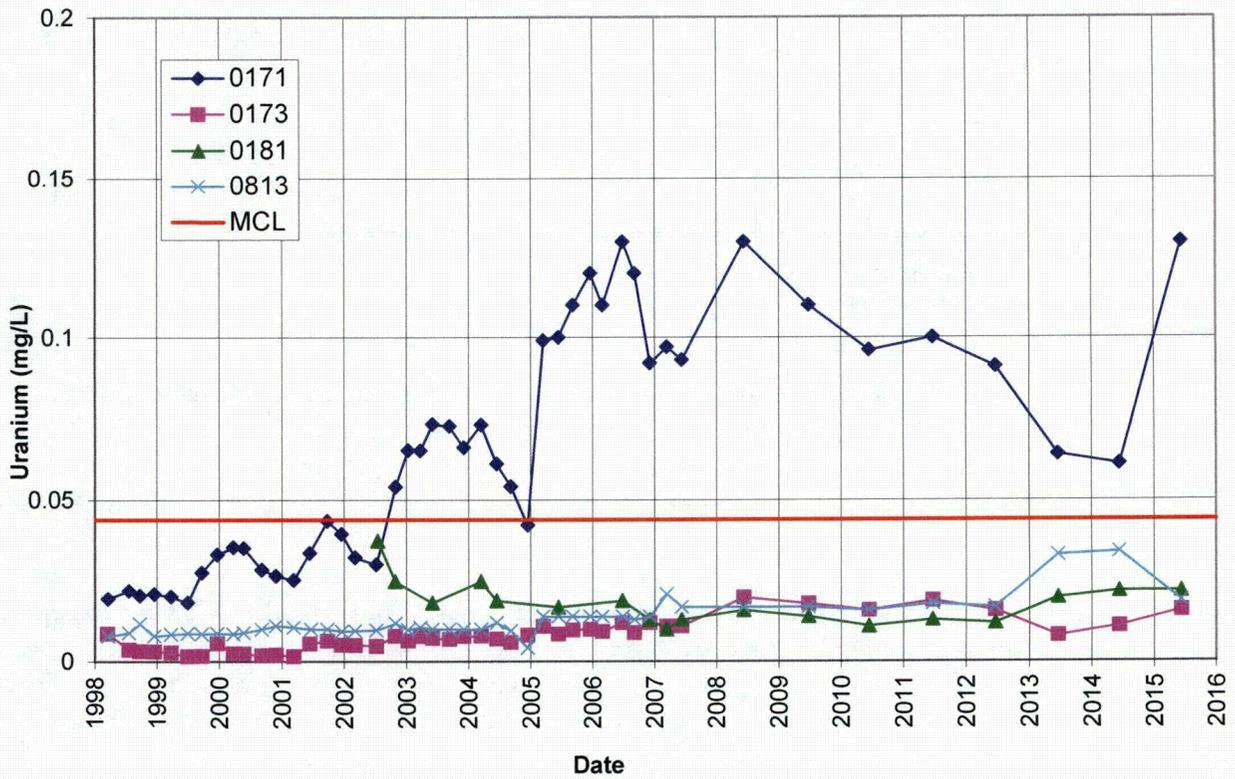
Figure 7-3. Time-Concentration Plot of Uranium in Groundwater at the Green River Disposal Site

Uranium concentrations in groundwater remain below the LTSP limits in all POC wells except well 0171, and remain considerably below the proposed ACL of 4.4 mg/L in all POC wells (Figure 7-3). Uranium concentrations at well 0171 have varied considerably, ranging from a low of 0.0184 mg/L in 1999 to a high of 0.13 mg/L in 2006, 2008, and again in 2015. No conclusions regarding the variability of uranium concentrations in well 0171 have been reached.

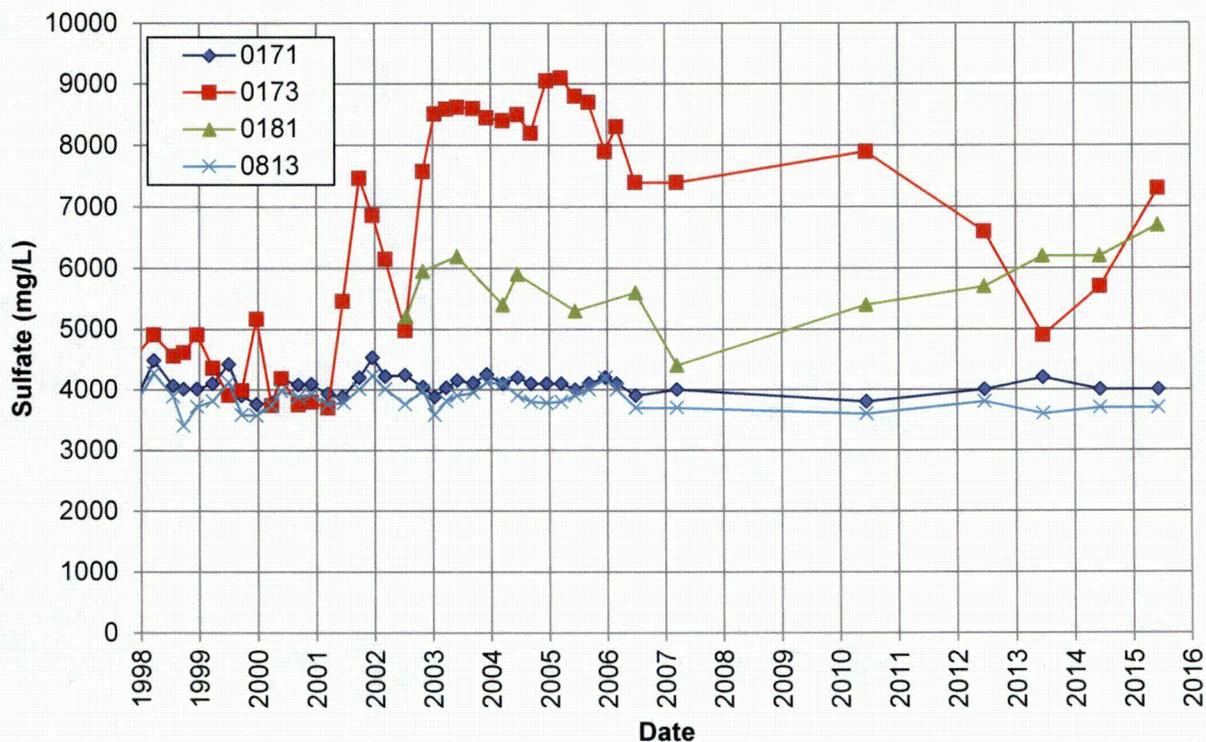
Figure 7-4. Time-Concentration Plot of Sulfate in Groundwater at the Green River Disposal Site

Sulfate concentrations continue to exceed the LTSP limits in all POC wells except 0813. The 2015 concentrations were within historical results (Figure 7-4).

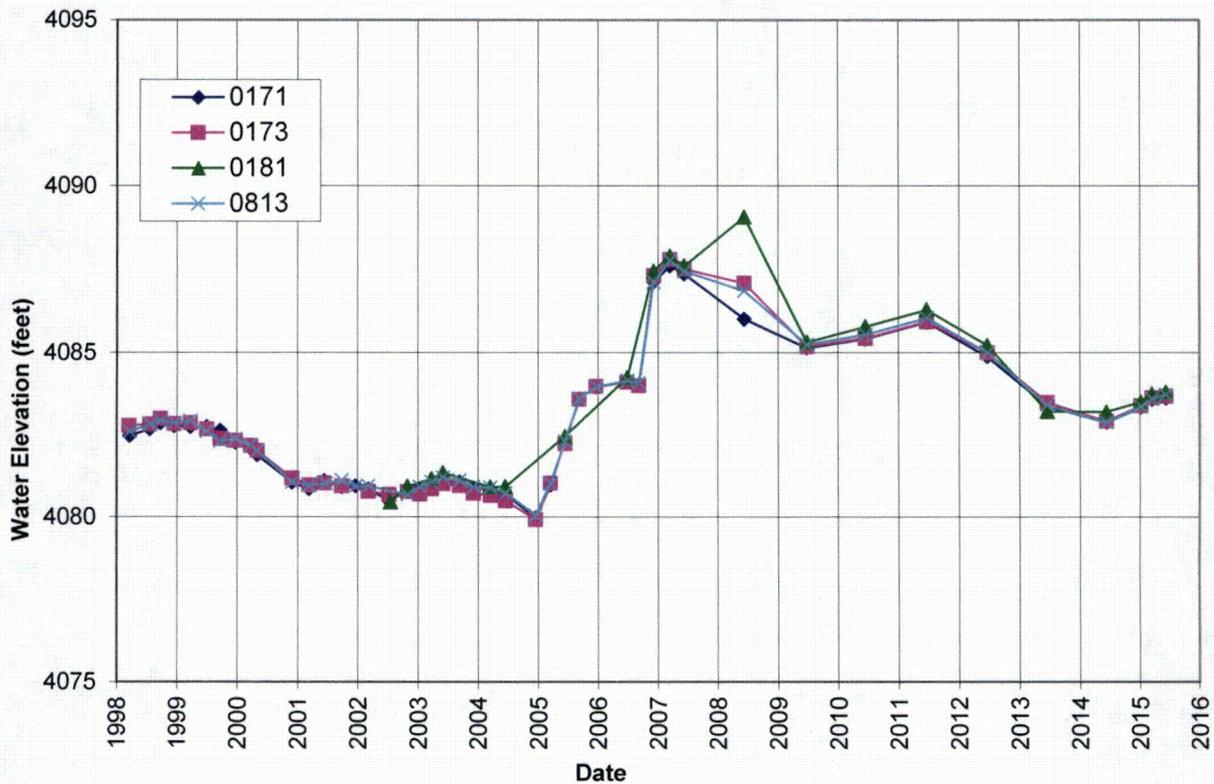
Figure 7-5. Groundwater Elevations at the Green River Disposal Site

Groundwater-level monitoring near the disposal cell, using the POC wells, has shown little change since 2013. These POC wells, which are completed in the middle sandstone aquifer, indicate that the groundwater elevation decreased approximately 3 feet overall from 1998 through 2004, and then increased approximately 8 feet between 2004 and 2007. Water levels have decreased approximately 4 to 5 feet since 2007 (Figure 7-5).

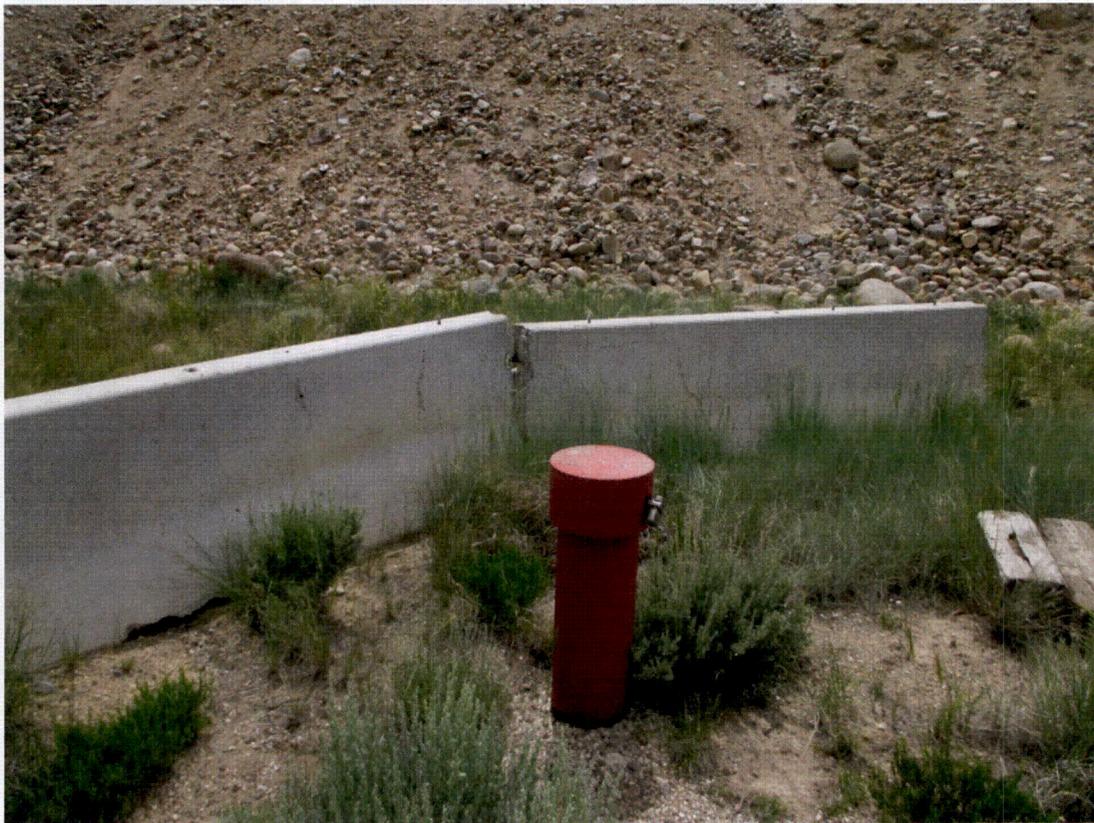
Sixteen wells constitute the groundwater monitoring network for the site. The wells were secure and in excellent condition (PL-4). The Gunnison County landfill operators have placed concrete barriers to protect monitoring well 0716, which is located on landfill property, from landfill activities (PL-5). The edge of the spoil pile was approximately 10 feet from the barriers, and was

*GUD 6/2015. PL-5. Monitoring well 0716 protected by jersey barriers.*

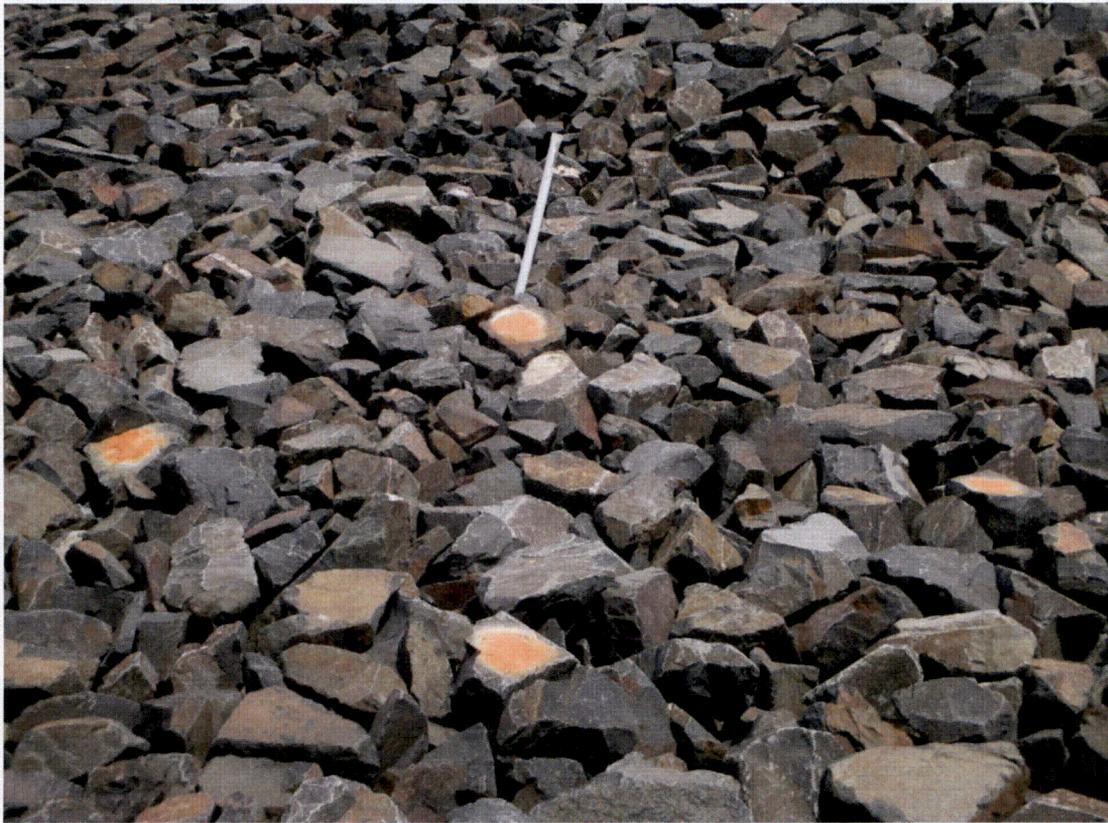
*GUD 6/2015. PL-9. Riprap test area No. 3.*

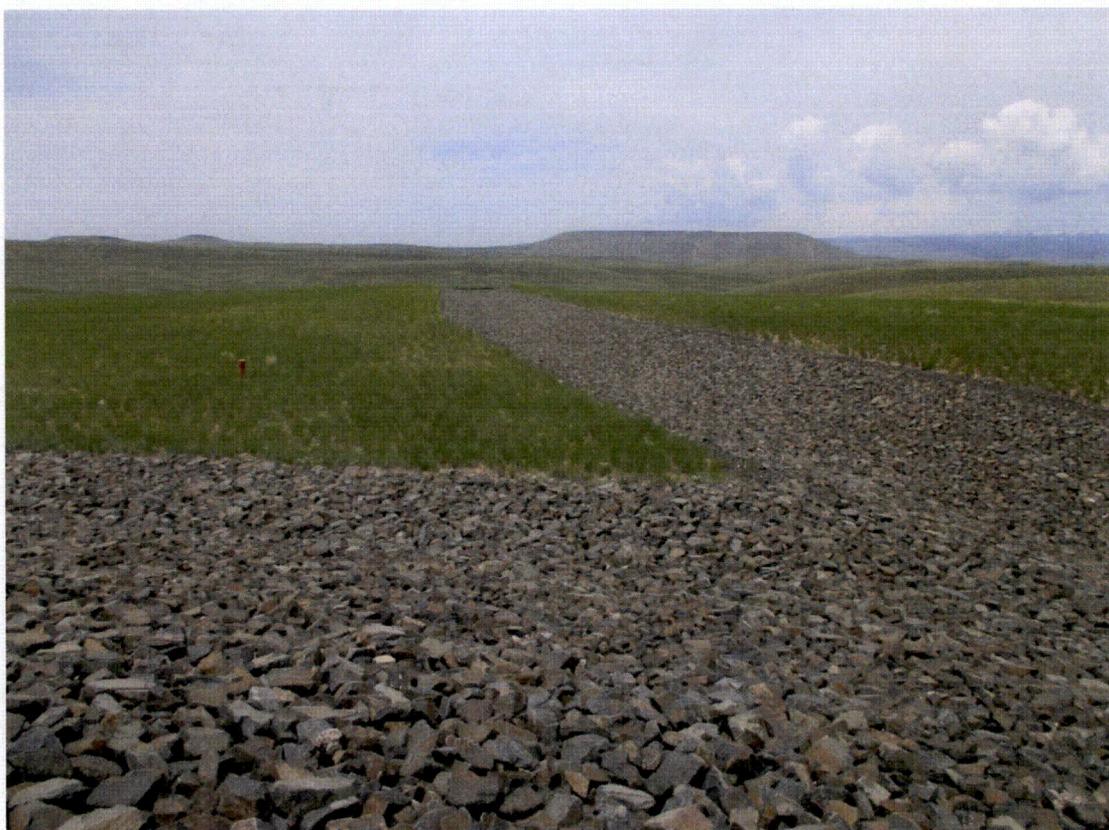
*GUD 6/2015. PL-11. Revegetated area near the northwestern side of disposal cell.*
