## 5.0 Falls City, Texas, Disposal Site

### 5.1 Compliance Summary

The Falls City, Texas, Uranium Mill Tailings Radiation Control Act (UMTRCA) Title I Disposal Site was inspected on January 20, 2015. The site was in excellent condition. Some perimeter signs are discolored and becoming illegible; these will be replaced. Inspectors identified no other maintenance needs or cause for a follow-up inspection.

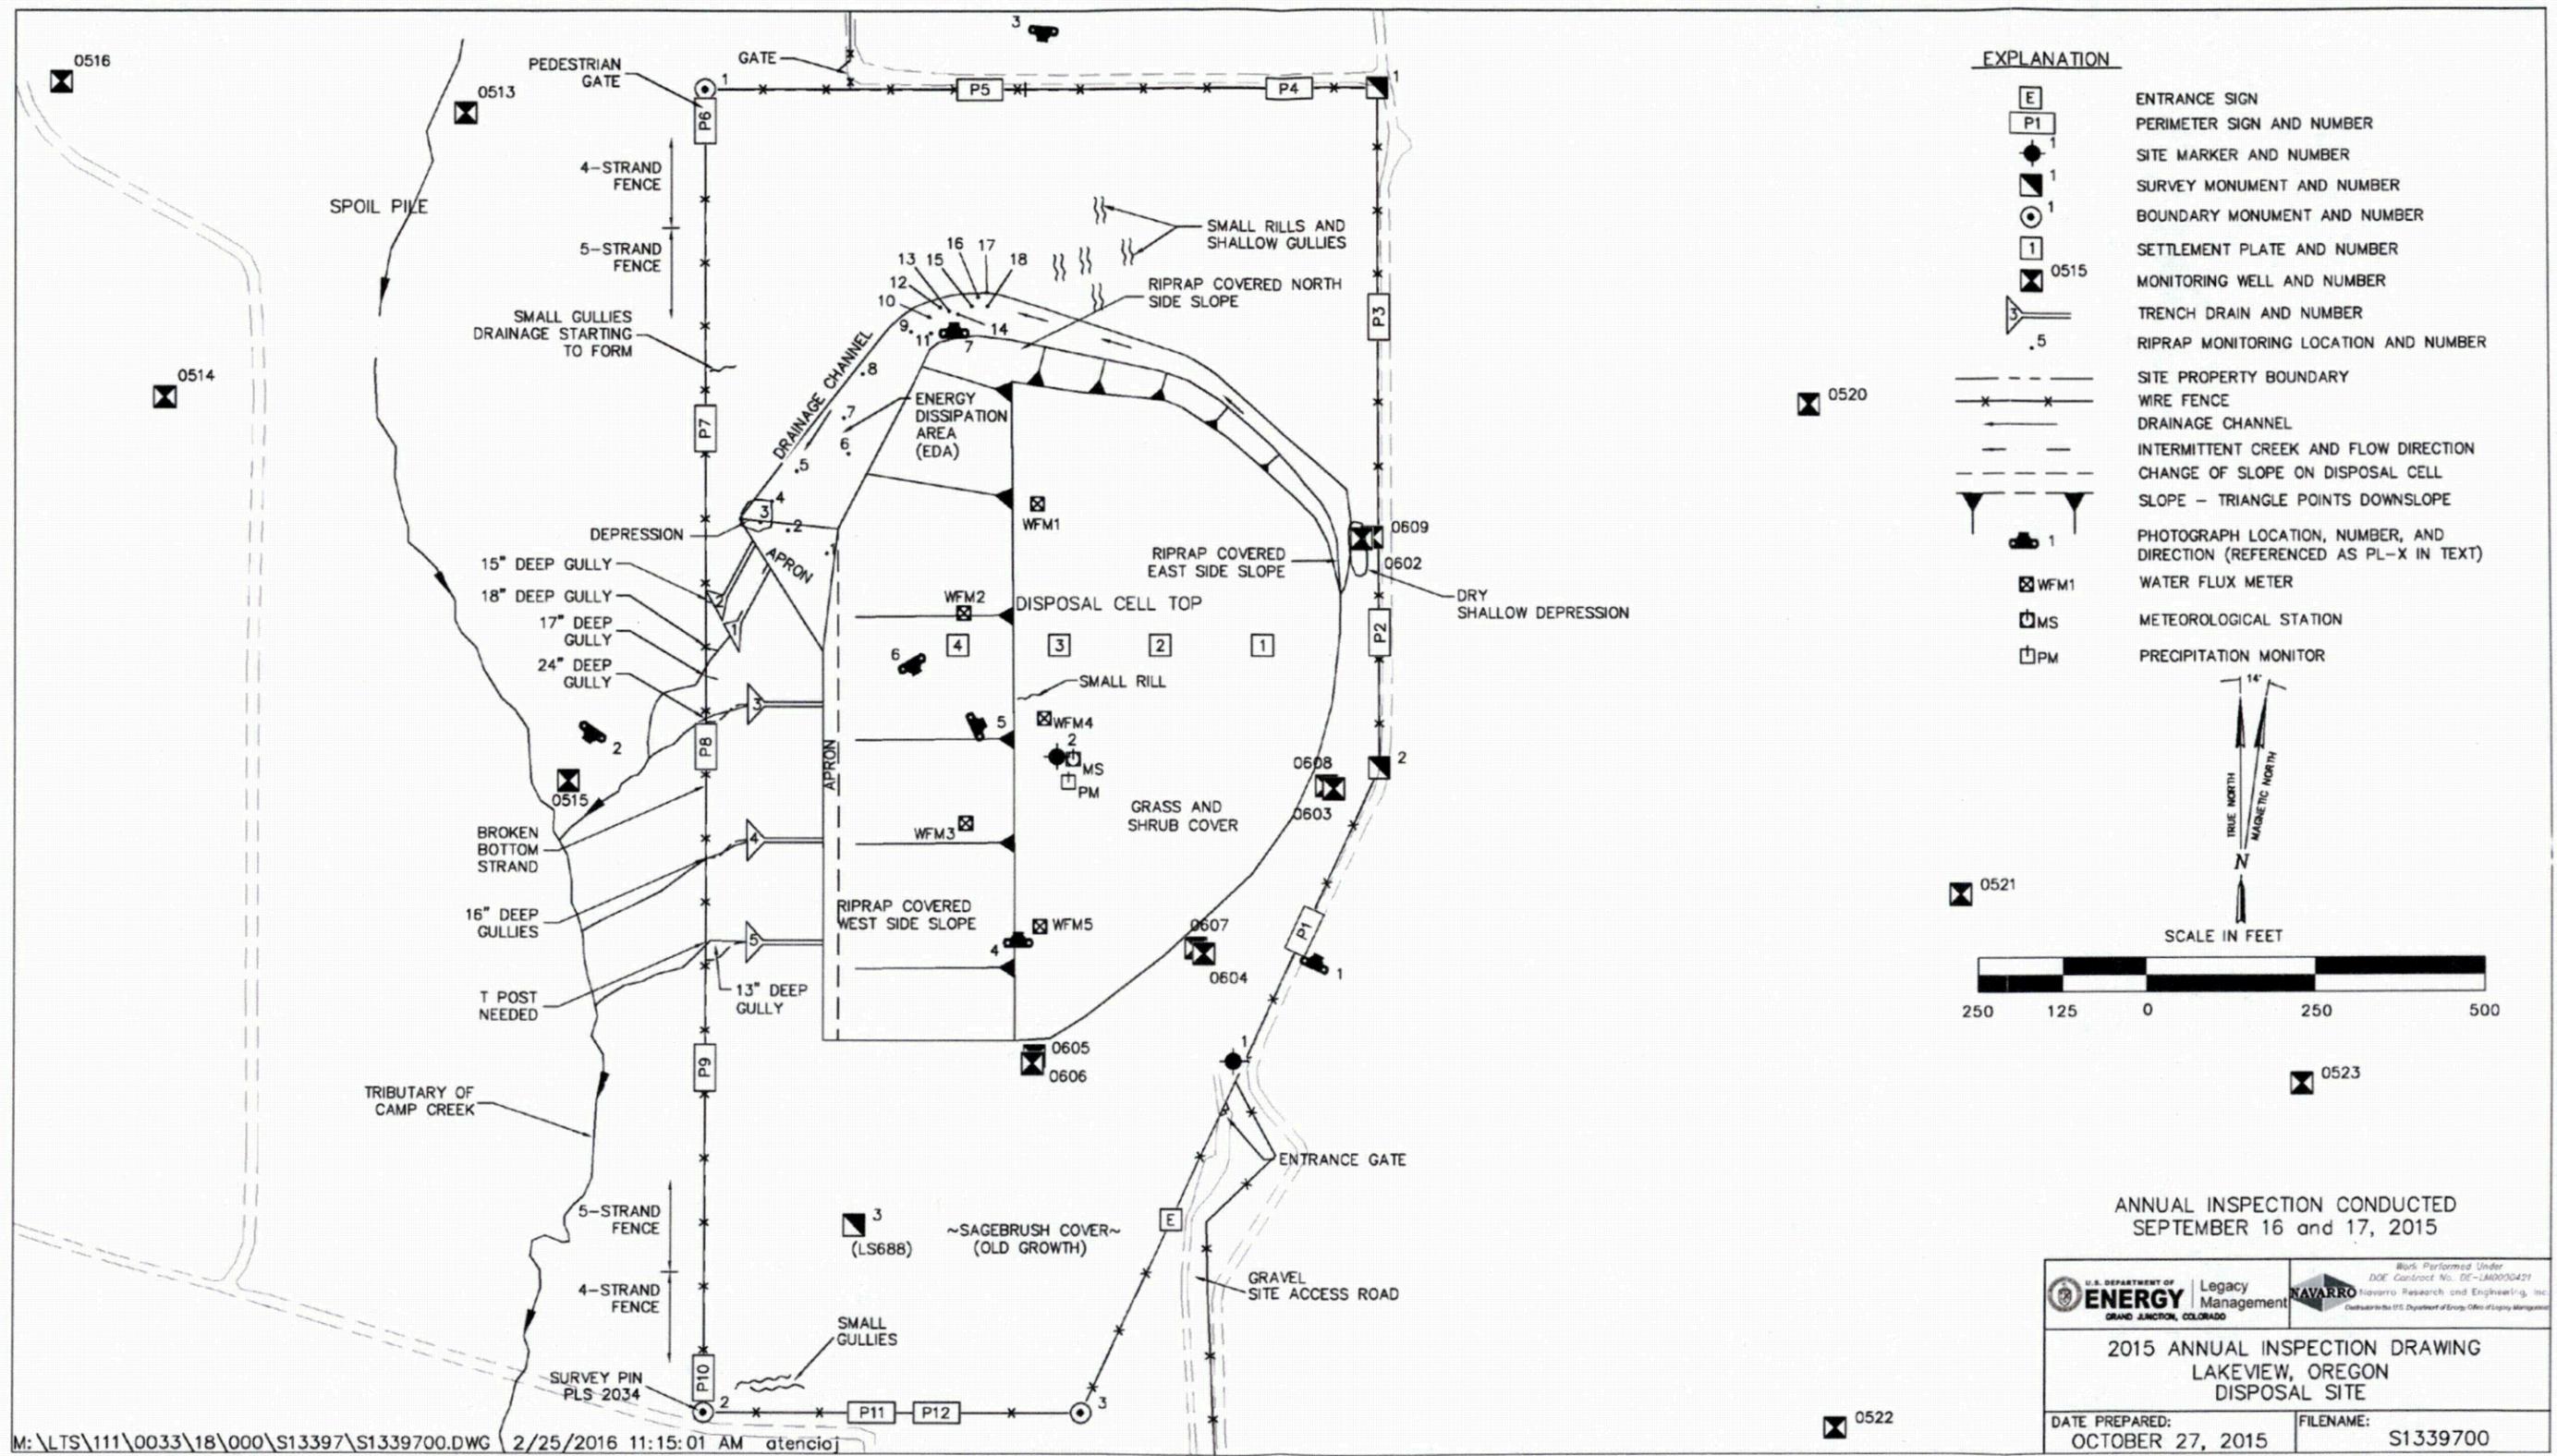
Figure 9-1. 2015 Annual Inspection Drawing for the Lakeview Disposal Site

The locations of site surveillance features are shown on Figure 9-1. Inspection results and recommended maintenance activities associated with site surveillance features are included in the following subsections. Photographs to support specific observations are identified in the text and on Figure 9-1 by photograph location (PL) numbers.

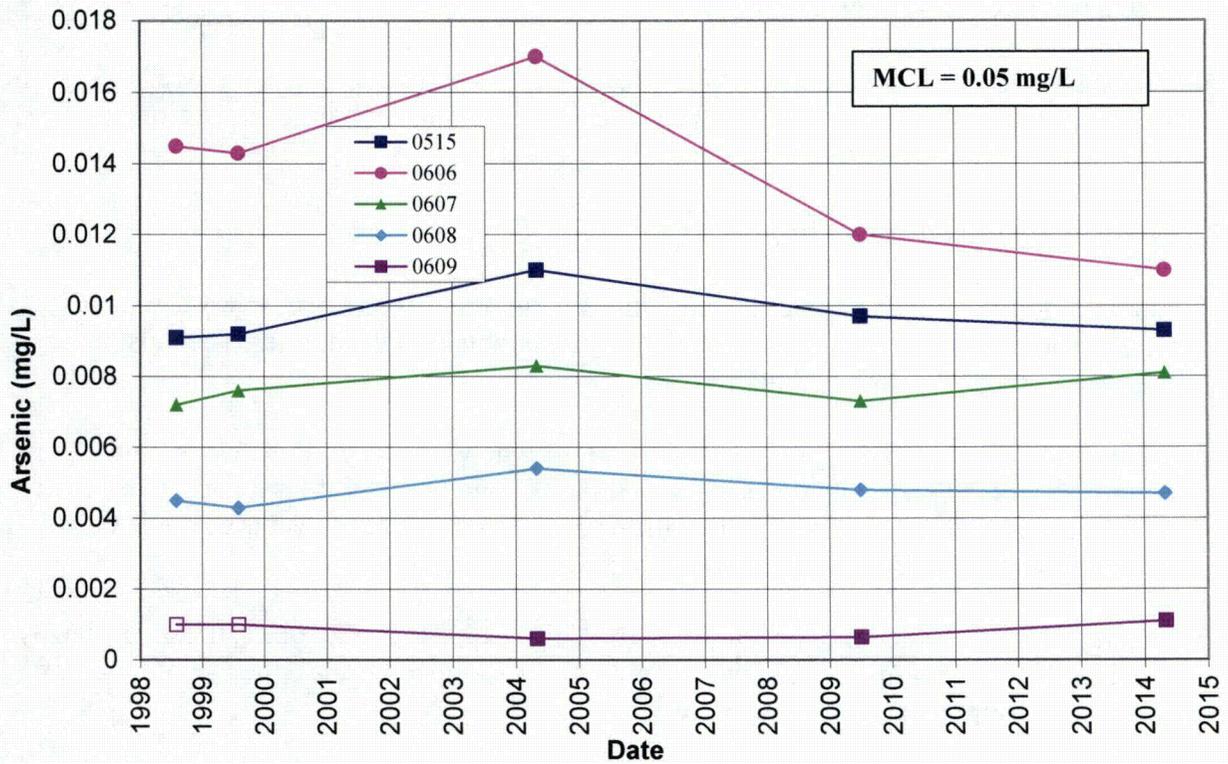
Constituents analyzed every 5 years include arsenic, cadmium, and uranium. Their maximum concentration limits (MCLs), established by the U.S. Environmental Protection Agency in Table 1 to Subpart A of 40 CFR 192, are 0.05 milligram per liter (mg/L) for arsenic, 0.01 mg/L for cadmium, and 0.044 mg/L for uranium. Concentrations of these constituents continued to remain significantly below their respective limits in 2014. Arsenic concentrations were similar to the 2009 results (Figure 9-2), and all but one cadmium concentration result were below the laboratory detection limit of 0.00012 mg/L (Figure 9-3), and uranium concentrations remained stable or slightly increased (Figure 9-4). Based on the monitoring results to date, there is no indication of any degradation of groundwater near the site. The next cell performance monitoring is scheduled for 2019.

Figure 9-2. Time-Concentration Plot of Arsenic in Groundwater at the Lakeview Disposal Site

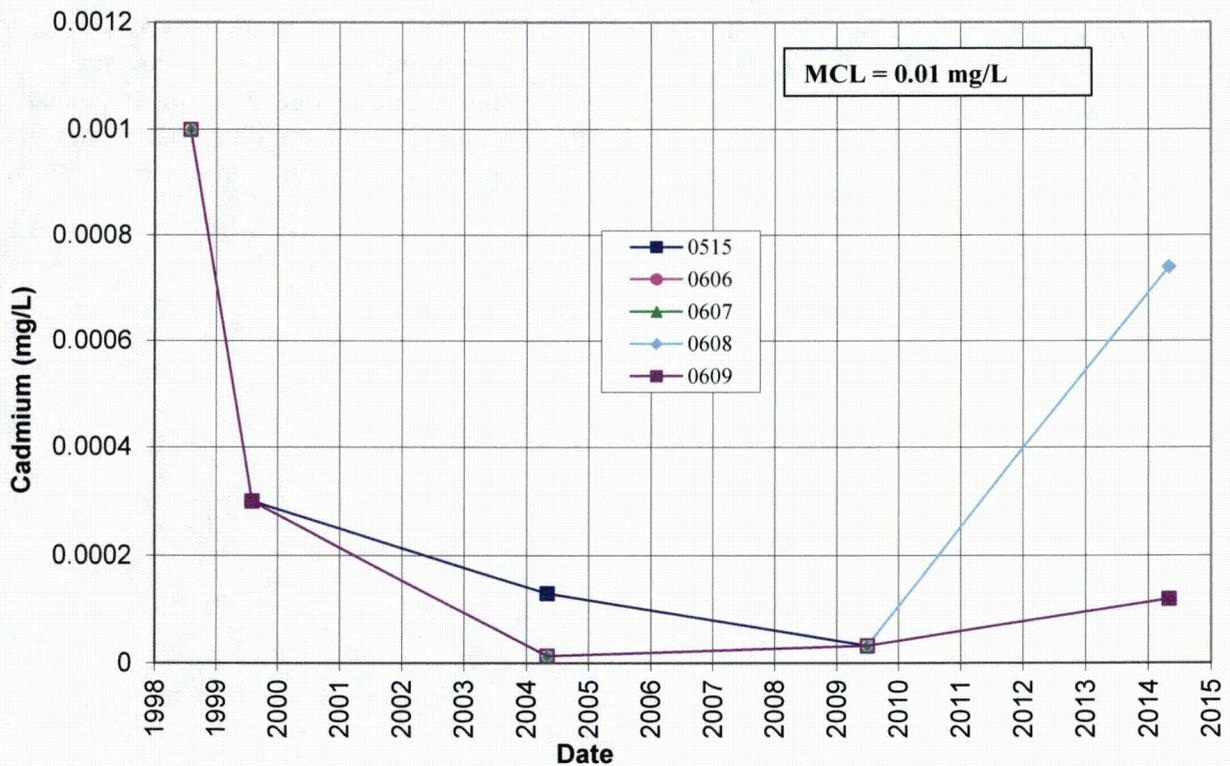
Figure 9-3. Time-Concentration Plot of Cadmium in Groundwater at the Lakeview Disposal Site

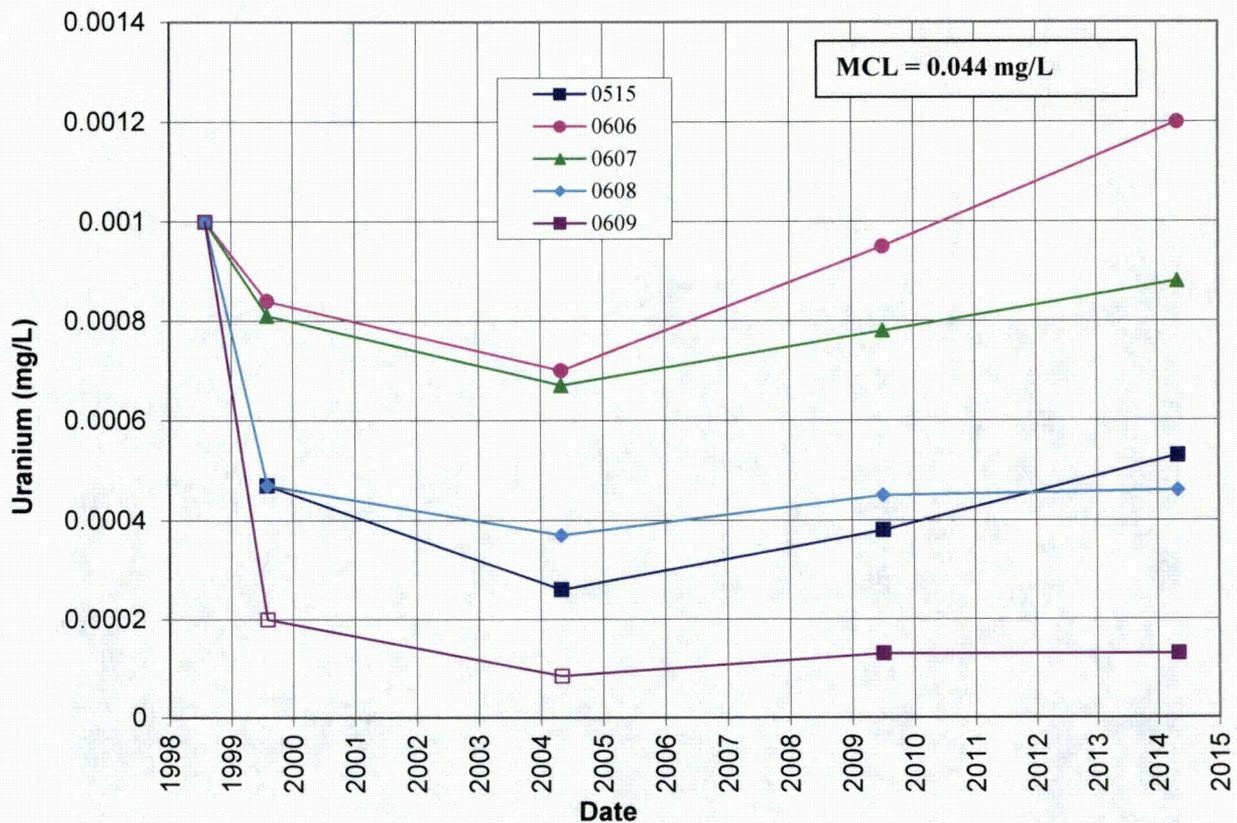
Figure 9-4. Time-Concentration Plot of Uranium in Groundwater at the Lakeview Disposal Site

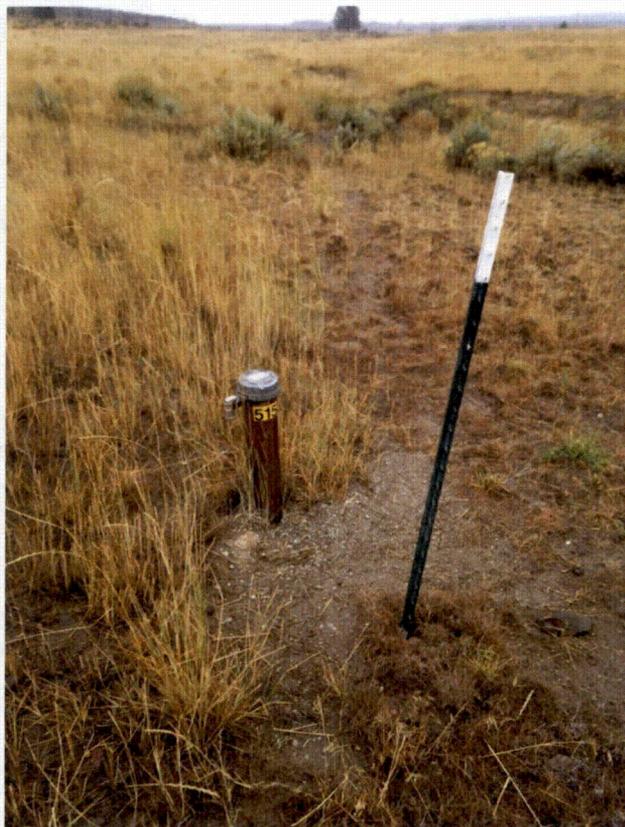
LKD 9/2015. PL-2. Well 0515.

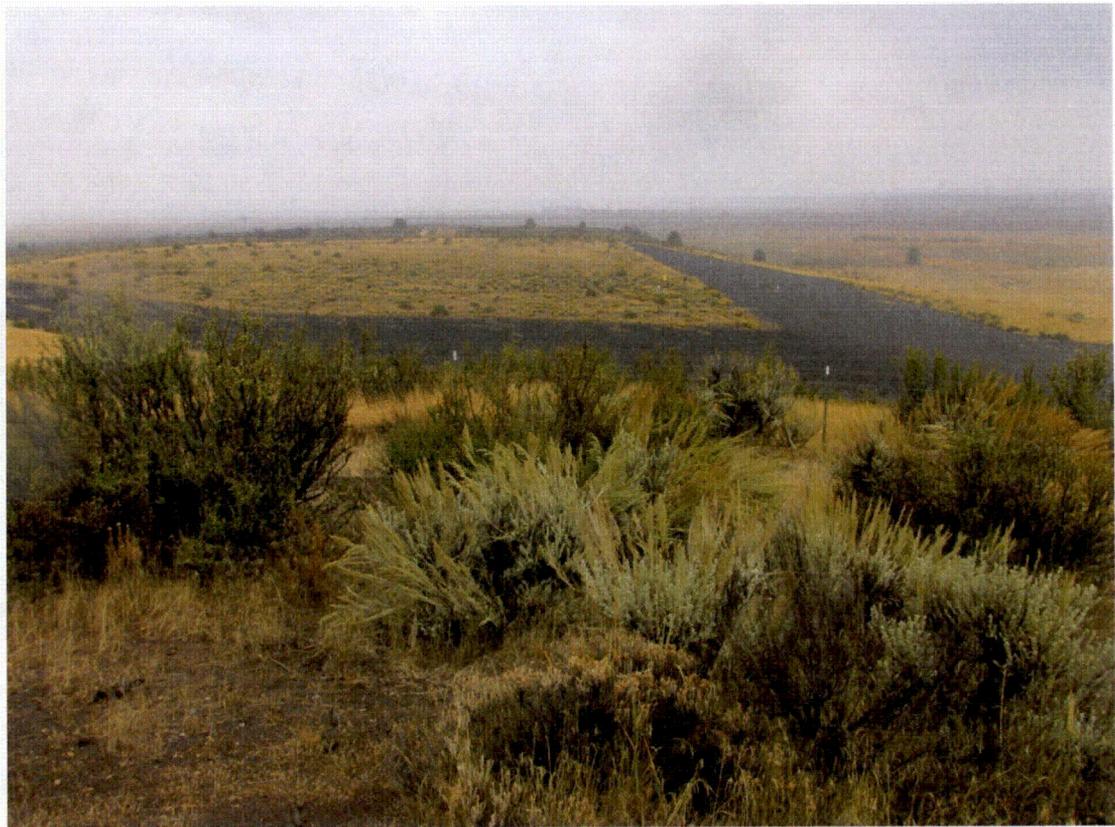
*LKD 9/2015. PL-3. View south of disposal cell top and west side slope.*

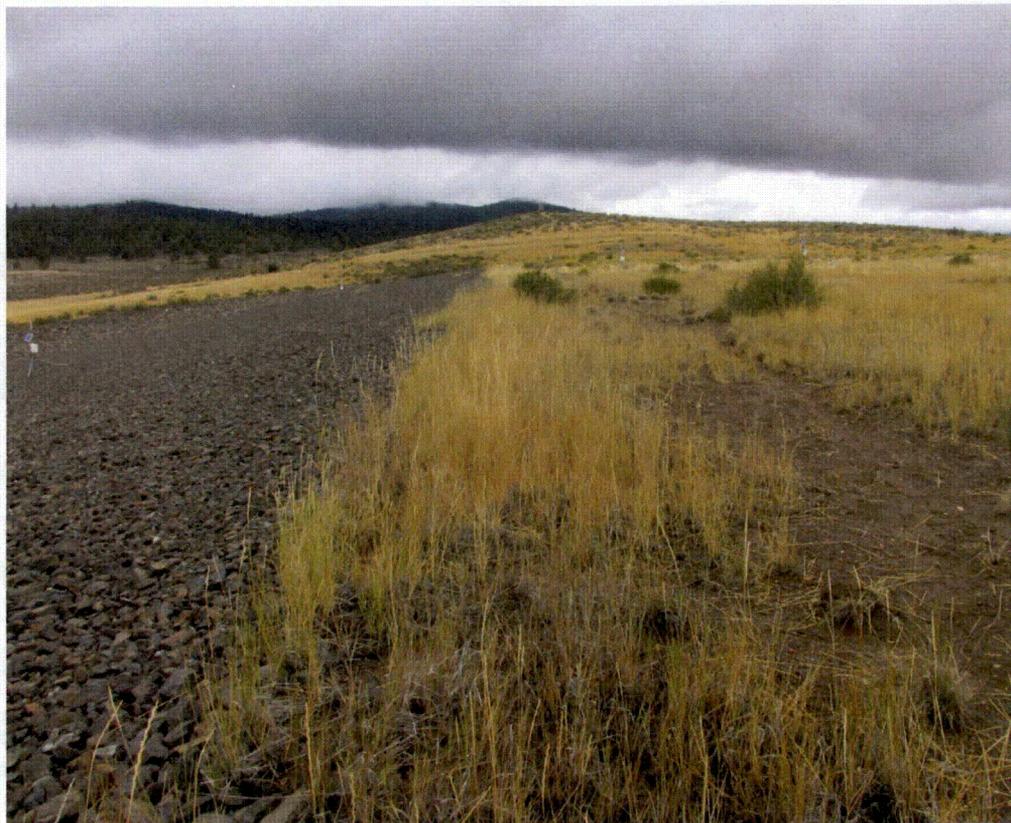
The contact boundary between the cell top and side slopes (PL-4) was inspected and generally appears stable and uniform except at the northwest corner of the cell top, where some soil has been transported off the top slope, allowing for some grass to establish at the top of the side slopes. One minor erosion rill was observed along the west edge (slope crest) of the top slope during this inspection (see Figure 9-1 and PL-5). No structural or cell performance concerns are associated with the minor encroachment of the grass onto the side slope or the presence of the minor rill because the riprap rock cover is continuous beneath the top-slope soil cover, the slope crests, and the side slopes. The extent of rilling along the slope crest will continue to be monitored.

*LKD 9/2015. PL-4. View north along transition zone from cell top to west side slope.*

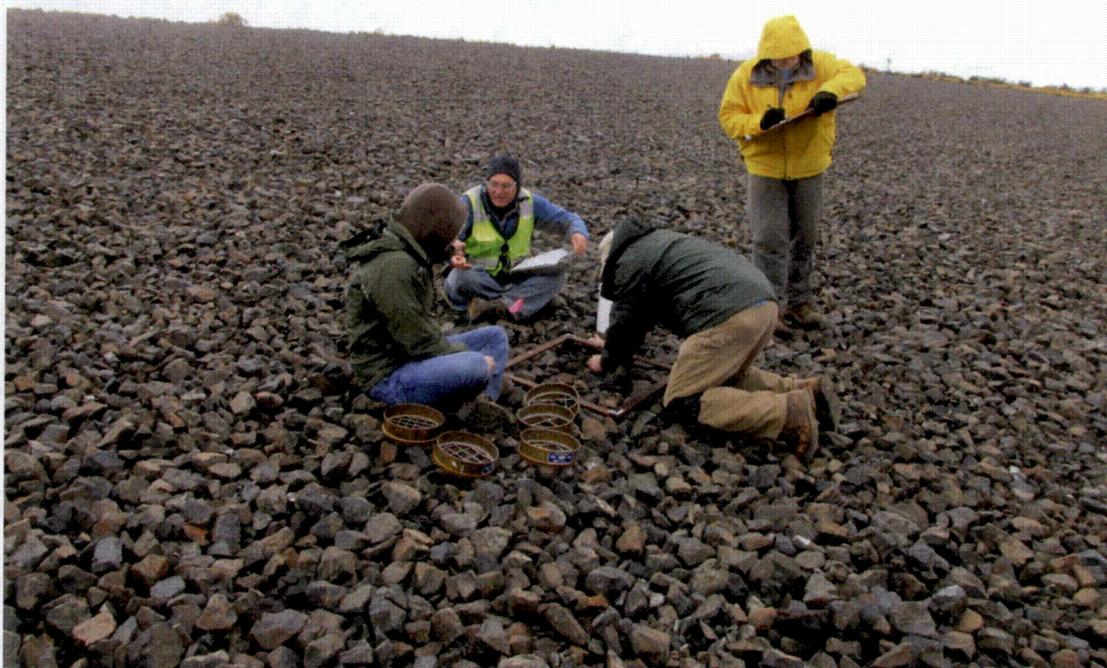
Addendums to the LTSP commit DOE to annually determining the  $D_{50}$  value of the west side slope rock riprap through gradation monitoring to ensure that the riprap is large enough to protect the disposal cell from erosion during a major precipitation event. This gradation monitoring method measures the number of rocks retained per sieve size. With NRC's consent, an additional sieve size (1 inch) has been included in the monitoring since 2009. Normally, sampling locations are randomly selected before each monitoring event. However, for the 2015 inspection, the rock monitoring approach deviated from the normal procedure, at NRC's request, by using a pre-established monitoring grid in a subset area of the west side slope (see Figure 9-1). This changed the sampling approach from random to biased, thus potentially compromising data comparability. Particle size distribution by count data was collected at 20 locations, and approximately 25 rocks were sampled at each location. Monitoring on the west side slope is shown in PL-6.

*LKD 9/2015. PL-6. View southeast of inspectors, a Geo-Smith Engineering representative, and a State of Oregon representative, performing rock monitoring at monitoring location 13.*

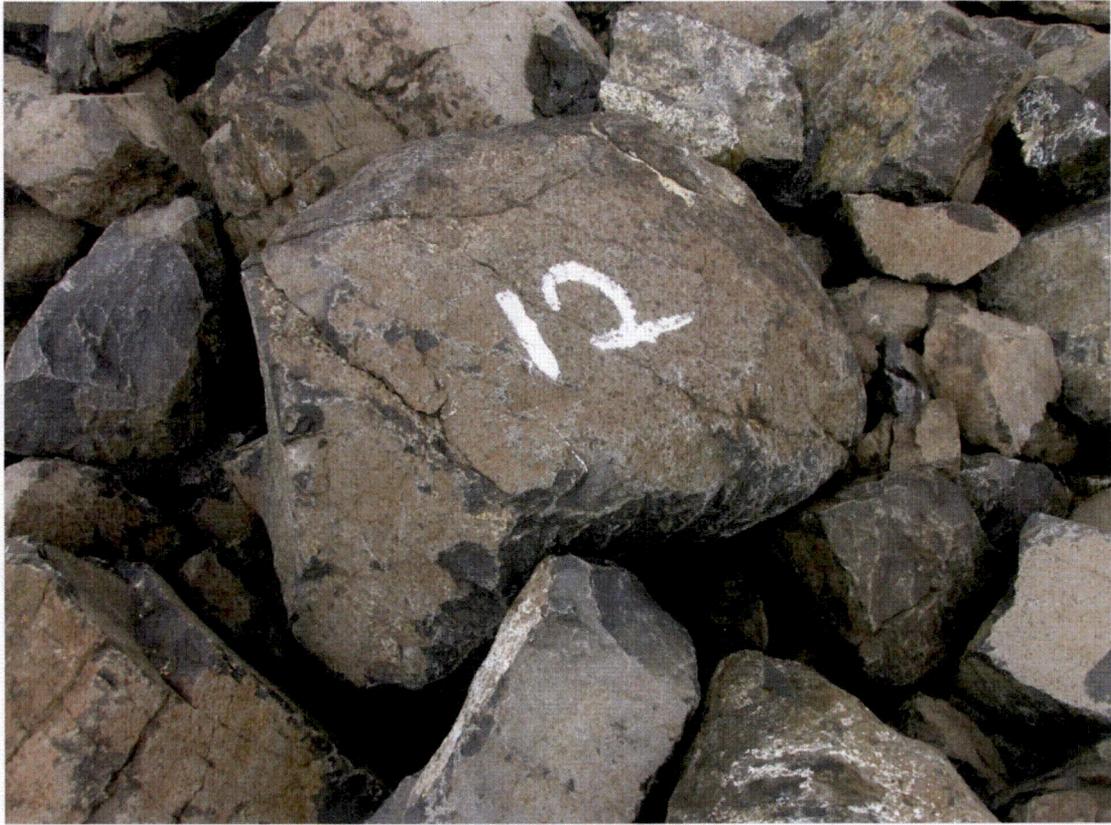
*LKD 9/2015. PL-7. Riprap photo-monitoring location 12 in the EDA.*
