Jocassee and Keowee Dams, Breach Parameter Review

Breach Parameter Review

February 2013

Jocassee Dam – Breach Parameter Independent Review

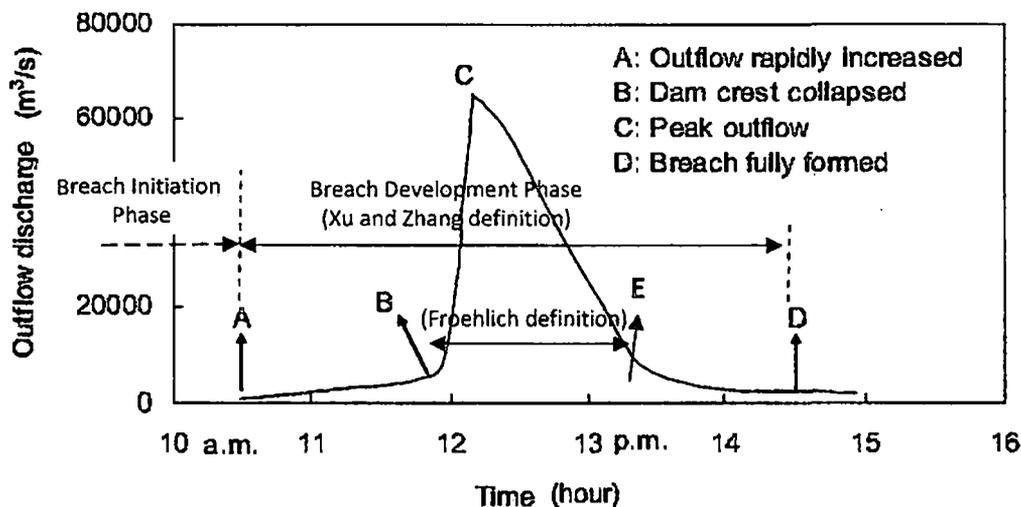
Figure 3. Definition of breach initiation and breach development phases in Xu and Zhang (2009) shown for observed discharge during the failure of

Teton Dam [Adapted from Xu and Zhang (2009)].

Figure 3 shows an example of the outflow hydrograph during the piping failure of Teton Dam in 1976. The time of 10:30 a.m. is a critical point that separates the breach initiation phase (ending at point A) from the breach development phase (from point A to point D). After 10:30 a.m. (point A) the rates of discharge and erosion of embankment materials from the pipe increased more rapidly. After the collapse of the dam crest at about 11:55 a.m. (point B), the breach developed rapidly due to overtopping of the collapsed dam crest and soon reached a peak discharge at about 12:15 a.m. (point C). The failure time associated with the breach development process, T_f , was approximately 4 hours.

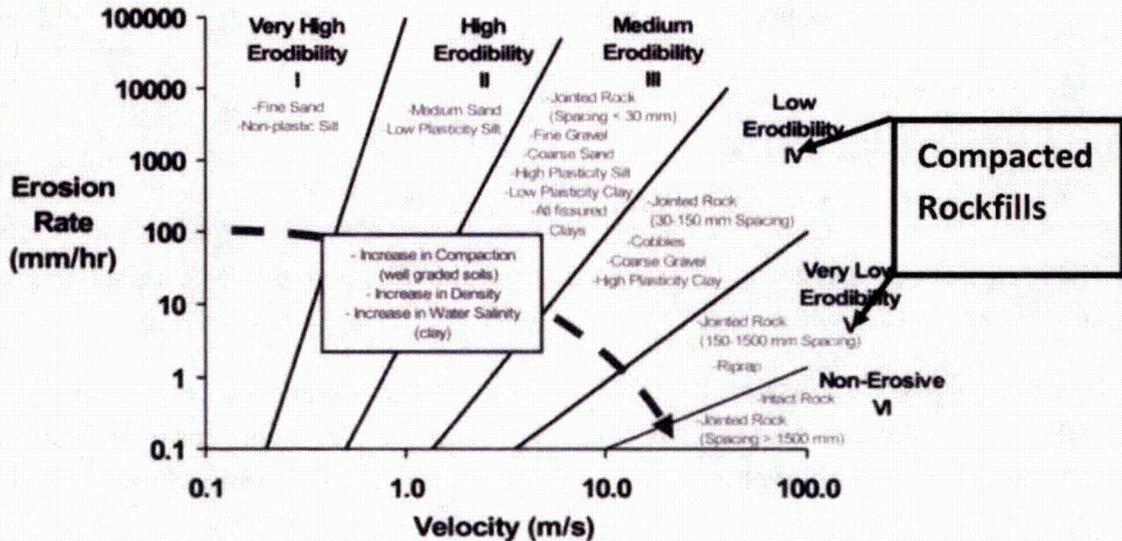
Figure 4a. Briaud (2008) erosion categories for soils and rocks based on velocity.

zone. These considerations would conservatively place the Jocassee Dam embankment in the low erodibility category (IV) and likely in the very low erodibility category (V).

As discussed earlier, the Xu and Zhang equations incorporated the various erosion resistance categories (low, medium or high) based on the technical paper by Briaud (2008). Our interpretation, based on the rockfill materials, compaction and density, places the rockfill at Jocassee Dam between the very low and low erodibility categories (see Figures 4a and b).

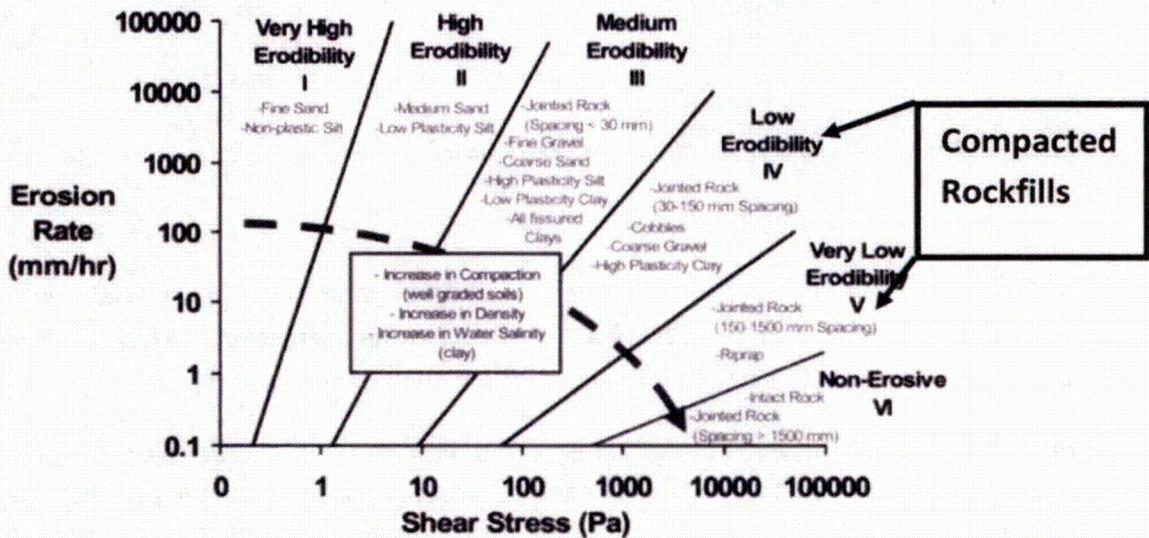
Figure 4b. Briaud (2008) erosion categories for soils and rocks based on shear stress.

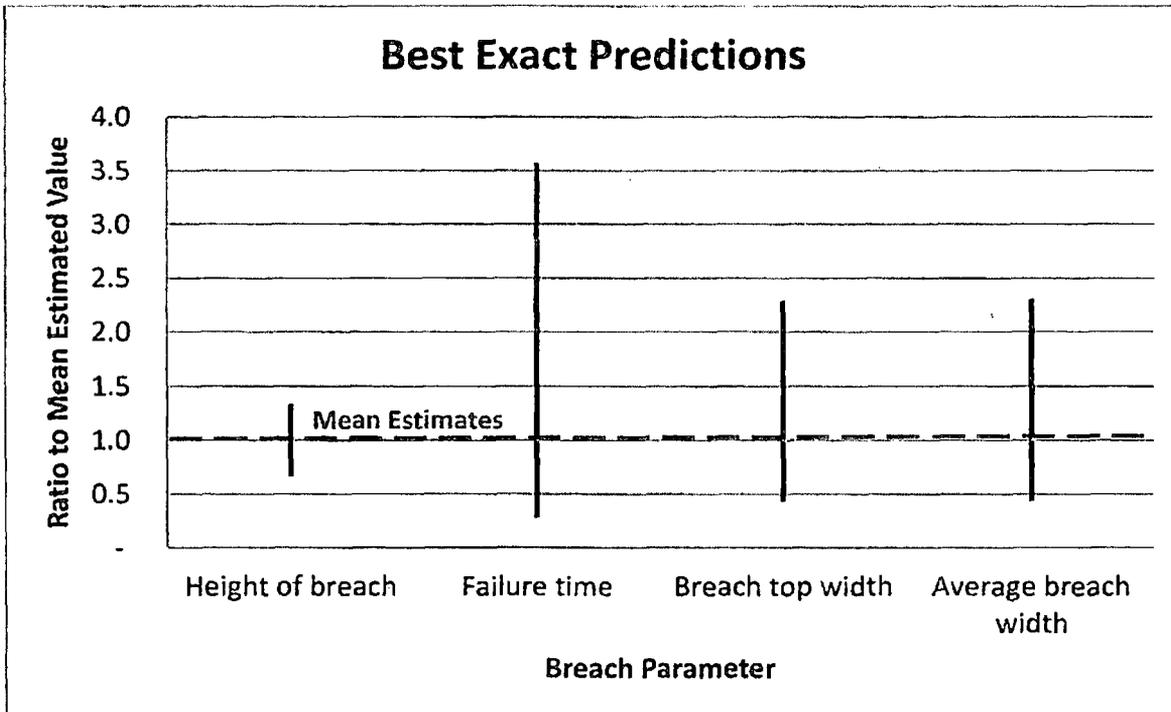
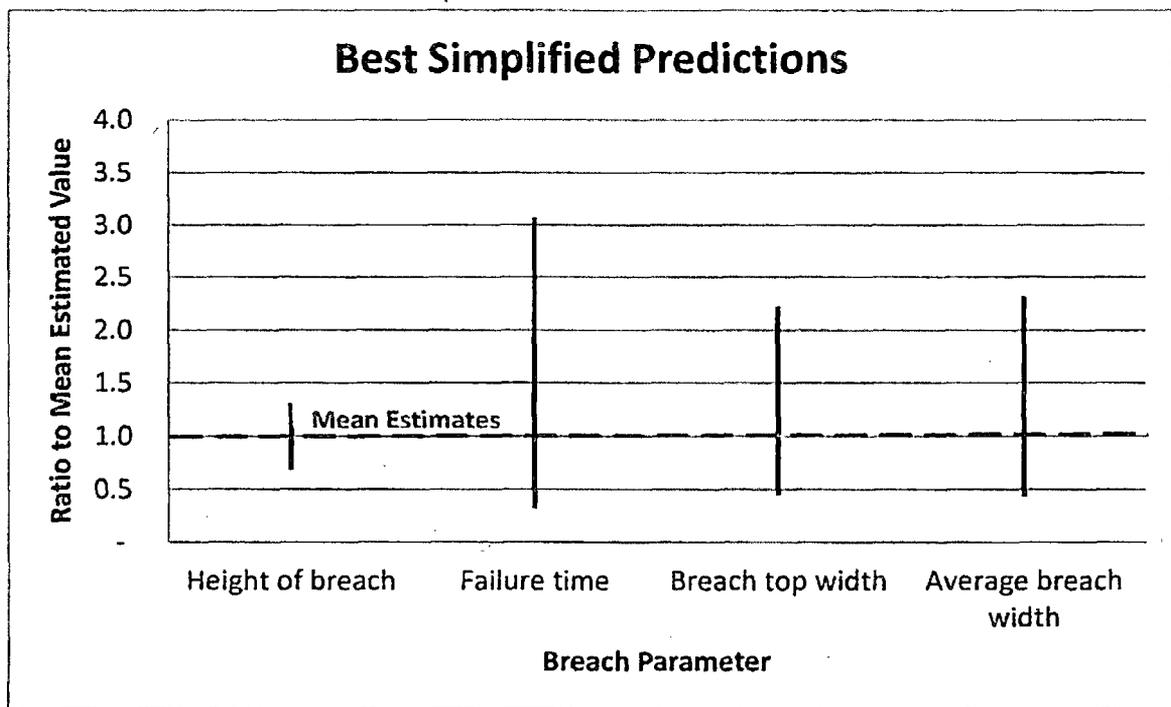
The confidence interval estimates for each breach parameter are shown in Table 2 as lower and upper bound estimates that define the width of the confidence interval both below and above the mean estimates. Similar to the examples for Banqiao and Teton dams, which we discuss in Section 6.2, the asymmetry in the confidence intervals can be seen for all breach parameters except height of the breach, which is symmetrical because of the additive form of the regression equations for height of the breach as explained in Section 6.2. The symmetry in breach parameter estimates for height of breach and the asymmetry in estimates for failure time, breach top width, and average breach width can be seen in Figures 5a and b. In these figures the confidence intervals for breach parameter estimates for Jocassee Dam are plotted as a ratio to the mean estimate for the Xu and Zhang (2009) Best Exact and Best Simplified Prediction equations, respectively. The asymmetry in the confidence intervals for failure time, breach top width, and average breach width can be seen by the longer lines above the mean estimate (plotted at a ratio = 1.0 shown by the blue dashed line) than below the mean estimate.

Figure 5. Relative width of confidence intervals for Xu and Zhang (2009) breach parameter estimates for Jocassee Dam based on low erodibility expressed as a ratio to the mean estimate (ratio = 1.0).
