### **FINAL REPORT: CRACKED LPI PIPE AT OCONEE-3**

PREPARED FOR  
DUKE POWER COMPANY

LTC:92:0017-01:01

JANUARY 1992

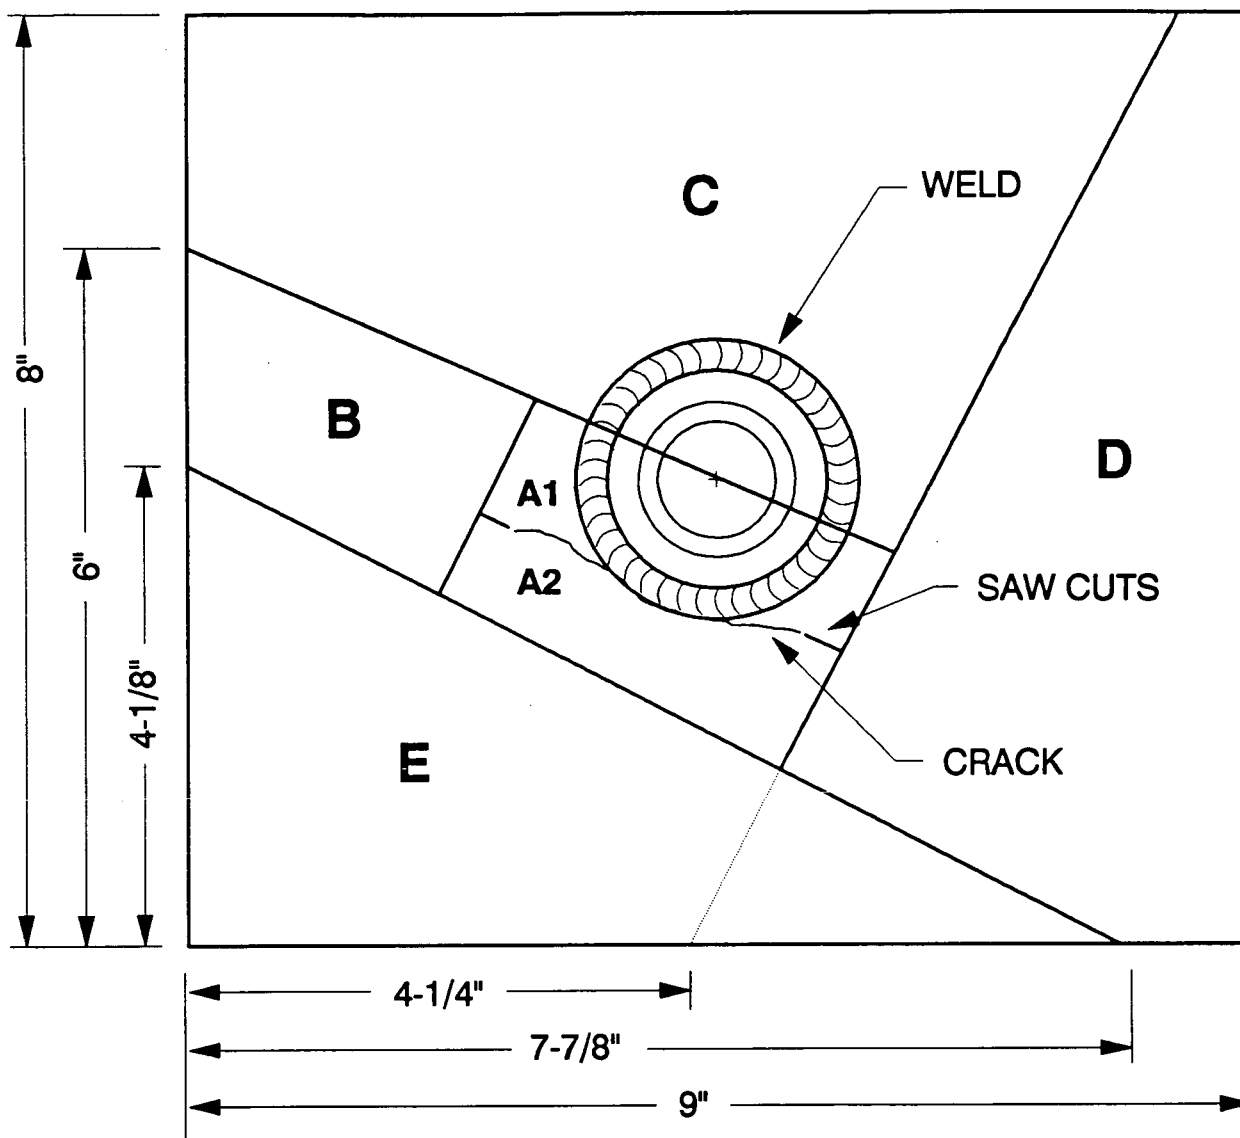
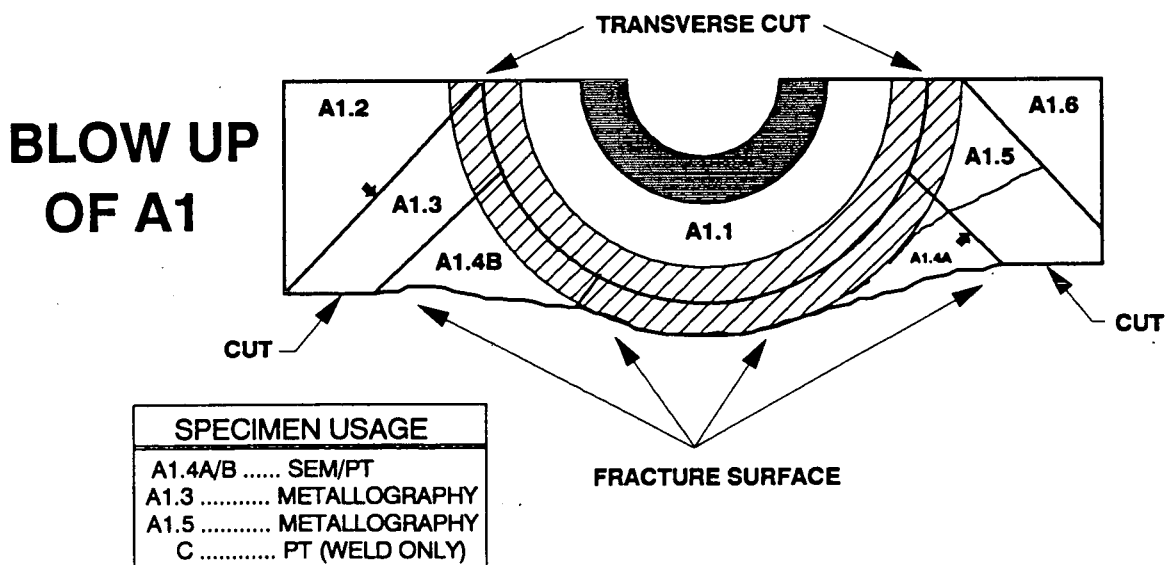
The ID surface of the twelve inch pipe was wiped down with clean absorbents saturated with ethanol to remove the bulk of the loose surface contamination and permit handling of the assembly outside of a fume hood.\* The pipe stub was removed by making a transverse cut about 1-1/4 inch from the OD surface of the twelve inch pipe section, and the throughwall crack was further isolated as shown in Figure 5. Initial sectioning was performed dry on a horizontal band saw.

Specimen A1 was further sectioned to isolate the fracture surface for SEM examinations and to obtain metallography samples as shown in Figure 5. The SEM specimens (A1.4A and A1.4B) were ultrasonically cleaned in ethanol to remove loose surface deposits prior to the SEM examination.

FIGURE 5: SECTIONING DIAGRAM FOR TWELVE INCH LPI PIPE SECTION
