SUBJECT: Responds to NRC 930507 ltr containing findings in EDSFI Repts 50-269/93-02, 50-270/93-02 & 50-287/93-02. Corrective actions: detailed single failure analysis of Keowee governor sys will be performed & procedures will be upgraded.

Subject: Oconee Nuclear Site  
Docket Nos. 50-269, -270, -287  
Inspection Report 50-269, -270, -287/93-02  
Reply to Findings

By letter dated May 7, 1993 the NRC issued Electrical Distribution System Functional Inspection Report No. 50-269/93-02, 50-270/93-02, and 50-287/93-02. Within this report, six findings were designated as requiring a sixty day response.

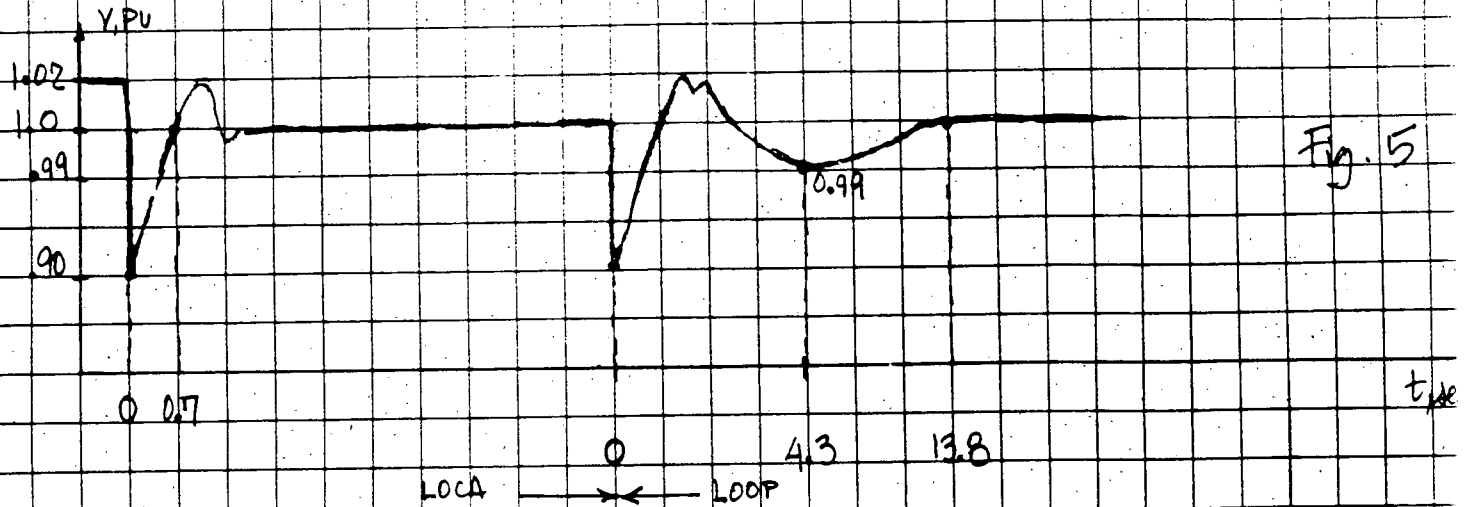
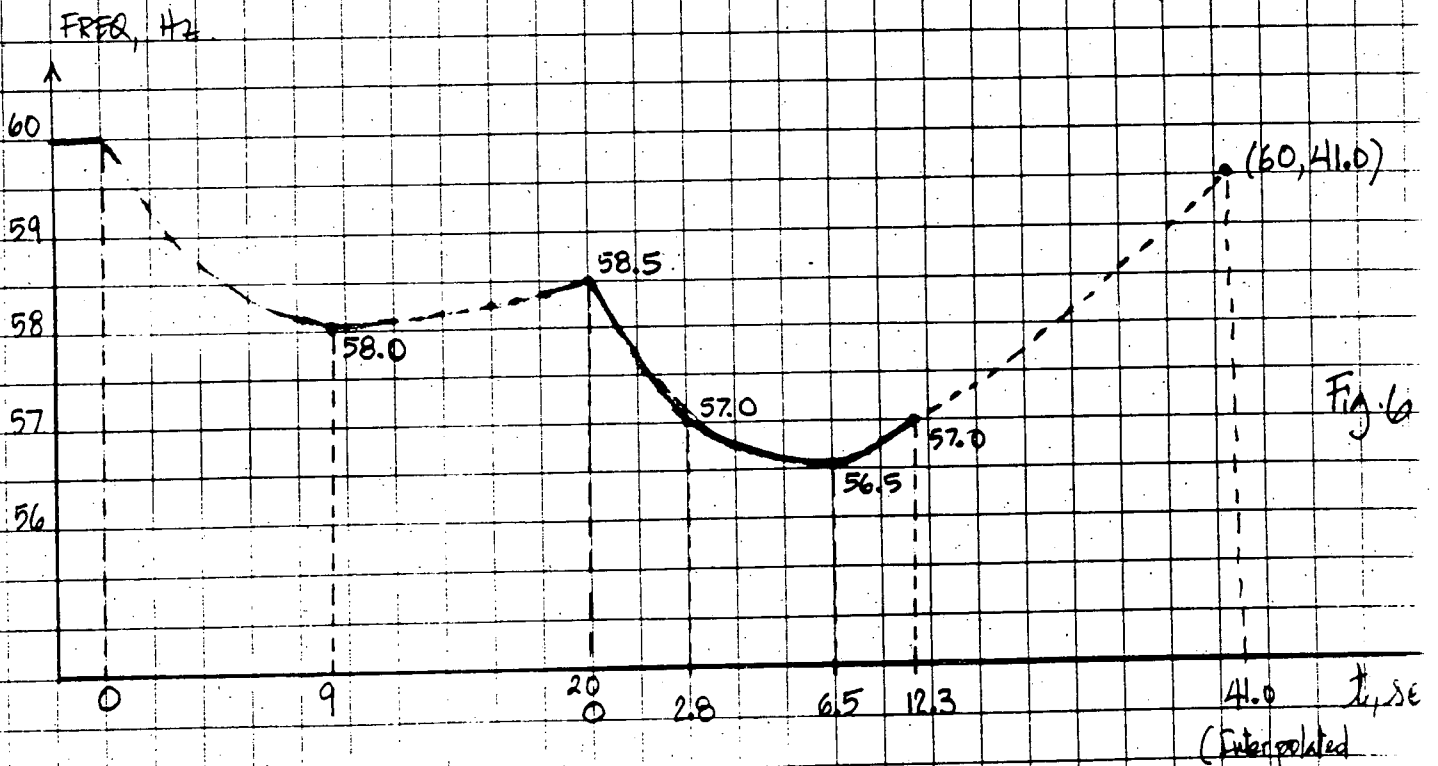
KEOWEE GENERATOR VOLTAGE & FREQ

For the LOCA/LOOP condition, when the two loop units are connected to Keowee, the frequency drops to 56.5 Hz and remains below 57 Hz for approximately 10 seconds (see Fig 6). This will result some reduction in process flow. The critical process is the LPI system. B&W analysis requires that 90% of the required flow must be obtained within 48 seconds. This 90% represents 90% flow of one LPI pump. In a LOCA event, two LPI pump motors will be started and run. It is judged that the system frequency of 56.5Hz for 10 seconds will not cause two LPI pumps to produce flow less than the analyzed flow rate. Since this low frequency condition occurs during the time that two other LOOP units are being loaded to Keowee( due to a single failure of the overhead path), other failures need not be postulated and therefore the two LPI pumps should always be available.
