Docket Nos.: 50-269, 50-270, 50-287 License Nos.: DPR-38, DPR-47, DPR-55 EA 94-125

#### SUBJECT: ENFORCEMENT CONFERENCE SUMMARY AND NOTICE OF VIOLATION (NRC INSPECTION REPORT NOS. 50-269/94-21, 50-270/94-21, AND 50-287/94-21)

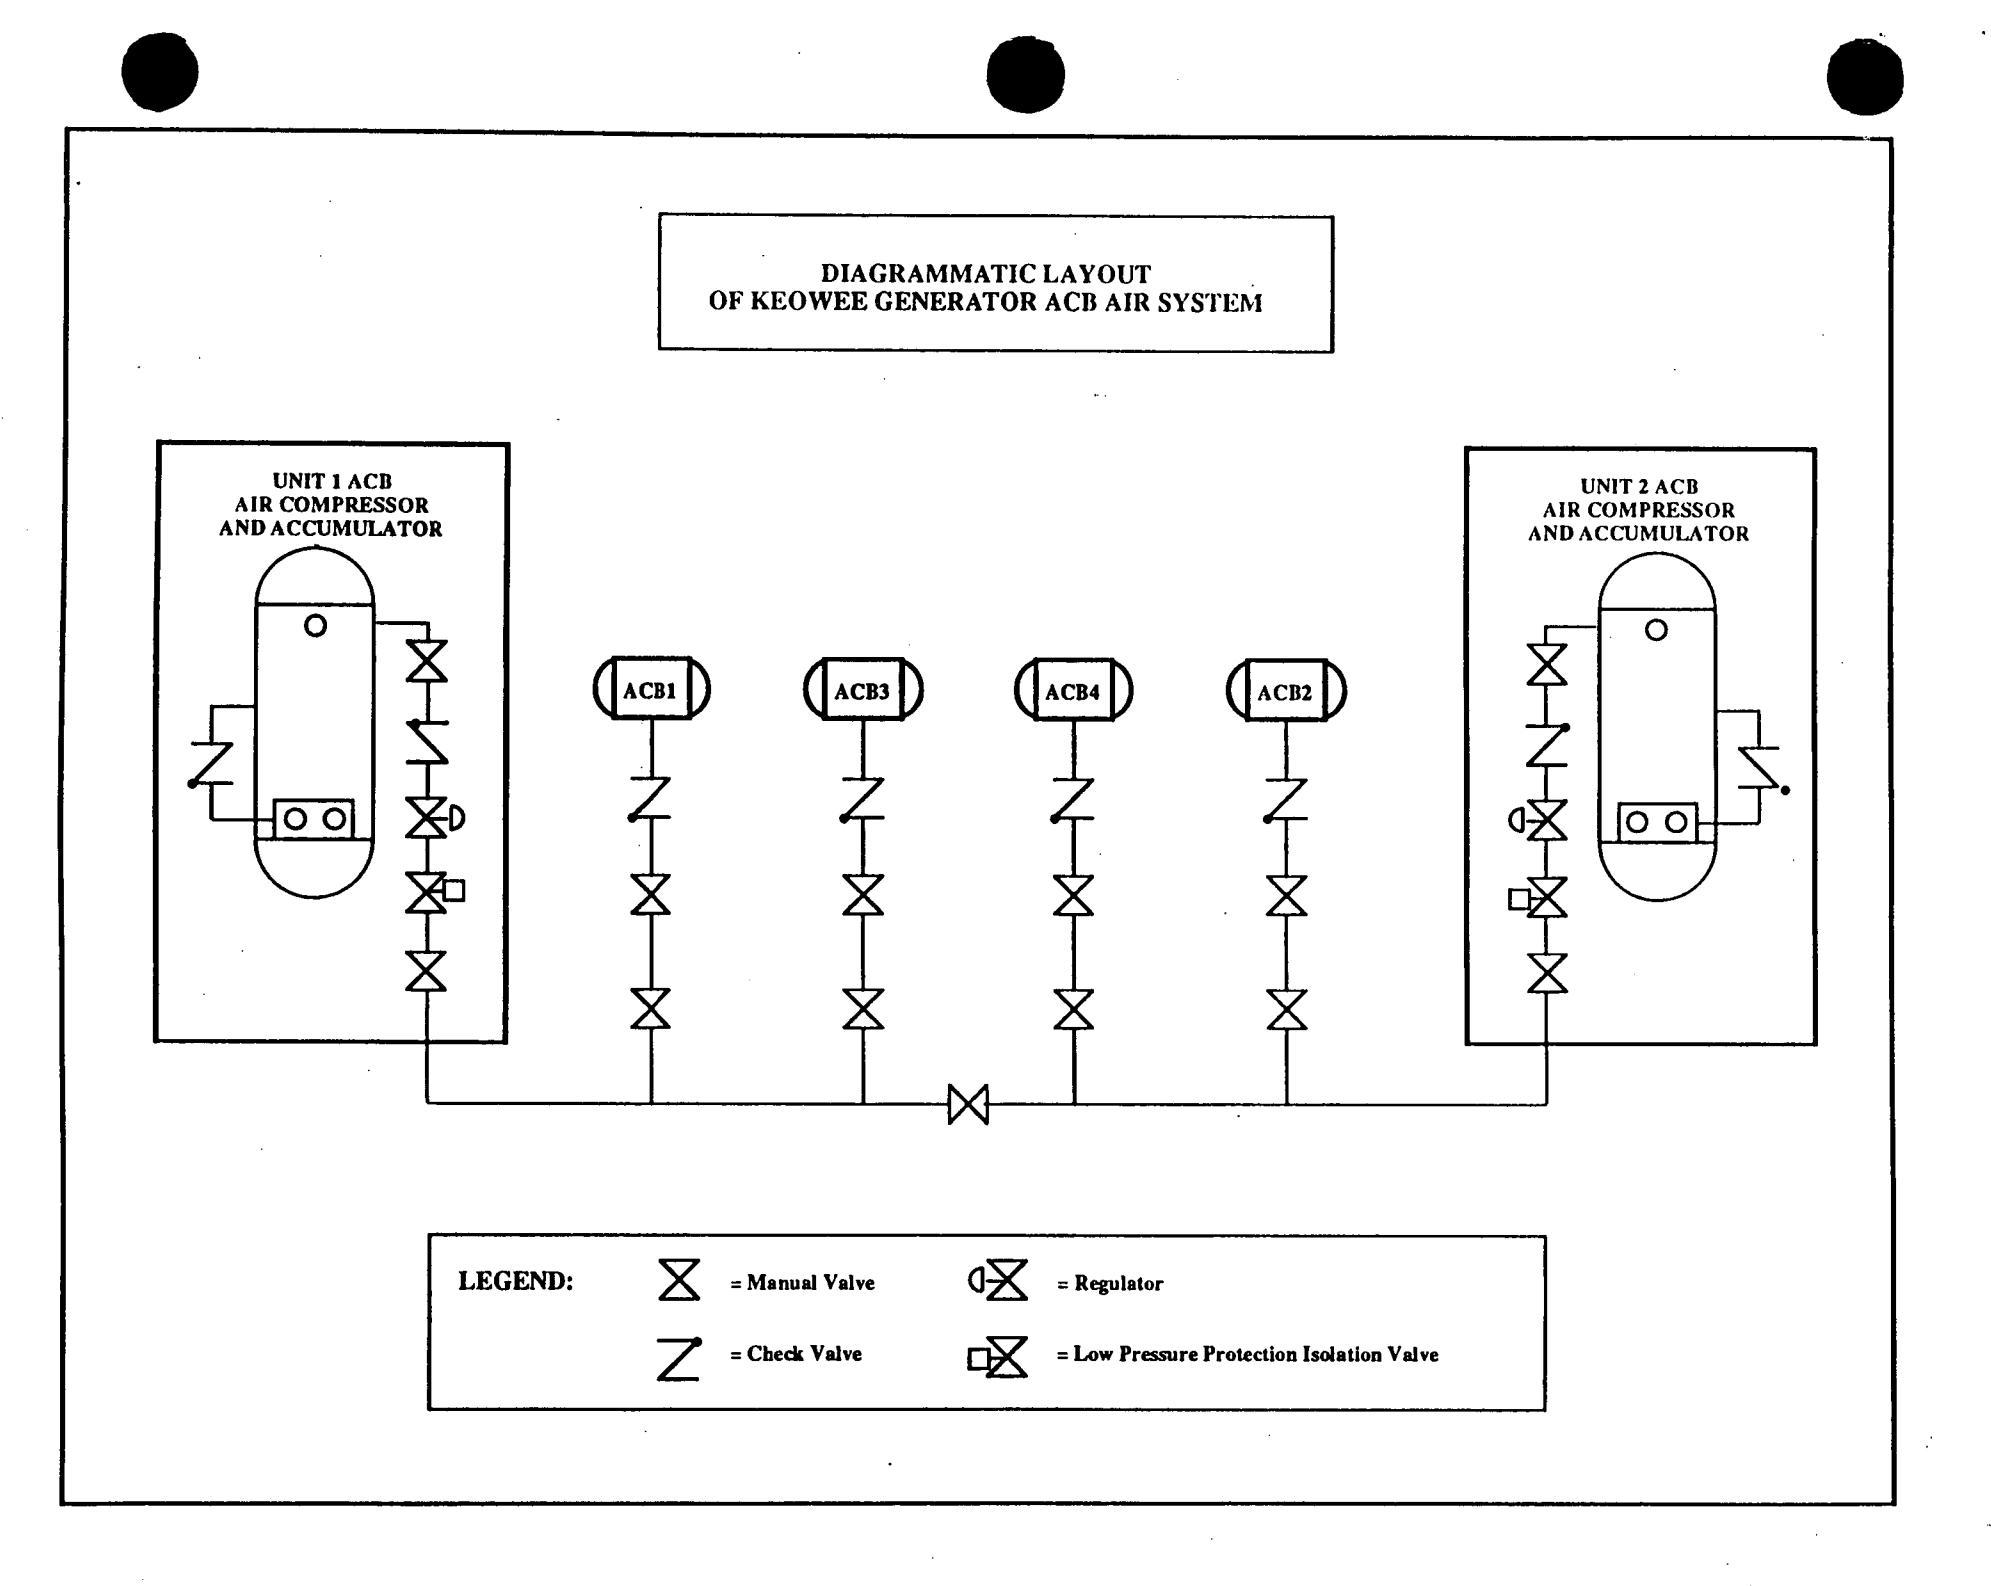
DURING SEQUENCE OF CHARGING ACB 1 RESERVOIR, COMBINATION OF REGULATOR STICKING AND LEAKS IN ACB 3 CAUSED ACB 3 RESERVOIR PRESSURE TO DROP TO 118 PSI

# INSPECTED AND REPAIRED UNIT 1 AIR COMPRESSOR AIR REGULATOR

# REPAIRED ACB 4 AND TESTED SYSTEM FOR AIR LEAKAGE
