UNITED STATES
NUCLEAR REGULATORY COMMISSION
REGION I
631 PARK AVENUE
KING OF PRUSSIA, PENNSYLVANIA 19406

Subject: Special Inspection No. 50-443/86-52

This refers to the special team inspection conducted by Mr. Jacques P. Durr of this office on November 3-14 and 19-21, 1986 and to the discussions of our findings held by Mr. Durr with Messrs. W. B. Derrickson and W. P. Johnson at the conclusion of the inspection. The inspection was of activities authorized by NRC License No. NPF-56 at the Seabrook Station, Unit No. 1, Seabrook, New Hampshire.

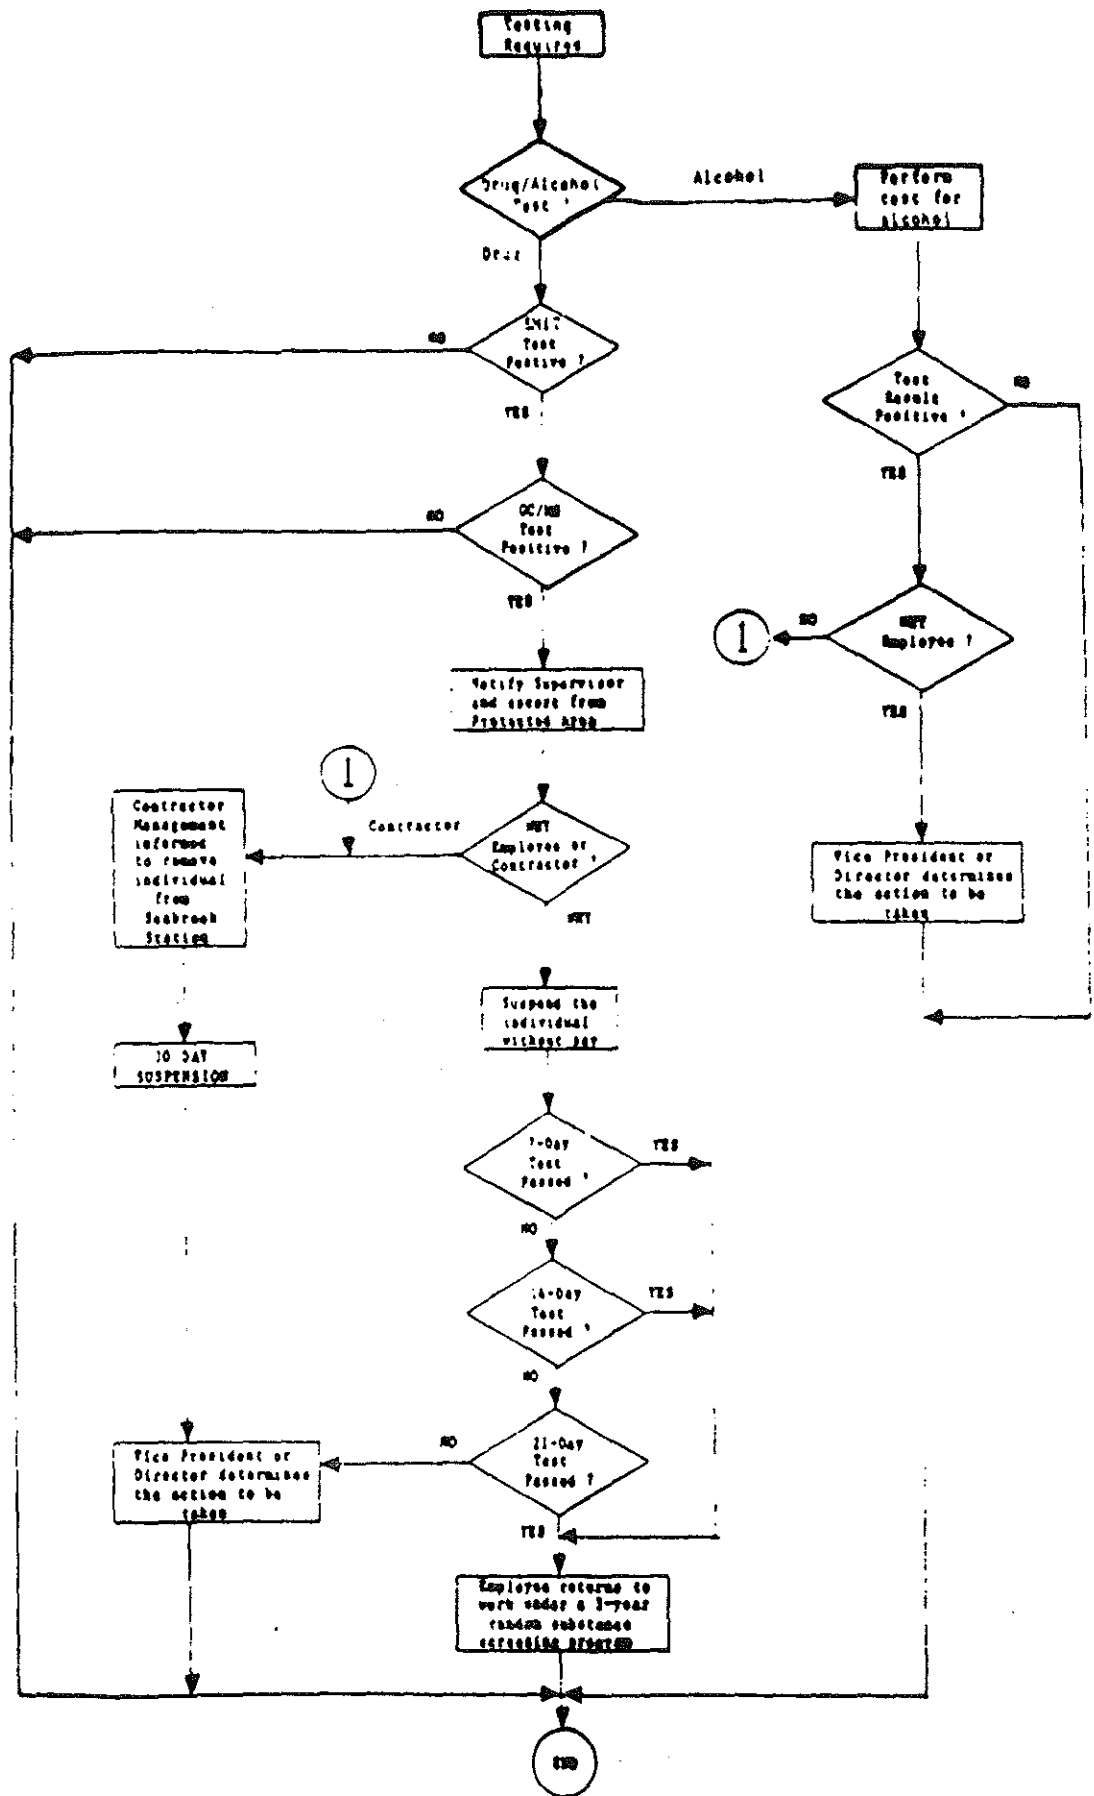
FIGURE 1

3. Initial, Periodic, Random or "For Cause" Drug or Alcohol Testing

(These actions are illustrated in Figure 1)
