Subject: Inspection Report NO. 50-443/87-07

- Report No. 50-443/87-07
- Docket No. 50-443

Facility Name: Seabrook Unit No.1

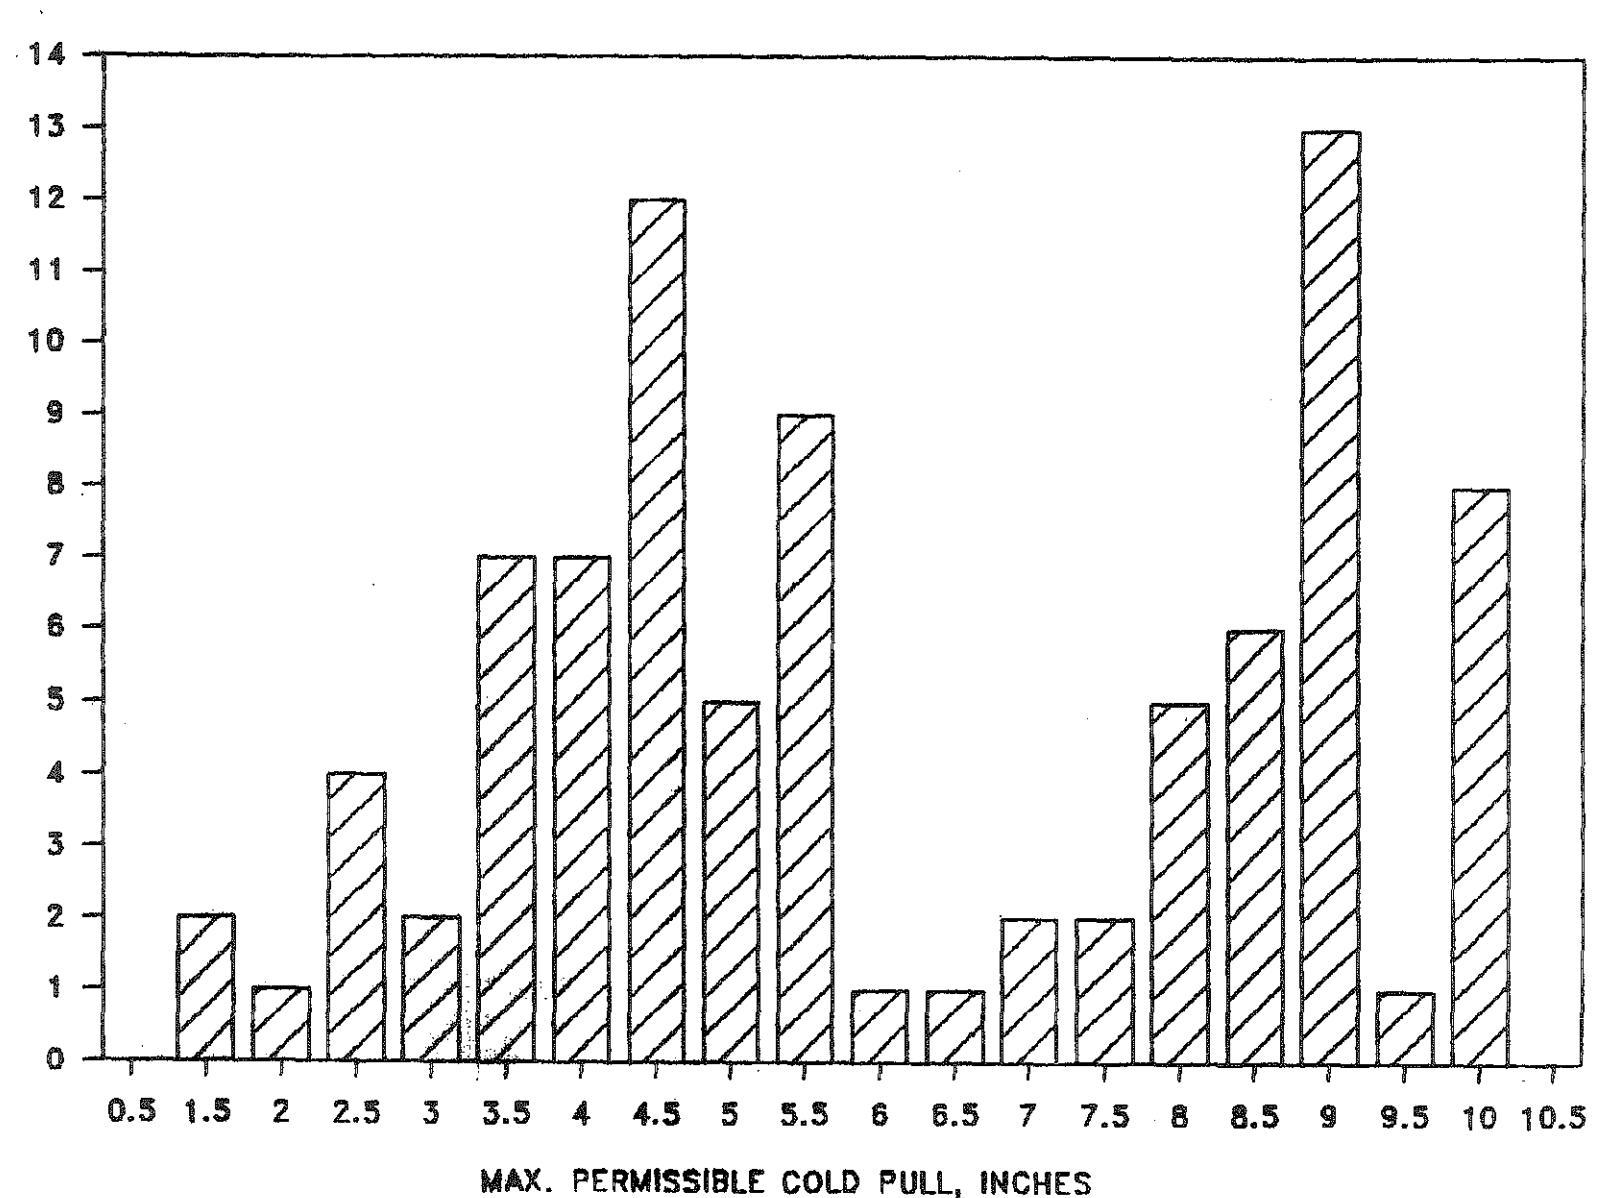
COLD PULL MARGIN IN PIPING SYSTEMS

The above results provided a very high level of confidence (95%) that the potential of cold pull in piping systems installed prior to January 1983 is of no consequence regarding compliance with code design stress limits and overall system reliability.

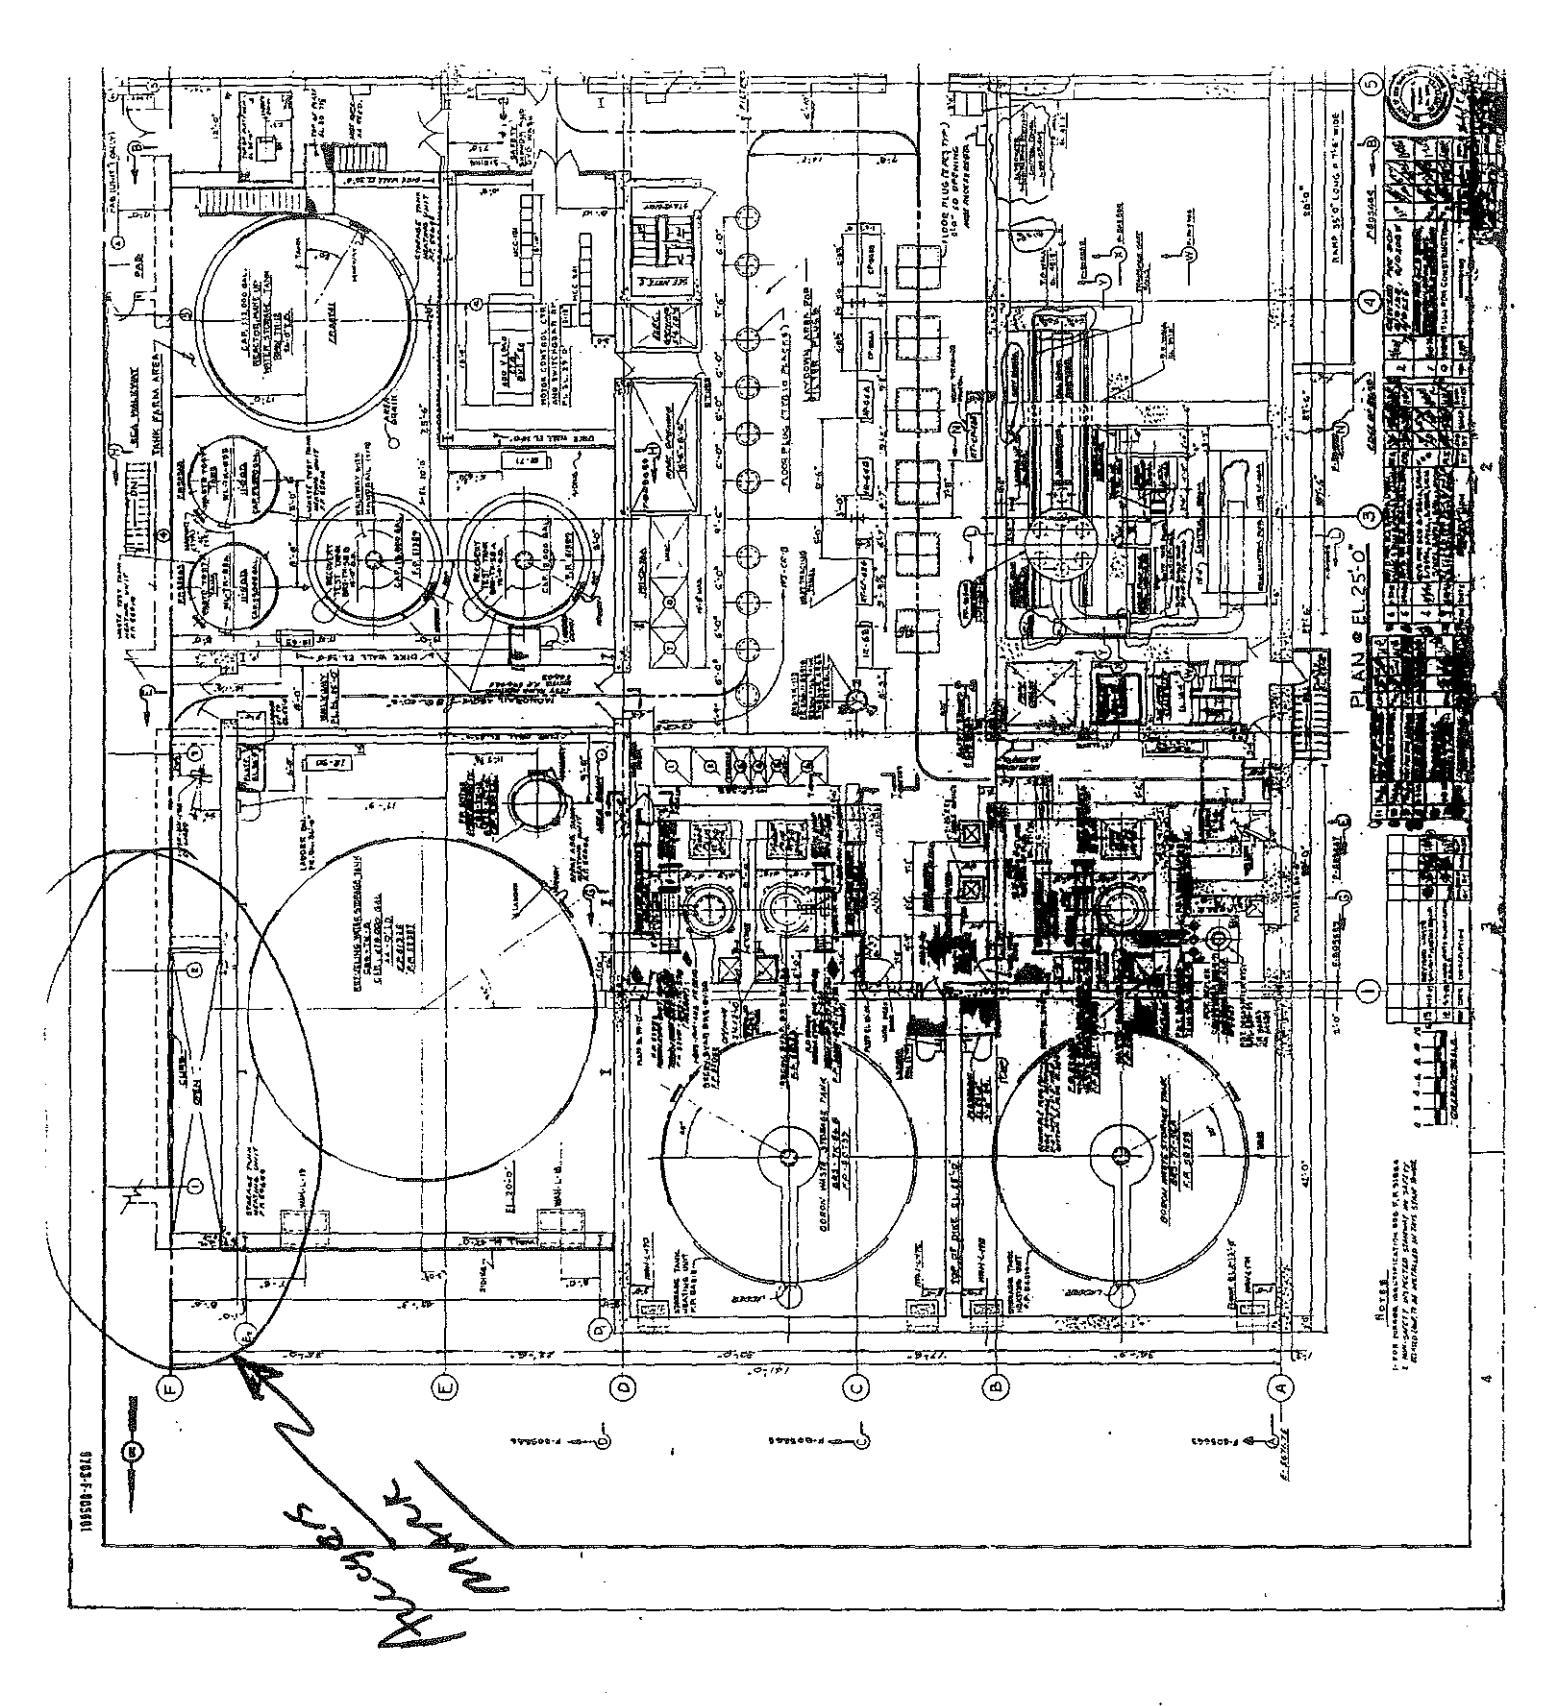
DRAWING No.4

Through discussion with the alleger on 4/20/87 and review of inspection documentation the NRC staff has established that inspections were directed toward the areas of concern to the alleger.

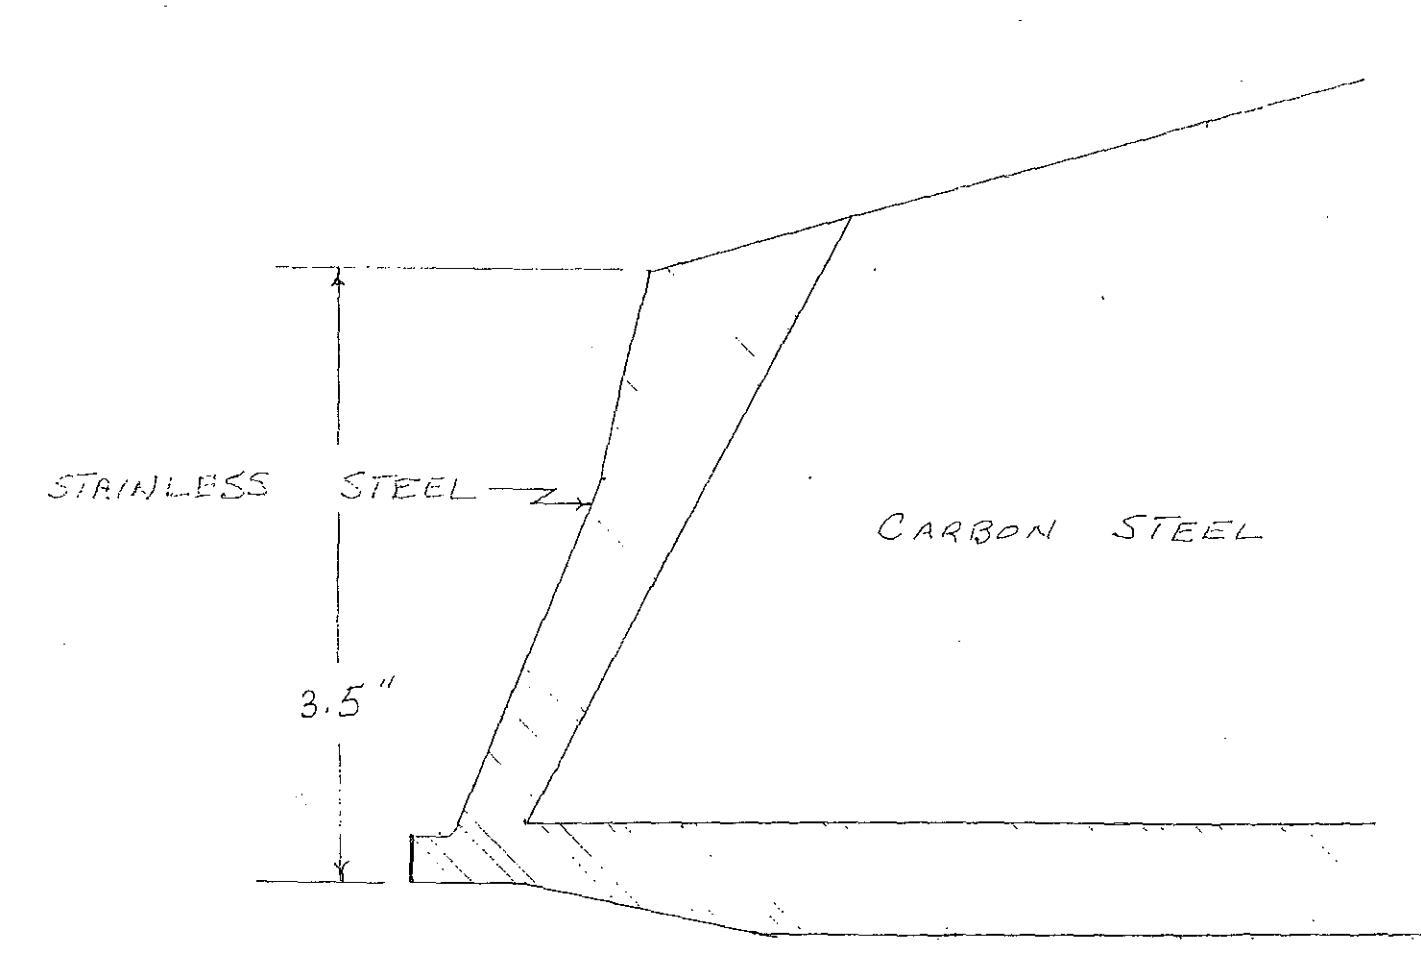
STEAM GENERATOR NOZZLE PRIMARY DRAWING No 5

The radioisotope used to perform the radiography of the steam generator nozzles is acceptable under the governing rules of the ASME Code, Sections III and V.

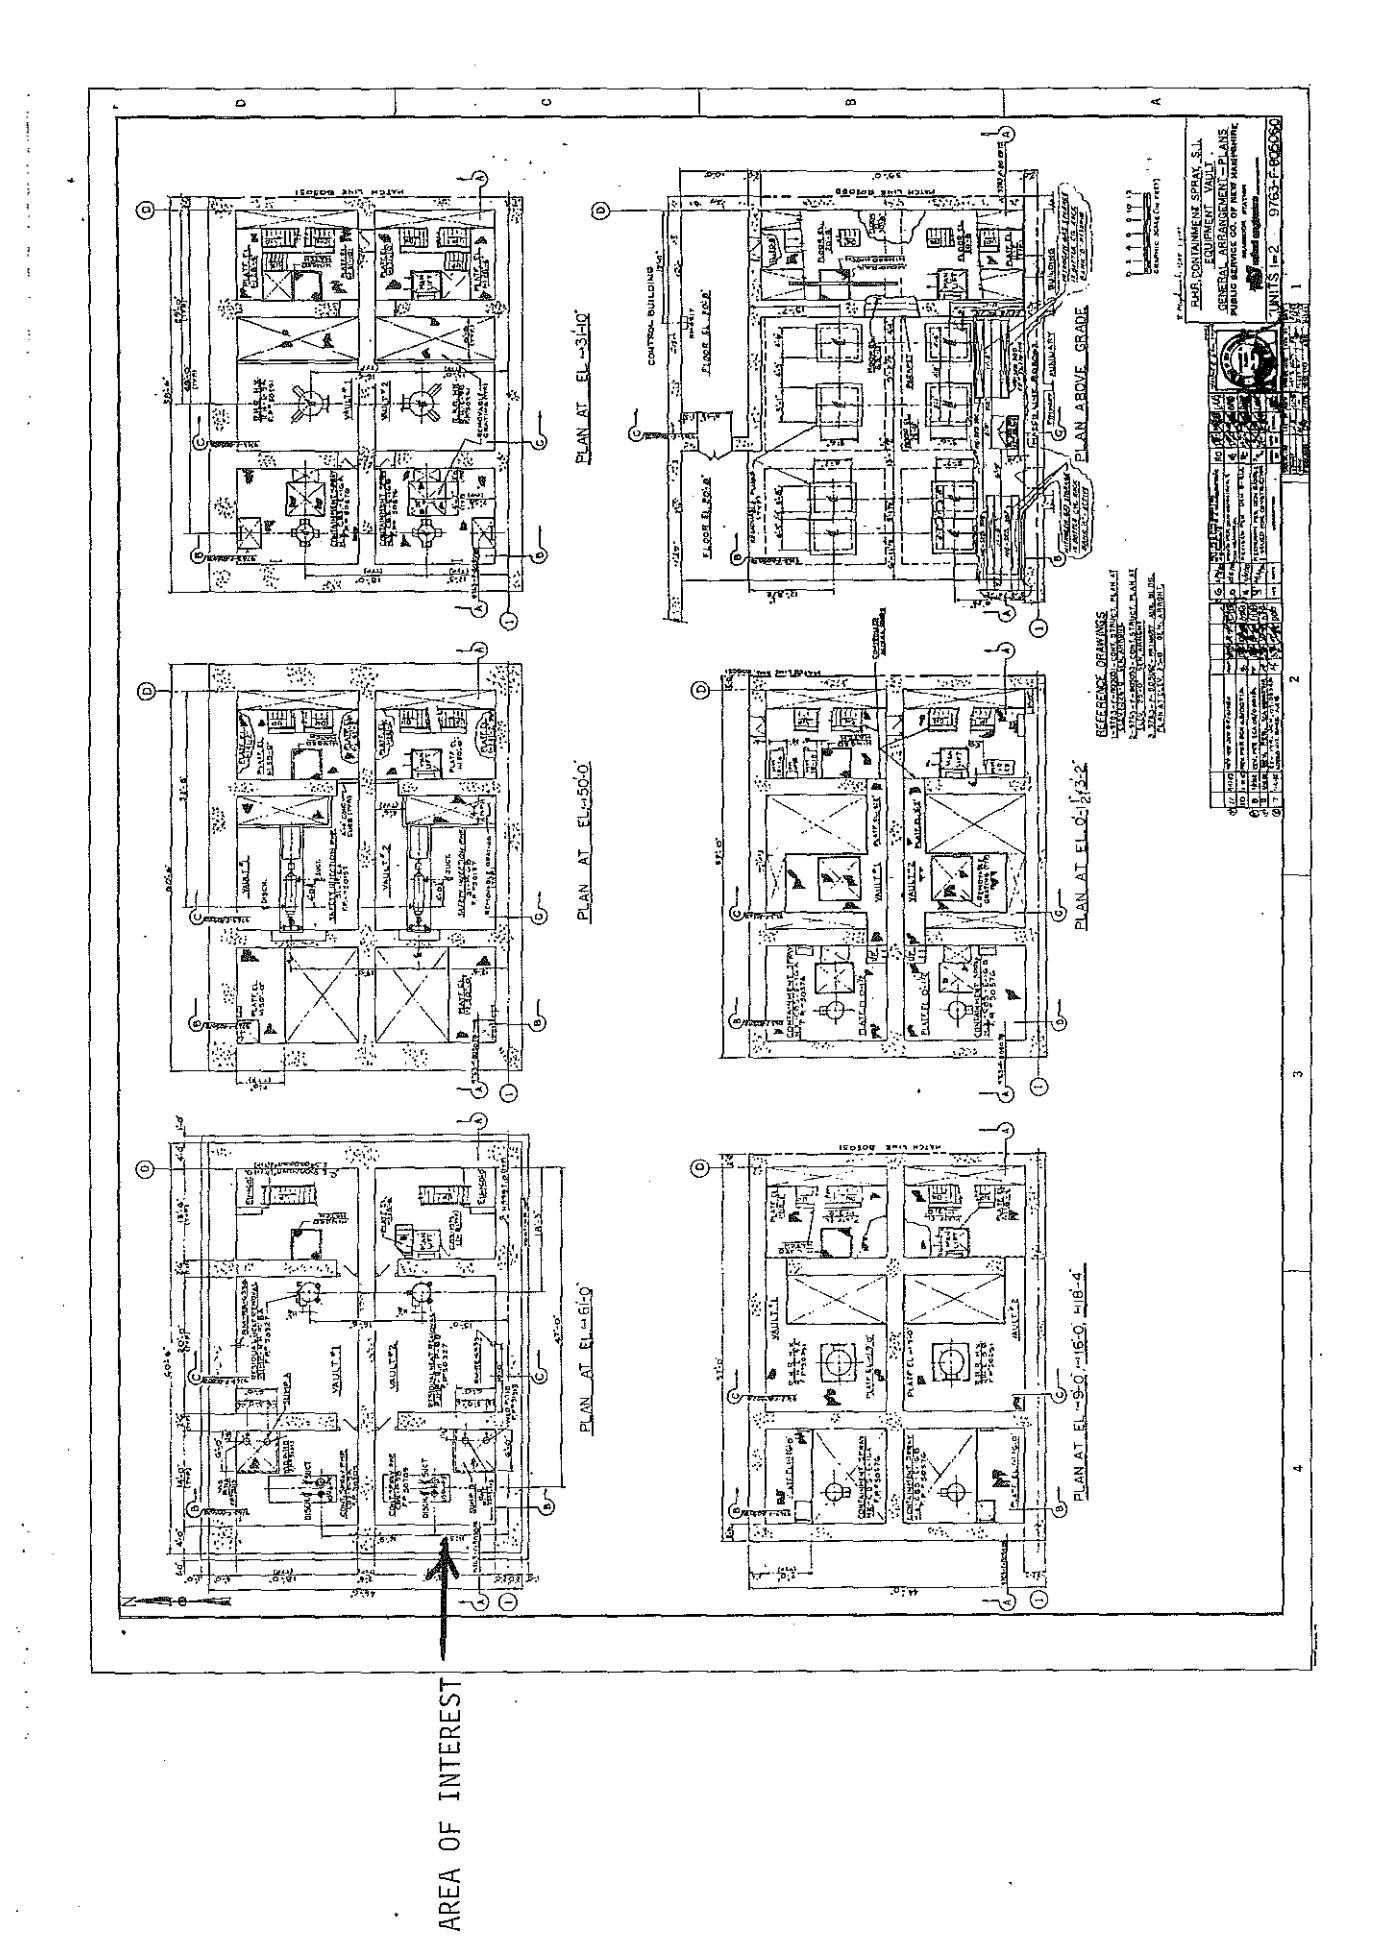
DRAWING No.6

A Nonconformance Report (NCR), No. 2109, dated 6/10/83, was issued which describes a flooding incident affecting the CBS pump. The NCR states, "The subject pump was involved in a flood causing the CBS pump skid to be subjected to approx. 2 1/2' of water. Pump skid is located in Unit 1 RHR Vault, South side Elv. - 56."

A Westinghouse technical representative was contracted to inspect the motor on 7/8/83. An insulation resistance check was performed and a measured value of 800 Megohms to ground was recorded. The technician contacted the factory and was informed that the motor should be run to dry the insulation and lubricate the bearings. Subsequently, the pump manufacturer, Bingham-Willamette, Ltd., provided a technician in 1984 to disassemble the pump end and inspect the bearings and seals; damaged parts were replaced and the NCR closed out.

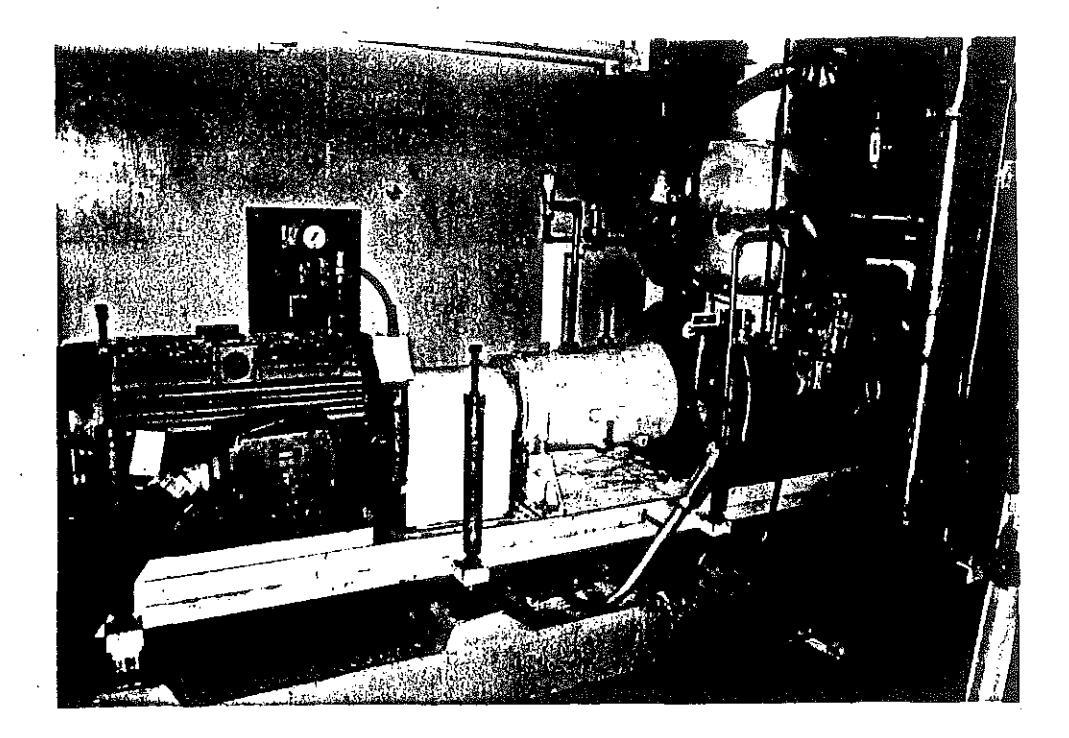
A tour of the waste process building disclosed that the pumps being described by the alleger are located at elevation - 3 and are the recovery evaporator reboiler pumps, BRS-P-87A and BRS-P-87B, and the waste evaporator reboiler pump, WL-P-93 (See photos No. 12 & 13 and Drawing No. 7). These pumps have 30" diameter suction piping and 24" diameter discharge piping and the pump baseplates are mounted on spring loaded supports to compensate for expansion. These pumps service the boron recovery and the liquid waste system, respectively, and are not safety related. The boron recovery system processes reactor coolant and primary drain water for possible reuse as primary grade water and boric acid, or for offsite disposal. The liquid waste system is non-nuclear safety class and designed to provide a central collection point for radioactive liquid waste.

The aforementioned pumps did recently experience a failure of the spring support system and a Request for Engineering Services, dated 12/23/86, and a Design Coordination Report, dated 1/3/87, were initiated. The failures were two adjacent spring mount isolators on pump BRS-P-87A base plate which broke at the relieved area above the threads. The licensee is currently processing a design change to strengthen this area on the supports. At the time of this inspection, the design change had not been completed.
