#### **Briefing on Indian Point Baffle Bolt Inspections**

April 19, 2016

**Enclosure 1**

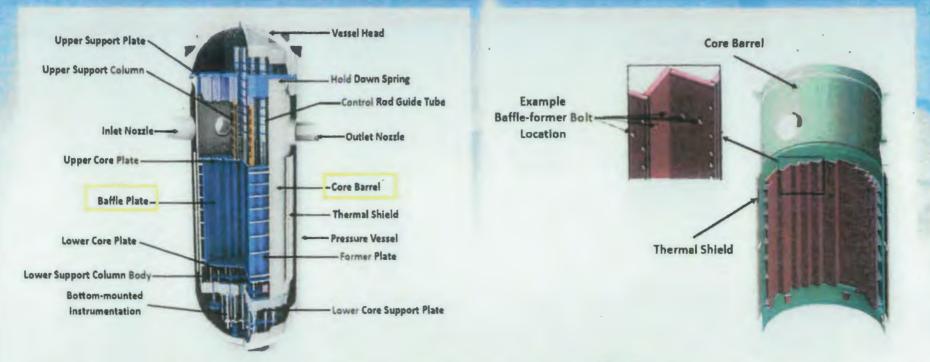
Function of baffle-former assembly is to direct coolant flow through the core. It also provides lateral support to the core during a seismic event or loss-of-coolant accident (LOCA).

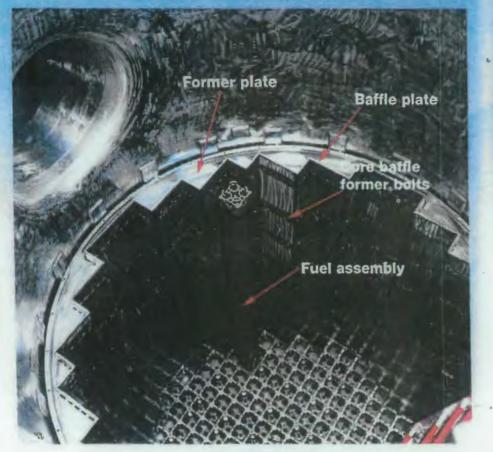
- No impact from a few bolt failures
- Large numbers of failed bolts could cause:
  - Flow leakage through gaps between adjacent plates
    - Fuel degradation (baffle jetting erosion)
    - Increased core bypass flow (less fuel cooling)
  - Baffle plates impacting fuel assemblies during LOCA event, potentially leading to grid deformation
