Subject: 2016 Annual Site Inspection and Monitoring Report for Uranium Mill Tailings Radiation Control Act Title II Disposal Sites

2016 Annual Site Inspection and Monitoring Report for Uranium Mill Tailings Radiation Control Act Title II Disposal Sites

November 2016

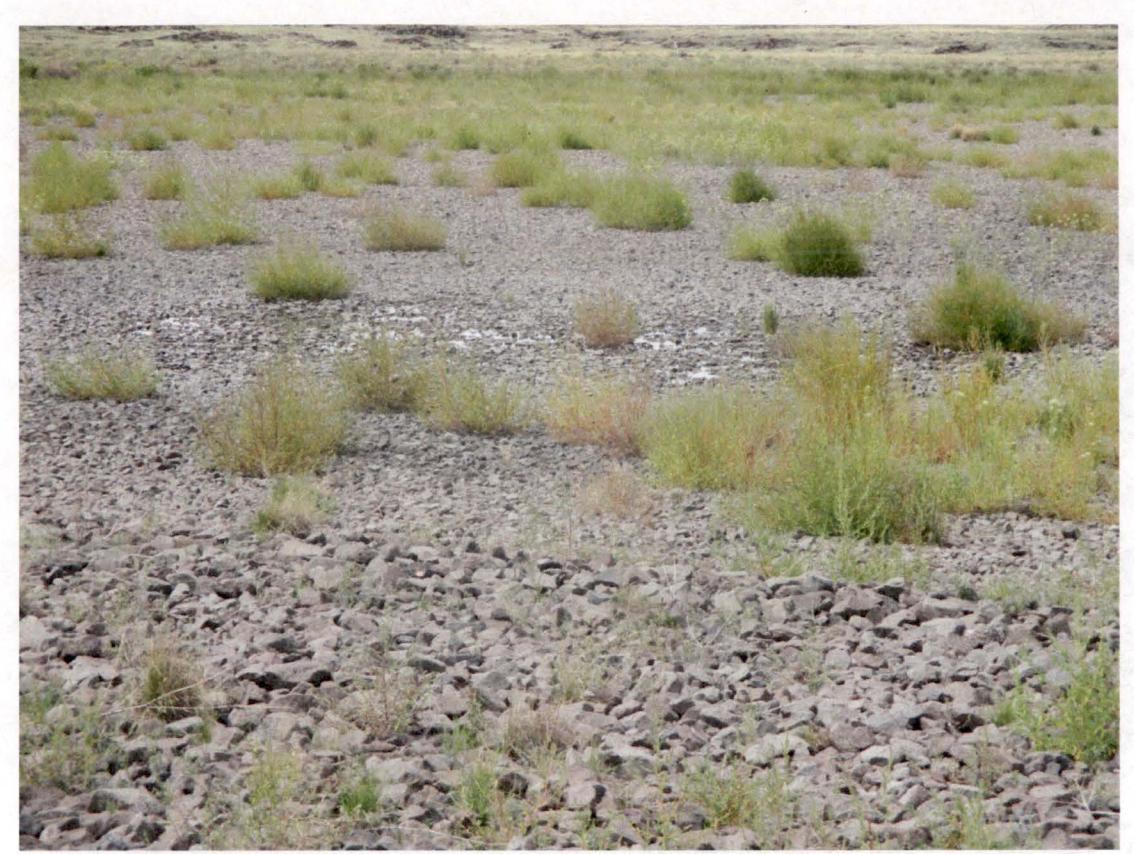
PL-13. Ponded Water on Northwest Extension of Carbonate Tailings Disposal Cell

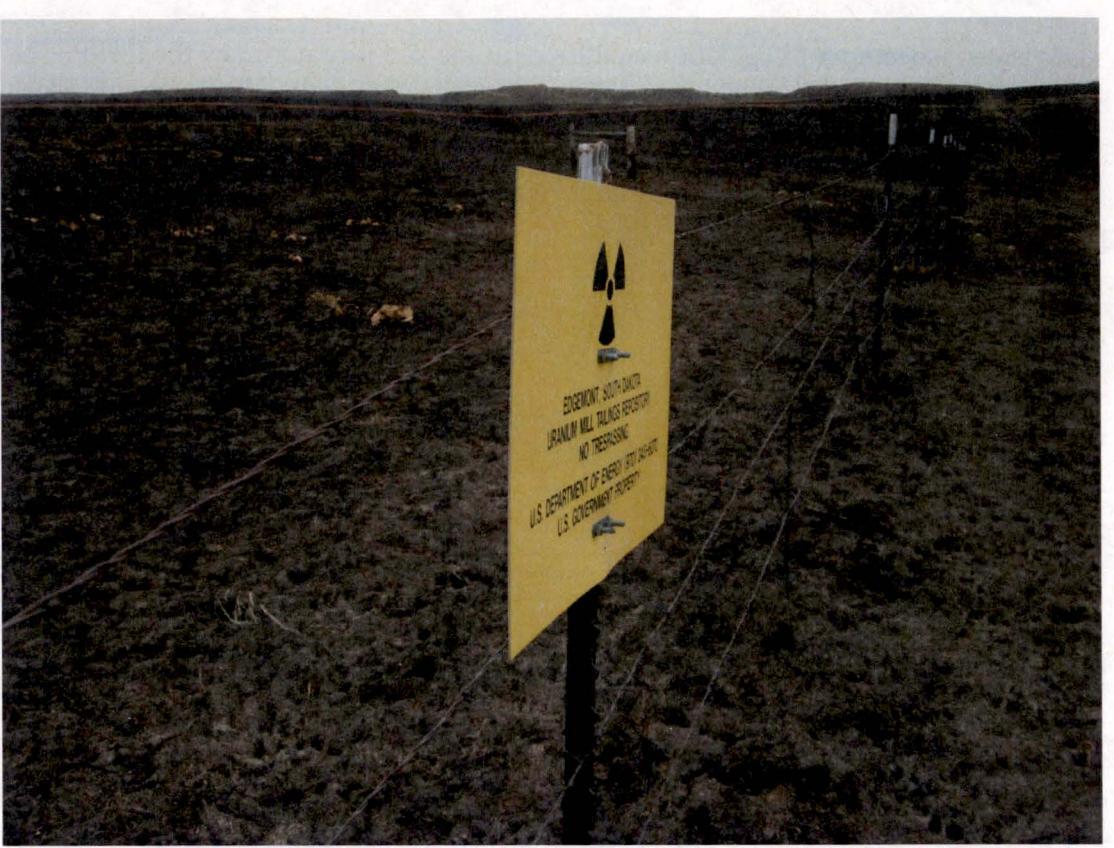
PL-1. Wire Gate and Perimeter Sign P1 Near Northwest Corner of Site, July 22, 2016

The steel wire perimeter fence was not damaged except for a short section near the entrance gate, which was repaired by the grazing licensee. The perimeter signs mounted on the fence were undamaged. The only fire-related damage requiring repair was caused by construction of the firebreak. The firebreak is approximately 20 feet wide and extends from the entrance gate to the inner fence near the west drainage channel, but it does not go east of the inner fence, as noted on Figure 2-1. This section was reseeded and regraded by the licensee. The entrance signpost was knocked over and will be reset by the licensee, with a new sign installed. All engineered structures, such as the embankment and diversion channels, were undamaged.

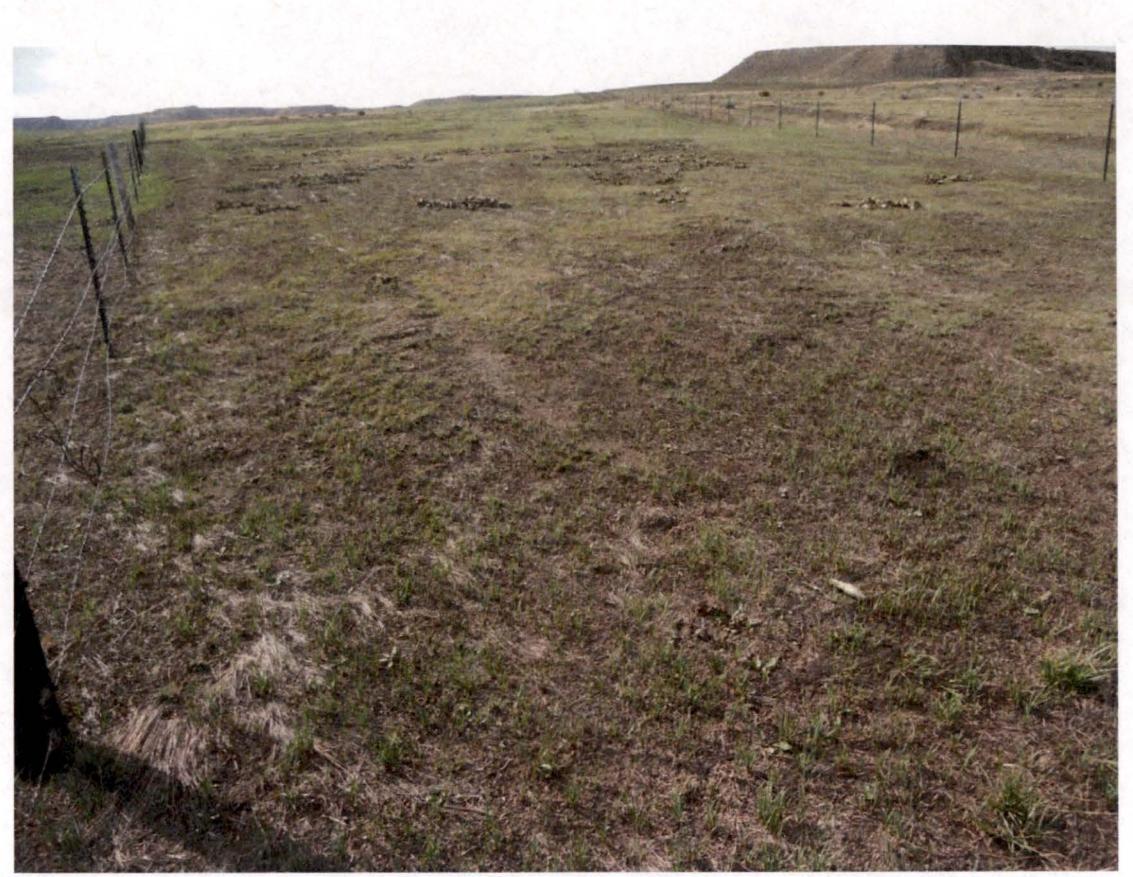
PL-7. Vegetation Regrowth Observed on September 6, 2016

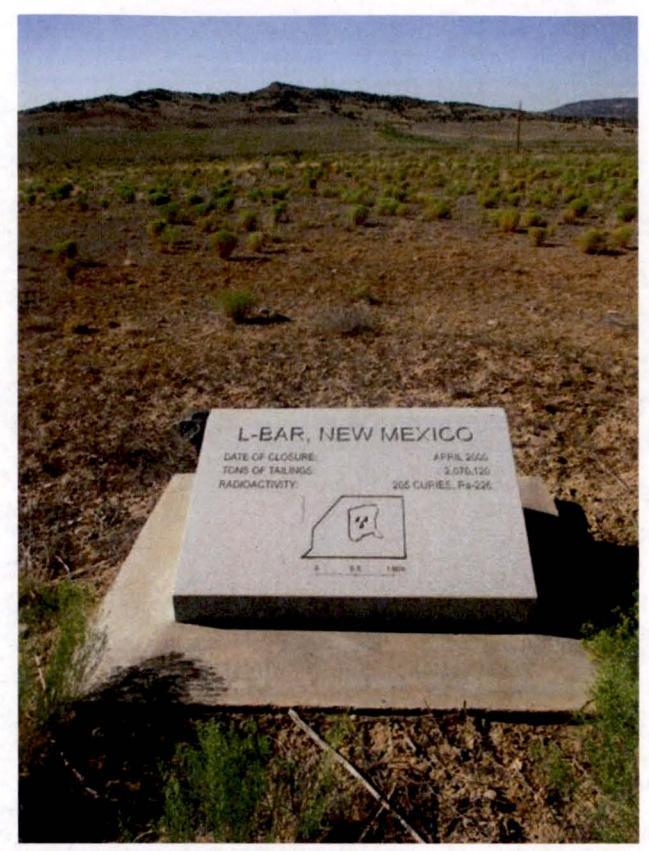
PL-5. Site Marker

The site has one granite site marker, which is located north of the disposal cell adjacent to the site access road (PL-5). No maintenance needs were identified.

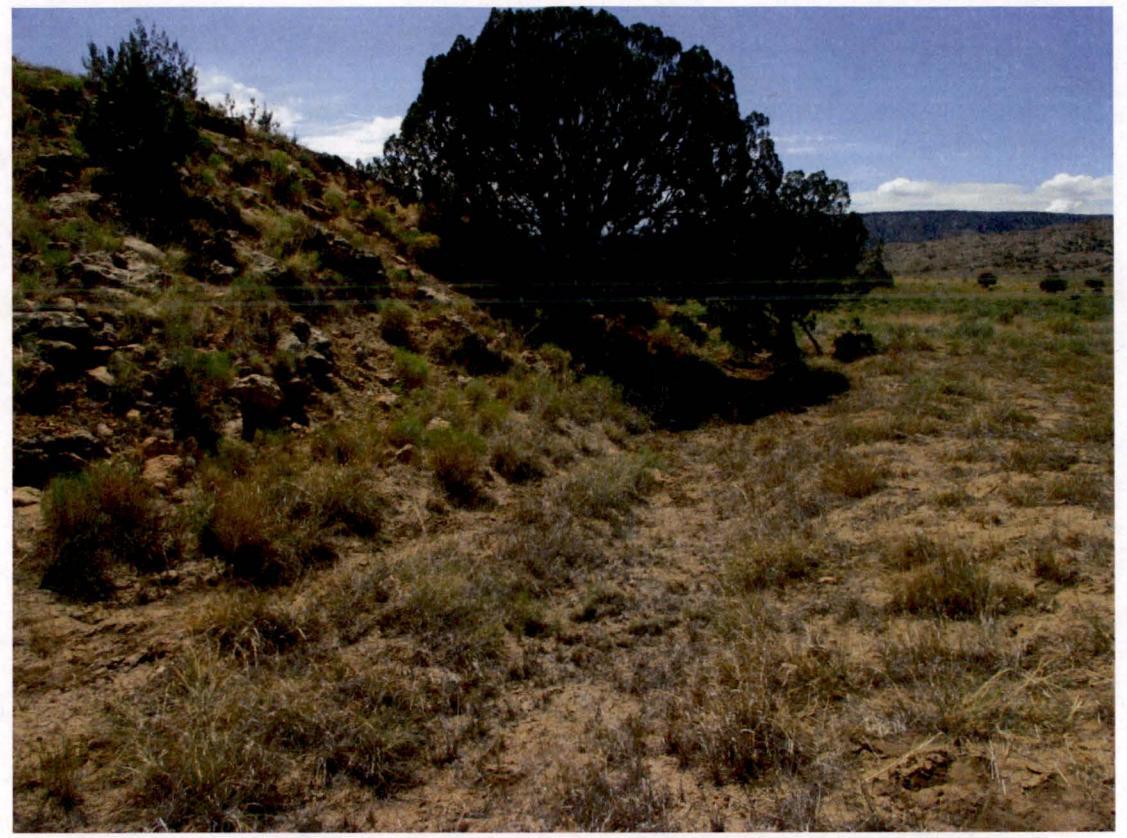
PL-15. Potential Seep Area at Tres Hermanos Sandstone Outcrop

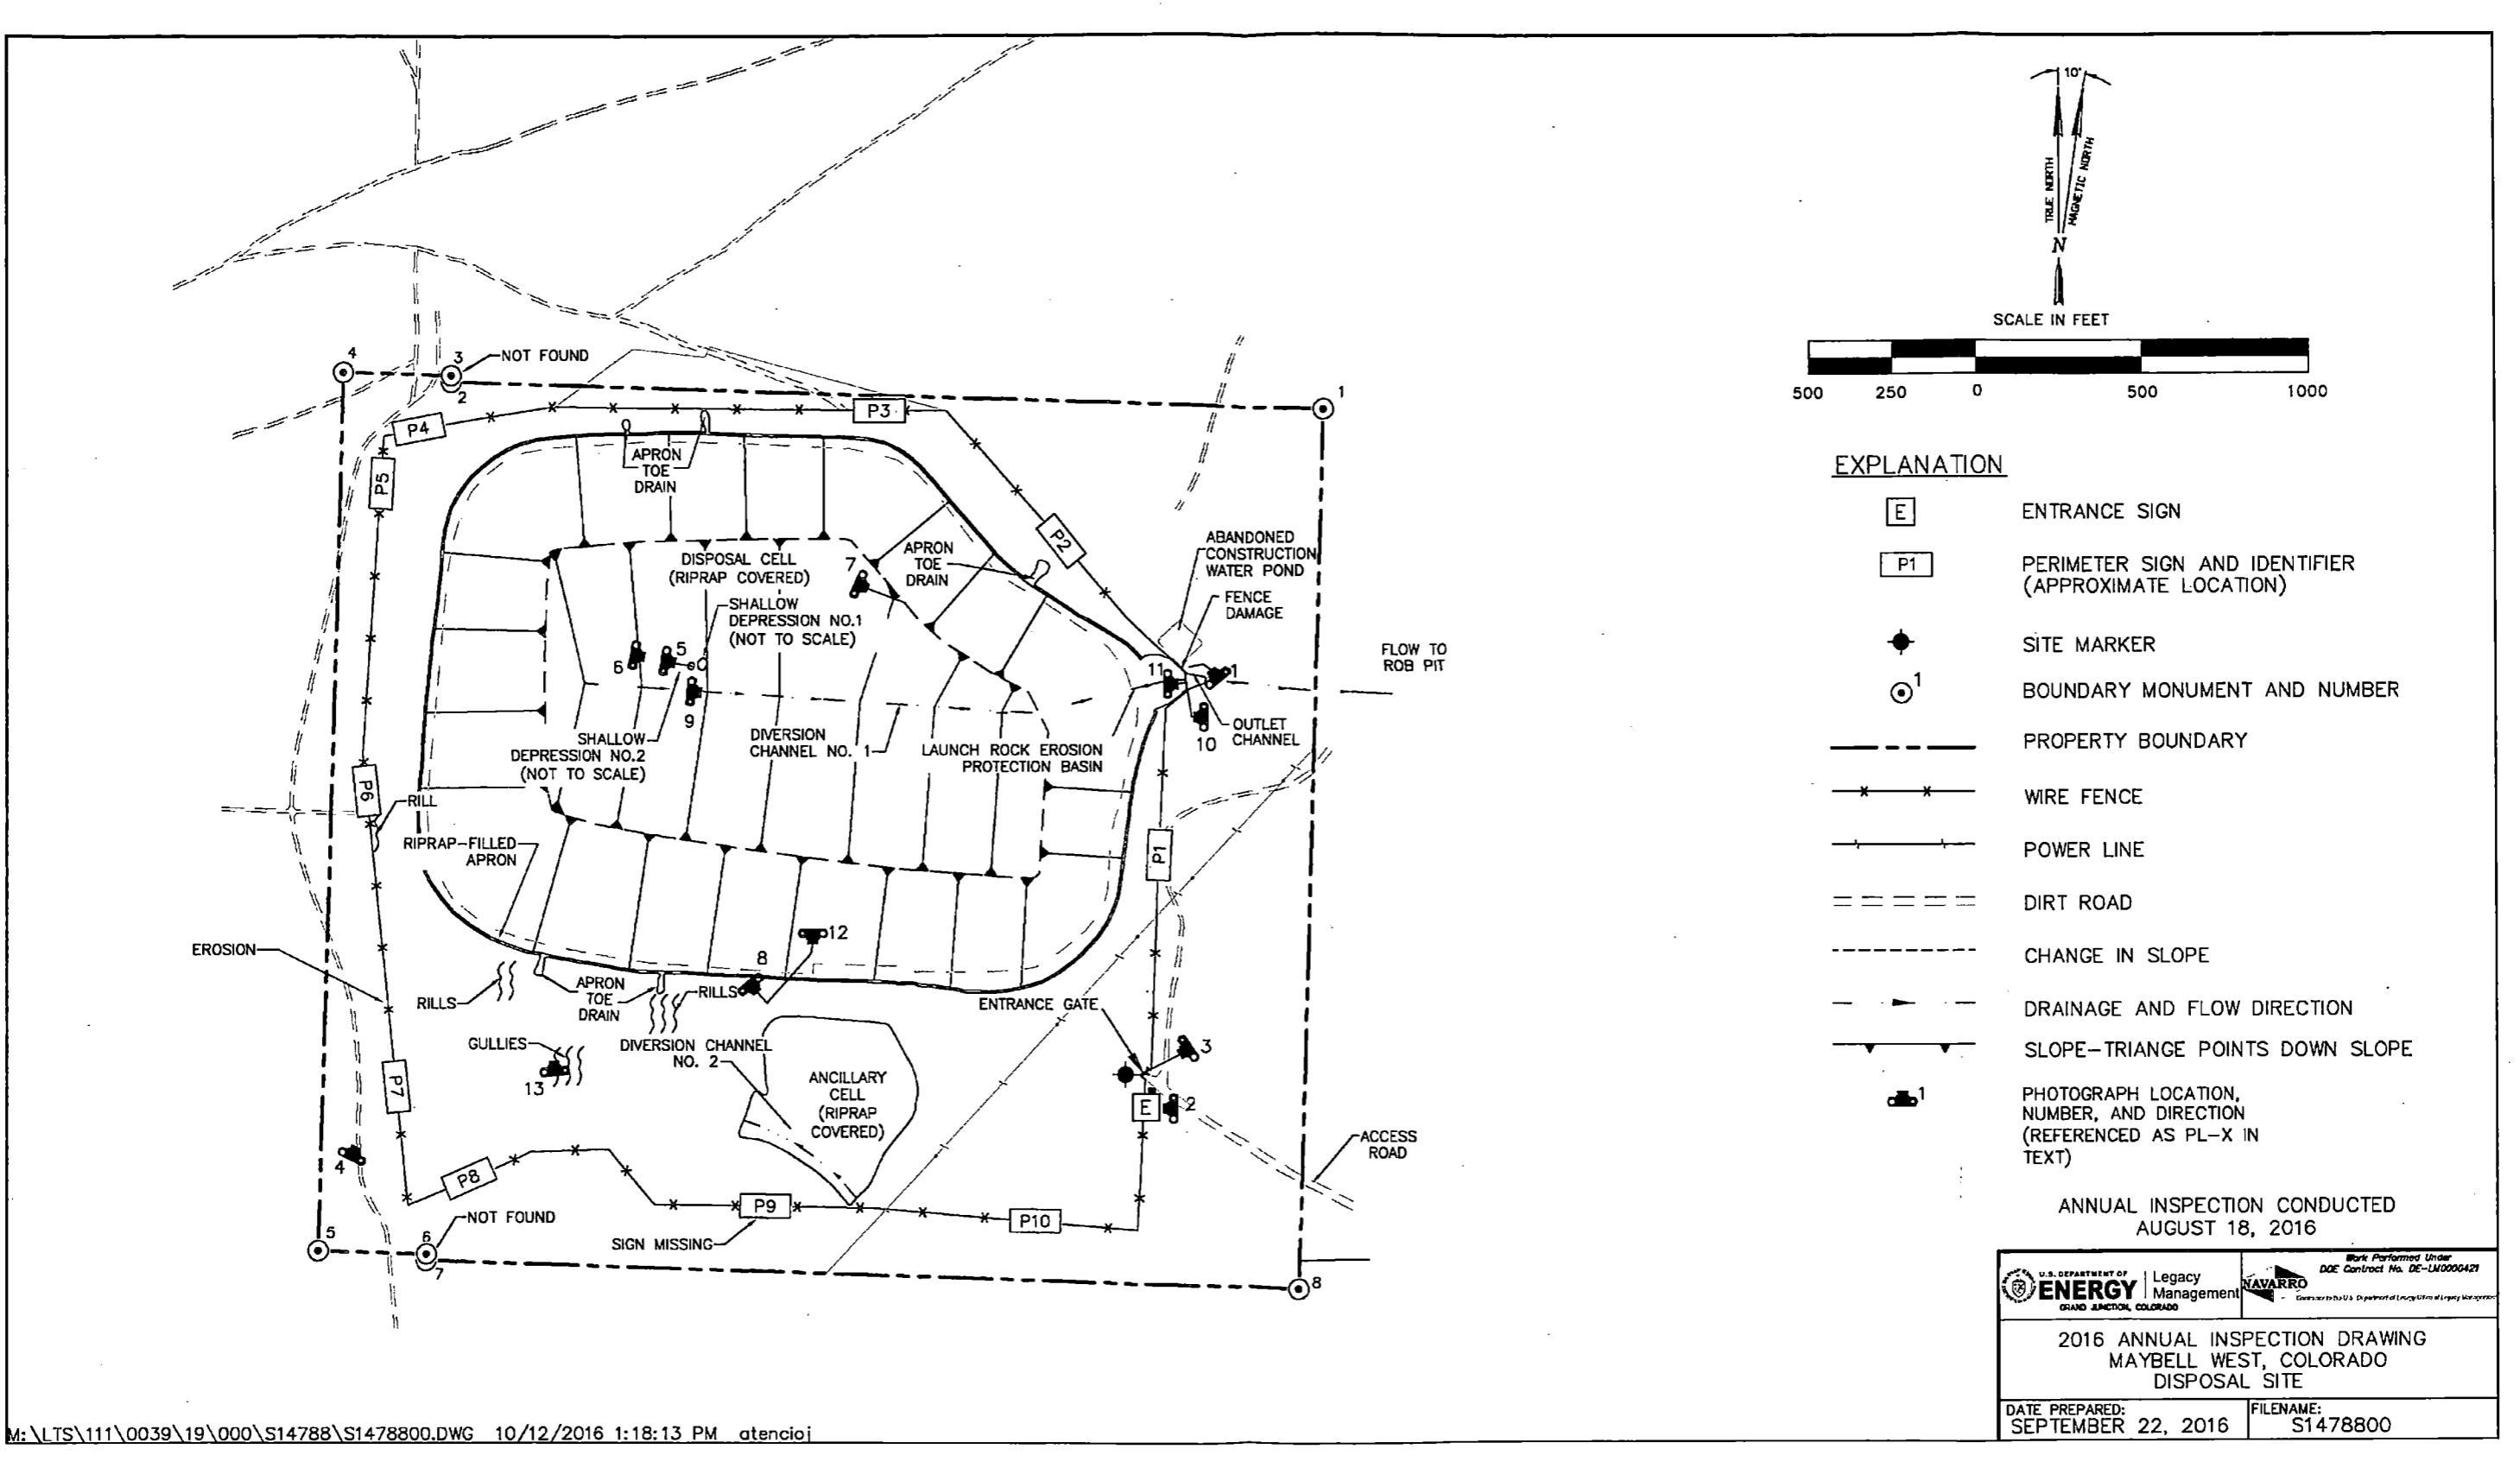
Figure 4-1. 2016 Annual Inspection Drawing for the Maybell West, Colorado, Disposal Site

The locations of site surveillance features are shown on Figure 4-1. Inspection results and recommended maintenance activities associated with site surveillance features are included in the following subsections. Photographs to support specific observations are identified in the text and on Figure 4-1 by photograph location (PL) numbers.

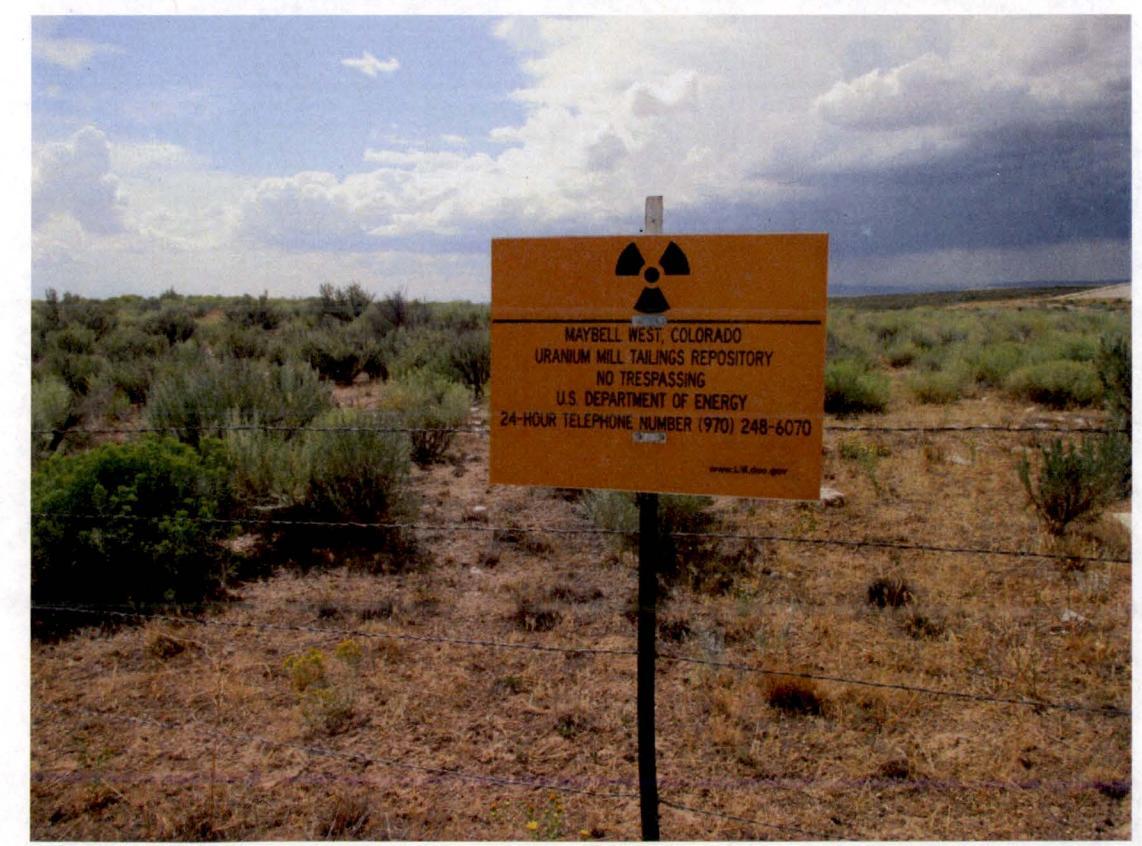
PL-2. Entrance Sign

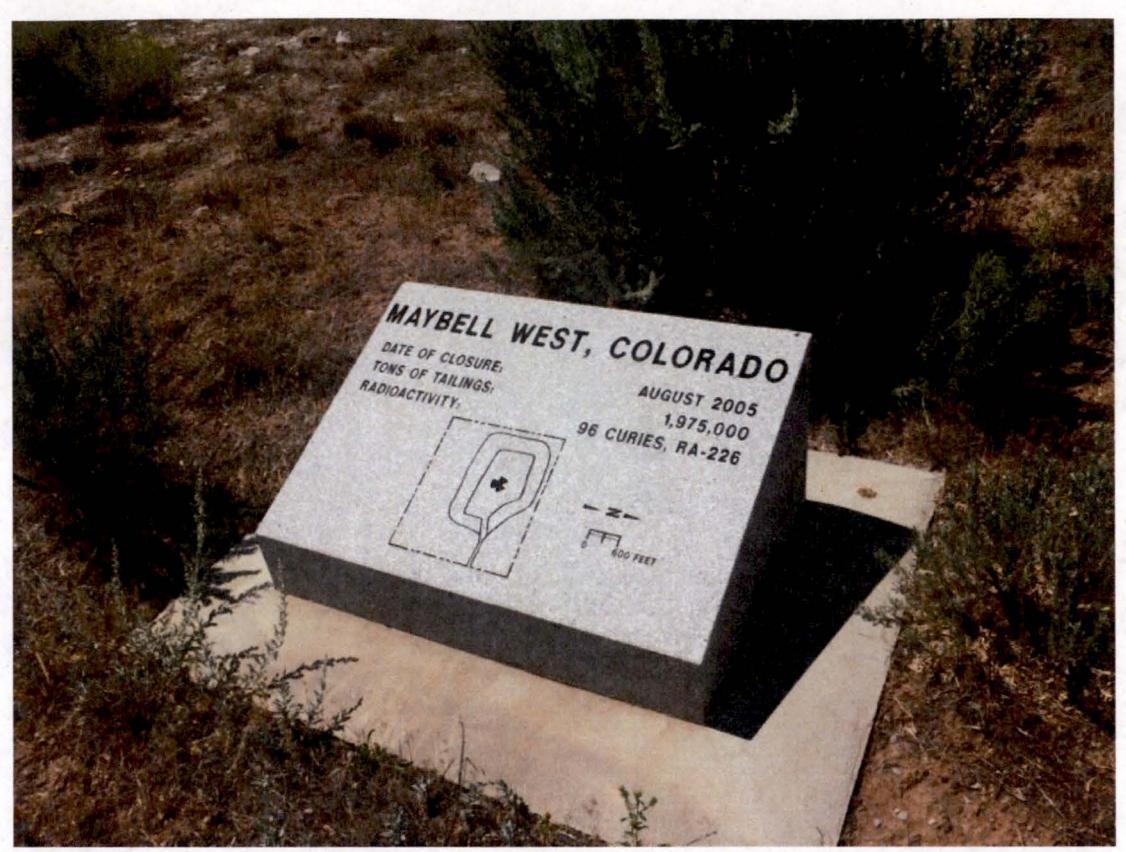
PL-3. Site Marker

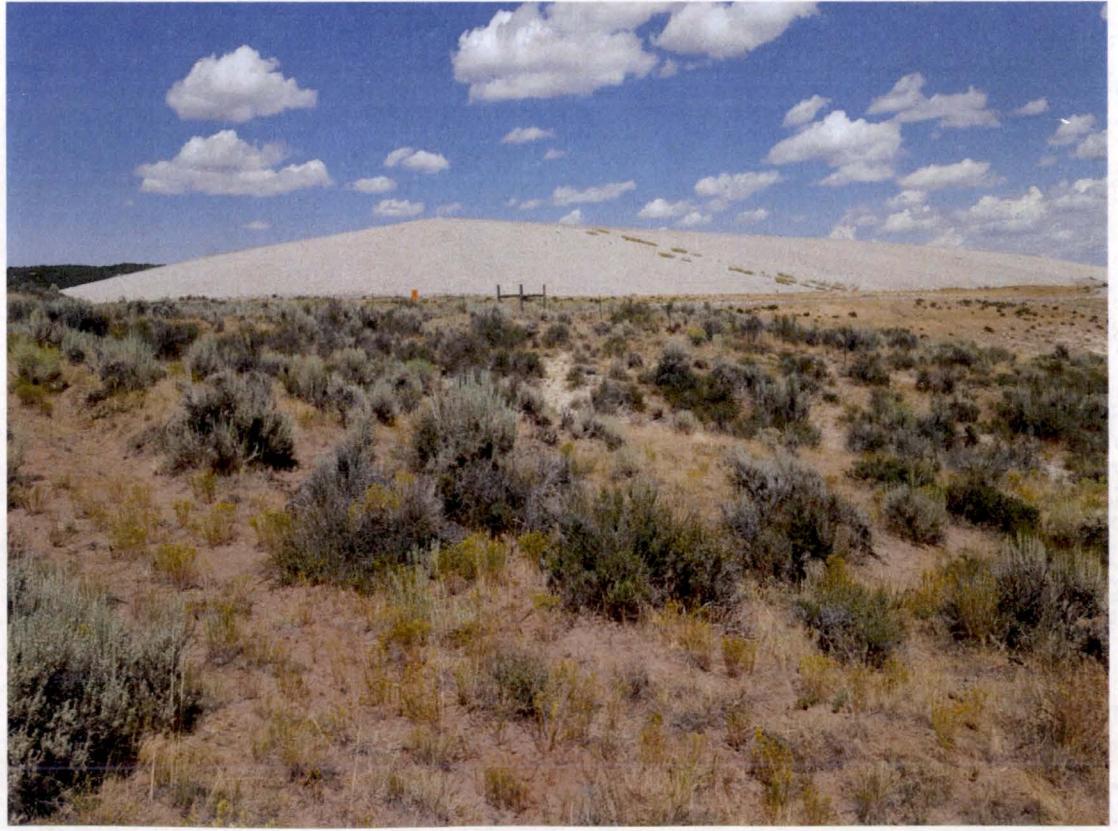
The rock-covered disposal cell, a reclaimed former heap leach area that occupies about 60 acres of the site, rises to a maximum height of approximately 75 feet above the surrounding landscape (PL-4). No evidence of slumping, erosion, or rock degradation was observed. However, a small shallow depression (Depression No.1) is present just north of Diversion Channel No. 1 (PL-5). This depression, approximately 25 feet long, 15 feet wide, and 1 foot deep in the center, appears to be the result of settlement of the underlying materials since completion of the cell. The depression was approximately the same size as noted during the last annual inspection, although a second smaller and shallower depression (Depression No.2) appears to be developing just west of the first (PL-6). Measurements of both depressions will continue to be performed during annual inspections to determine if additional, more significant, settlement is occurring. No standing water was observed within either depression. The depressions currently do not cause significant ponding of water, prevent positive drainage of the cover, or threaten the integrity or performance of the disposal cell.

PL-4. Southwestern Portion of Disposal Cell

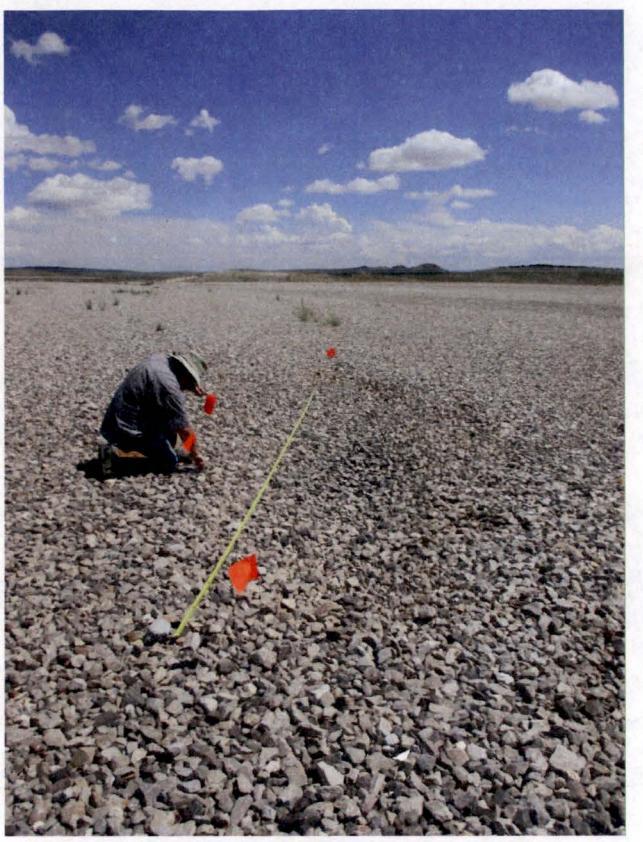
PL-5. Measuring Depression No.1

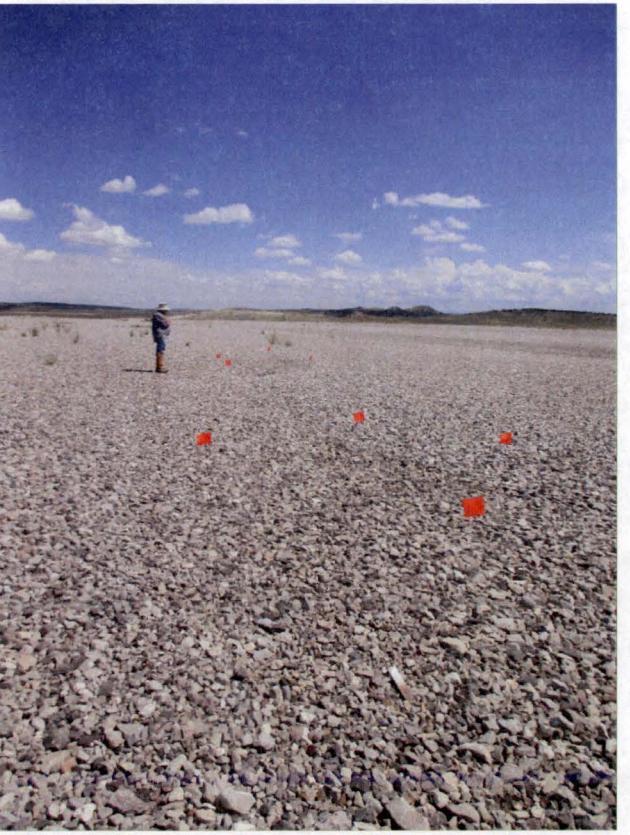
PL-6. Depression No. 1 and No. 2 Marked by Pin Flags

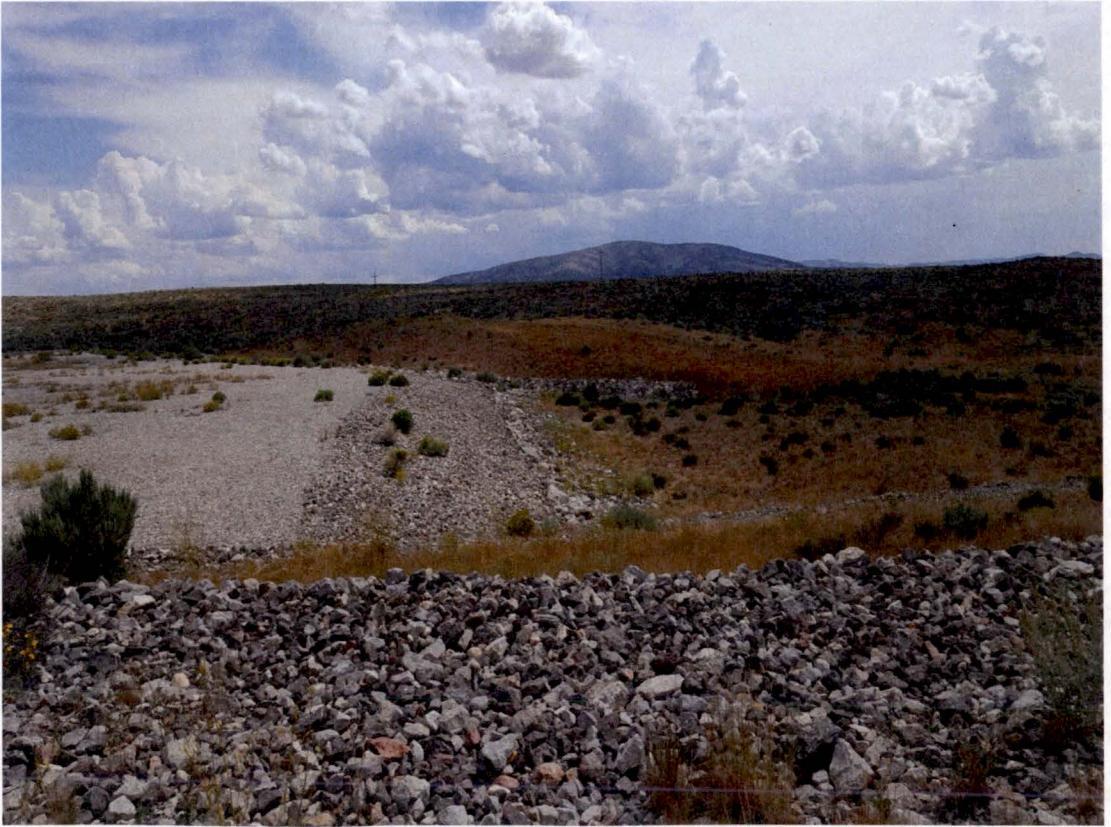
PL-12. Interface of Top and West Side Slope of Ancillary Cell; Outlet of Diversion Channel No. 2 in Background

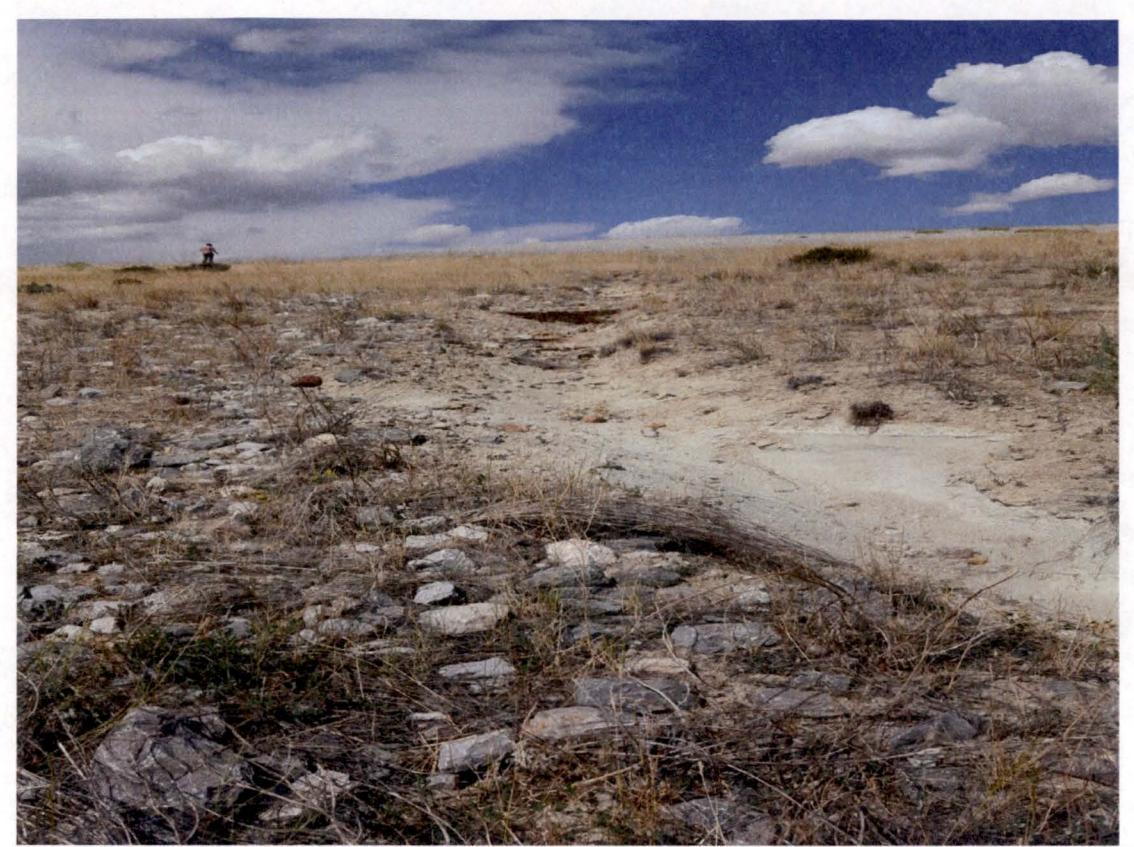
The rock berm that runs along the northern edge of the ancillary cell continues west across the slope south of the main disposal cell to provide protection against erosion. Several gullies and rills have developed below this south slope but do not threaten the integrity of the disposal cell (PL-13). They will continue to be monitored and repaired as needed. This erosion is expected to stabilize over time as site vegetation improves. The rock berm appears to be effective at controlling head-cutting from these gullies and providing protection to the disposal cell.

PL-13. Gully Southwest of Disposal Cell; Looking Upslope

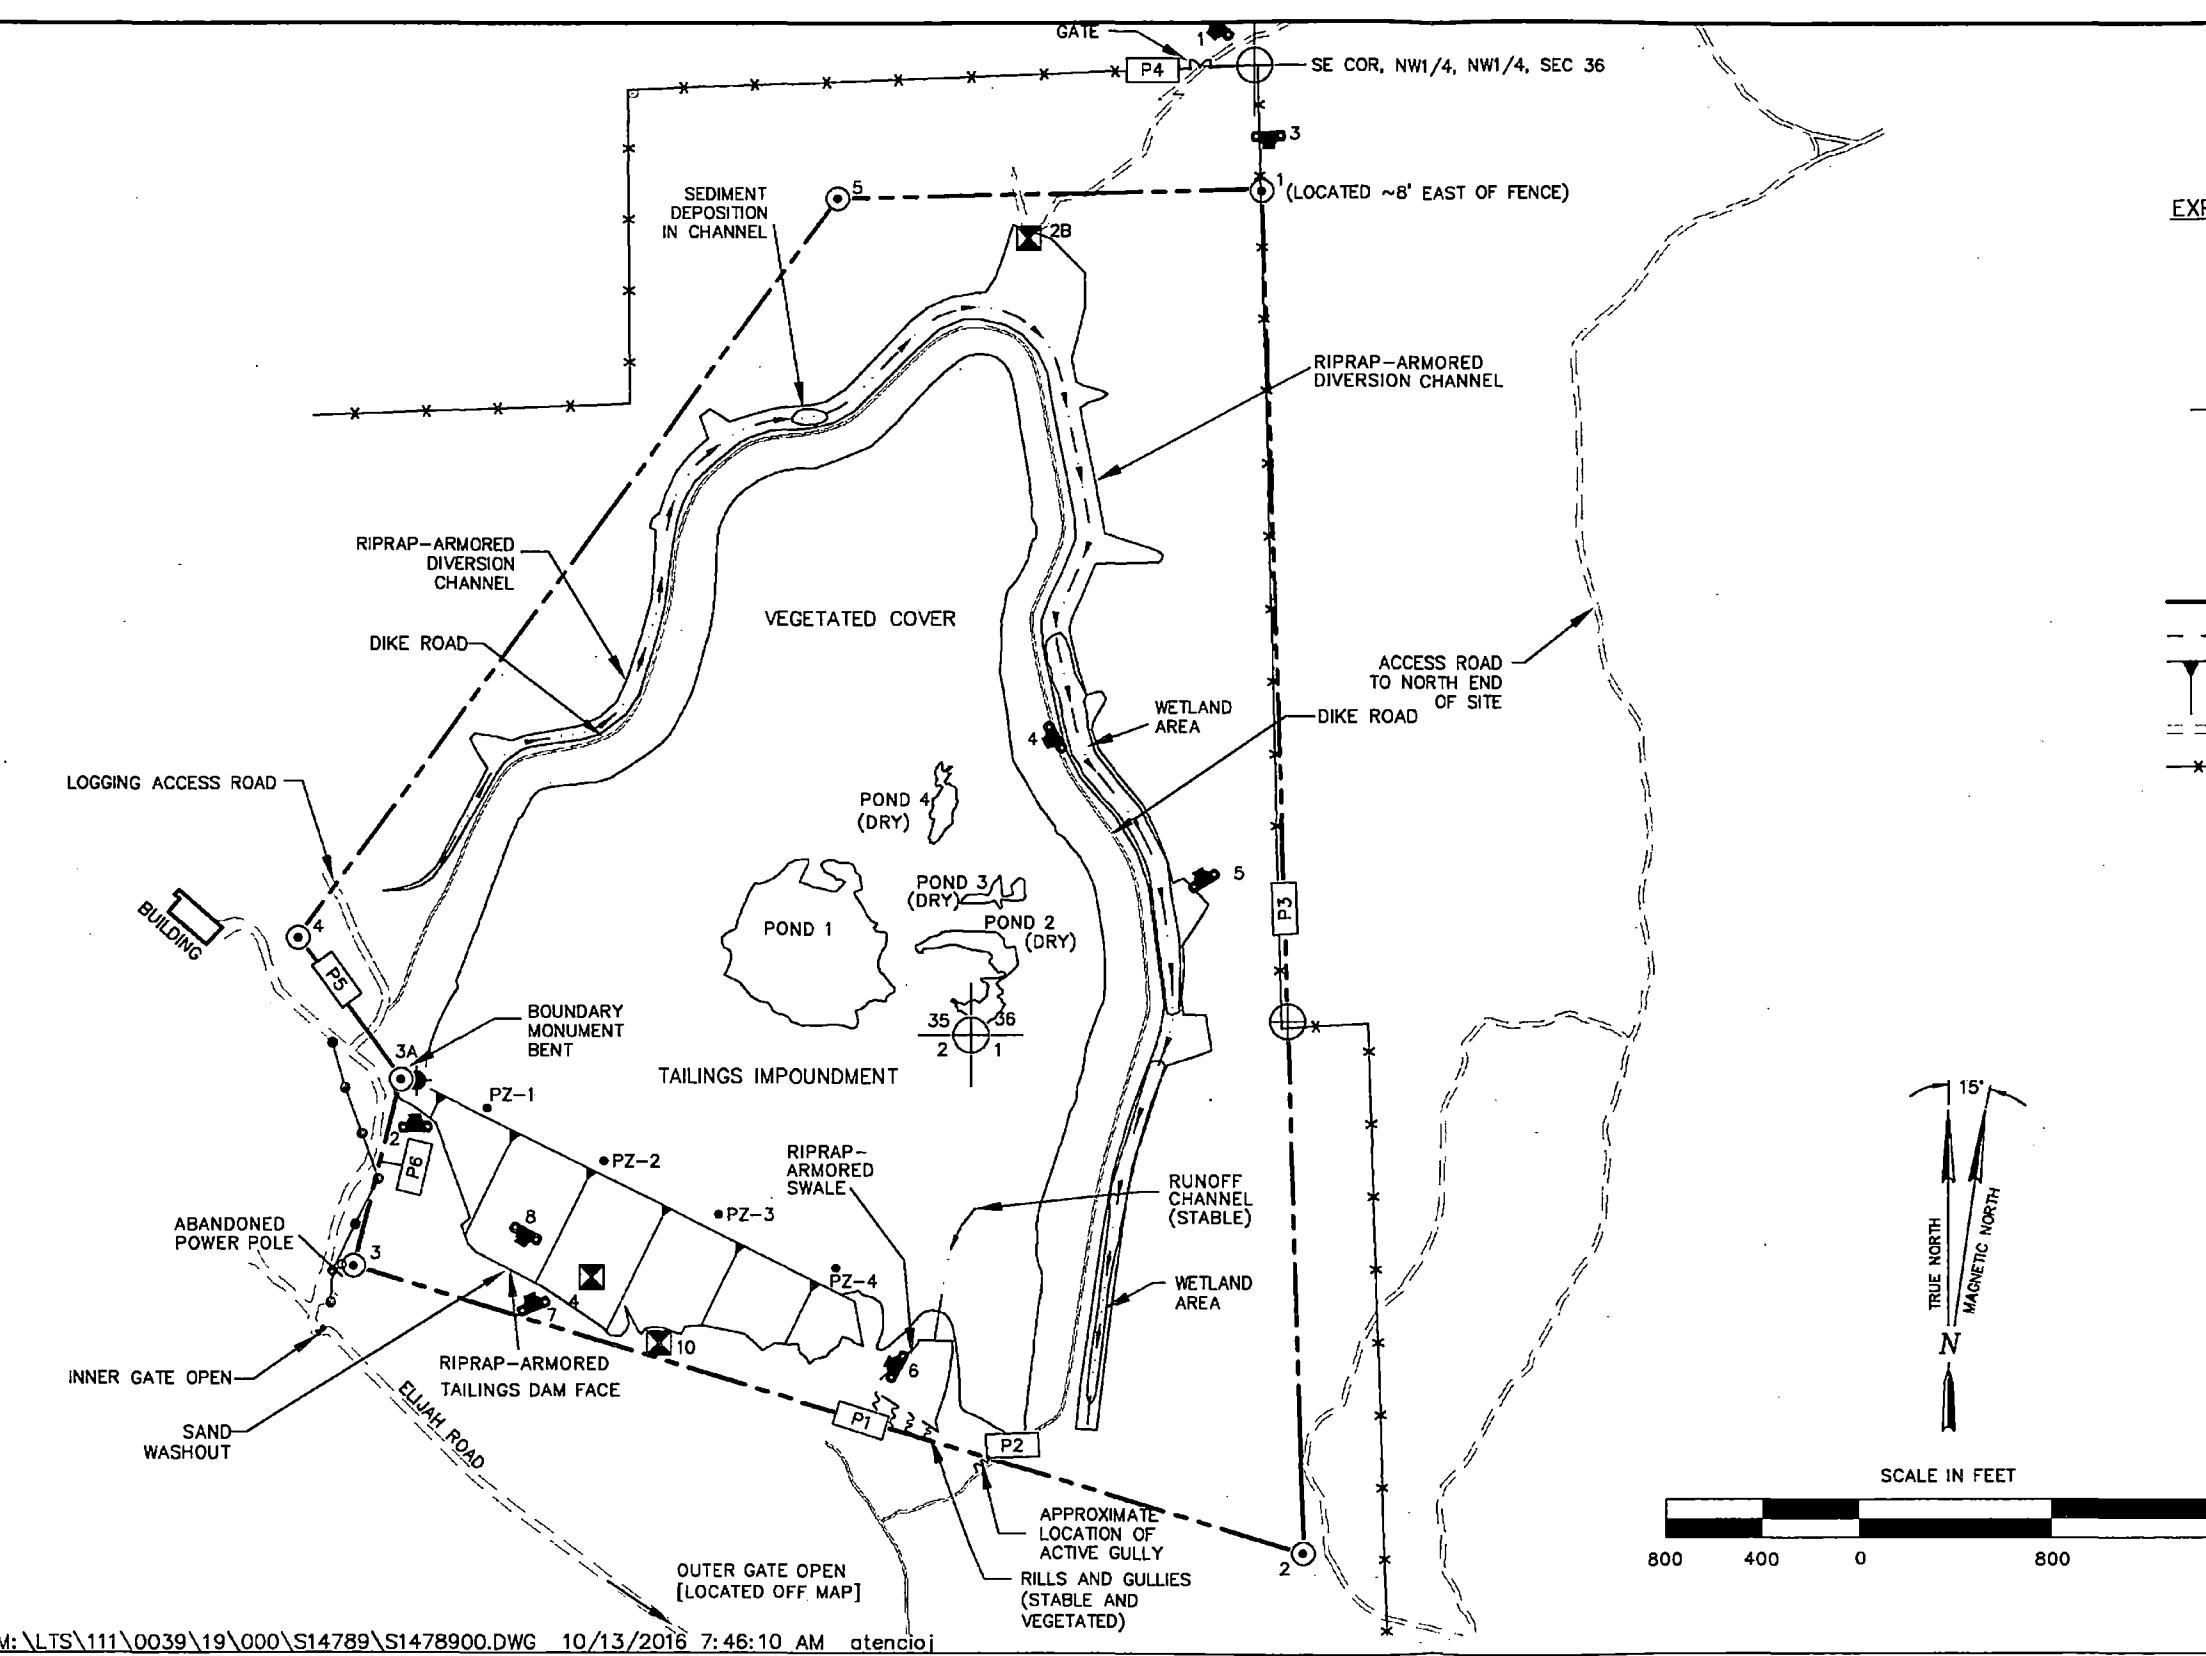
Figure 5-1. 2016 Annual Inspection Drawing for the Sherwood, Washington, Disposal Site

Figure 5-1 shows the locations of site surveillance features. Inspection results and recommended maintenance activities associated with site surveillance features are presented in the following subsections. Photographs to support specific observations are identified in the text and on Figure 5-1 by photograph location (PL) numbers.

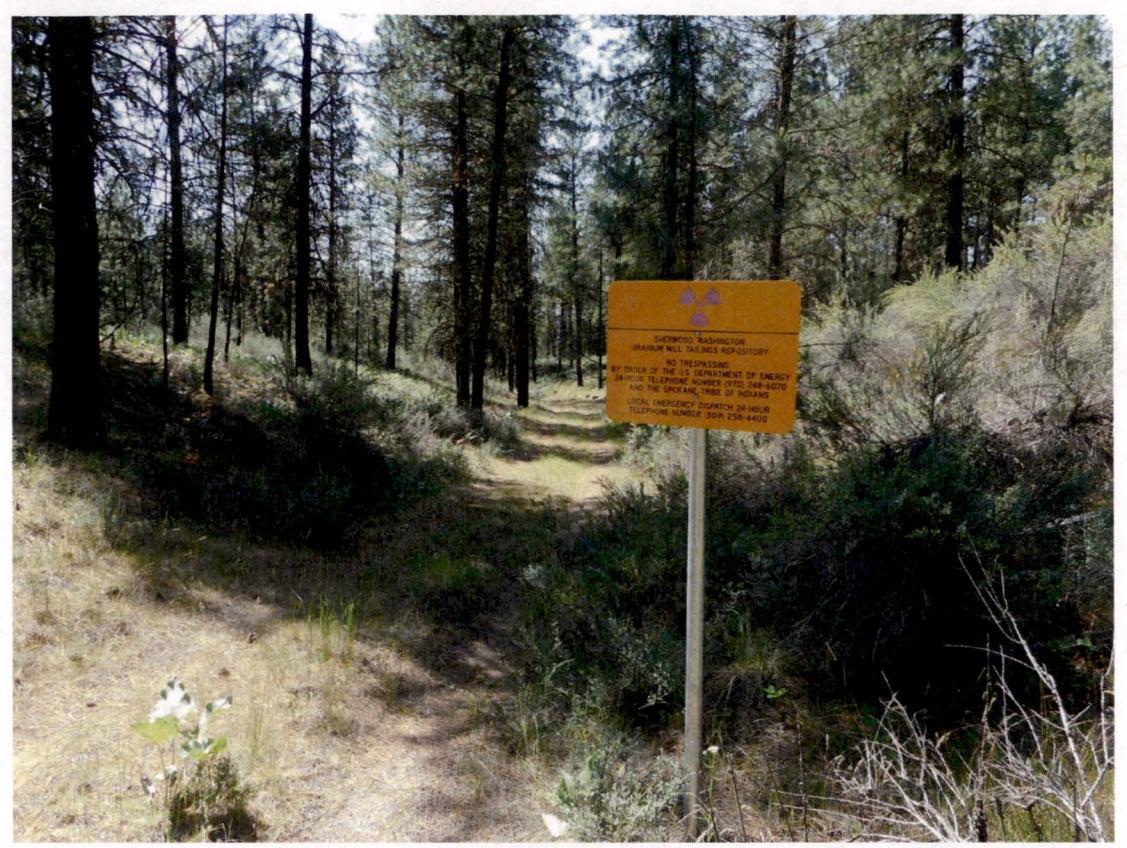
Six warning or perimeter signs, designated P1 through P6, are along the site boundary at likely access points around the site. The signs are attached to steel posts set in concrete. Vandalism of signs commonly occurs, including removal of signs or bullet damage. Text on signs may become illegible due to fading or bullet damage. Missing or illegible signs are replaced as necessary. All of the signs were present and legible, and no maintenance needs were identified (PL-1).

PL-1. Perimeter Sign P4

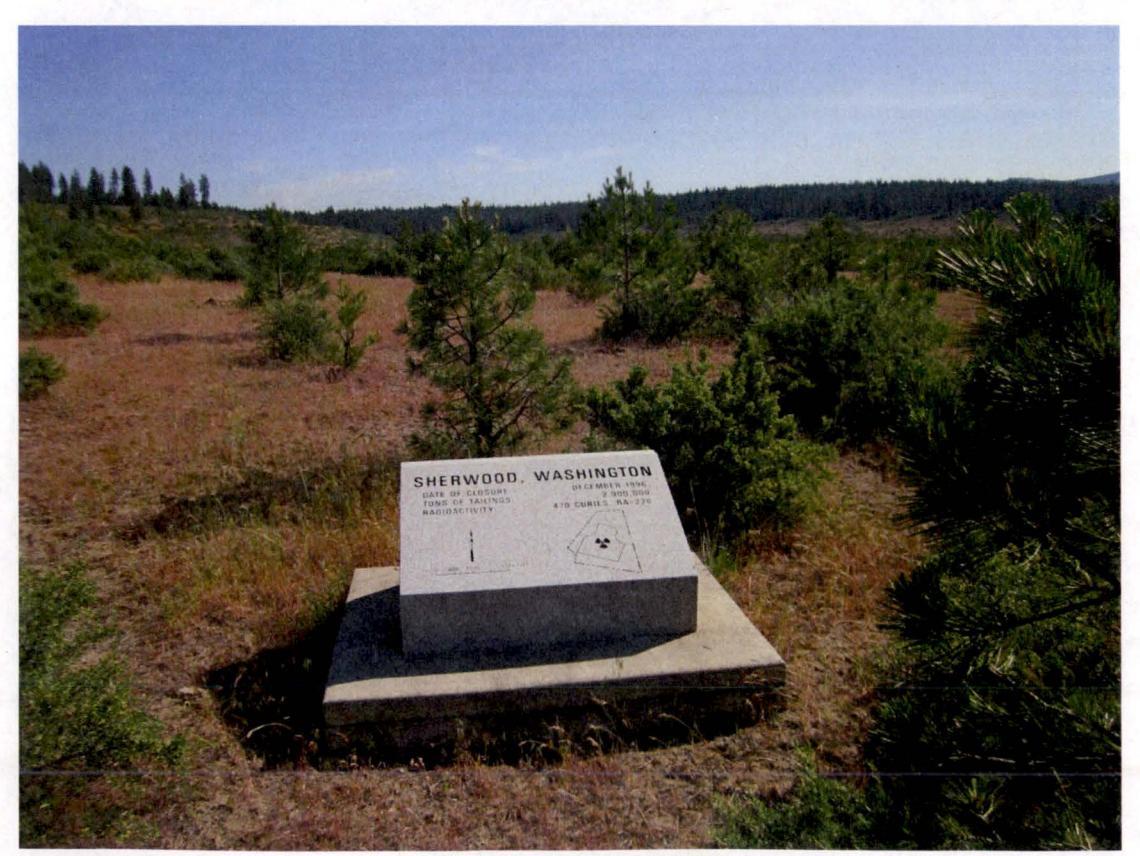
One granite site marker is present on the southwest side of the site where the access road lies closest to the site boundary. Site marker was stable and legible. No maintenance needs were identified (PL-2).

PL-2. Granite Site Marker

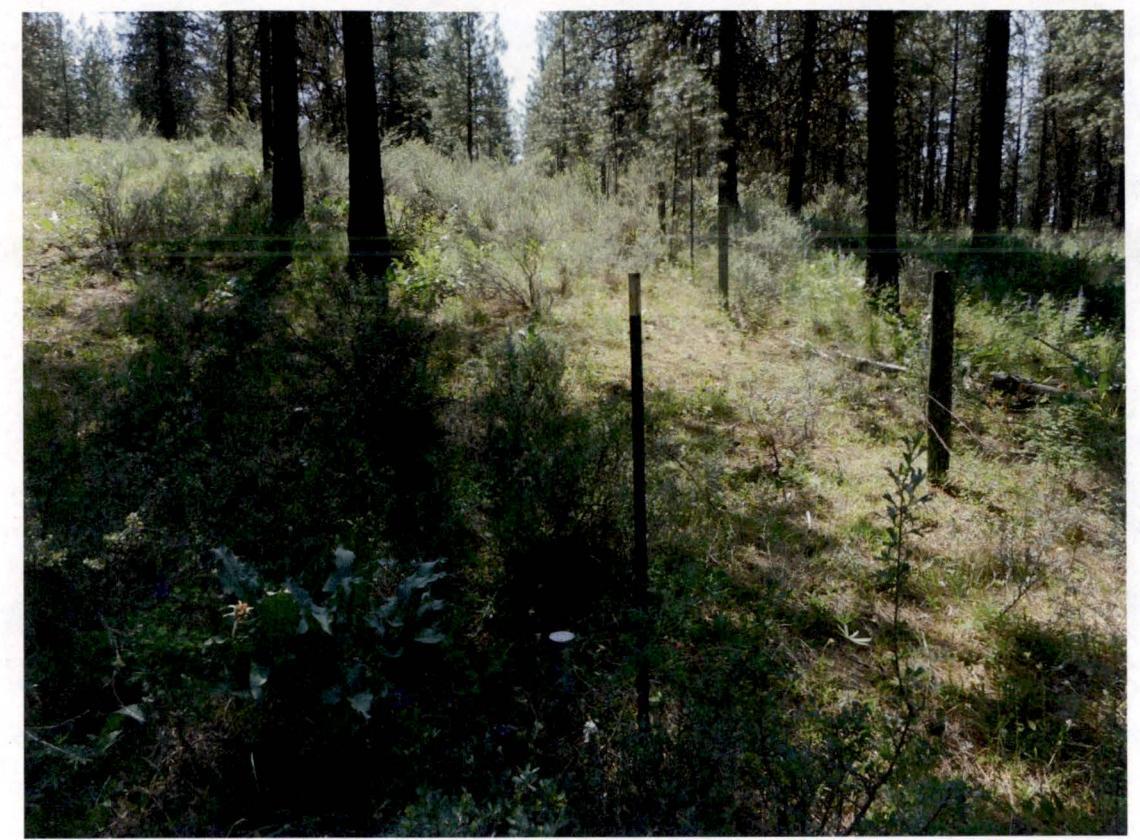
Six boundary monuments set in concrete define the site boundary (PL-3). Boundary monument BM-3A, near the granite site marker, is bent but does not need to be repaired. Because surrounding vegetation had made it difficult to locate some of the monuments, metal t-posts were installed at each monument location. All boundary monuments were verified to be present and stable during the 2016 inspection (PL-3).

PL-3. Boundary Monument BM-1

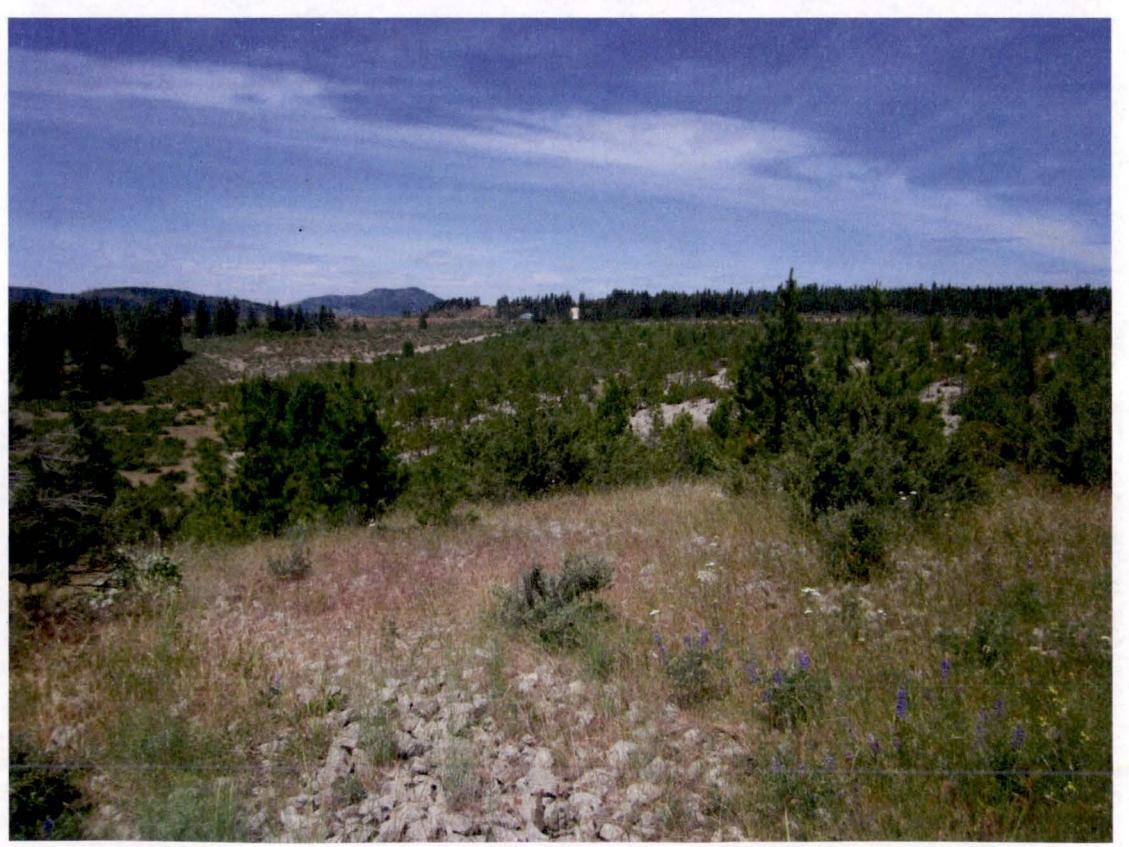
The tailings dam face has a rock cover consisting primarily of highly durable quartz monzonite. The face was designed to allow a vegetated cover, including mature trees, to establish and stabilize the surface and prevent erosion. Consequently, the presence of this vegetation does not harm the function of the dam, and the dam will not be compromised if the rock cover eventually degrades. The dam face is thickly vegetated (PL-6).

PL-6. Face of Tailings Dam, View to West
