Subject: 2016 Annual Site Inspection and Monitoring Report for Uranium Mill Tailings Radiation Control Act Title II Disposal Sites

2016 Annual Site Inspection and Monitoring Report for Uranium Mill Tailings Radiation Control Act Title II Disposal Sites

November 2016

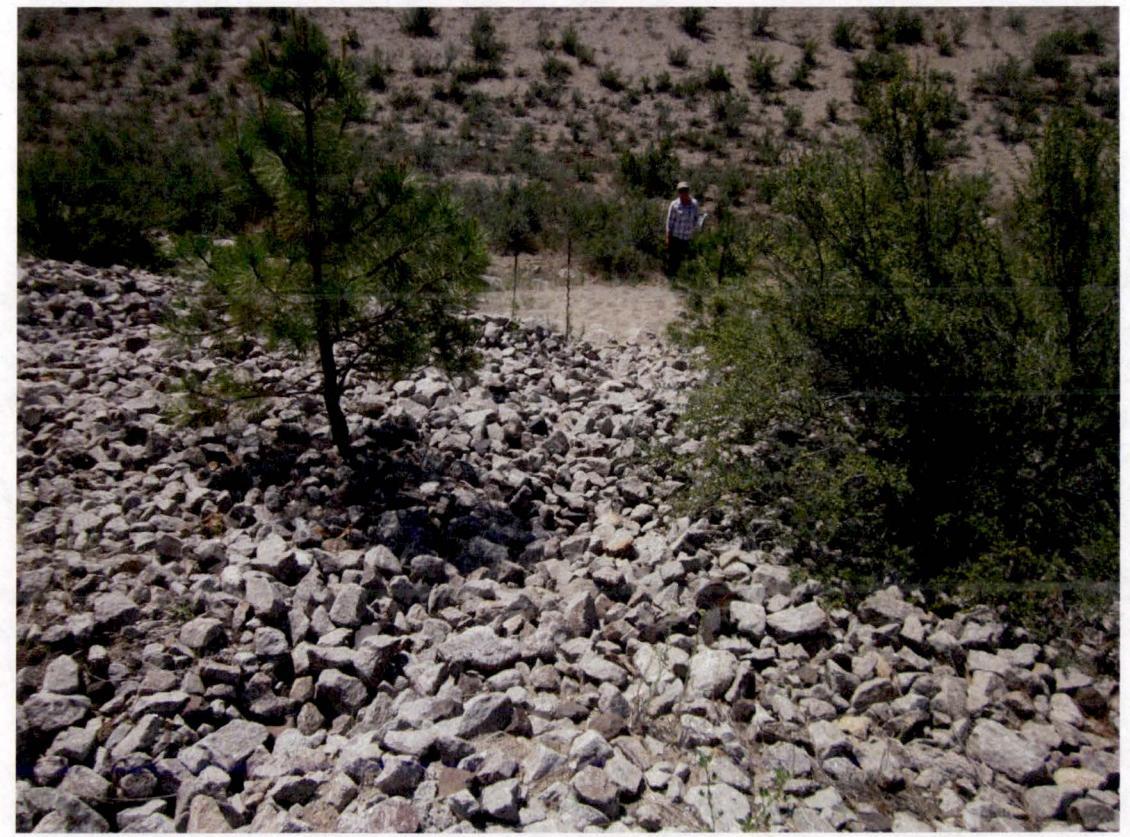
PL-8. Erosion at Base of Dam, View to Southwest

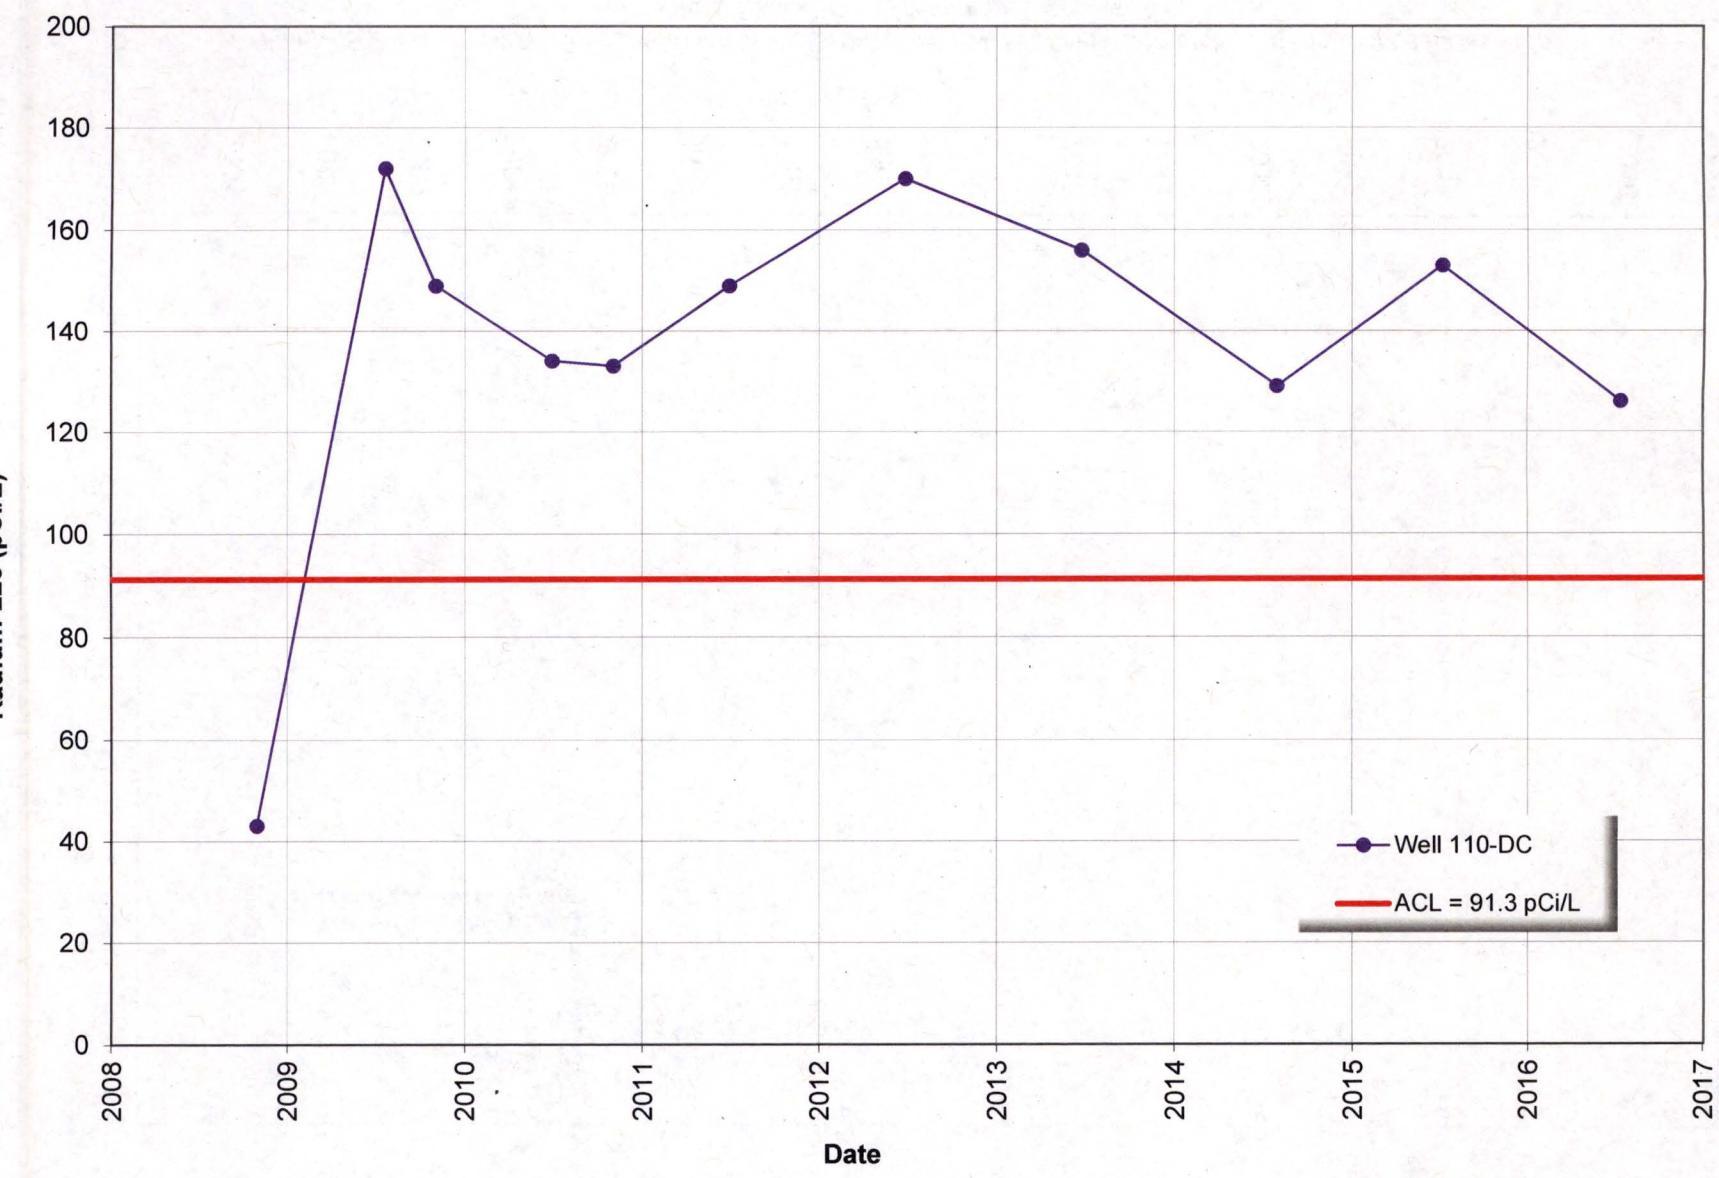
Figure 6-3. Radium-226 Concentrations in Well 110-DC at the Shirley Basin South, Wyoming, Disposal Site

The concentration of cadmium in well 5-SC remained less than the ACL as it has since 2005. Radium-228 continued to exceed the ACL in both wells 54-SC and well 5-DC (Figure 6-2). Additionally, the ACL for radium-226 continues to be exceeded in well 110-DC (Figure 6-3).

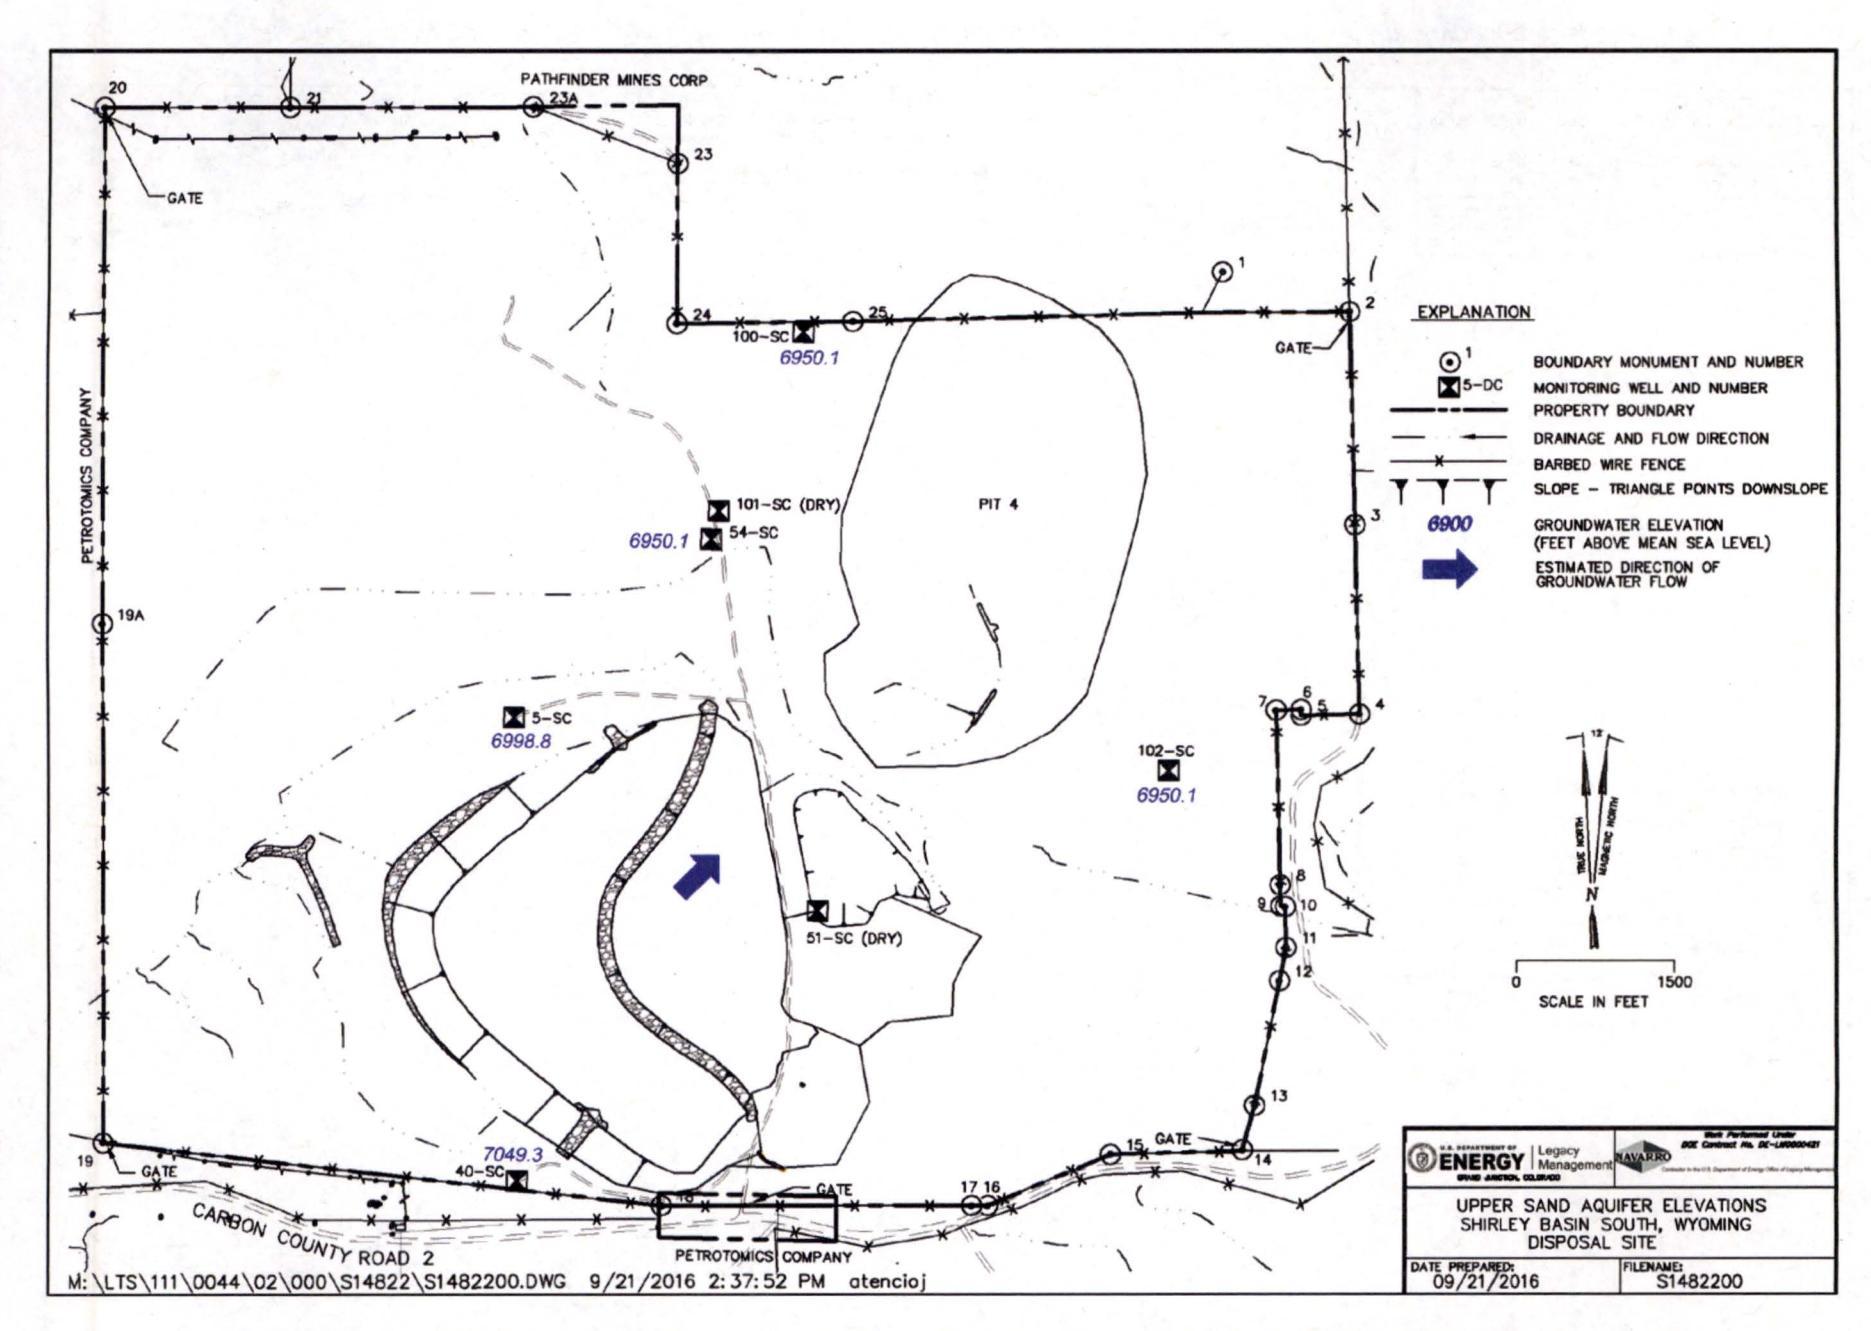
Figure 6-8. July 2016 Groundwater Elevations in the Upper Sand Aquifer at the Shirley Basin South, Wyoming, Disposal Site

Water-level elevations for the upper sand aquifer are shown on Figure 6-8. Water levels are increasing in wells 100-SC and 102-SC, but they are remaining constant in the other upper sand aquifer wells. The apparent flow direction is to the northeast, along the formation dip and toward Pit 4. The dry wells (51-SC and 101-SC) indicate that the upper sand aquifer has not recovered in the vicinity of Pit 4. Because the aquifer is no longer confined at the Pit 4 location, and because the flooded open-pit mine on the Ur-Energy property downgradient of the Shirley Basin South site might be a groundwater sink, aquifer water levels on the Shirley Basin South site might never recover to their pre-mining elevations.

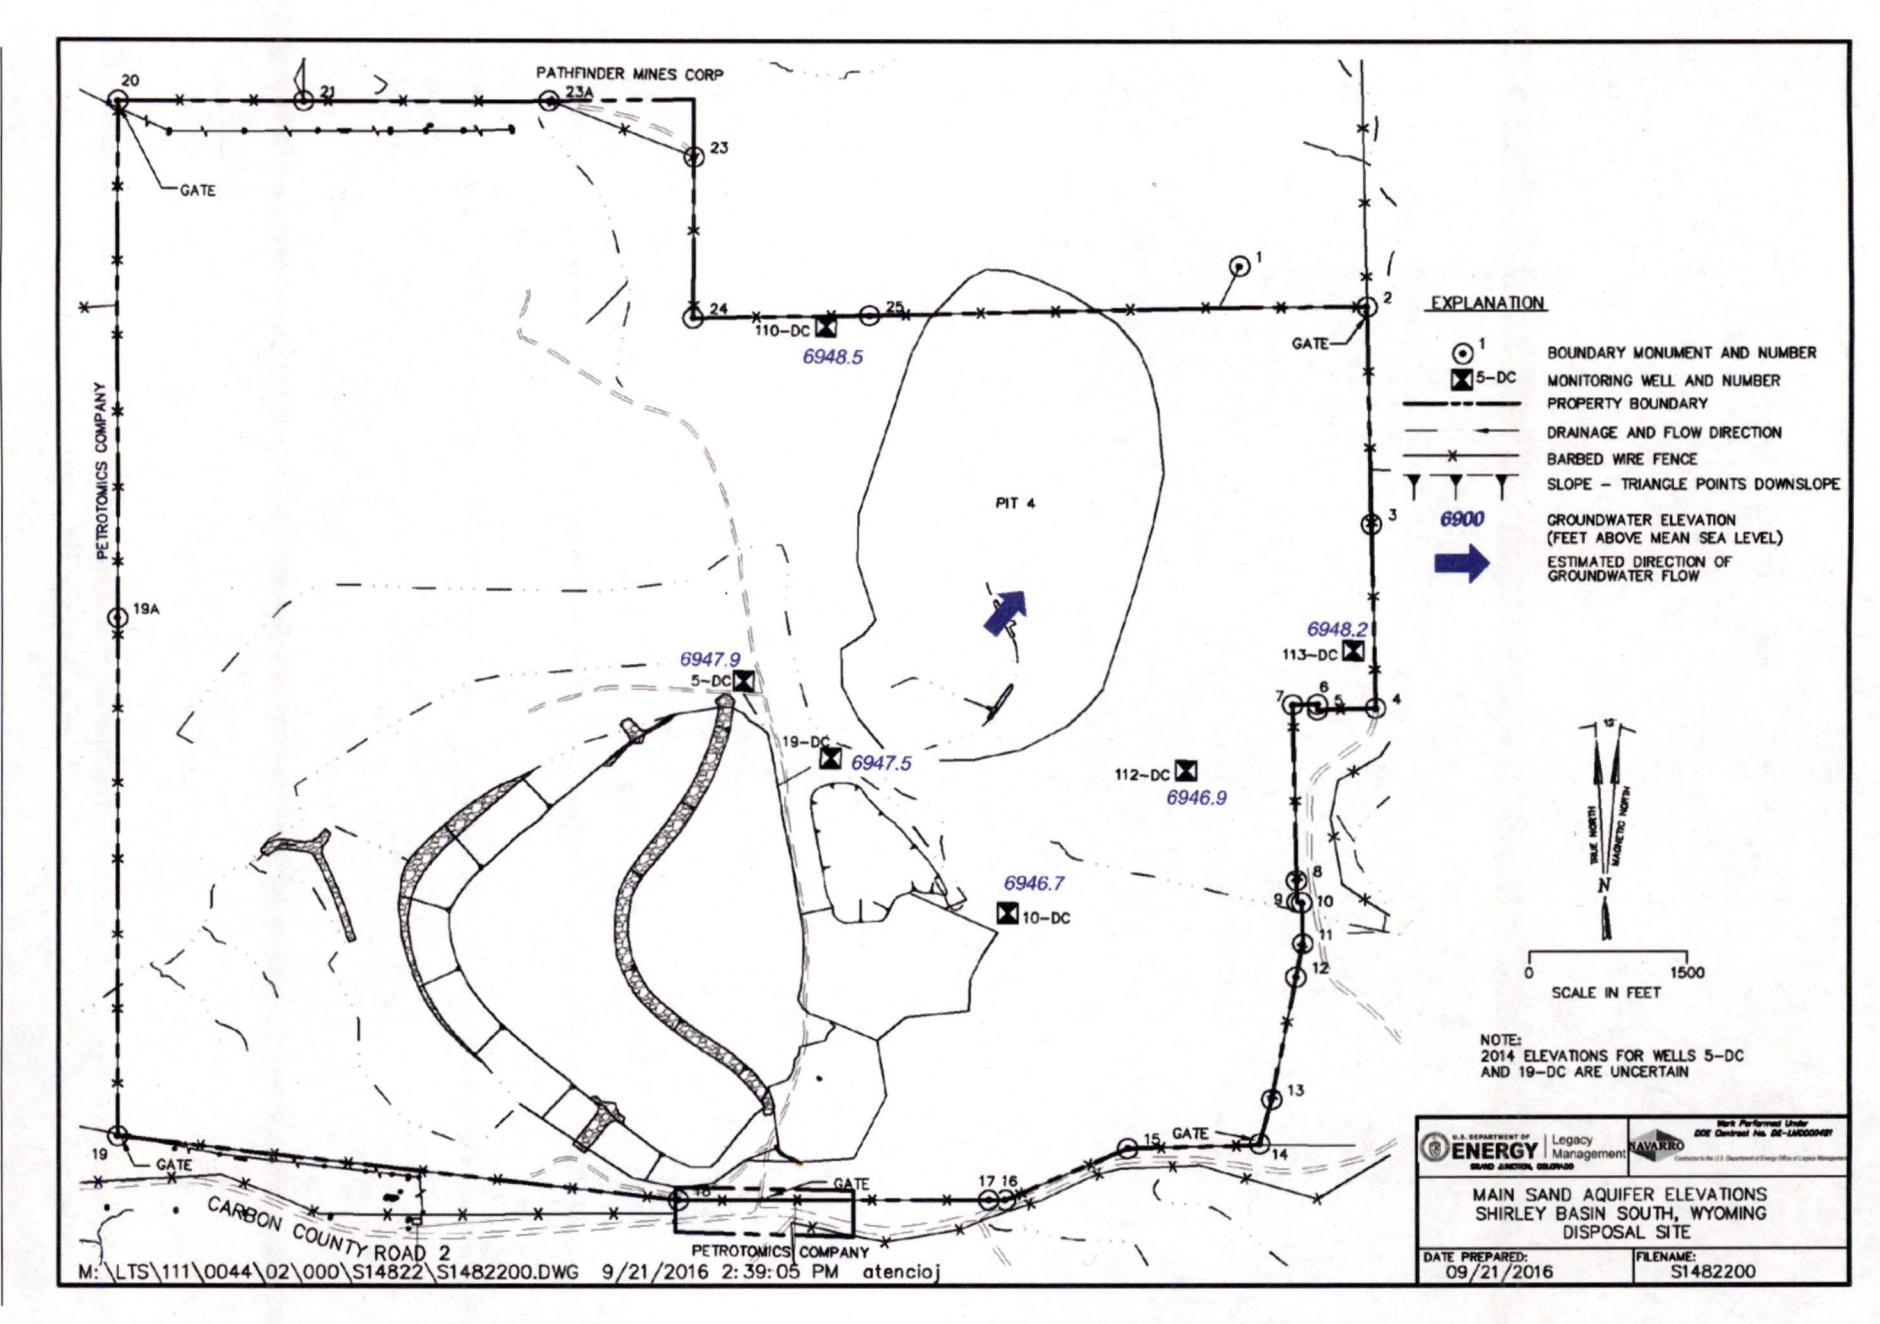
Figure 6-9. July 2016 Groundwater Elevations in the Main Sand Aquifer at the Shirley Basin South, Wyoming, Disposal Site

Main sand aquifer water elevations, shown on Figure 6-9, have been gradually rising at all wells since 2000, with an average rate of increase of approximately 0.7 foot per year since DOE began monitoring water levels in 2005 (Figure 6-10). The rising levels indicate a gradual recovery of the aquifer. However, the altered conditions at Pit 4 might prevent a return to pre-mining elevations of the water table. Also, the water surface elevation of the downgradient pit lake on the adjacent Ur-Energy property might control the surface elevation of the aquifers on the Shirley Basin South site. Groundwater flow is generally toward the northeast.

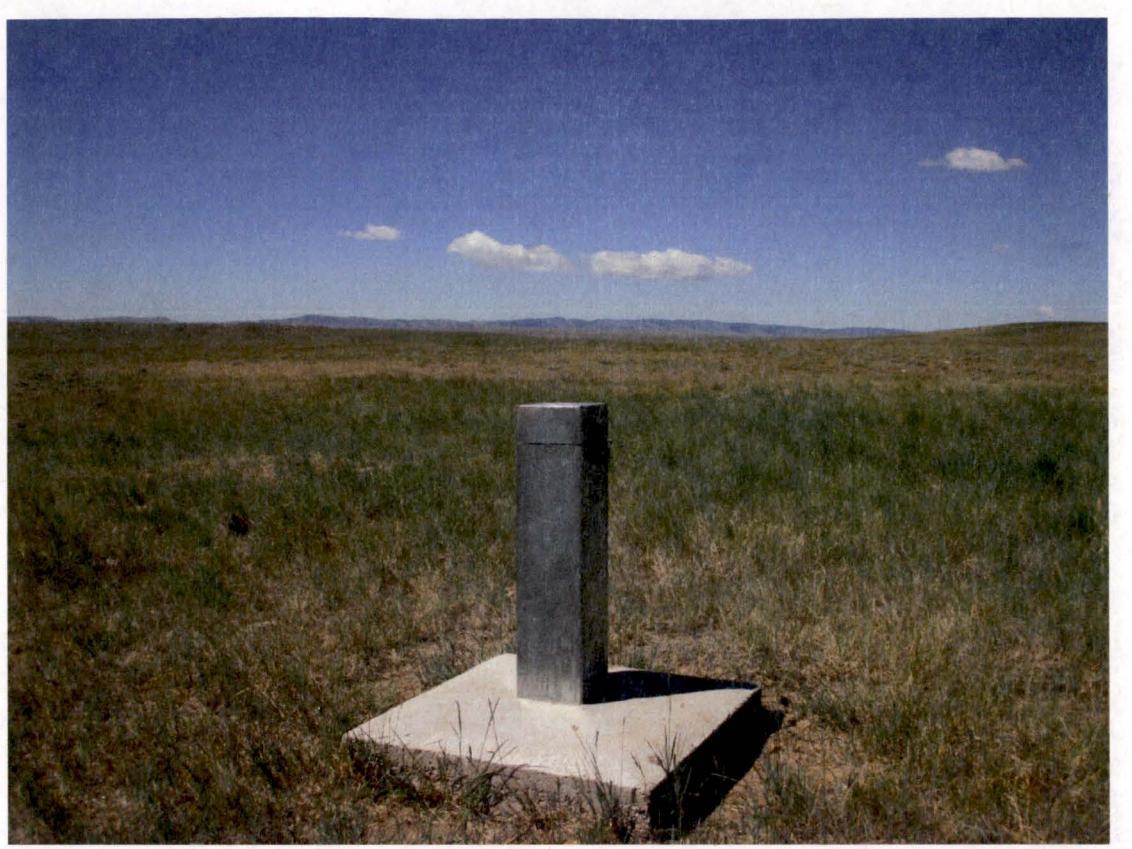
The site groundwater monitoring network consists of 14 wells; six of these wells were installed downgradient of the disposal cell in the fall of 2008. The wellhead protectors were undamaged and locked (PL-5). No maintenance needs were identified.

PL-5. Monitoring Well 113-DC
