BREAKWATER DAMAGE BY SEVERE  
STORM WAVES AND TSUNAMI WAVES

Robert L. Wiegel

5 March 1982

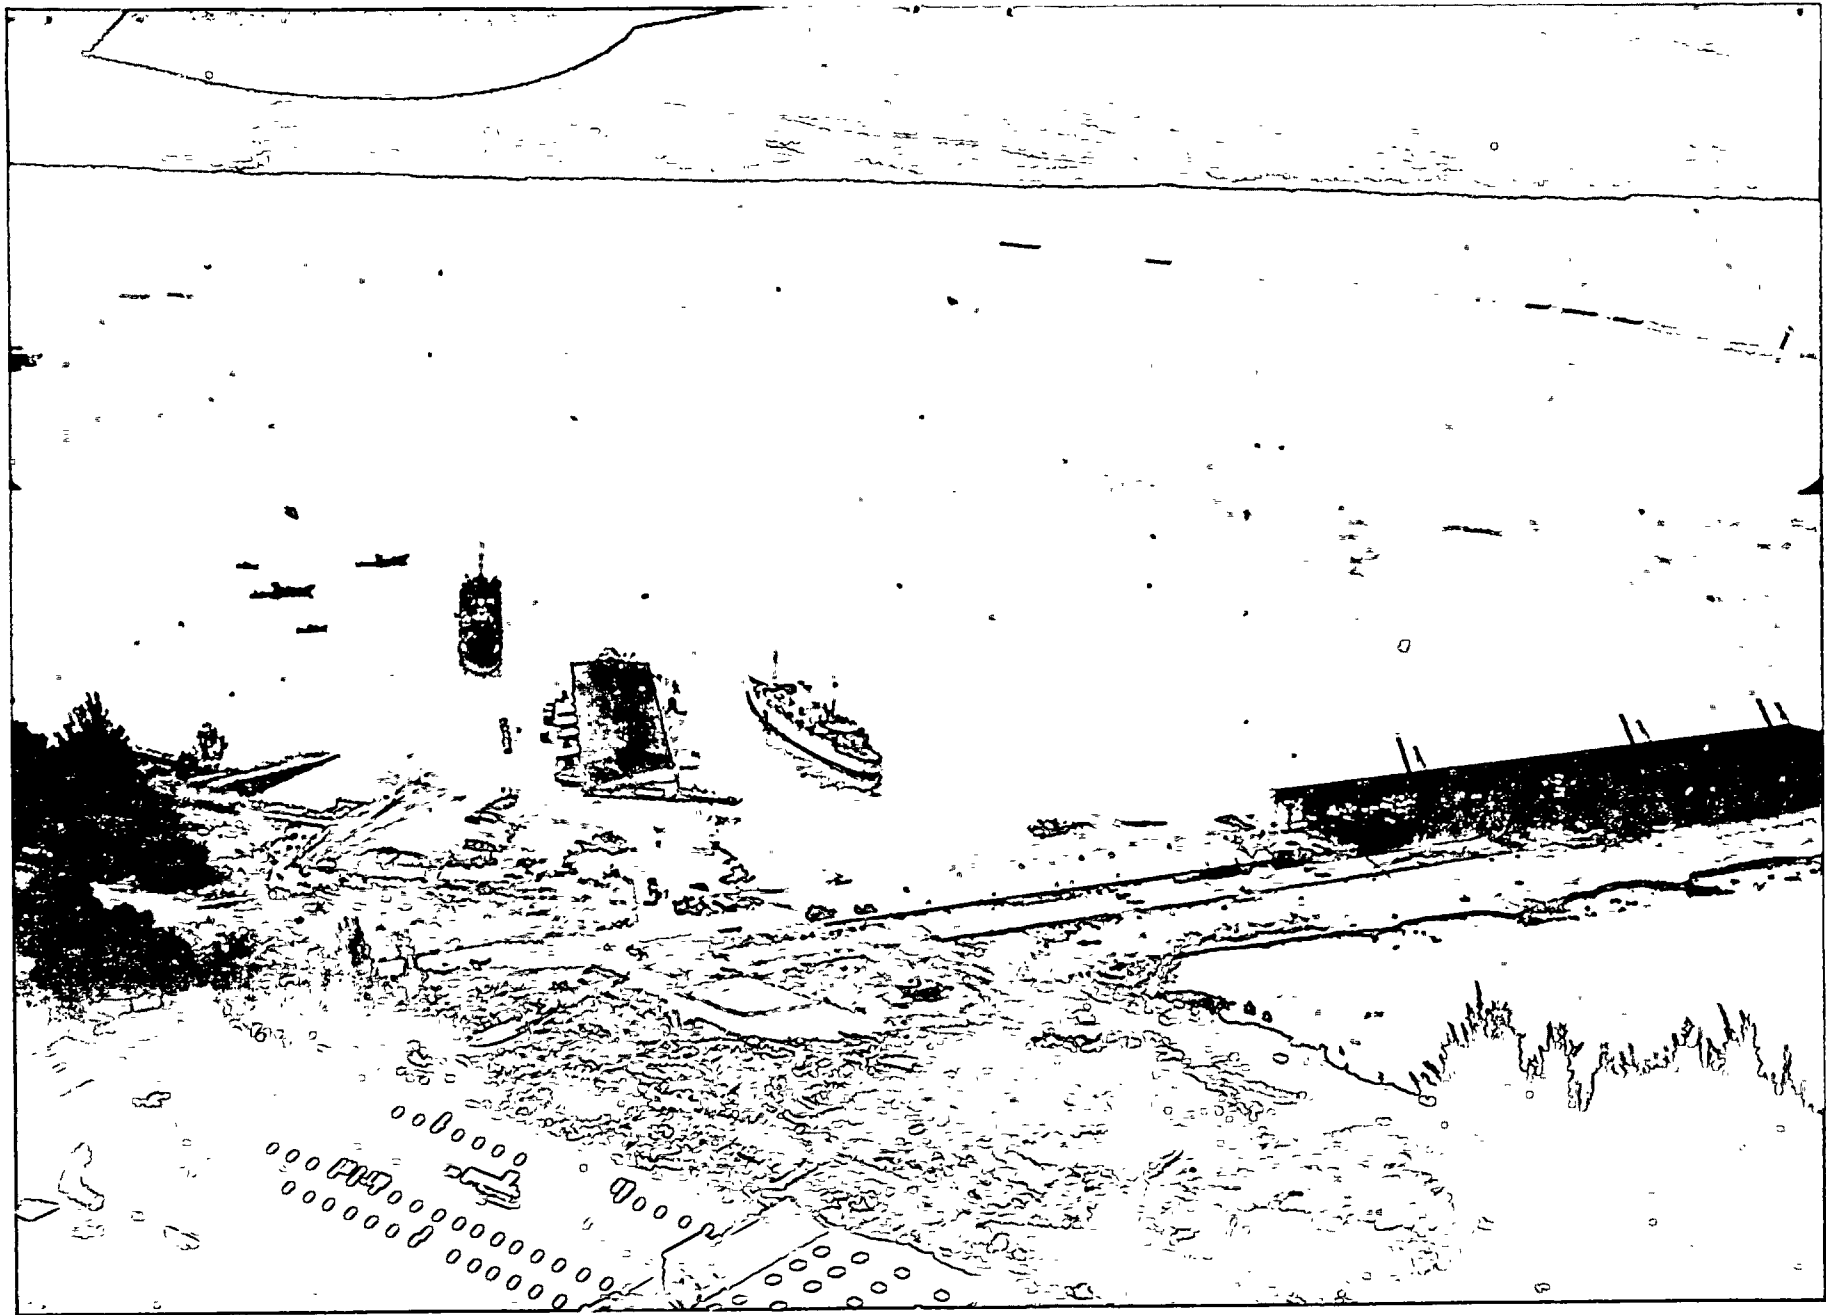
Figure 2. Breakwater and port at Hilo, Hawaii after the 1 April 1946 tsunami

Another view of the damaged breakwater is shown in Figure 2.

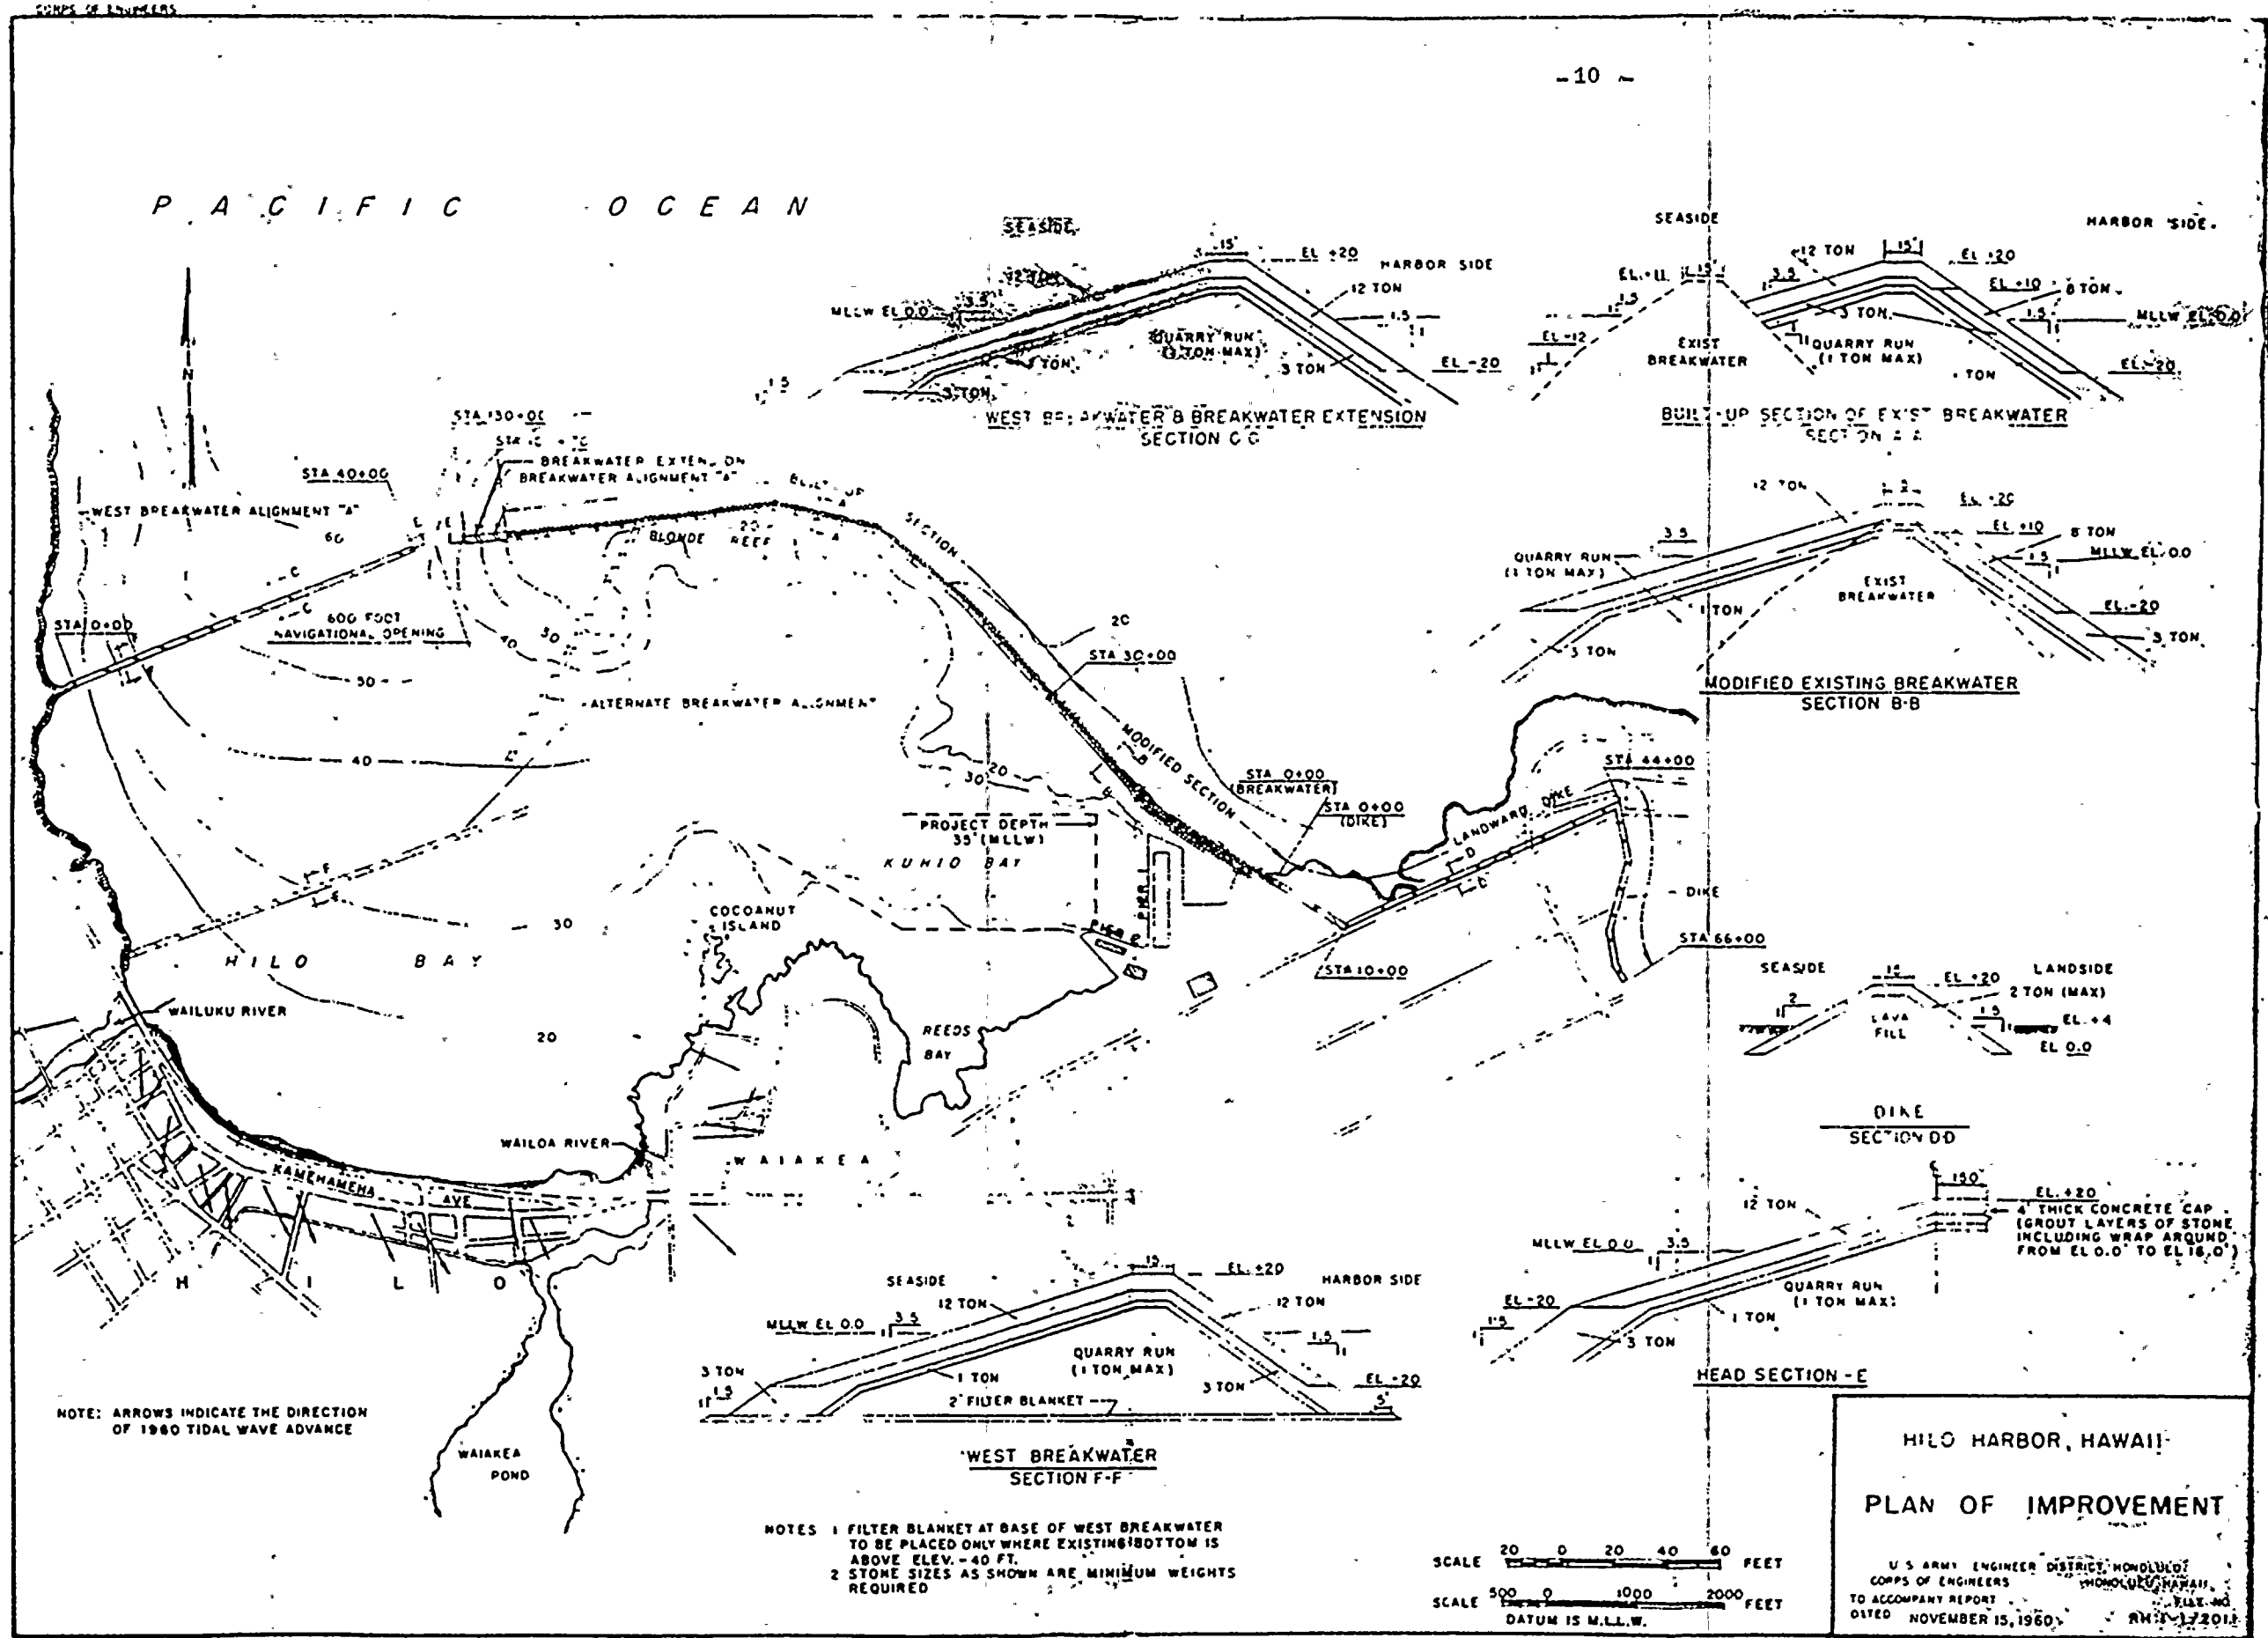
FIGURE 3

Two cross sections of the "existing" breakwater (1960) and proposed modified cross sections are shown in Figure 3 (which is from their Plate A-1, following page A-24).

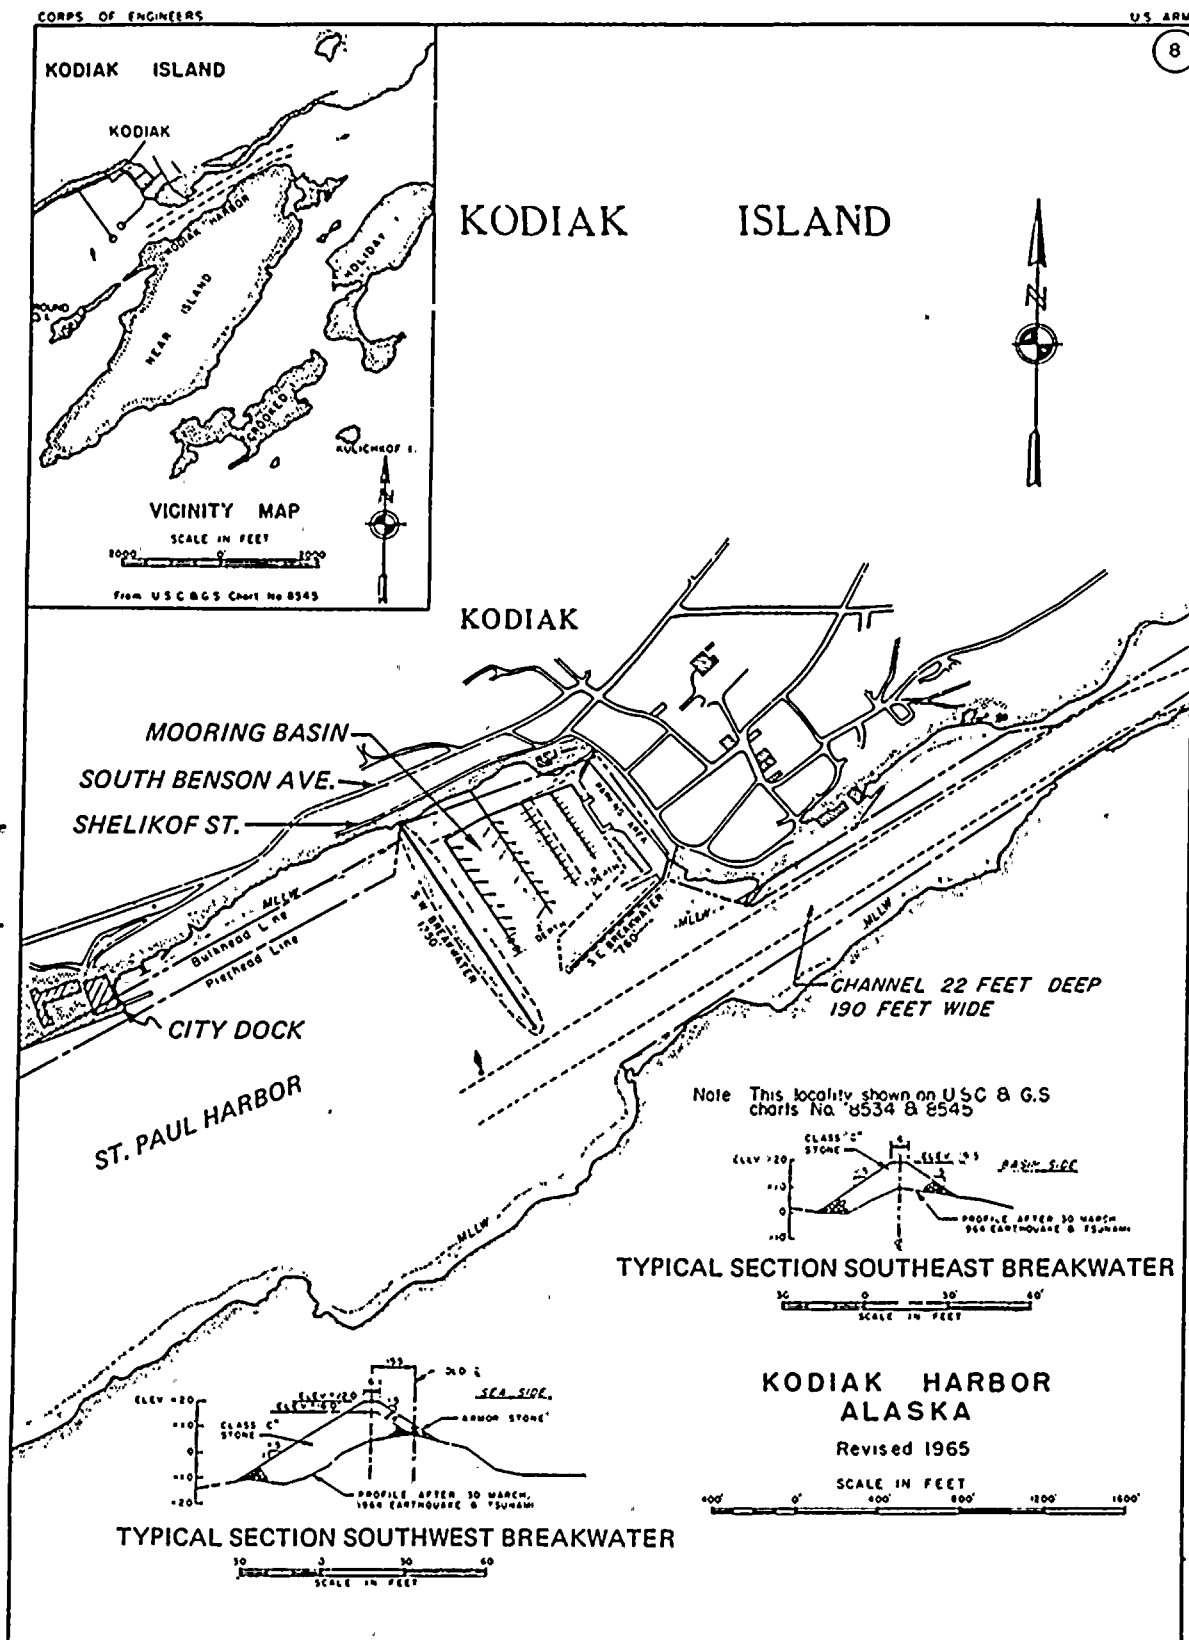
"The damage to the breakwater was due partly to compaction settlement caused by the tremors and partly to the tsunami. Figure [4c] shows typical sections of the breakwaters as they were measured after the earthquake, as well as cross sections of the rebuilt breakwaters. The weight of the cover-layer stones and the core material of the breakwater are not exactly known. However, as judged from Figure [4b], the armor stones were quite light and would have been incapable of resisting any great degree of overtopping.

Figure 4c Map of Kodiak City and harbor with details of the breakwaters.  
(From Wilson and Torum, 1972)

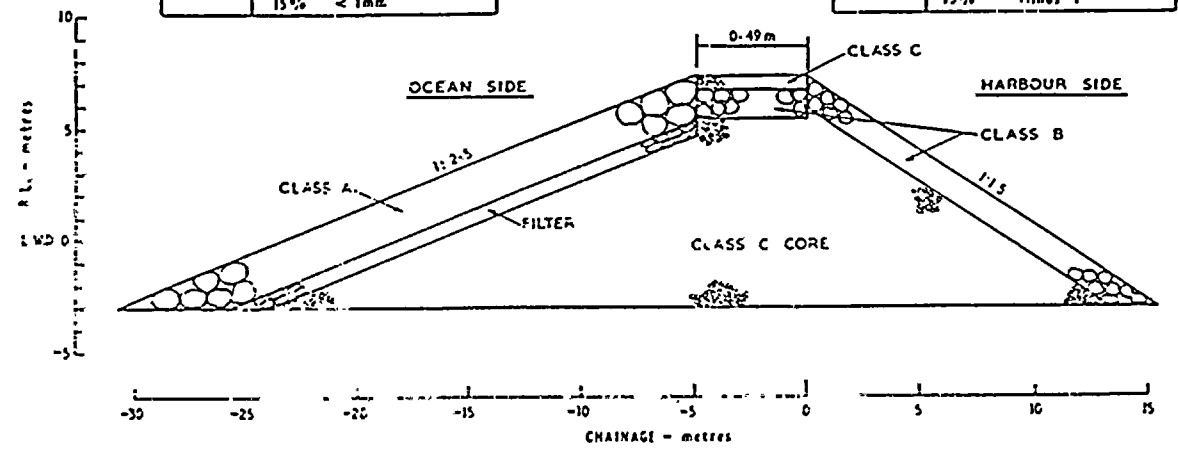
**FIGURE 8** TYPICAL CROSS SECTION OF BREAKWATER (From Foster, McGrath and Bremner, 1978)

- "(i) Failure occurred in a controlled manner with material being displaced from the crest and deposited on the leeward slope, forming a widened and lowered profile. The breakwater was composed of 3t nominal armour rock on the seaward face, 1/2 to 1 tonne filter rock and less than 150mm core material.
- (ii) Failure to the breakwater was closely simulated by model studies.
- (iii) Reconstruction of the breakwater was not commenced until 2-1/2 years after failure. During this period the breakwater acted as a submerged breakwater and continued to provide substantial wave protection within the harbour. Over this period waves of up to 1.8m height were experienced. All small boats continued to stay on their piled and bottom moorings and there was no damage to boats, moorings or shoreline revetments.

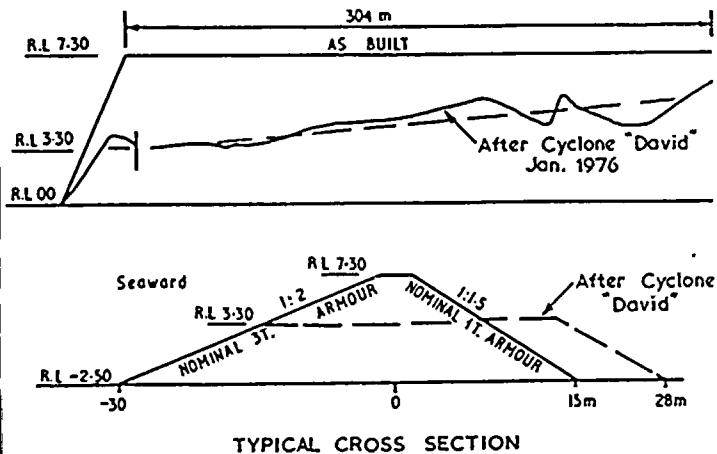
FIGURE 10 DAMAGE TO ROSSLYN BAY BREAKWATER BY CYCLONE DAVID

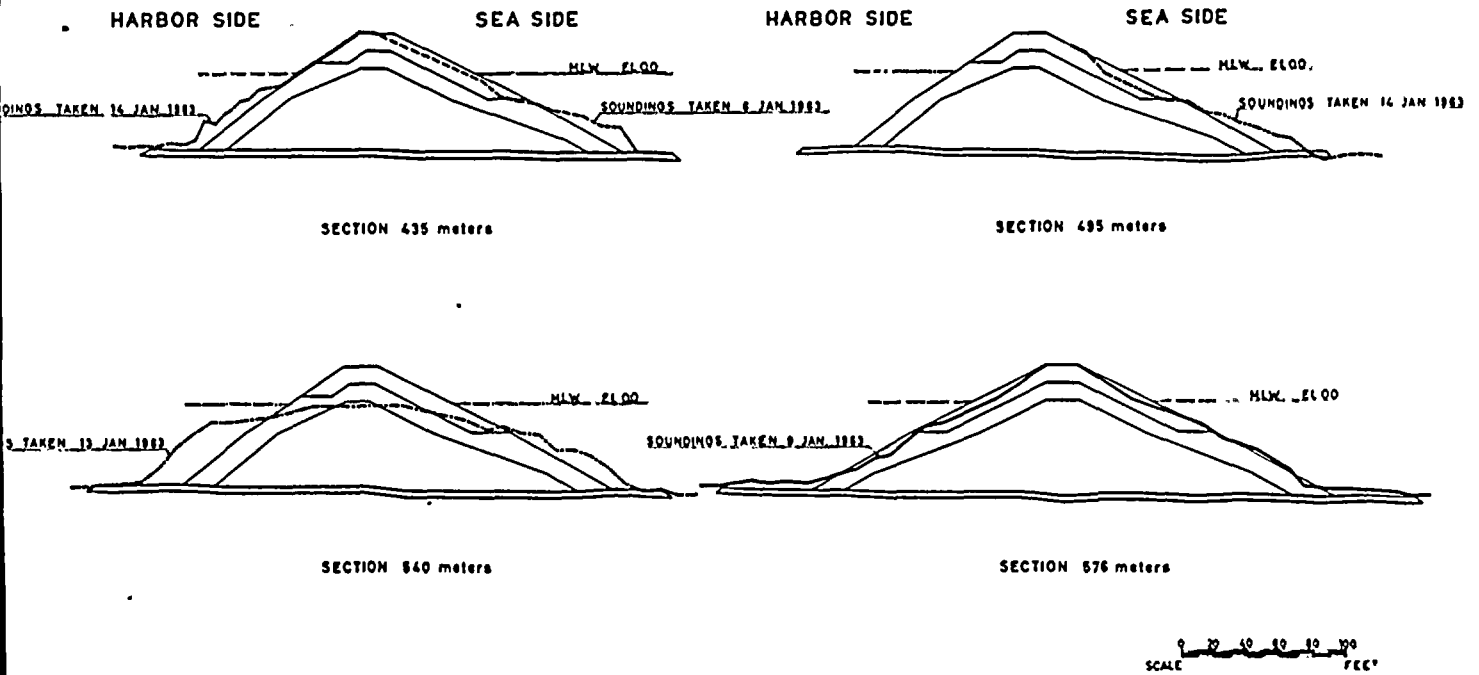
Figure 16 Breakwater sections after storm  
(From Reis de Carvalho, 1964)

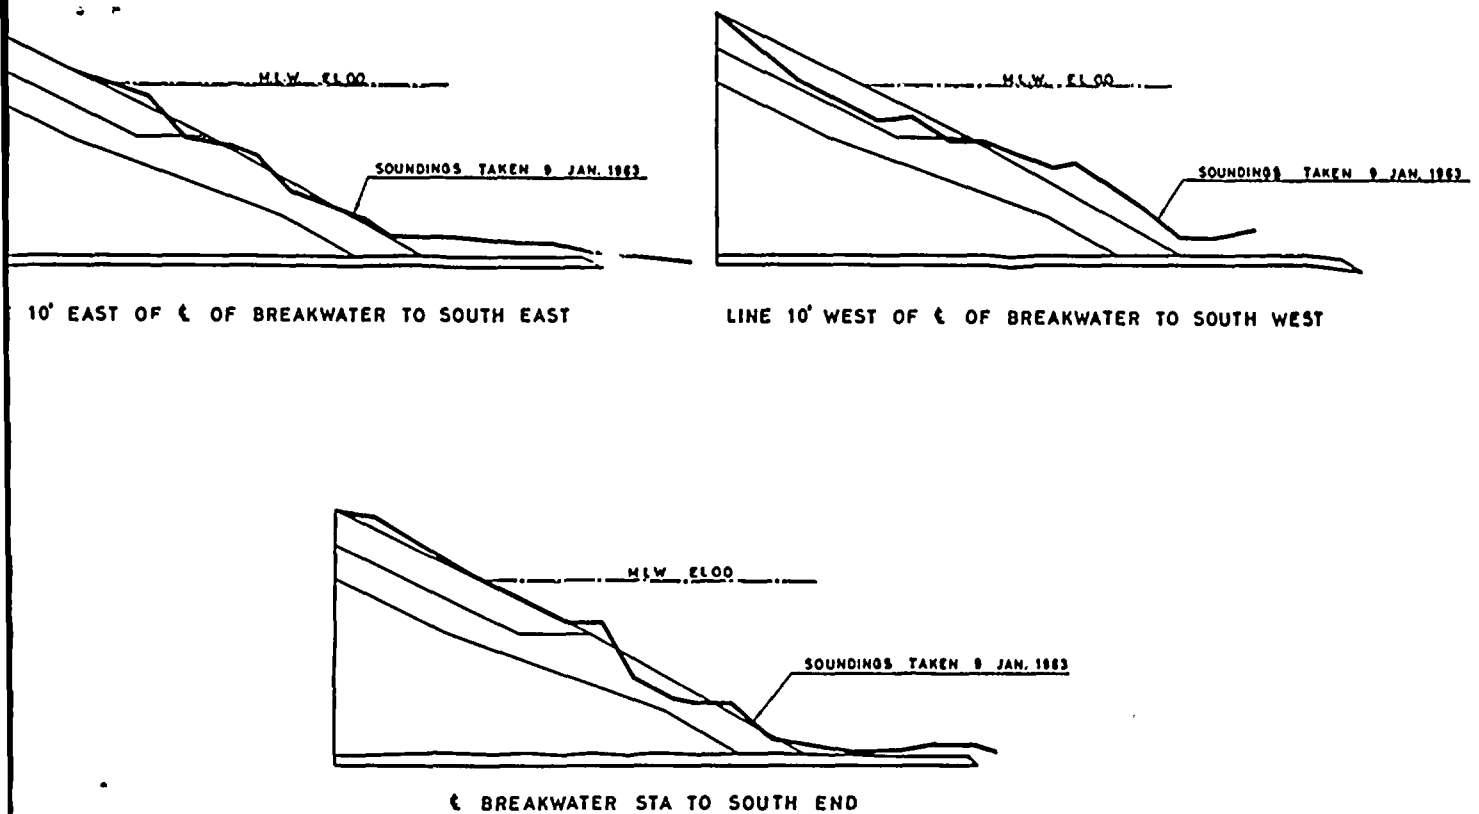
Figure 17 Breakwater sections after storm  
(From Reis de Carvalho, 1964)

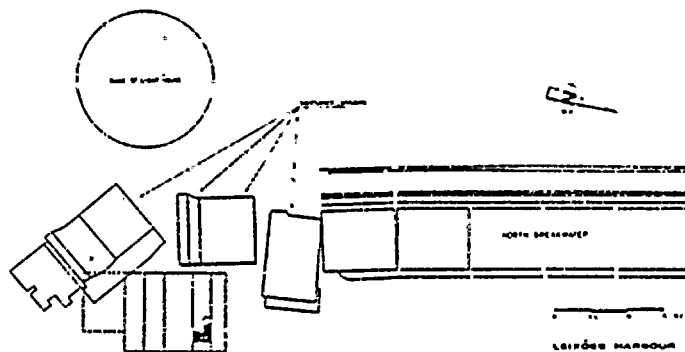
Figure 24. Damages at the head (Cont.)  
(From Morais and Abecassis, 1974)

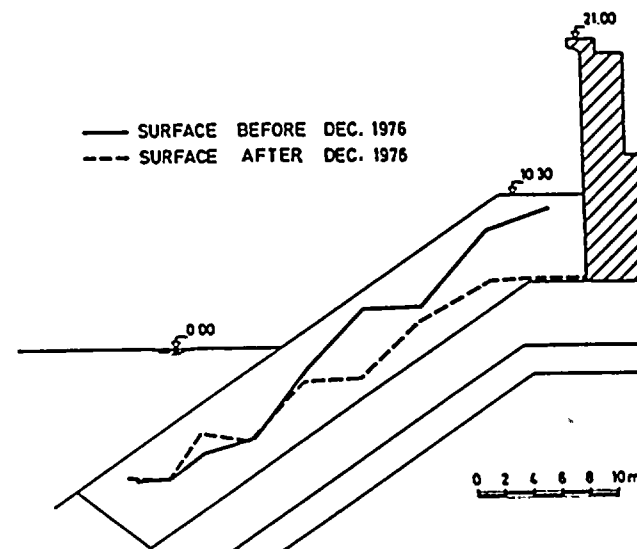
"The armour layer has been damaged twice since its construction. No repairs were made after the first damage in March 1976. During the storm 1-4 December 1976 the armour was further damaged and the wave screen was in places broken down. Profiles showing the surface of the armour layer before and after this second damage has been recorded. 14 different profiles recorded at 860 m to 2100 m from the nearshore end of the breakwater were recorded. In Table [2] the damage to the armour layer during the storm as well as the damage before the storm is presented for the individual cross sections. The definition of damage is given later on. Fig. [28] shows an example profile recorded 860 m from the nearshore end.

Figure 28. Armour layer profiles recorded 860 m from nearshore end of breakwater

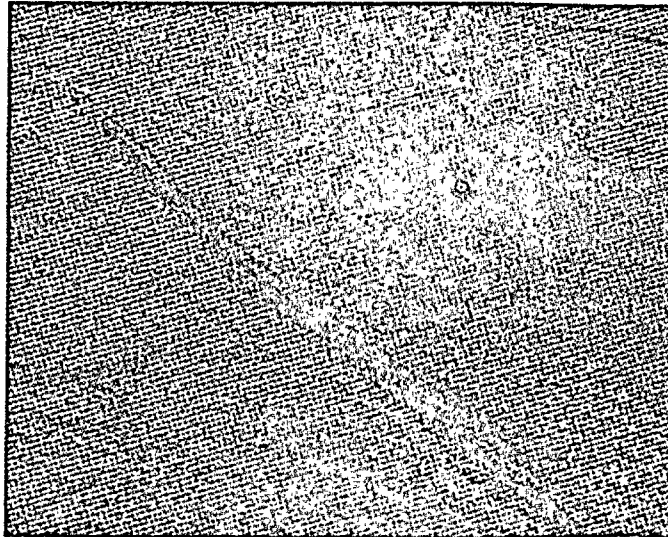
Figure 37. Jettied entrance to Humboldt Harbor and Bay during storm activity of February 1960. (From Magoon, Sloan and Foote, 1974)

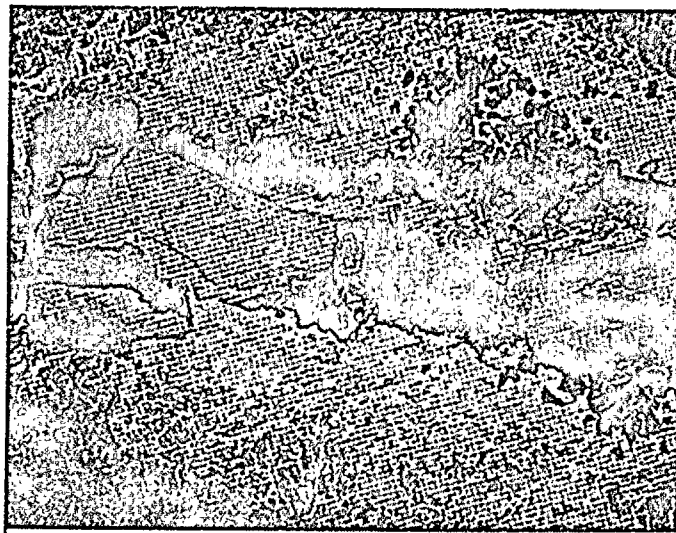
Figure 38. Monolithic breakup--Humboldt Harbor and Bay North Jetty. (From Magoon, Sloan and Foote, 1974)

an overhanging concrete mass shown in Figure 17.\* This subsequently collapsed, resulting in large broken pieces as shown in Figure [38]. In efforts to stabilize the heads of these structures, a great number of concrete blocks (see Figure 19\*) with maximum weights of 100 tons have been placed along the sides of the jetties. Essentially all of these blocks have been dislodged. Many of the blocks and supporting stones have been displaced landward and moved landward (see Figure 20\*).

"As described by Magoon and Shimizu, both the North and South Jetty heads have been repaired with 42 and 43-ton concrete dolosse armor units (see Figure 21\*). Most of these units are reinforced; however, as shown in Figure 22,\* unreinforced and fiber reinforced units have been placed at both the Humboldt jetties and at the Crescent City outer breakwater (see Figure 22\*). Based on the available inspections which do not include those units placed under water, about 12% of the unreinforced units are broken and none of the fiber reinforced units are broken."

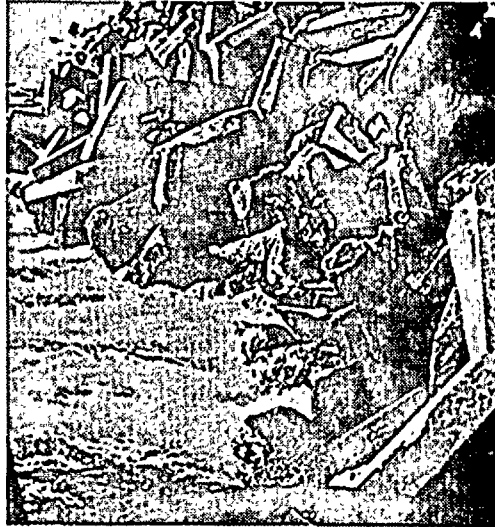
'It appears that the interaction of the focussed wave energy and the vertical caisson breakwater have caused a local concentrated attack on the rubble extension at the section indicated in the photographs.

'Model tests of the Gansbaai breakwaters have not simulated the prototype damage to the same extent and we can only conclude that the prototype failure was predominantly due to the fracture of the 17.1-ton units (0.3 stem ratio) and subsequent collapse of the profile.

Figure 45. Photo of damage at Gansbaai breakwater after storm of December 1977 (From Edge and Magoon, 1979)

'Field experience at this site as well as model studies have shown that repair of a fractured dolos slope is relatively unsuccessful, unless, either the fractured units are first removed, or the repair layer overlaps the stable layers on either side of the damaged portion.

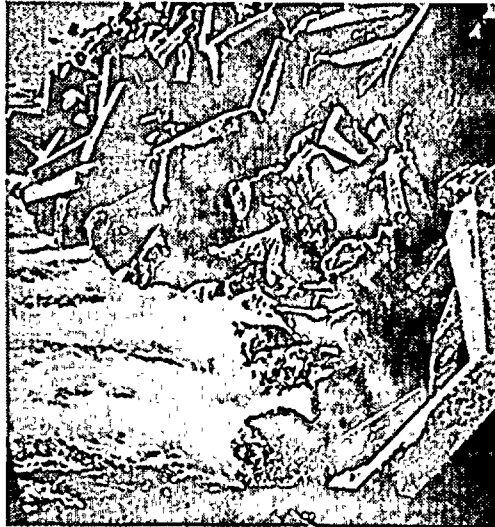
'It appears that the interaction of the focussed wave energy and the vertical caisson breakwater have caused a local concentrated attack on the rubble extension at the section indicated in the photographs.

'Model tests of the Gansbaai breakwaters have not simulated the prototype damage to the same extent and we can only conclude that the prototype failure was predominantly due to the fracture of the 17.1-ton units (0.3 stem ratio) and subsequent collapse of the profile.

Figure 45. Photo of damage at Gansbaai breakwater after storm of December 1977 (From Edge and Magoon, 1979)

'Field experience at this site as well as model studies have shown that repair of a fractured dolos slope is relatively unsuccessful, unless, either the fractured units are first removed, or the repair layer overlaps the stable layers on either side of the damaged portion.

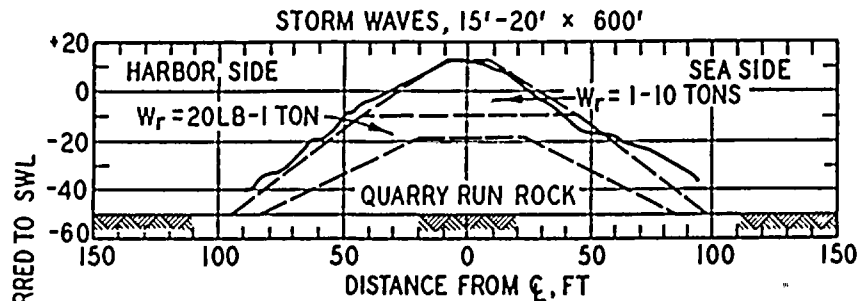
"Comparisons of prototype and model damage are shown in Figures [46] and [47]. The prototype section with minimum damage is compared with the model section tested using 15-ft waves, and the prototype section with maximum damage is compared with the model section tested using 21-ft waves. It is seen that the disposition of the armor units and the final shape of the damaged prototype structure are similar to that obtained in the model tests. However, the amount of breakwater material displaced was greater in the model than in the prototype. With the data available, it was impossible to make the comparisons, model to prototype, for identical wave conditions. However, the similarity of damages obtained is believed sufficient to show that model test results, if the model is properly designed, constructed, and operated and if the prototype structure is constructed correctly, can be relied upon to provide the basis for the design and construction of safe and efficient rubble-mound structures."

a. MINIMUM STORM DAMAGE TO BREAKWATER  
SAN PEDRO BAY, CALIF.

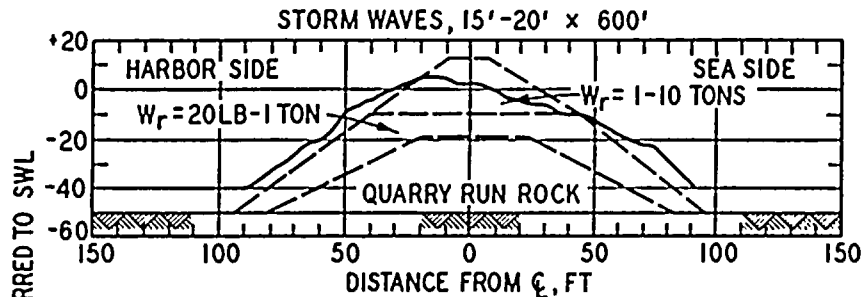
a. MAXIMUM STORM DAMAGE TO BREAKWATER  
SAN PEDRO BAY, CALIF.

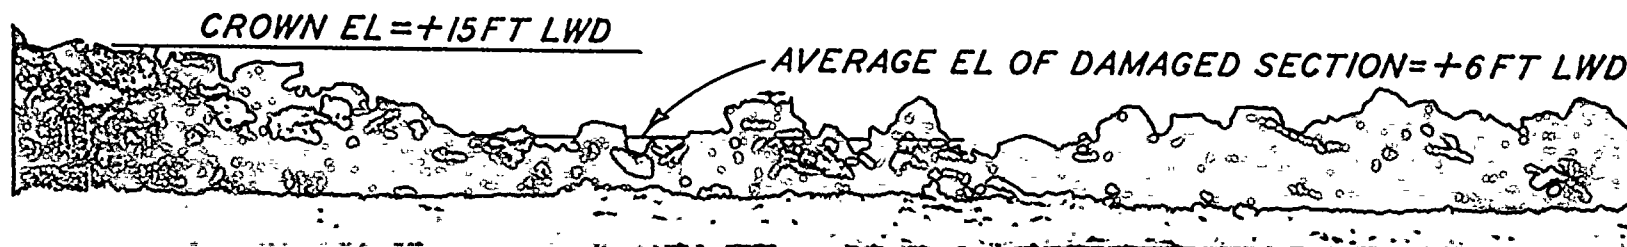
Tests were made using a hydraulic model of the rubble-mound breakwater located at Lake Superior at Silver Bay, Minnesota (Hudson, 1975). The breakwater was damaged by two storms. The first of these was on 10 May 1953 which occurred while the breakwater was still under construction, before the armor units had been placed. This will not be considered herein. The second storm occurred after completion of the breakwater, on 20 November 1953. The armor units were stones weighing from 10 to 14 tons, with a specific weight of 175 lbs/ft<sup>3</sup>. The design wave height was 14 feet. A typical cross section of the breakwater is shown in a photograph of the model test result in Figure 48a. A copy of a photo of the actual damage is shown in Figure 48b.

b. PROTOTYPE WAVE ATTACK, 20 NOV 1953  
DURATION = 11 HR  
WAVES INCRESCENT TO 15 FT IN HEIGHT

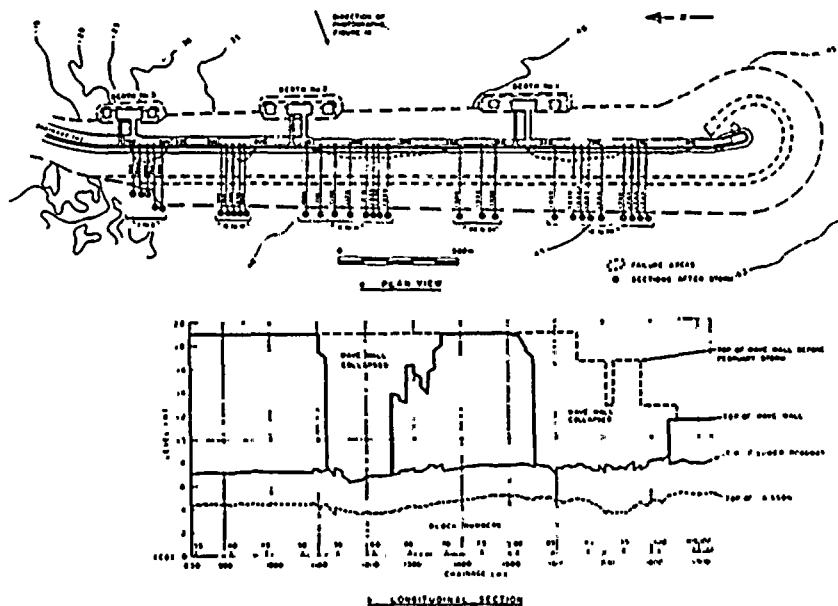
"After the storm, a survey was made of the damage, both above water (levels on wave wall, lower roadway and caisson tops, Fig. [51b]) and underwater (profiles, mainly of the damage areas, Fig. [51a]). The wave wall was seen to have collapsed completely over a distance of about 150m near Berth no. 2 and over a distance of 300m near Berth no. 1. In these sections no dolos armour was visible; in fact, near Berth no. 2, the dolos armour had disappeared over a total length of 250m (Fig. [53a]). In addition, there were two smaller areas between Berths nos. 2 and 3 where the dolosse had disappeared although there was no damage to the superstructure (Fig. [51a]).

Figure 51 Plan and longitudinal section of main breakwater after February 1978 storm (From Zwamborn, 1979)

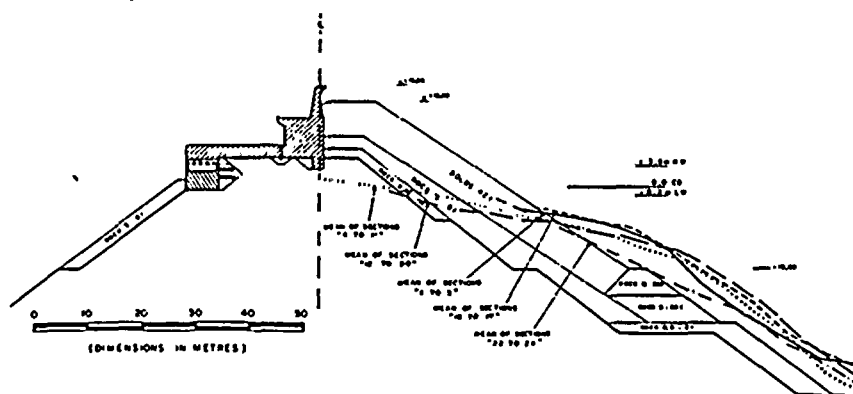
"The underwater profiles in the damage areas are remarkably similar. Mean profiles of the four failure areas, indicated in Fig. [51a], are shown in Fig. [52]. They all show an approximate slope of 1 in 5 to a depth of about -10m CD and 3 in 4, the original slope, below this level. Diver reports and underwater photography prove that virtually all dolosse in these areas were broken and the pieces mixed with underlayer and filter stone.

"The sections of the breakwater armour which did not fail show above water level, areas which suffered very little damage alternated by areas which were seriously damaged (Fig. [53b]). The section between chainages 1400 and 1500 (sections 22 to 24) shows a considerable loss of dolosse above water while the underwater profile indicates a buildup of material right down the slope (Fig. [52]).

Figure 52 Mean profiles after February 1978 storm (From Zwamborn, 1979)

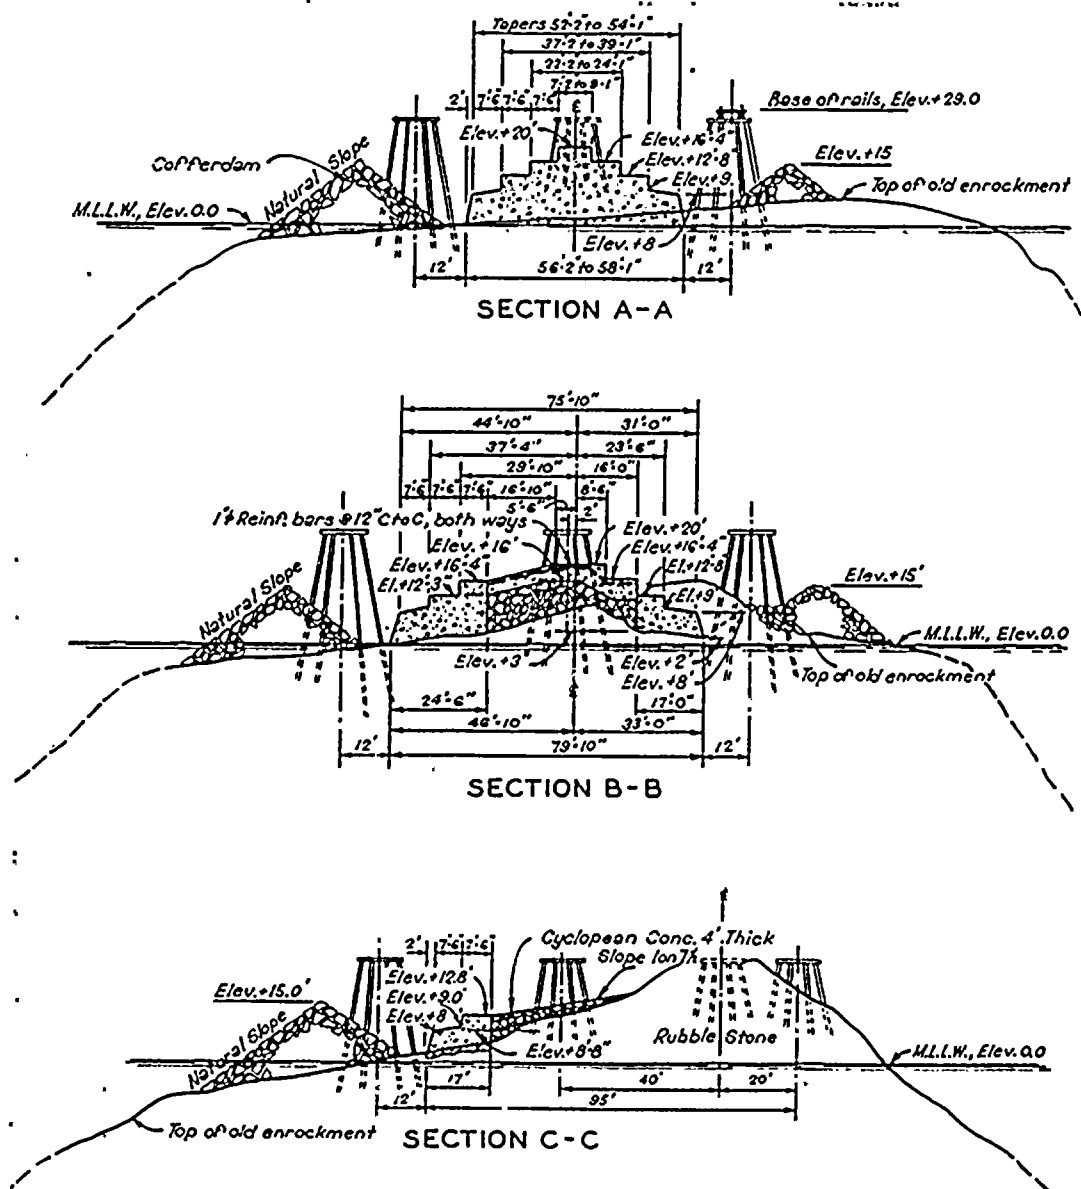
Figure 56

MOUTH OF COLUMBIA RIVER,  
OREGON AND WASHINGTON  
SOUTH JETTY TERMINAL

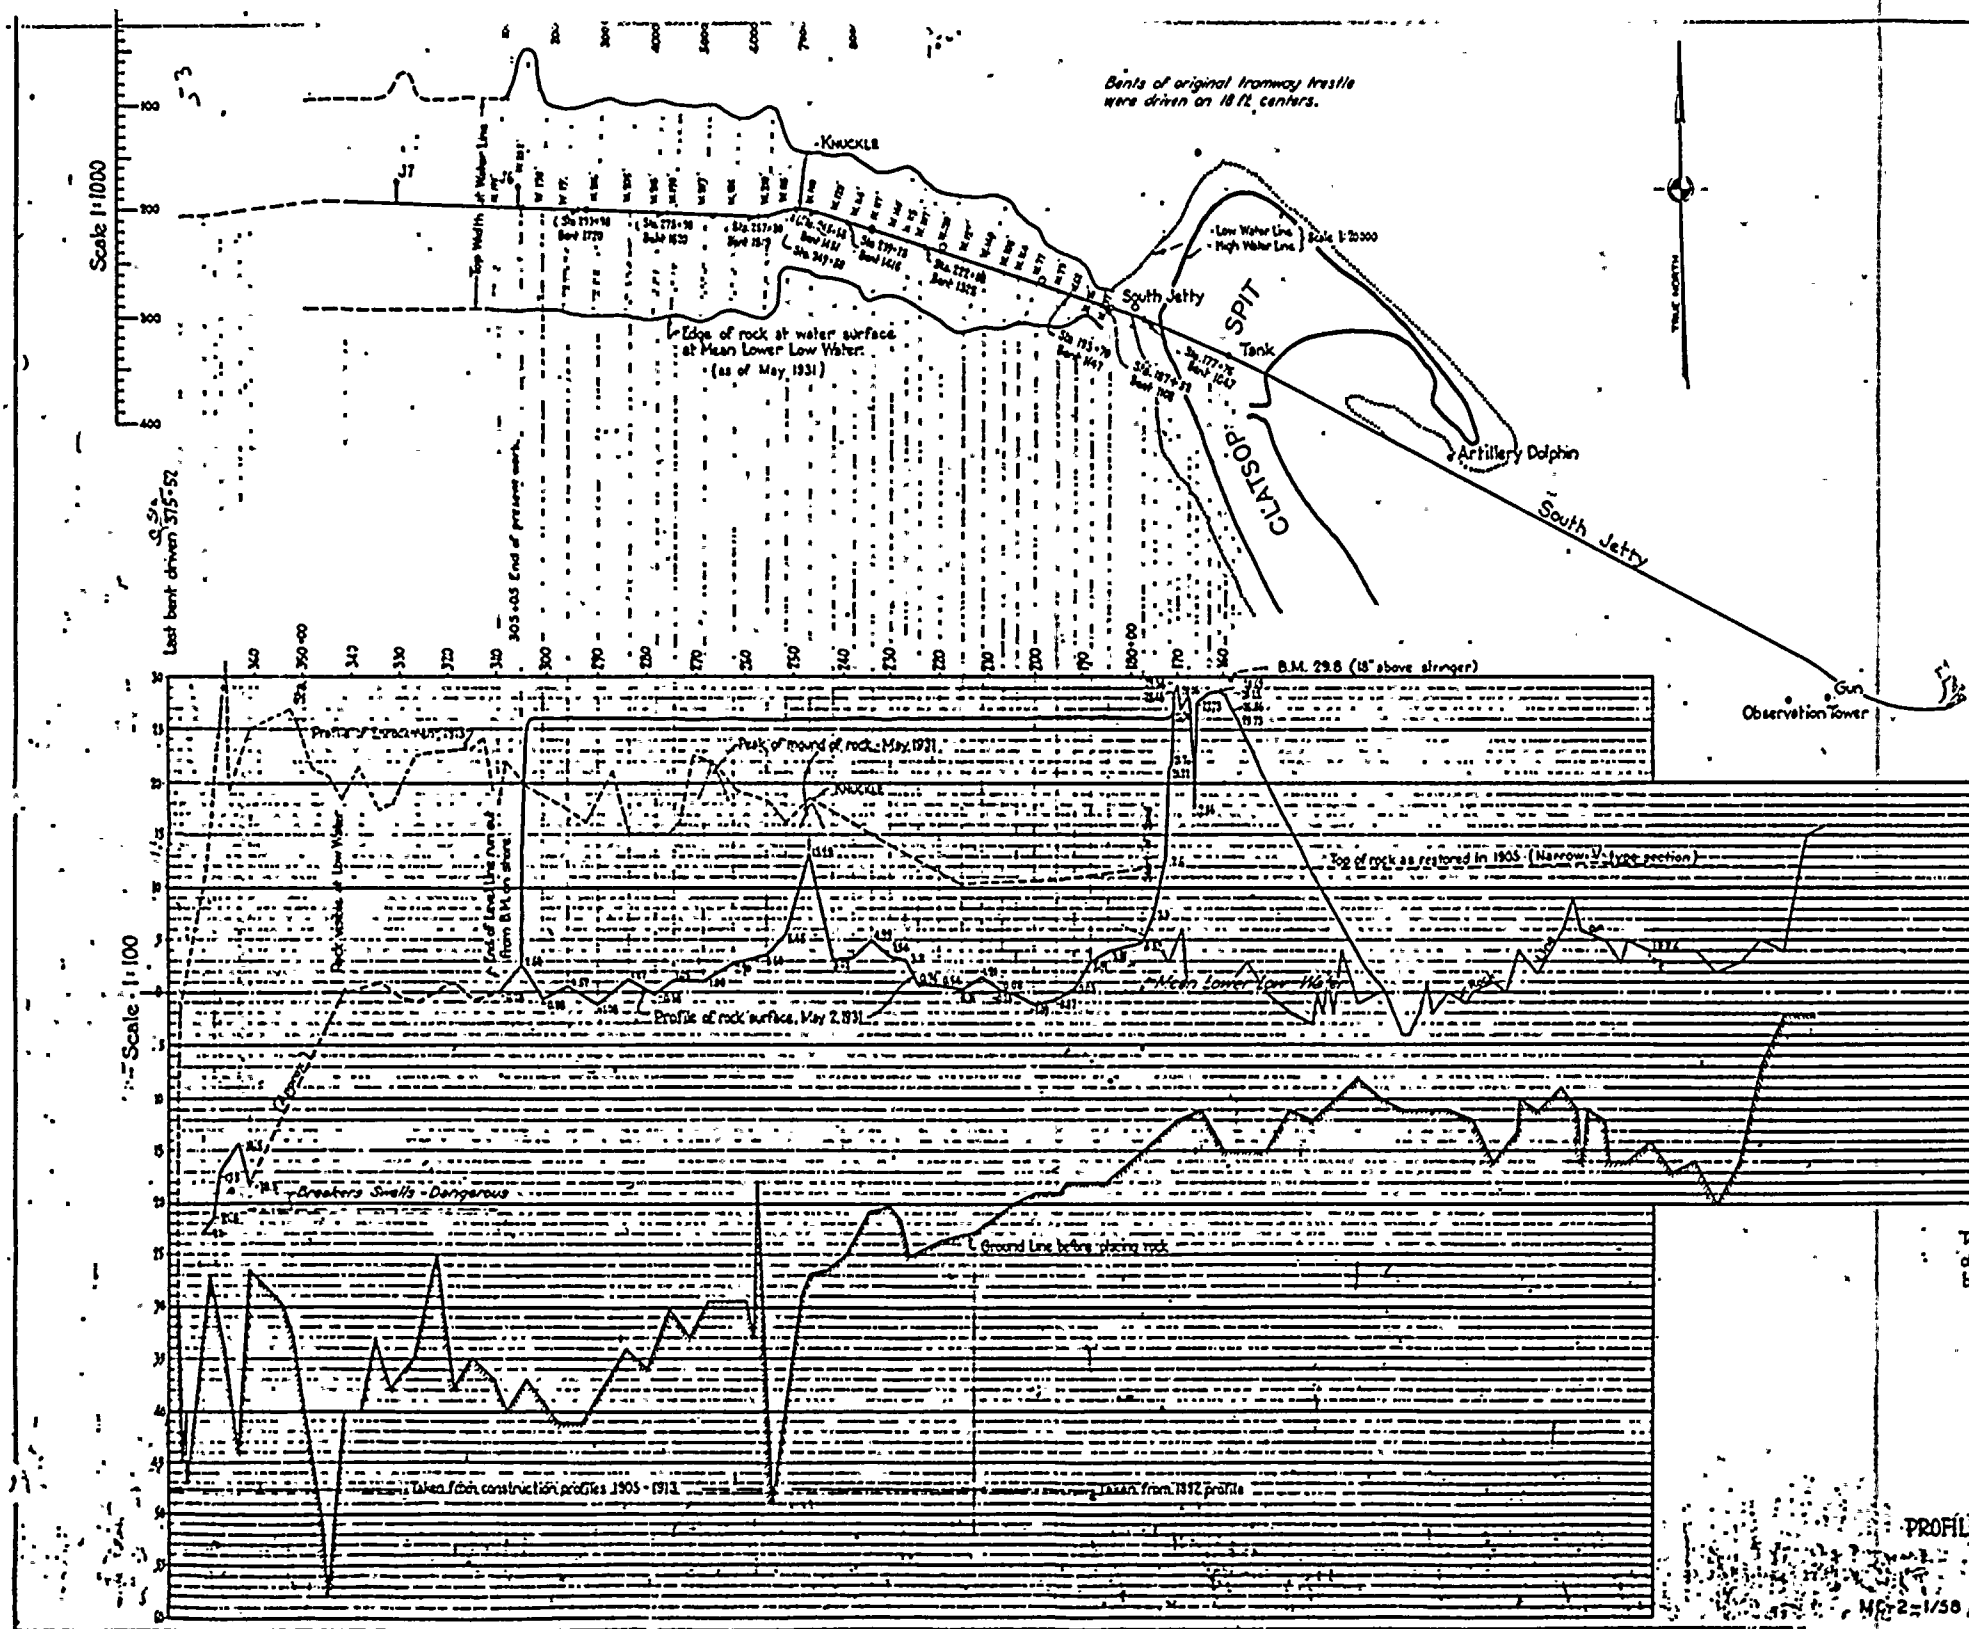
FIGURE 58

There appears to be a discrepancy here, in regard to the outer end of the jetty; a copy of a survey furnished to the writer by the U. S. Army Engineer District, Portland, is given in Figure 58. In this figure it can be seen that the survey of 2-3 May 1931 showed the top of the south jetty to have deteriorated to about mean lower low water (MLLW) from station 195+00 to 225+00 and from about 280+00 to 310+00, with it being at a higher elevation in between. From station 310+00 to 345+00 the top of the degraded jetty was estimated to be at about MLLW, with the notation on the chart stating "rock visible at low water." Note the horizontal scale, with the distance between stations 310 and 345 being 3500 feet. Another drawing was obtained by the writer from the U.S. Army Engineer District, Portland, showing the results of a survey made in April 1940. The survey between stations 324+00 and a little past 338+50 showed an elevation of about 25 feet above MLLW sloping down to about MLLW at 341+70. The surveyors estimated the top of the degraded jetty to be at an elevation of about MLLW seaward to about station 350+50, with a note on the drawing station "elev. MLLW to +2."

Thus, quite a few thousand feet of the jetty has remained in a degraded state for many decades with the elevation of the top of the jetty being at about MLLW.

**MOUTH OF COLUMBIA RIVER**  
**SOUTH JETTY**  
**PROFILE AND TOP WIDTH FROM CLATSOP SPIT WESTWARD**  
 MAY 2-3, 1931  
 U.S. ENGINEER OFFICE, PORTLAND OREGON DISTRICT  
 (EXTENDED TO INCLUDE OLD JETTY EAST OF CLATSOP SPIT)  
 MC-2-1/50, A-7-46/34
