DIABLO CANYON SITE

UNIT NO. 2

REPORT OF CONTAINMENT STRUCTURE

STRUCTURAL INTEGRITY TEST

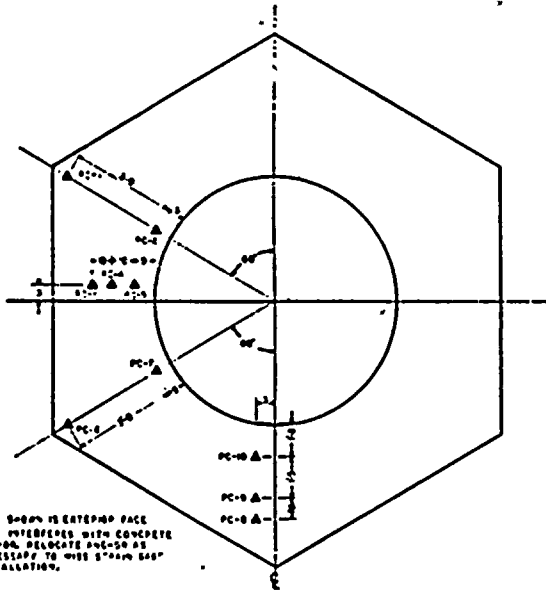
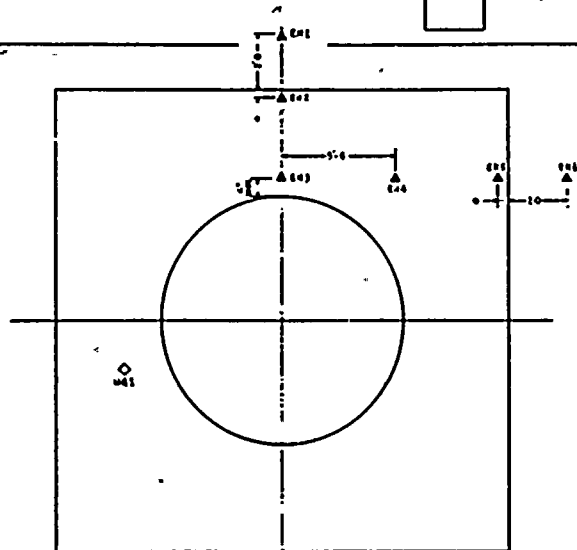
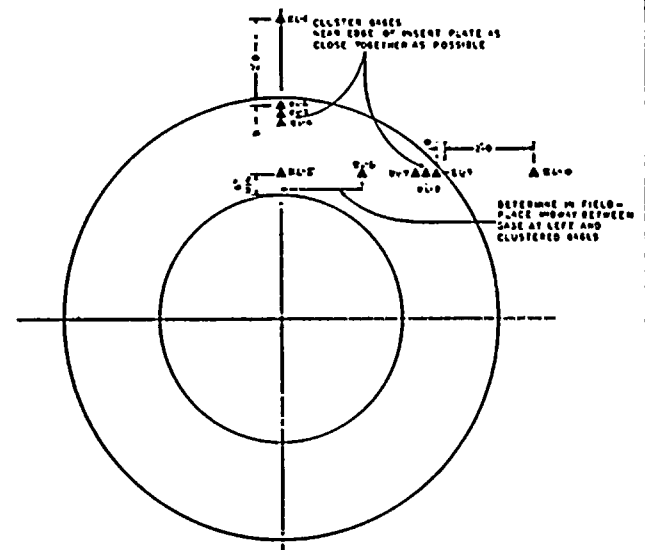
EMERGENCY HATCH **FIGURE 11**

Personnel hatch hexagonal collar plate (Identification PC): Ten triaxial strain rosettes show relatively low stress levels. The maximum tensile stress is 9.8 ksi. Such low readings were not expected and are interpreted as due to gage deterioration rather than actual strains.

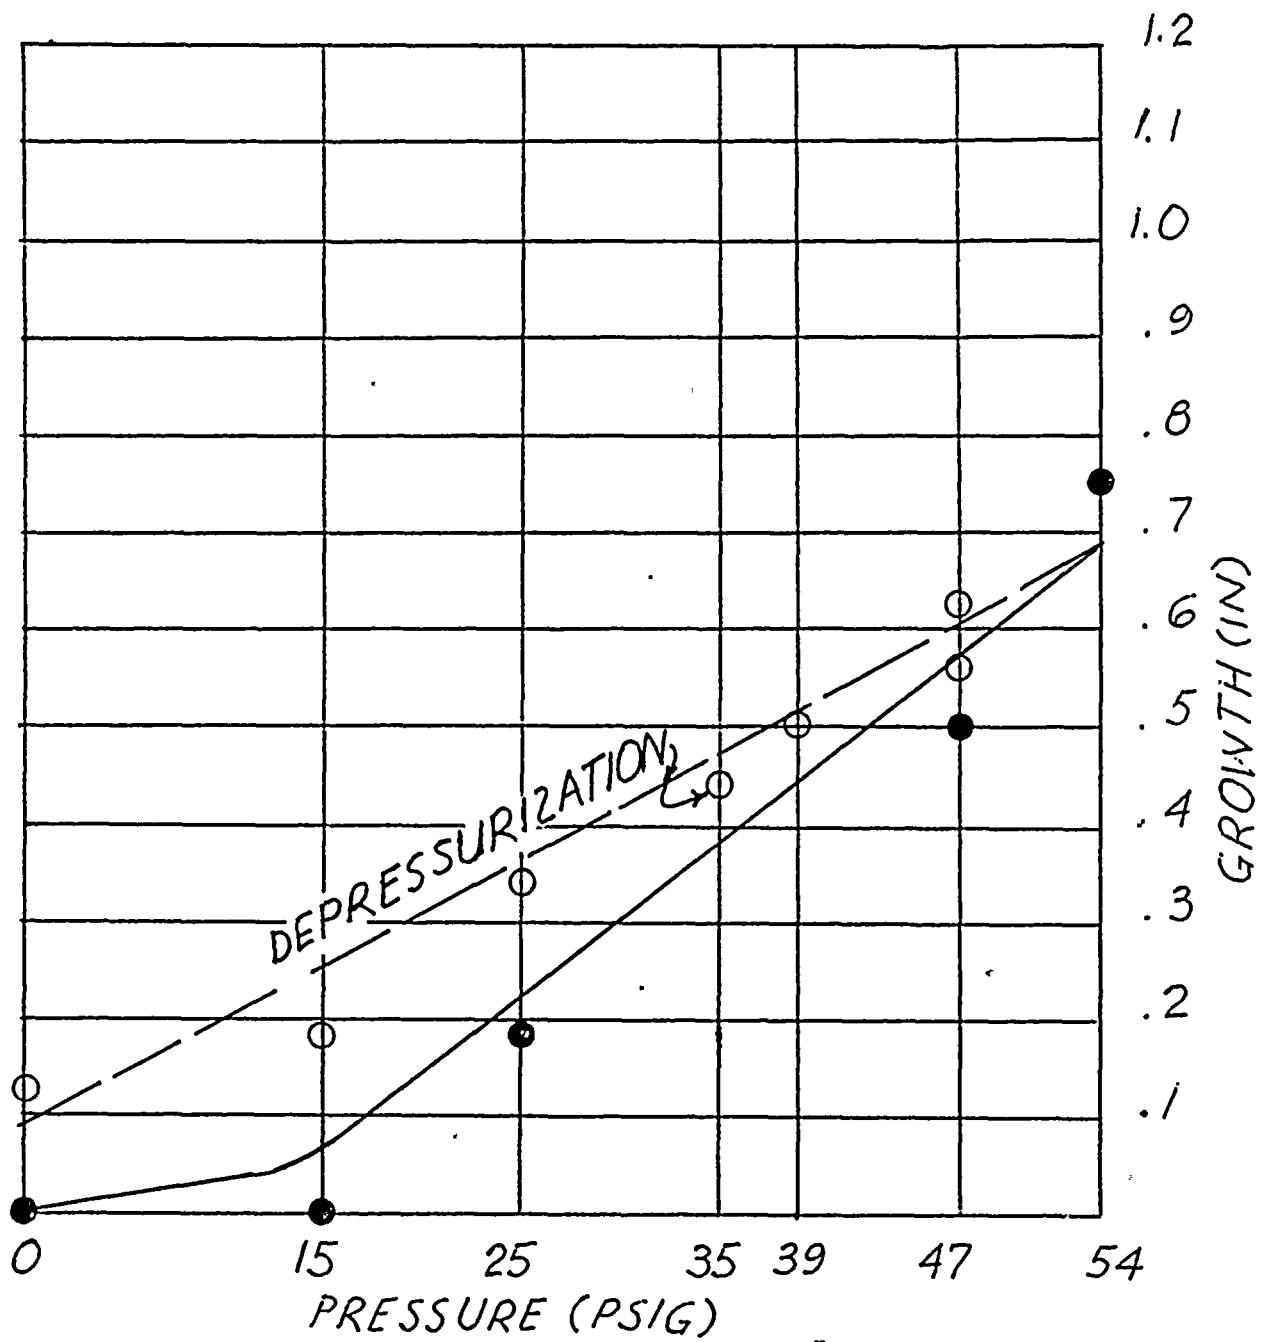
FIGURE 13.1

Figures 13.1 through 13.24 show plots of radial deformation measurements vs. pressure and the most probable load/deformation diagram developed from these plots.

RADIAL GROWTH vs PRESSURE DIAGRAM
OBSERVATION POINT NO. 1

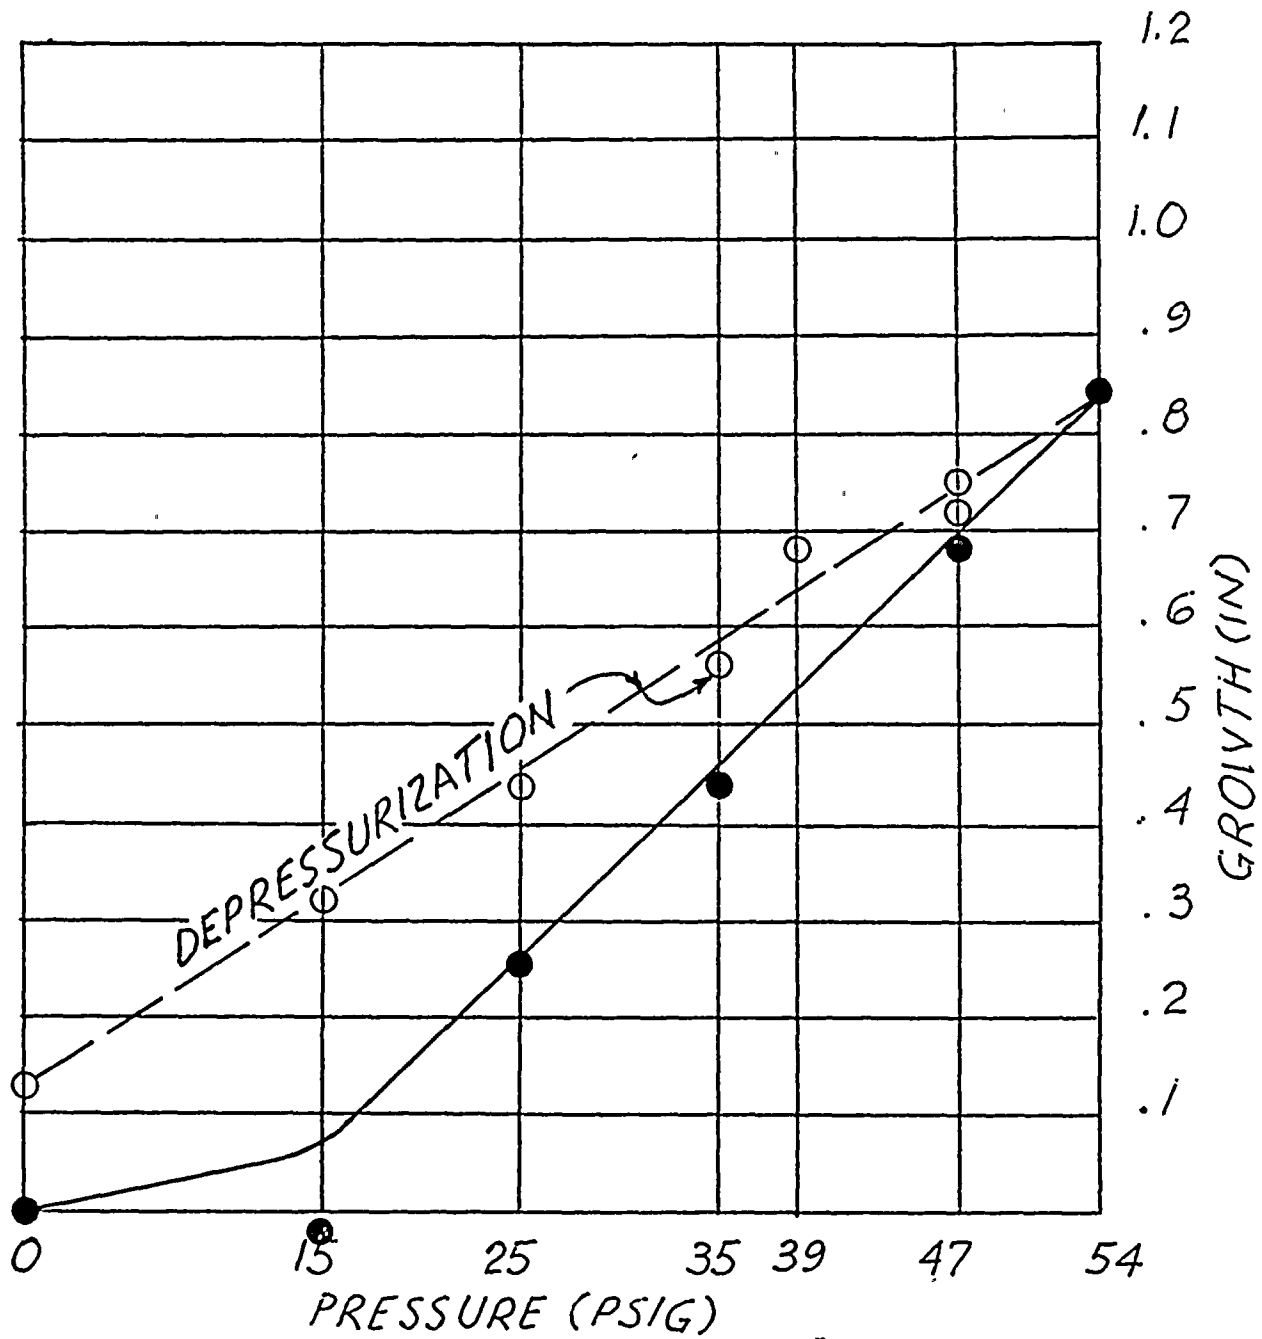
FIGURE 13.2

RADIAL GROWTH vs PRESSURE DIAGRAM
OBSERVATION POINT NO. 2

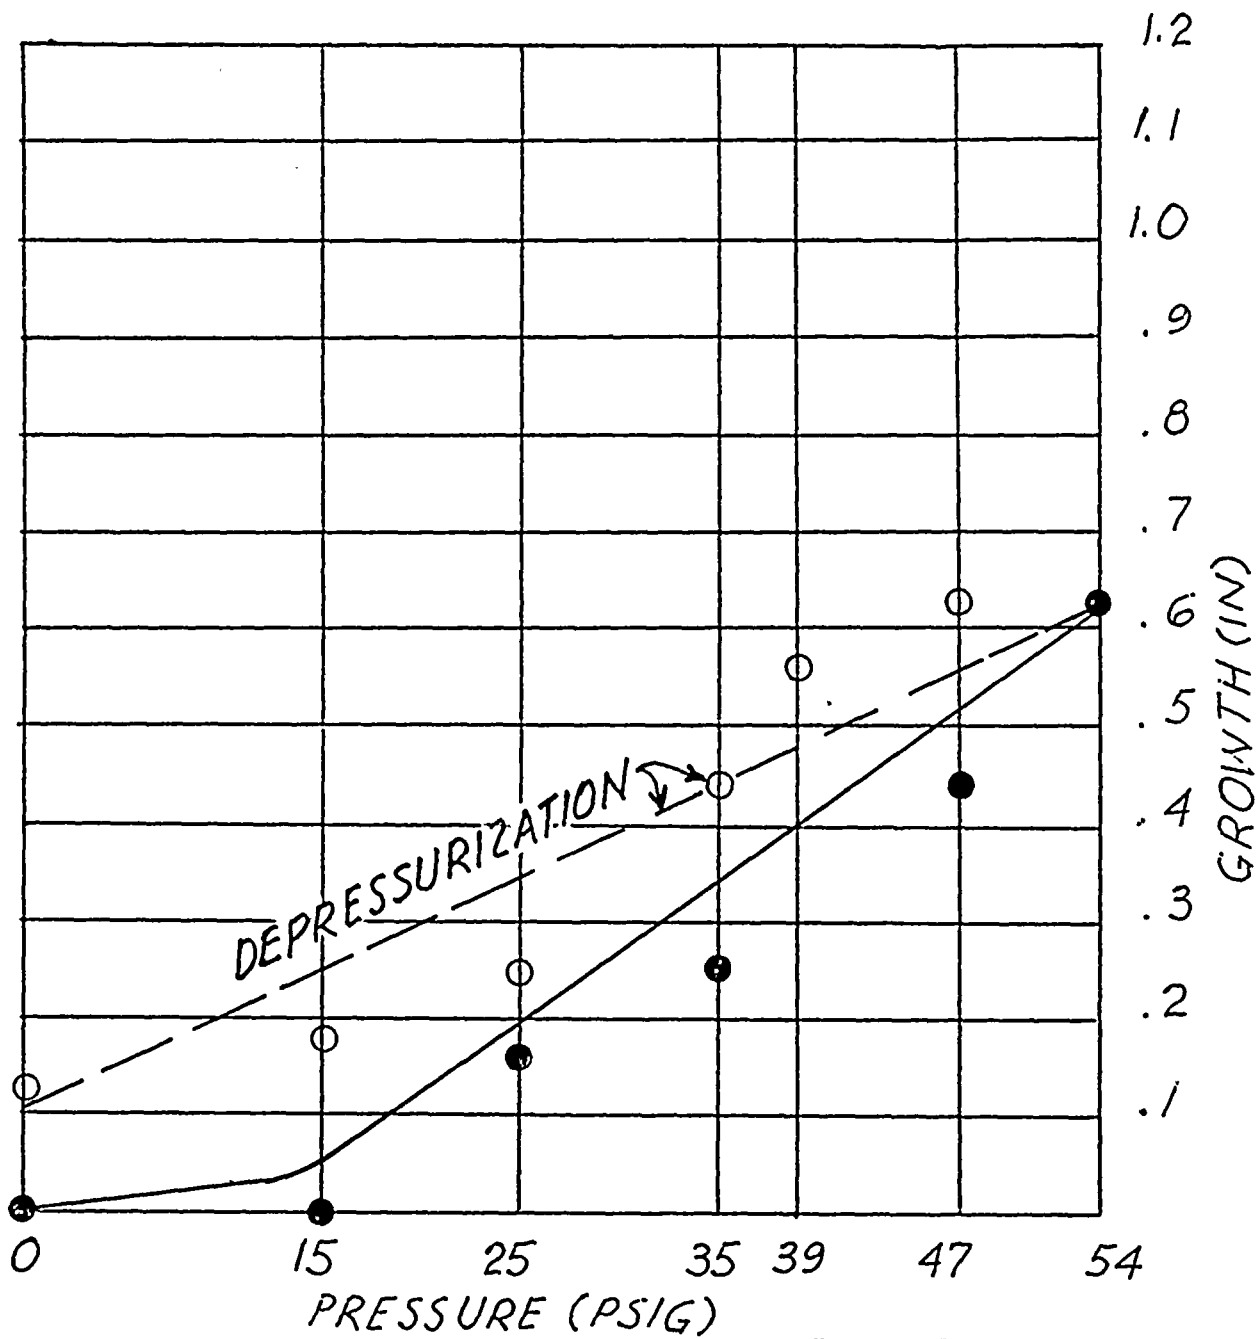
FIGURE 13.3

RADIAL GROWTH vs PRESSURE DIAGRAM
OBSERVATION POINT NO. 3
