Velan Valve Corporation  
2500 Industrial Park  
Winoona, Vermont 05498  
TEL: 802-863-4012  
FAX: 802-863-4014

Subject: Notification as required by 10CFR Part 21

As required by 10CFR Part 21 we are advising you of a potential safety related problem with our 2 1/2", 3" and 4" forged swing check valves.

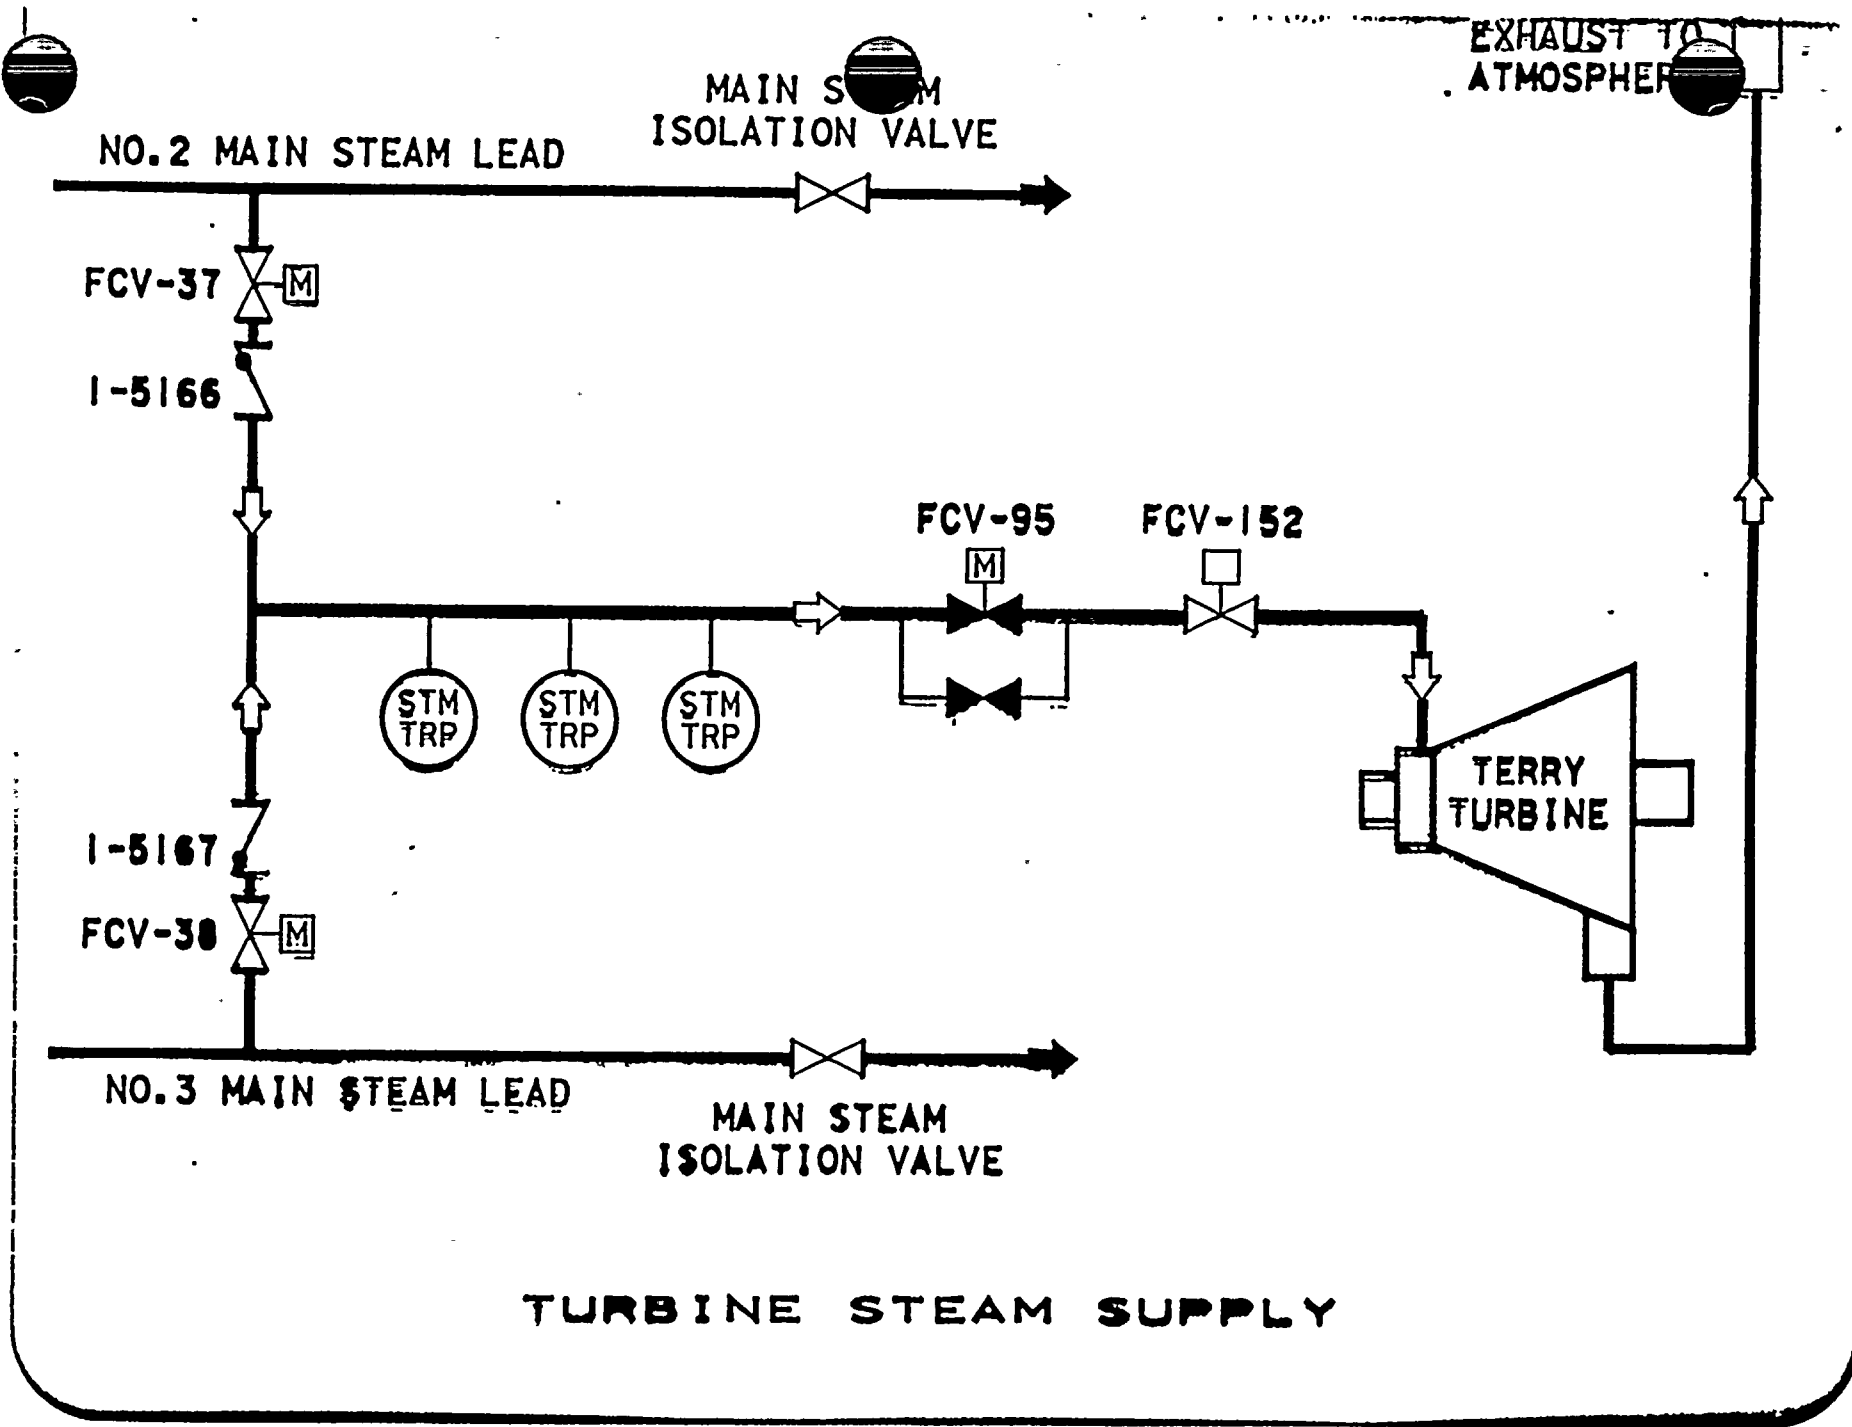
MAIN STEAM ISOLATION VALVE

- 2R4
  - 19 Valves Inspected
  - 1 Stuck Open
  - 1 Bushing Clearance Problem

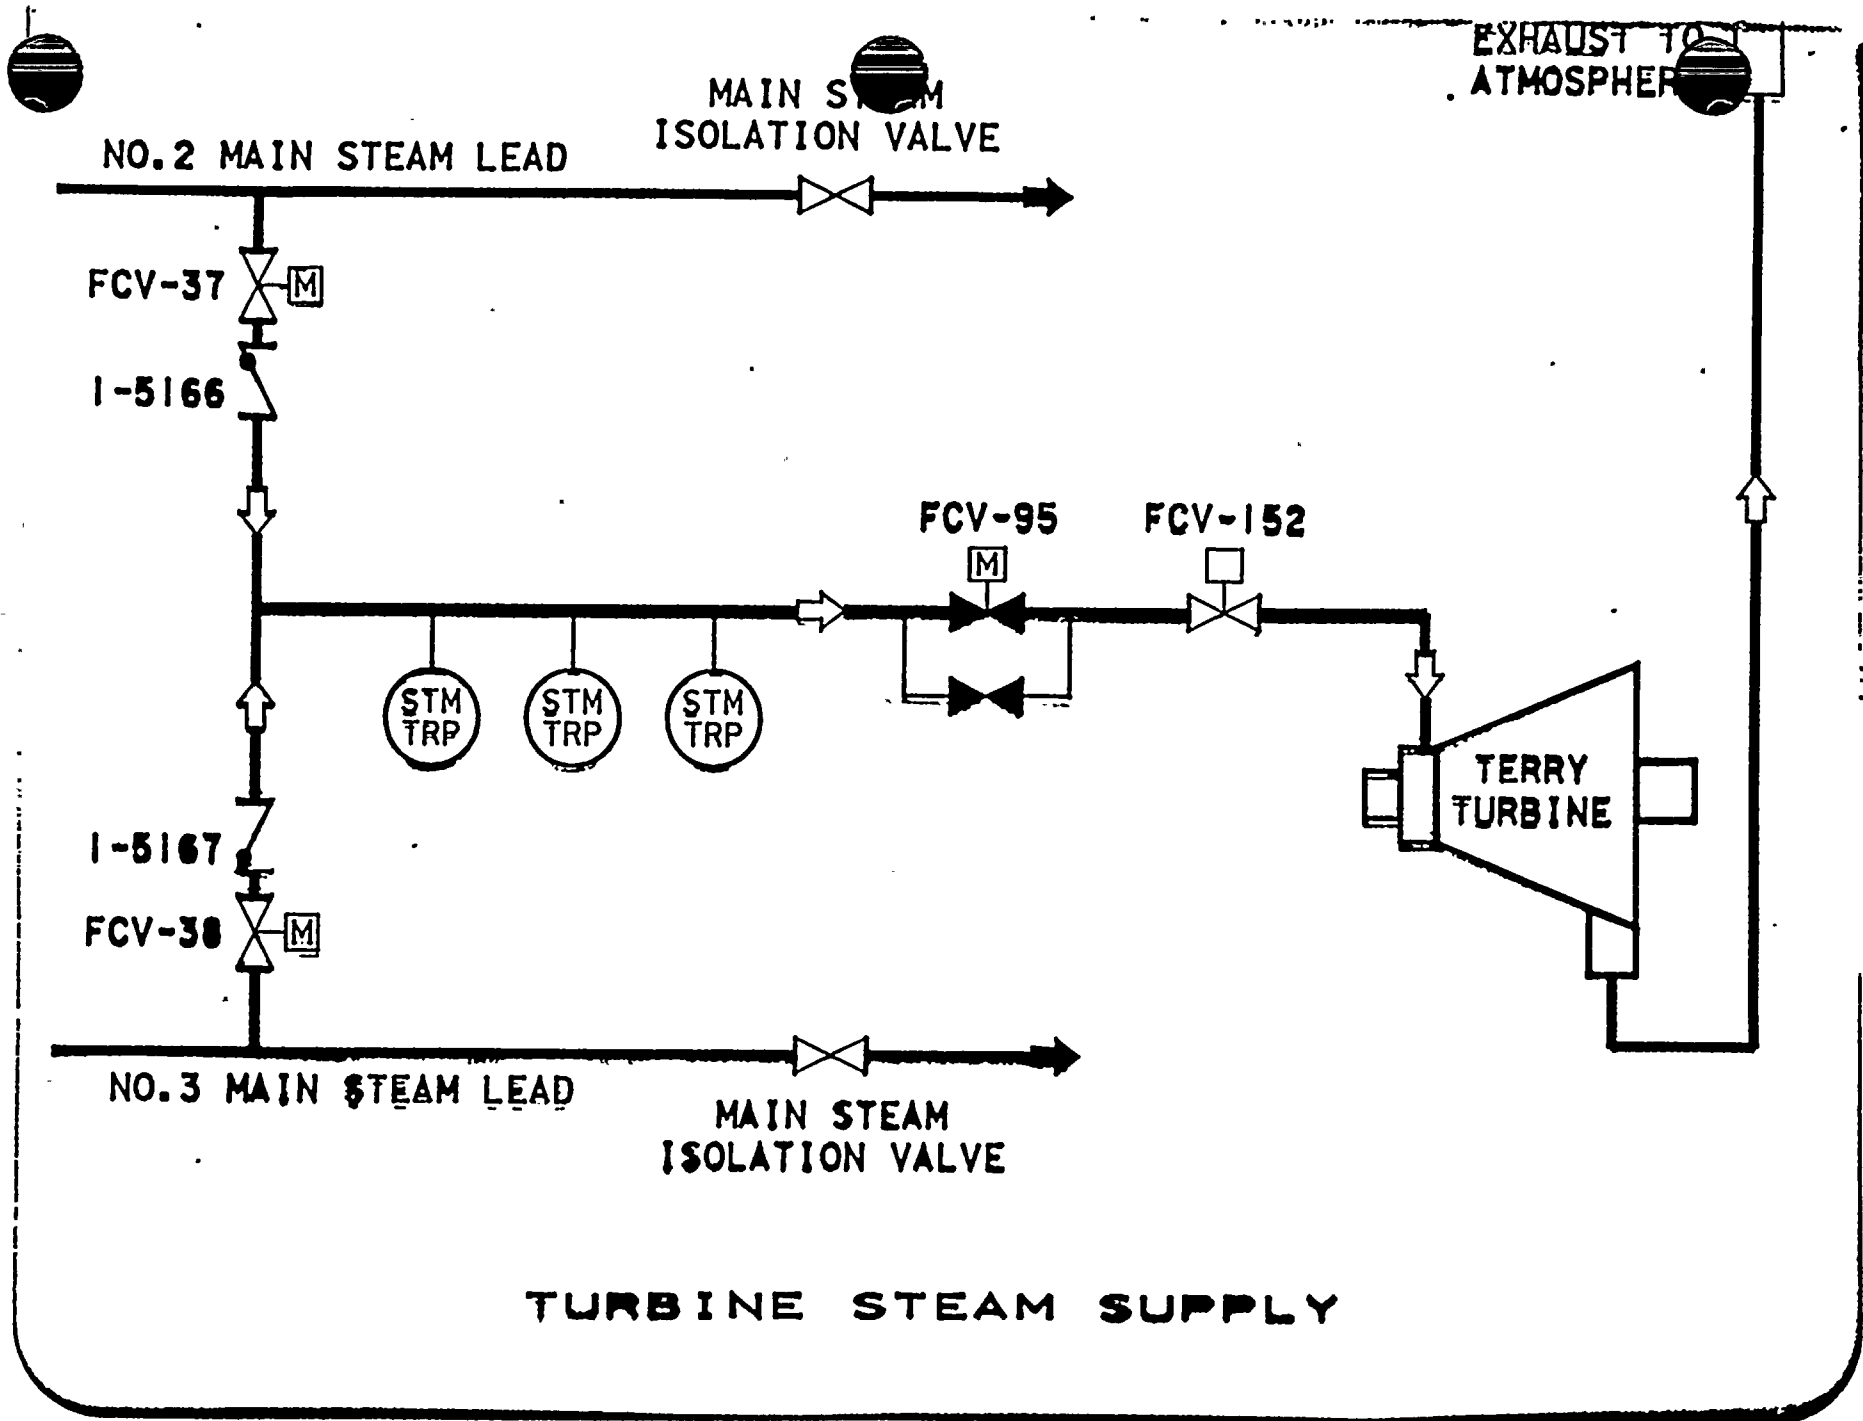
## *NCR 90-MM-N023*

(1) AR A0222168, RP #51.15 inspection identified overall internal clearances that were great enough to allow the bushings to potentially rotate free of the hanger block retention shoulders. Disc and hanger arm assembly were replaced.

1. AR A0242729 written to document stuck open condition.
2. AR A0243819 written to document disc to body contact on 8379B. Engineer also noticed that hinge connection was not loose as most check valves are. He characterized the bushings as appearing to have corrosion that inhibited the swing arm motion slightly. Valve internals have been replaced by new forged components.
3. AR A0246253 written to document that a side load applied on the swing arm caused the bushings to interfere. This valve failed the MP M51.15 inspection since the bushings can be maneuvered into binding. Disc and hanger block to be replaced.
