SUBJECT: LER 95-003-00: on 951120, TS 3.5.2 not met during ECCS on-line
 maint. Caused by personnel error. Precautions added warning
 not to clear safety injection pump coincident w/RHRP w/o
 verification. W/951221 ltr.

Docket No. 50-323, OL-DPR-82
Diablo Canyon Unit 2
Licensee Event Report 2-95-003-00
Technical Specification 3.5.2 not Met During Emergency Core Cooling System
On-Line Maintenance Due to Personnel Error

TITLE (4) **Technical Specification 3.5.2 not Met During Emergency Core Cooling System On-Line Maintenance Due to Personnel Error**

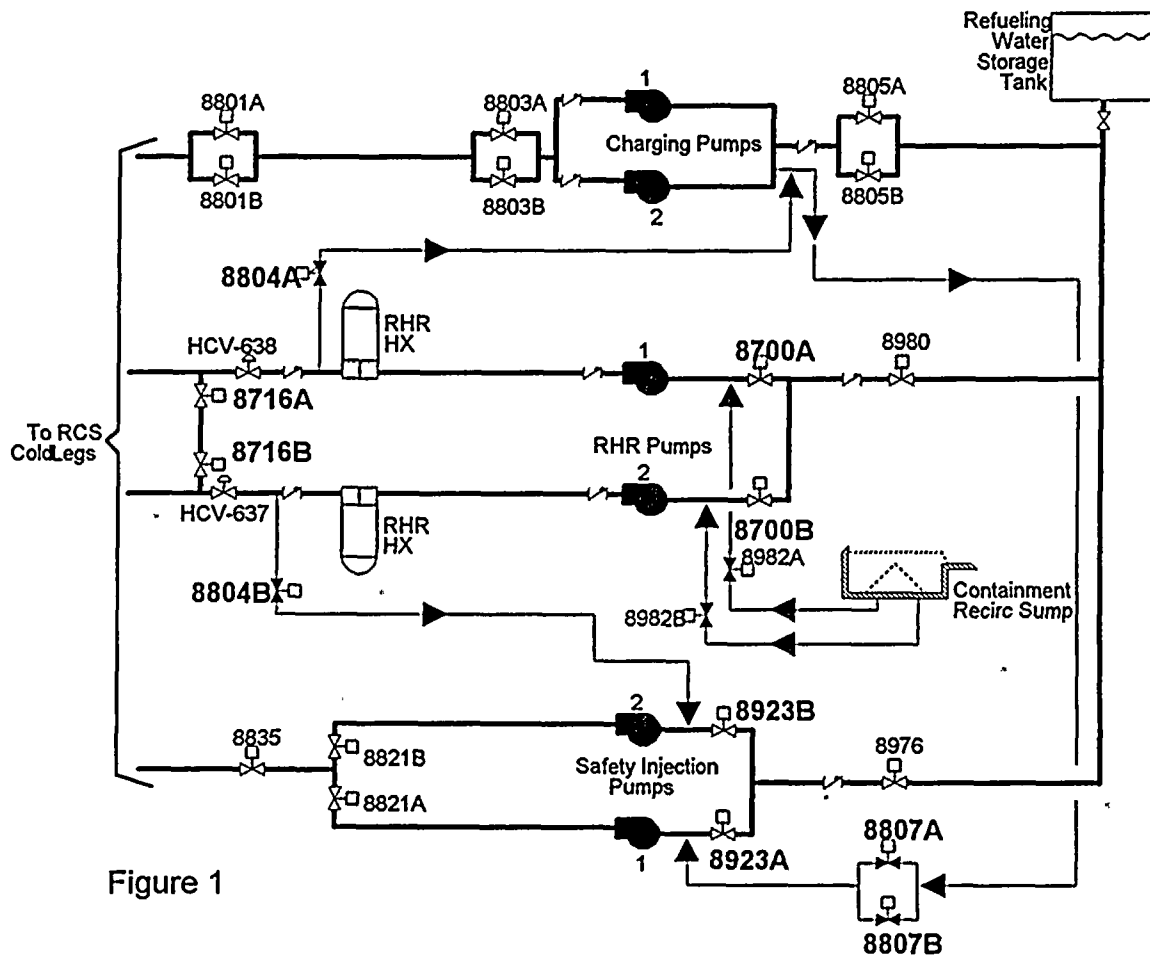
Figure 1

The ECCS is shown on the attached Figure 1, "ECCS Composite Drawing - Normal Injection Phase," and Figure 2, "ECCS Composite Drawing - Cold Leg Recirculation Phase."

The immediate cause of failure to comply with TS 3.5.2 was the closure and clearing of MOV 8923A concurrent with RHR PUMP 2 being out of service.

The root cause of the event was cognitive personnel error in that licensed operators failed to recognize the interdependency of cold leg recirculation suction flowpaths between the ECCS trains.

ECCS COMPOSITE DRAWING NORMAL INJECTION PHASE
