Subject: 10CFR21 Reporting of Defects and Non-Compliance -
Engine Systems, Inc. Report No. 10CFR21-0114, Rev. 0

Report No. 10CFR21-0114

COMPONENT: Subcover Assembly, P/N 1A-7846

SYSTEM: Emergency Diesel Generator

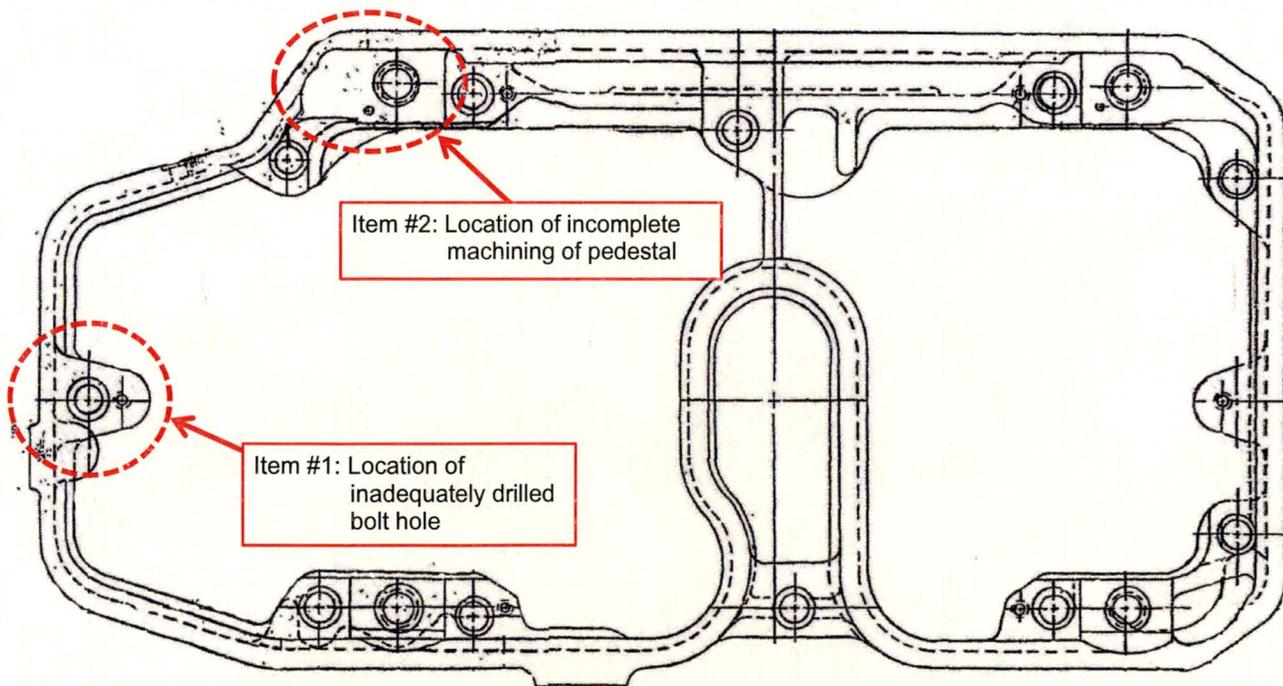
Figure 1: Outline Drawing of Subcover

Engine Systems Inc. (ESI) began a 10CFR21 evaluation on November 18, 2016 upon notification of an issue with a subcover assembly at Perry Nuclear Plant. Attempts to install the subcover on their Enterprise diesel engine revealed two issues that prevented successful installation. First, one of the bolt holes was not fully machined through the entire depth of the subcover. Though the bolt could be inserted into the top of its corresponding hole, it would not pass completely through. The second issue was an interference between the rocker arm shaft and its mating pedestal. It was found that incomplete machining of the pedestal prevented the shaft from sitting flat on the pedestal.

The issue regarding the inadequately drilled bolt hole would be detected during installation since it would prevent the bolt from passing through the hole. Therefore, it is determined this issue would have no impact on operability since the cover could not be installed with an incompletely drilled bolt hole.

The root cause analysis determined the cause to be machining errors that were not detected during ESI's dedication activities. As subcovers are returned, they will be re-machined at the vendor's facility, inspected by ESI, and returned to customers within 60 days of receipt. ESI will also incorporate revisions to the dedication report prior to the supply of any new or reworked subcovers to further clarify the inspection of these features during the dedication process, thereby preventing reoccurrence.
