REACTOR PRIMARY SYSTEM INVESTIGATION

AT NINE MILE POINT NUCLEAR STATION

May 1, 1970

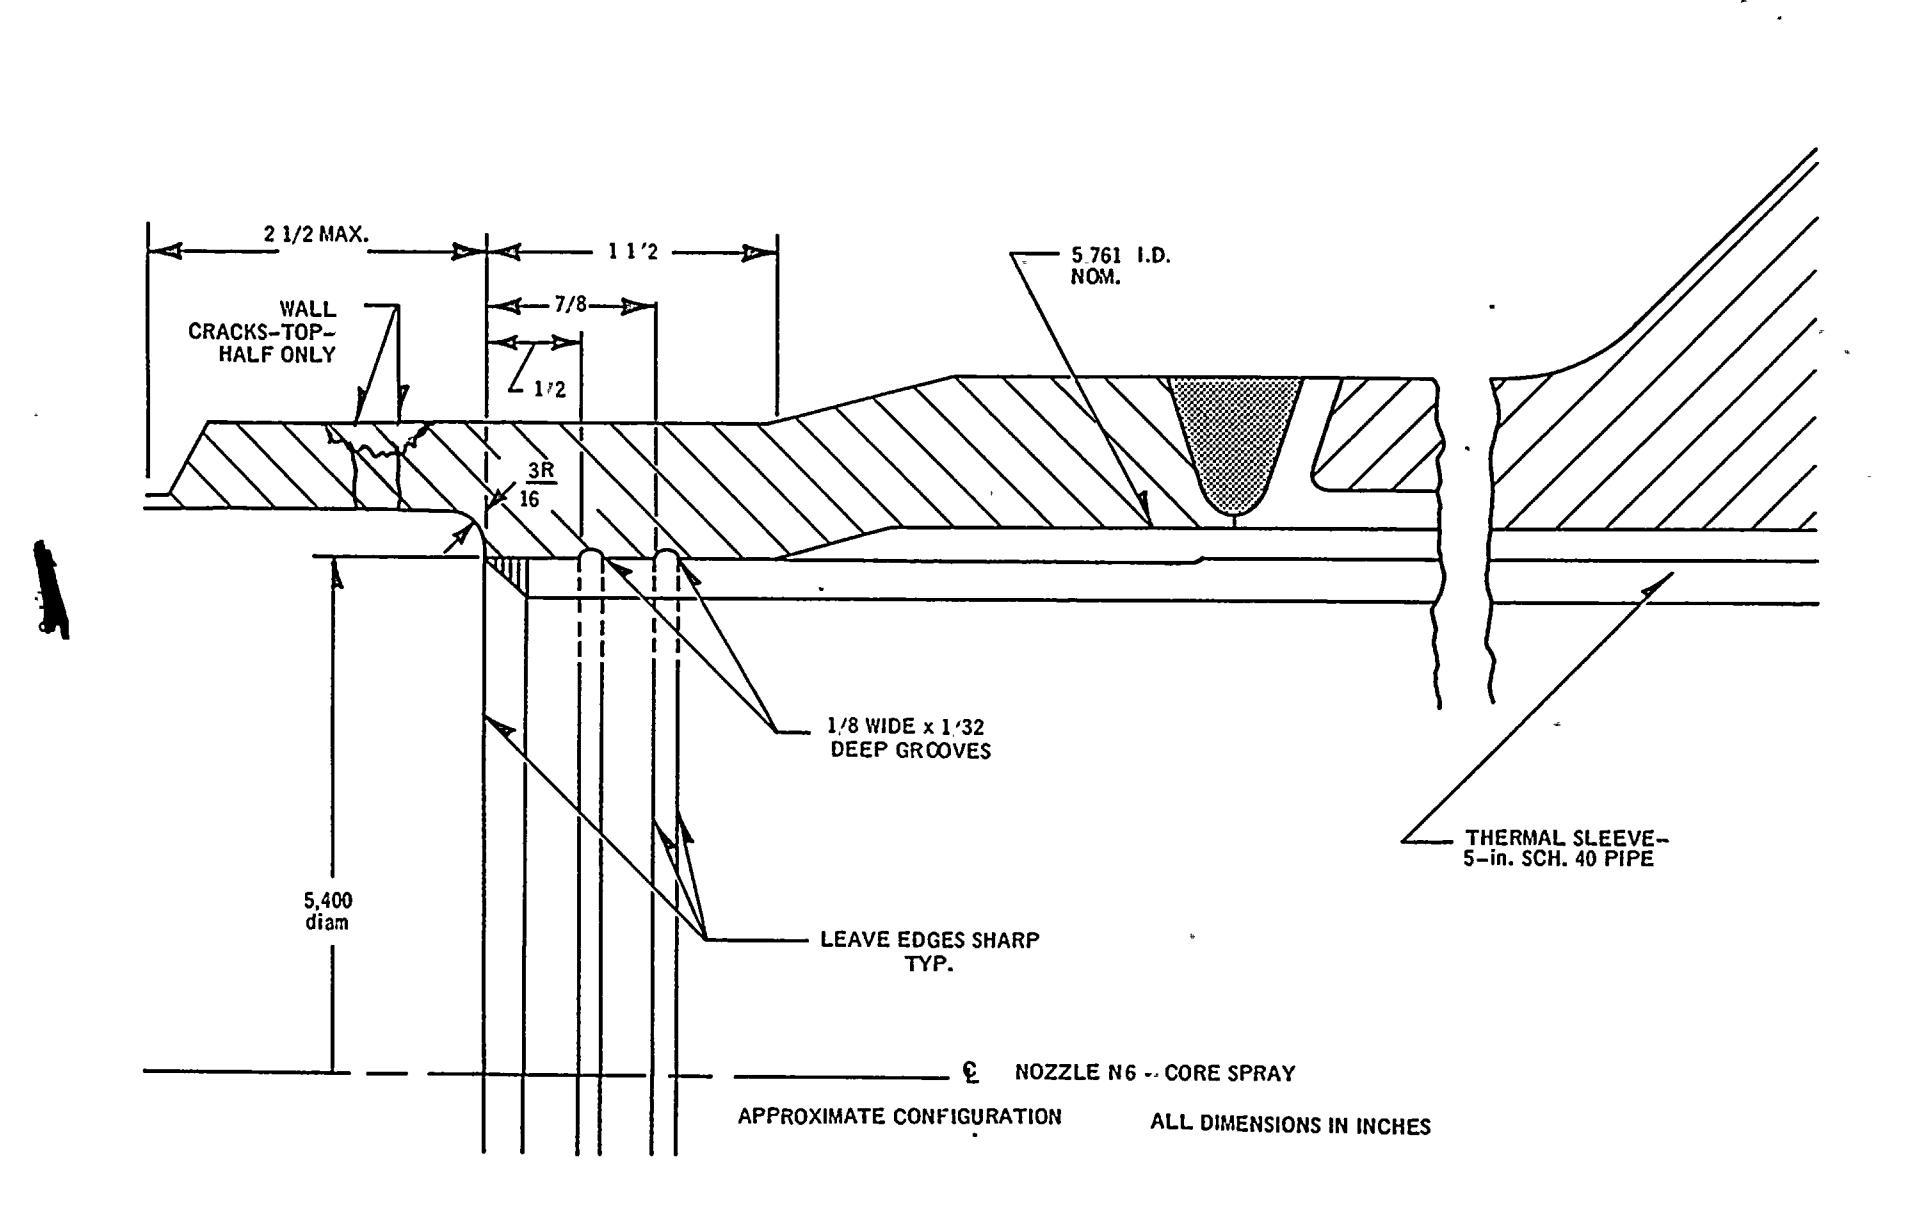
FIGURE 1-2. CROSS SECTION OF CORE SPRAY NOZZLE AND SAFE END N6B

On March 2, 1970, the station was shut down for repairs to the generator exciter reduction gear. During this outage, two small cracks were found in the west (Number 11) core spray nozzle (N6B) safe end.

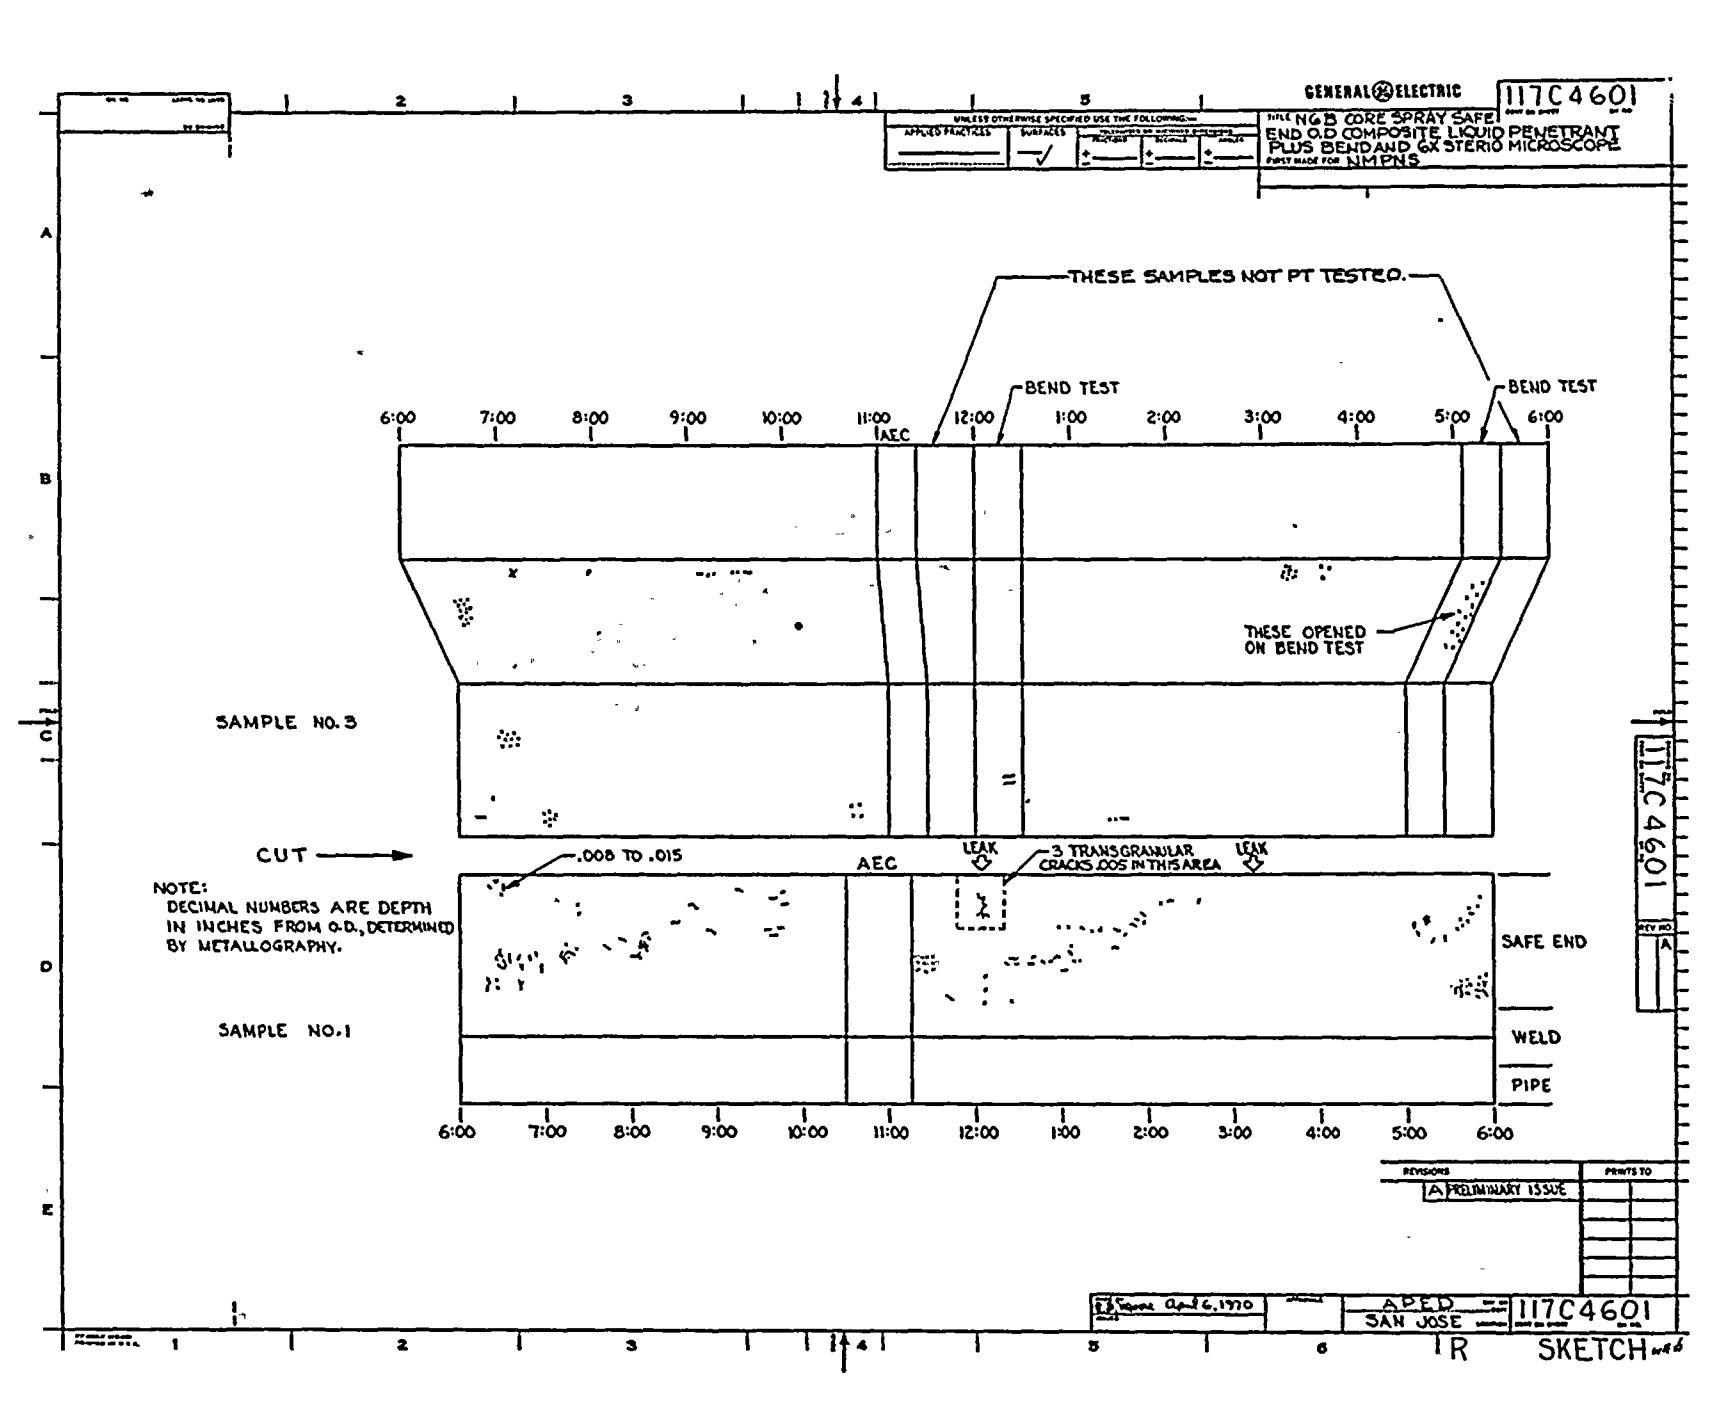
FIGURE 3-3. O.D. EXAMINATION SAFE END N6B

A penetrant test of the outside surface of Sample No. 1 shows large indications at the leak with some small linear indications between 12 and 2 o'clock (generally circumferential) and between 5 and 8 o'clock (generally axial) as shown in Figure 3-3.

Bend tests were used on selected samples to assist in evaluating surface cracks. Typical results of the effect of the bend tests on the surface cracks are shown in Figures 3-3 and 3-4.

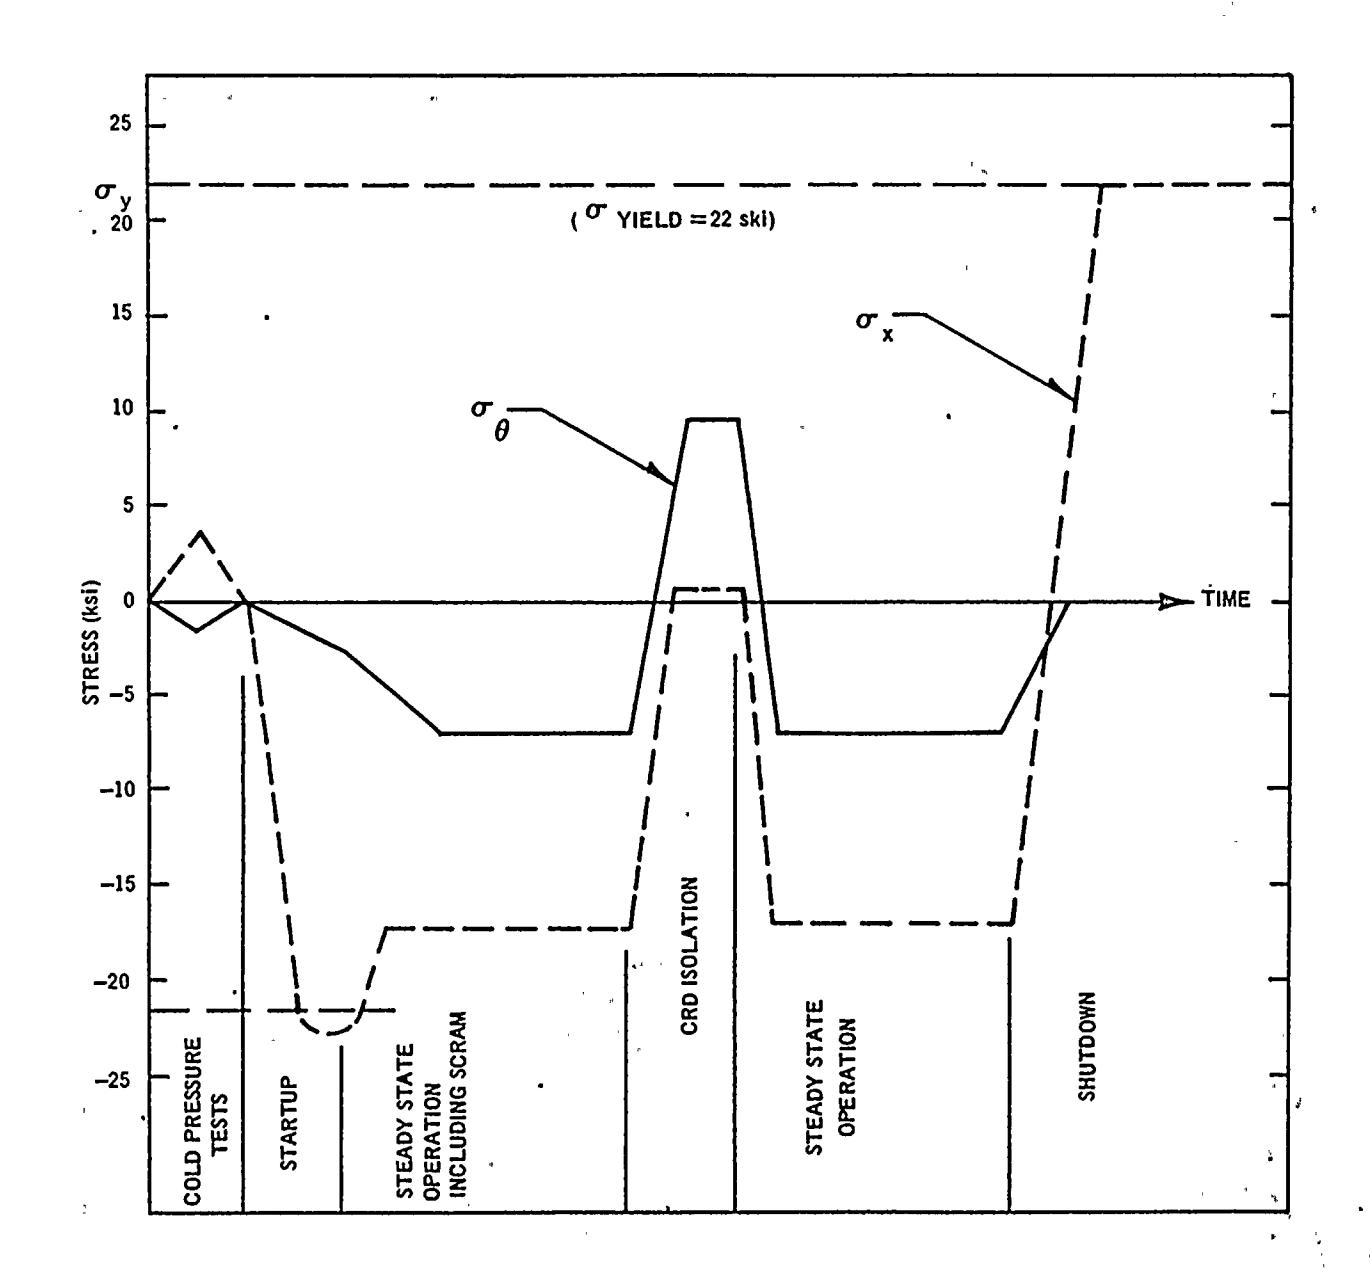
FIGURE 4-6. TOP OF STUB TUBE (O.D. SURFACE) PEAK STRESS VERSUS TIME C.E. CALCULATION VALUES ONLY

Notice from Figures 4-6 and 4-7 that both the top and bottom of the water-exposed side of the stub tube will exceed the tensile yield strength during the shutdown condition. Since this total accumulated shutdown condition could be 10 or 20% of the design life, this means that tensile stresses slightly in excess of yield may exist for sustained periods up to a total of 35,000 to 75,000 hours during the reactor shutdown at low temperature conditions. The condition of control rod drive isolation also produces tensile yield stresses, but this should occur for much shorter periods of time. Figures 4-8 and 4-9 indicate biaxial yielding on the i. d. surface where neither stress component alone is at the yield level, but the biaxial stress is at a yield condition, and reduces to a maximum stress of 13,000 psi during steady state operating condition which is less than 2/3 of the yield strength at 550° F.

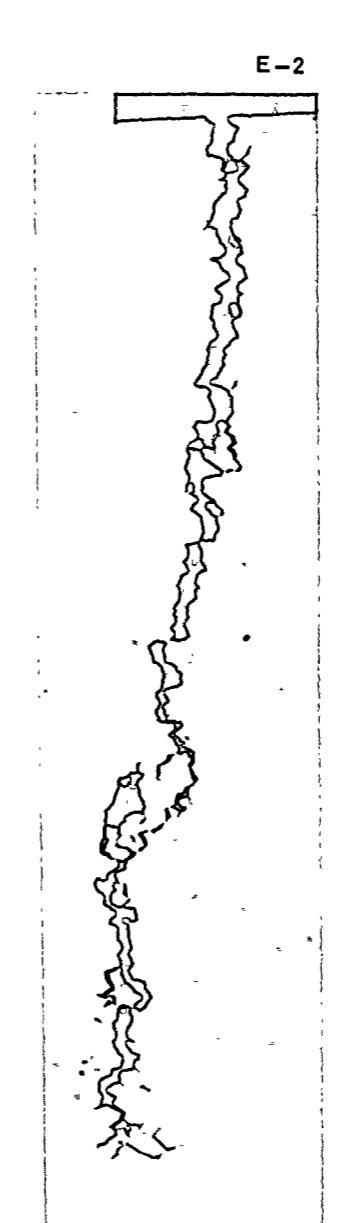
ULTRASONIC DETECTABILITY OF FIGURE 8-1. INTERGRANULAR CRACKS IN SAFE END N6B

UT-E2 A = 7.5MP = 6 TM = 1/4 in. CRACK 0.390 DEEP - 5/8 in. LONG SAMPLE 1 - 0.450 THICK

A = 3 MP = 0.8 TM = 1/8 in. CRACK 0.030 DEEP - 5/8 in. LONG SAMPLE 3 - 0.650 THICK

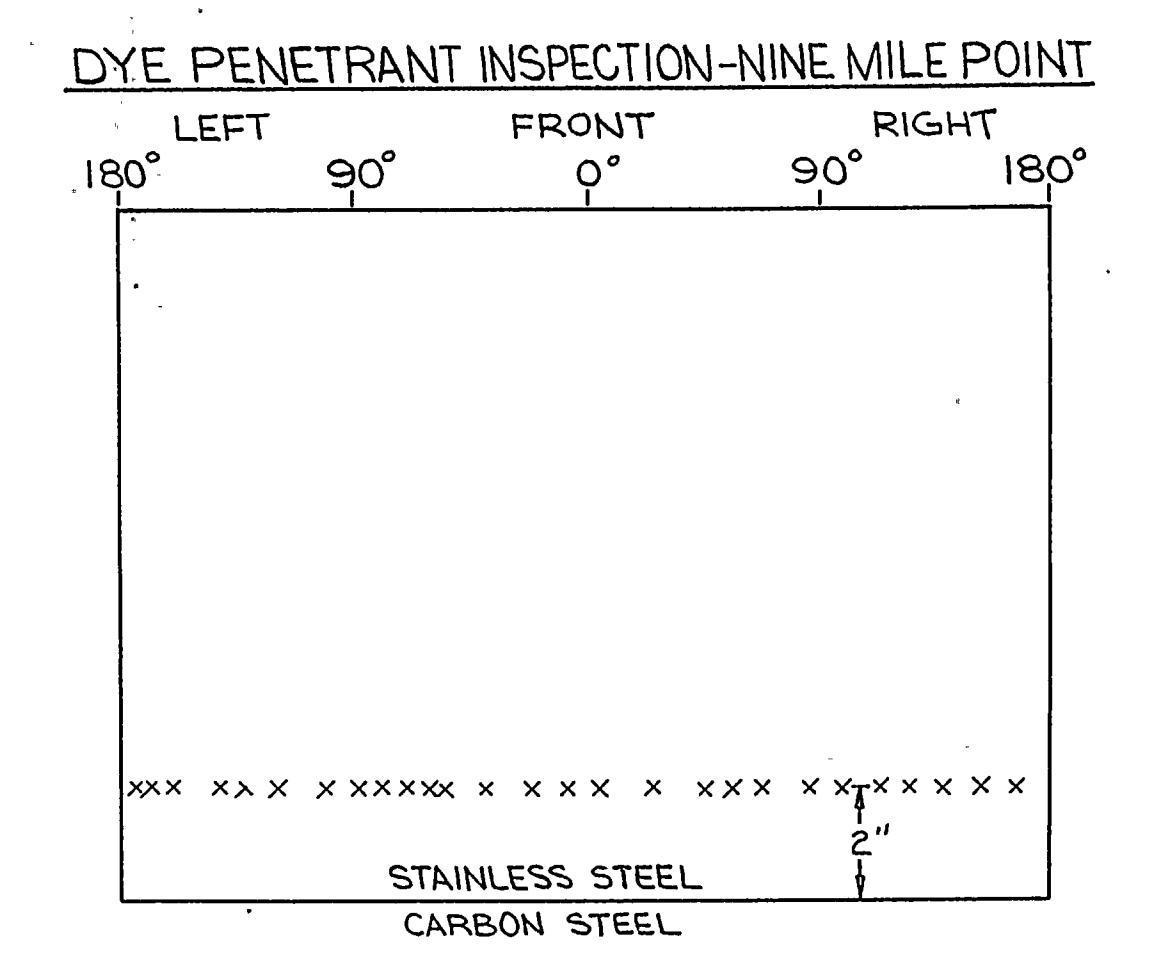
IDENTIFICATION: N7B-VESSEL HEAD SAFE END O.D. INSPECTION DATE: 3-12-70 BY: ORiginal perpedents for the testing finites

REMARKS: 2-1 SHOWS A SAMPLE 30° RIGHT OF 0°. 2-4 SHOWS THE 30° TO RIGHT AREA AFTER FIRST GRIND. - INDICATIONS REDEVELOPED.

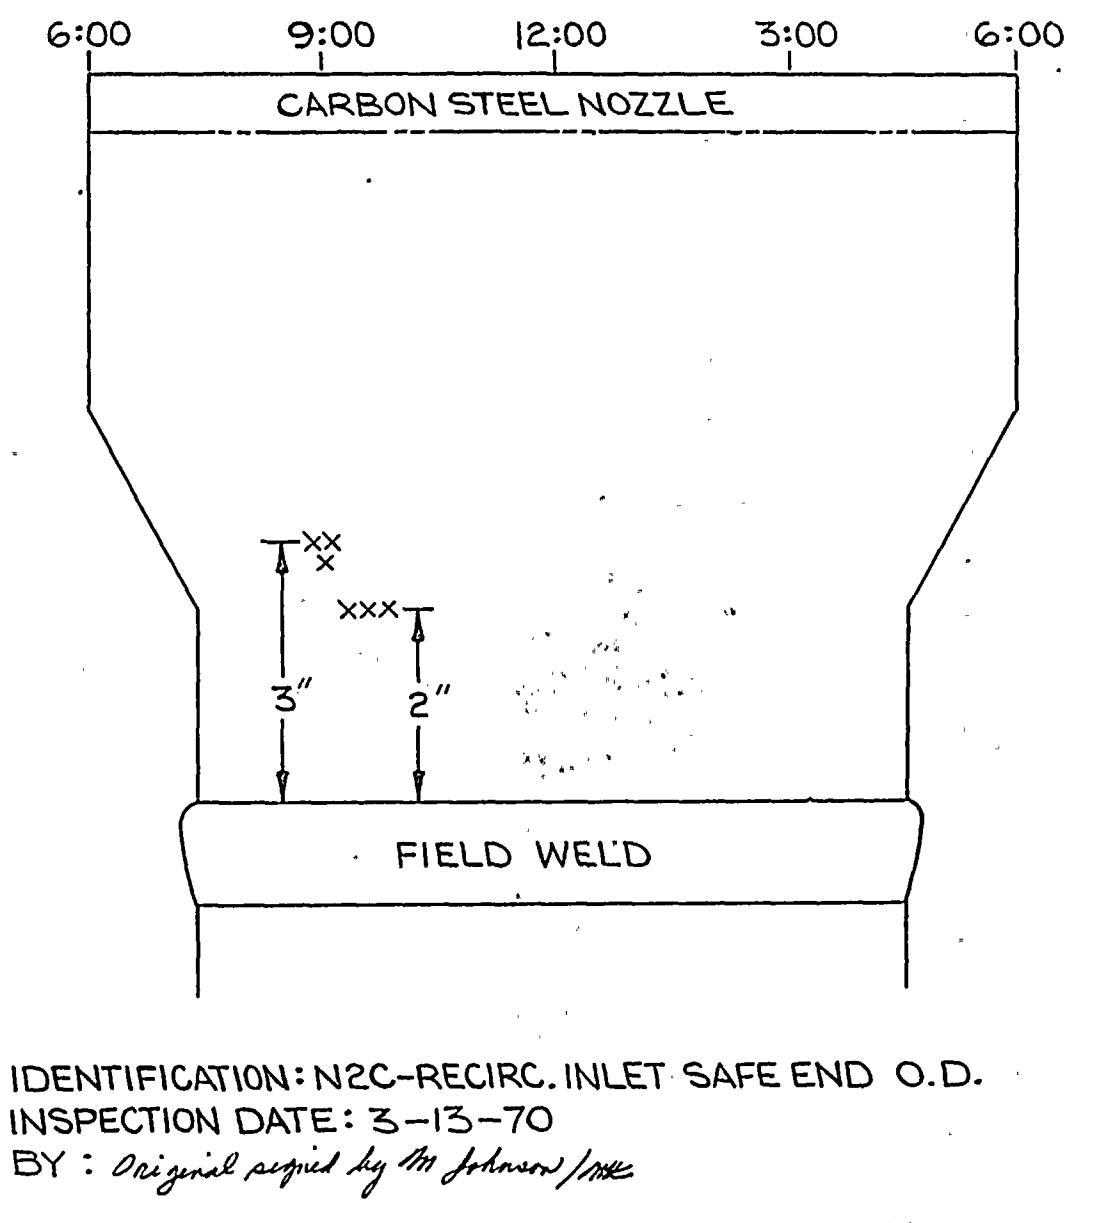
REMARKS: PHOTO 2-7 SHOWS 10:00 INDICATION ALL INDICATIONS REDEVELOPED

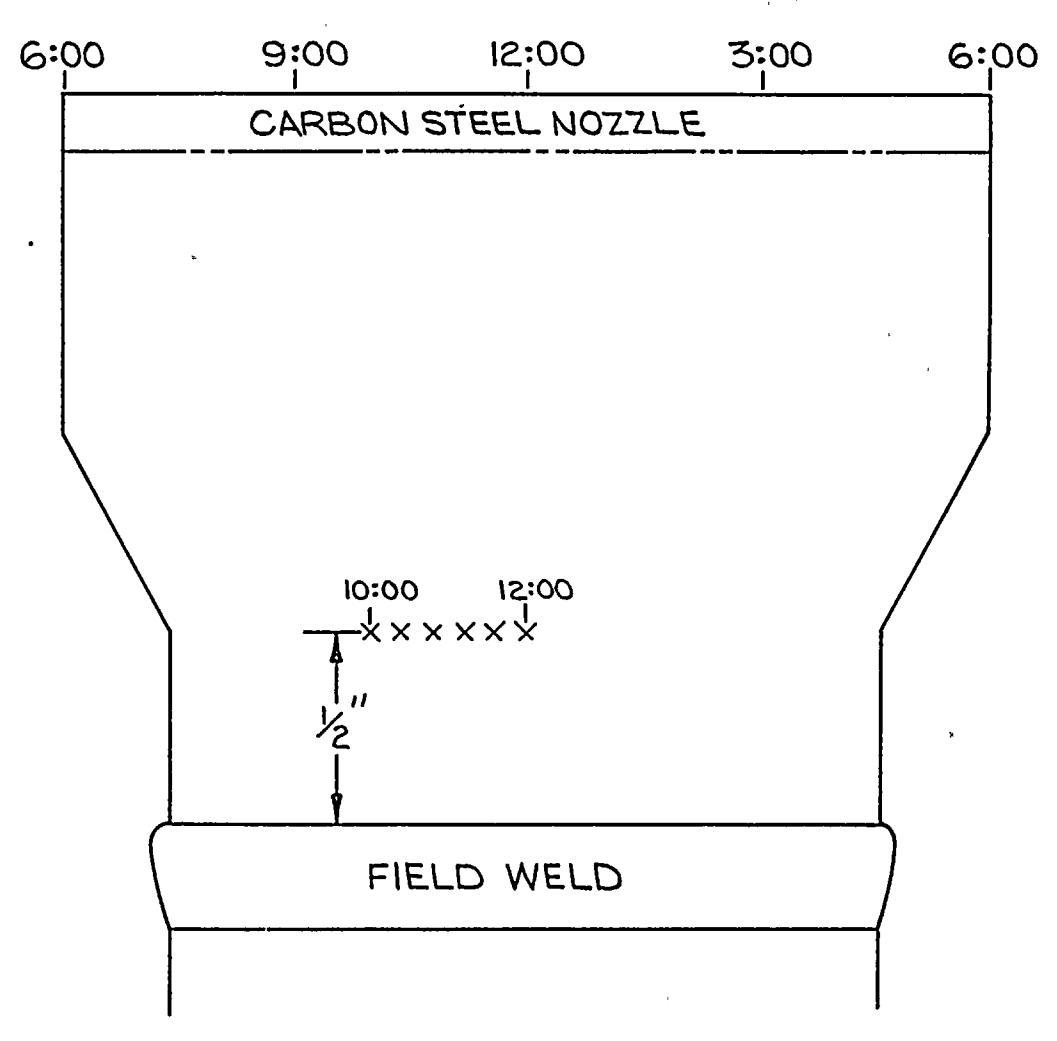
IDENTIFICATION: N5B-ISOLATION CONDENSER SAFE END O.D. INSPECTION DATE: 3-11-70

BY: Original Ligned by M. Johnson Mill REMARKS: PHOTO I-8 12:00 AREA OF INDICATION I-9 12:00 AREA OF REDEVELOPMENT I-10 12:00 AREA AFTER FIRST GRIND I-11 12:00 AREA AFTER REDEVELOPMENT I-12 10:00 AREA AFTER SECOND GRIND I-13 10:00 AREA AFTER REDEVELOPMENT PT PROCEDURE USED: 21A8570 MILLON SWIT.5 SWIT. NO.4 SKETCH

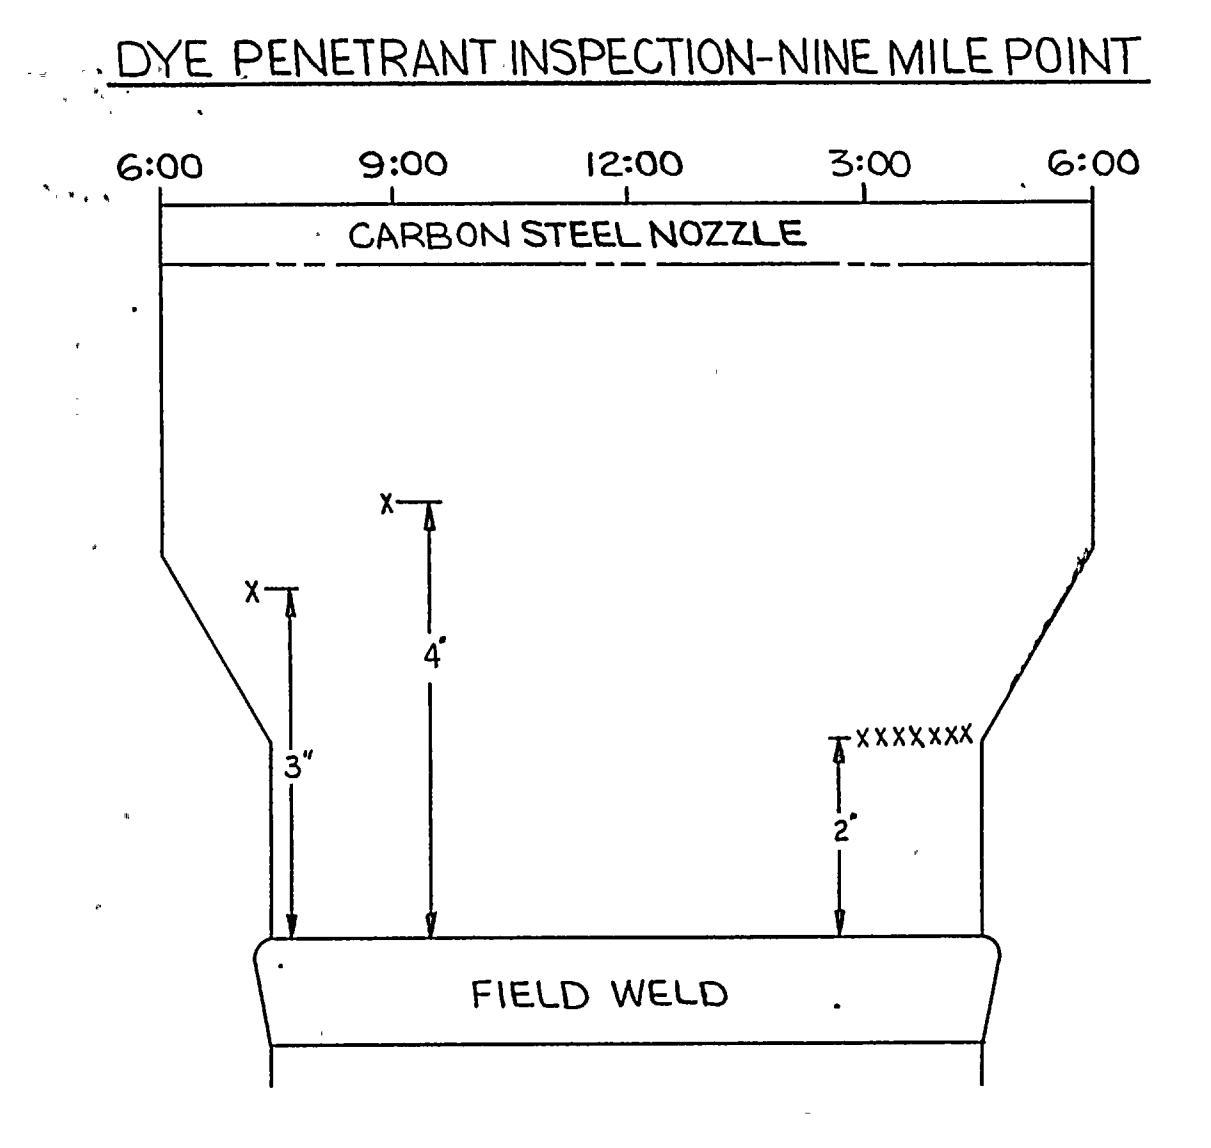
IDENTIFICATION: NIA-RECIRC. OUTLET SAFE END O.D. INSPECTION DATE: 3-13-70 BY: Original Signal by M. Johnson / Marc

REMARKS: ALL INDICATIONS REDEVELOPED

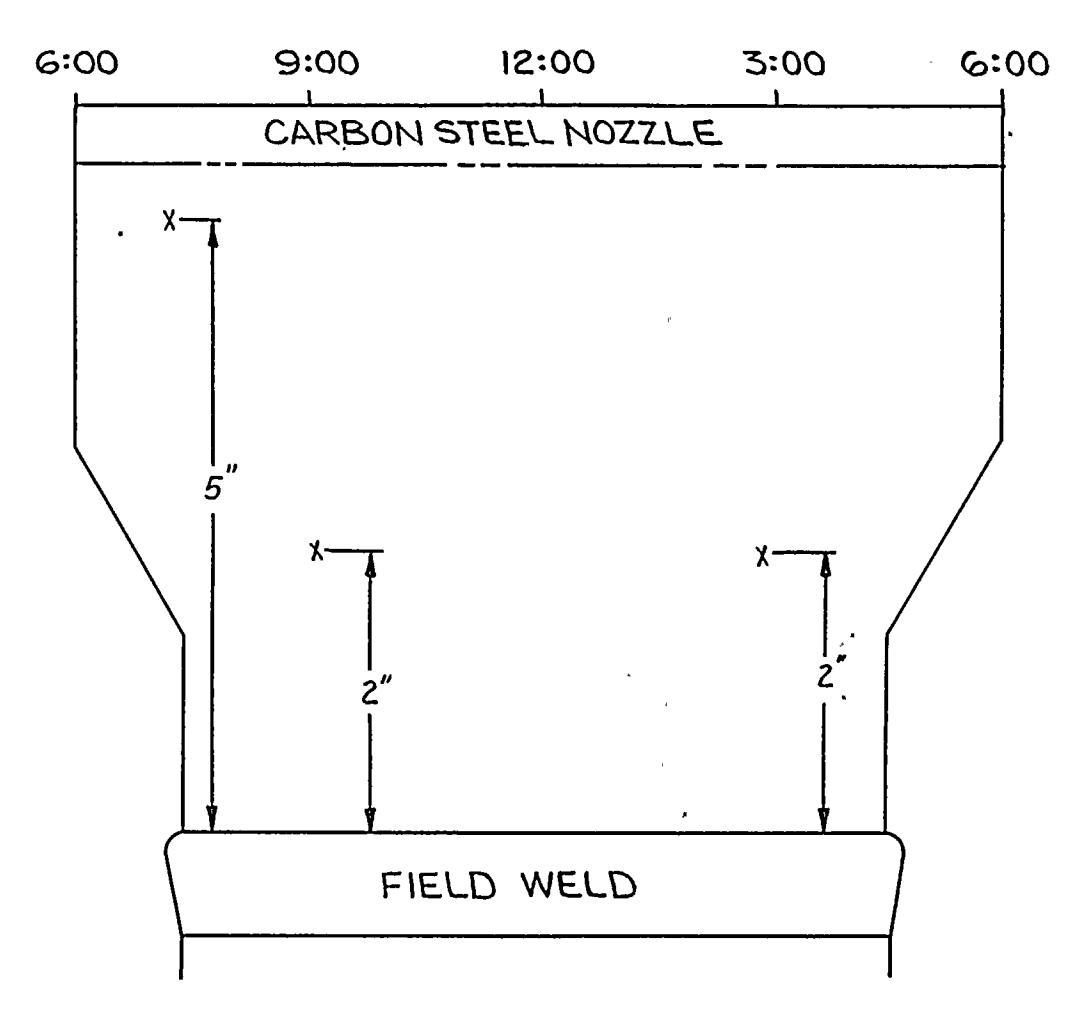
IDENTIFICATION: NIB-RECIRC. OUTLET SAFE END O.D. INSPECTION DATE: 3-13-70 BY: Original Signal by Mr. Johnson / March

REMARKS: ALL INDICATIONS REDEVELOPED

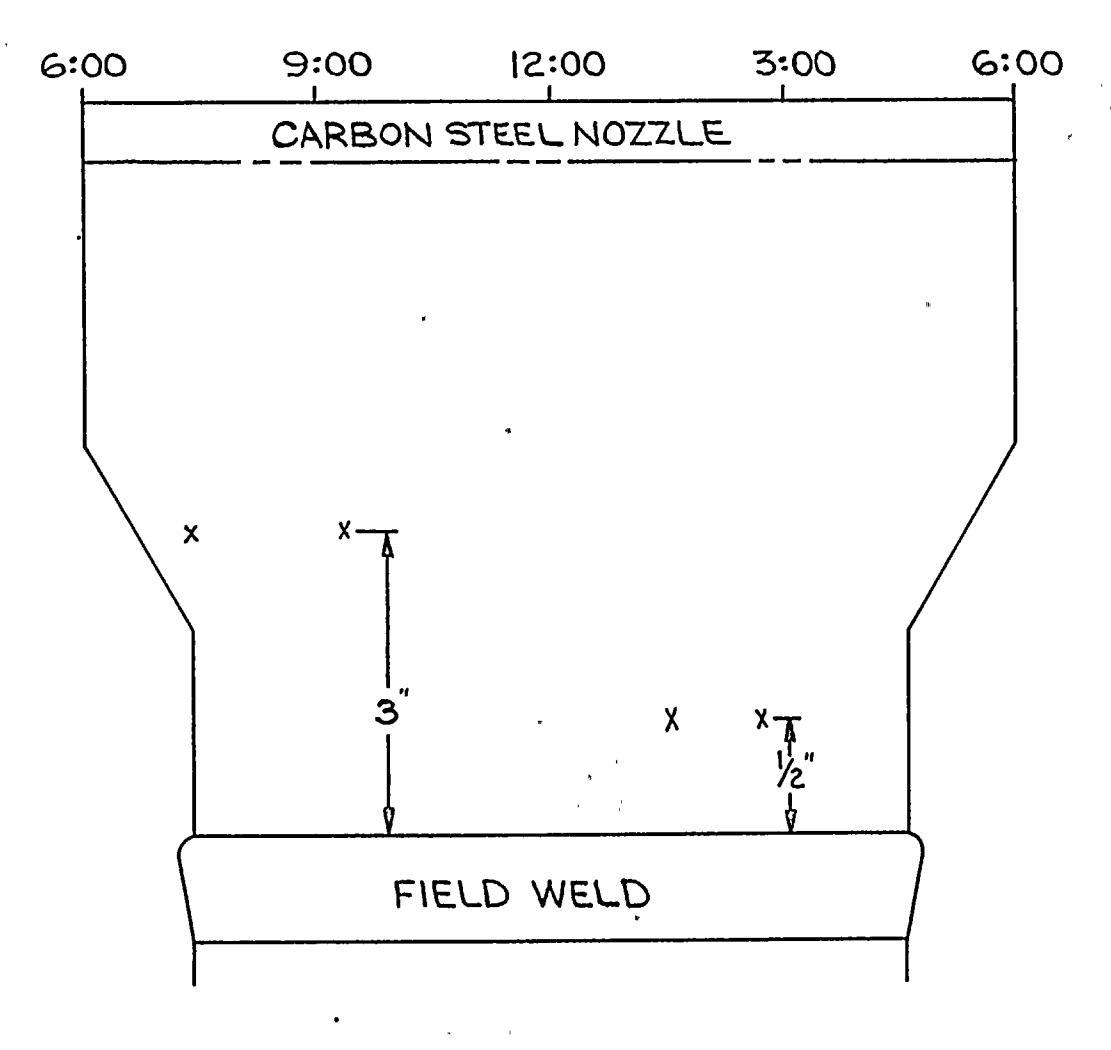
IDENTIFICATION: NIC-RECIRC. INLET SAFE END O.D. INSPECTION DATE: 3-13-70 BY: Original Signed by M. Johnson Marc

REMARKS: ALL INDICATIONS REDEVELOPED

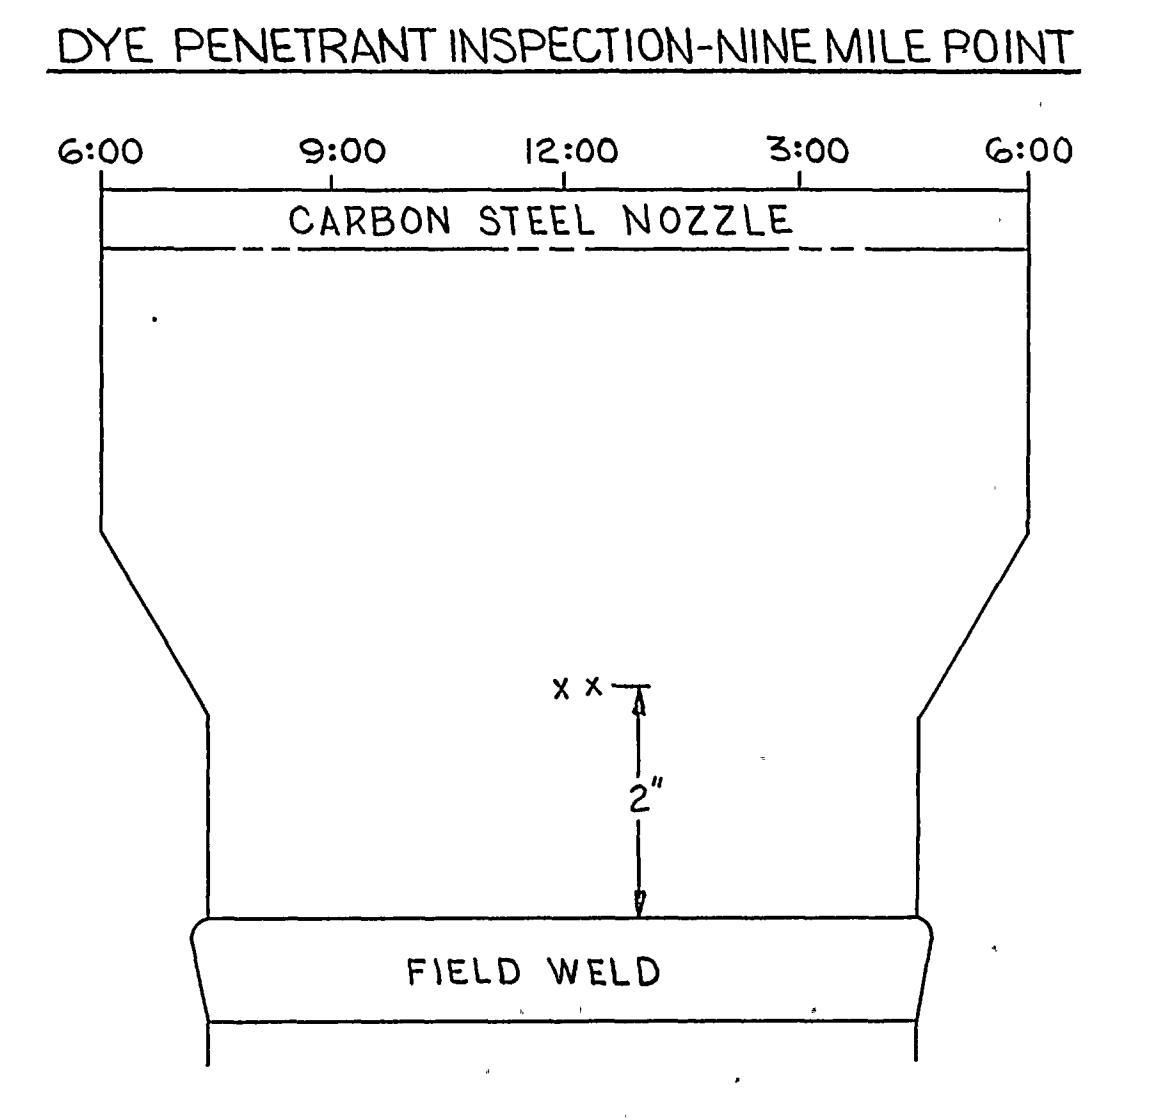
IDENTIFICATION: NID-RECIRC. INLET SAFE END O.D. INSPECTION DATE: 3-13-70 BY: Original diquid by M. foliame / Miles

REMARKS: ALL INDICATIONS REDEVELOPED

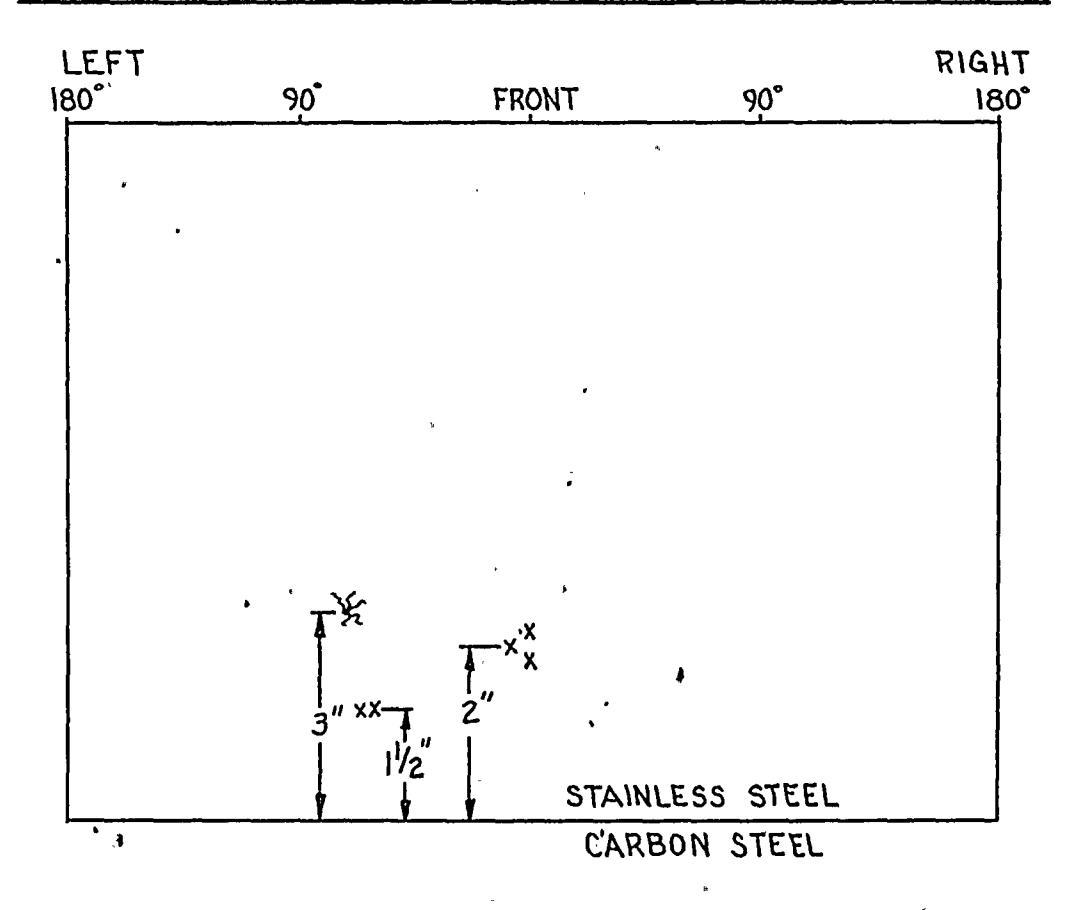
IDENTIFICATION: N7M-VESSEL HEAD SAFE END O.D. INSPECTION DATE: 3-12-70 BY: Original Ligned Ly Mr. Johnson'/Mar

REMARKS: PHOTO 2-5 SHOWS LINEAR CRAZE INDICATION ALL INDICATIONS REDEVELOPED

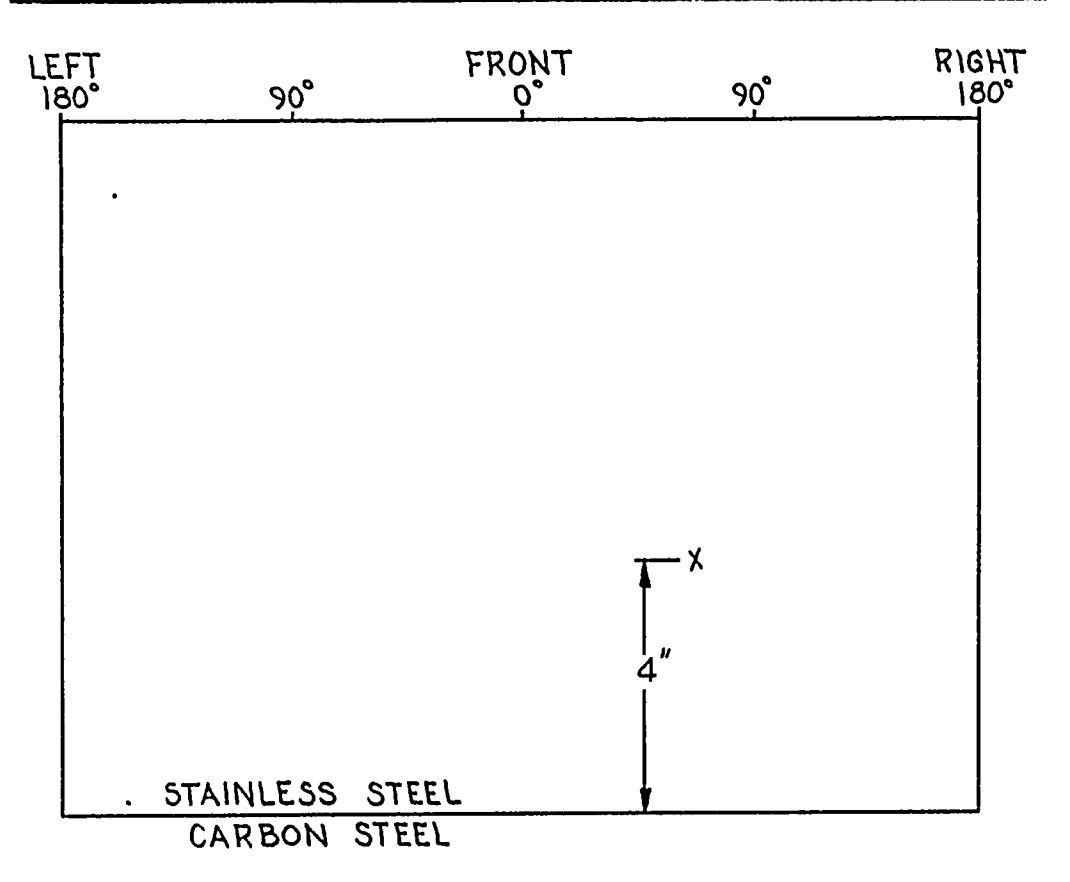
IDENTIFICATION: NTK-VESSEL HEAD SAFE END O.D. INSPECTION DATE: 3-12-70 BY : Original sligned by Mr. Johnson / Muc.

INDICATION REDEVELOPED

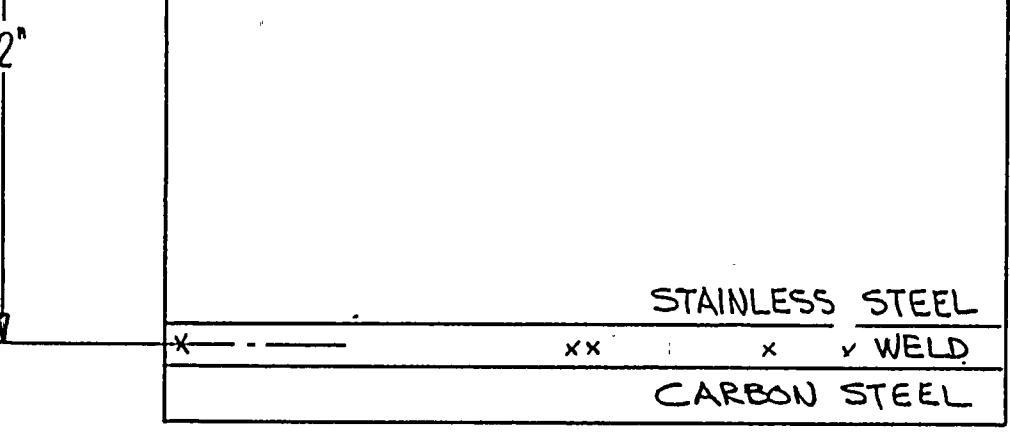
IDENTIFICATION: N7F-VESSEL HEAD SAFE END I.D. INSPECTION DATE: 3-28-70 BY: P.E. Lundeman

REMARKS: PHOTO 3-12 SHOWS FRONT INDICATION.

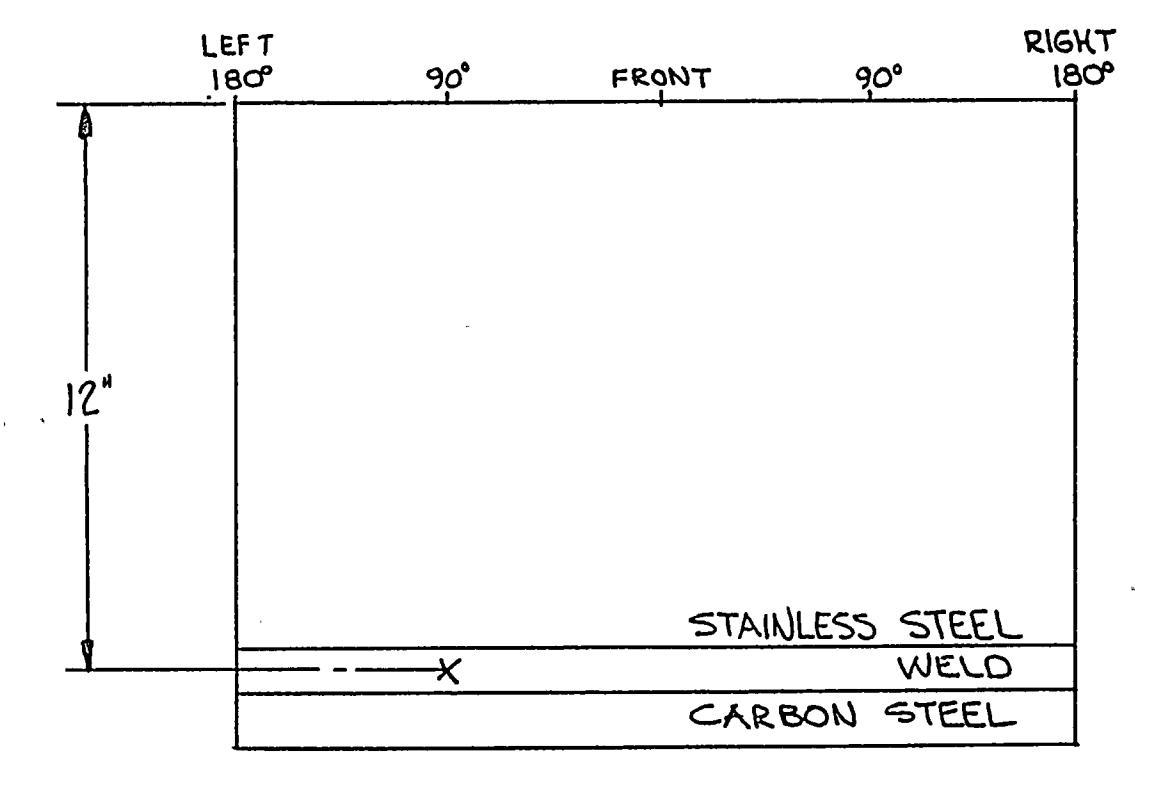
REMARKS; PHOTO 4-3 SHOWS 90° LEFT INDICATION

IDENTIFICATION-NTJ-VESSEL HEAD SAFE END I.D. INSPECTION: 3.28-70 BY: R.E.Sundamon

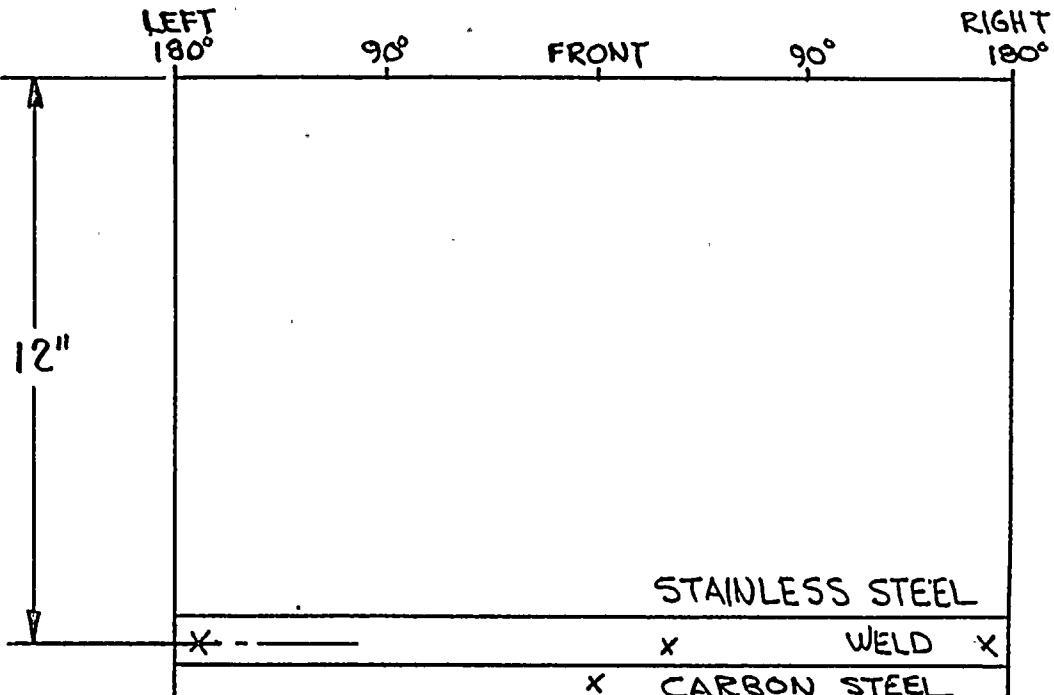
IDENTIFICATION : NTR-VESSEL HEAD SAFE END I.D. INSPECTION DATE: 3-129-70 BY R.E. Lindeman

REMARK: PHOTO 4-6 SHOWS FRONT RIGHT INDICATION

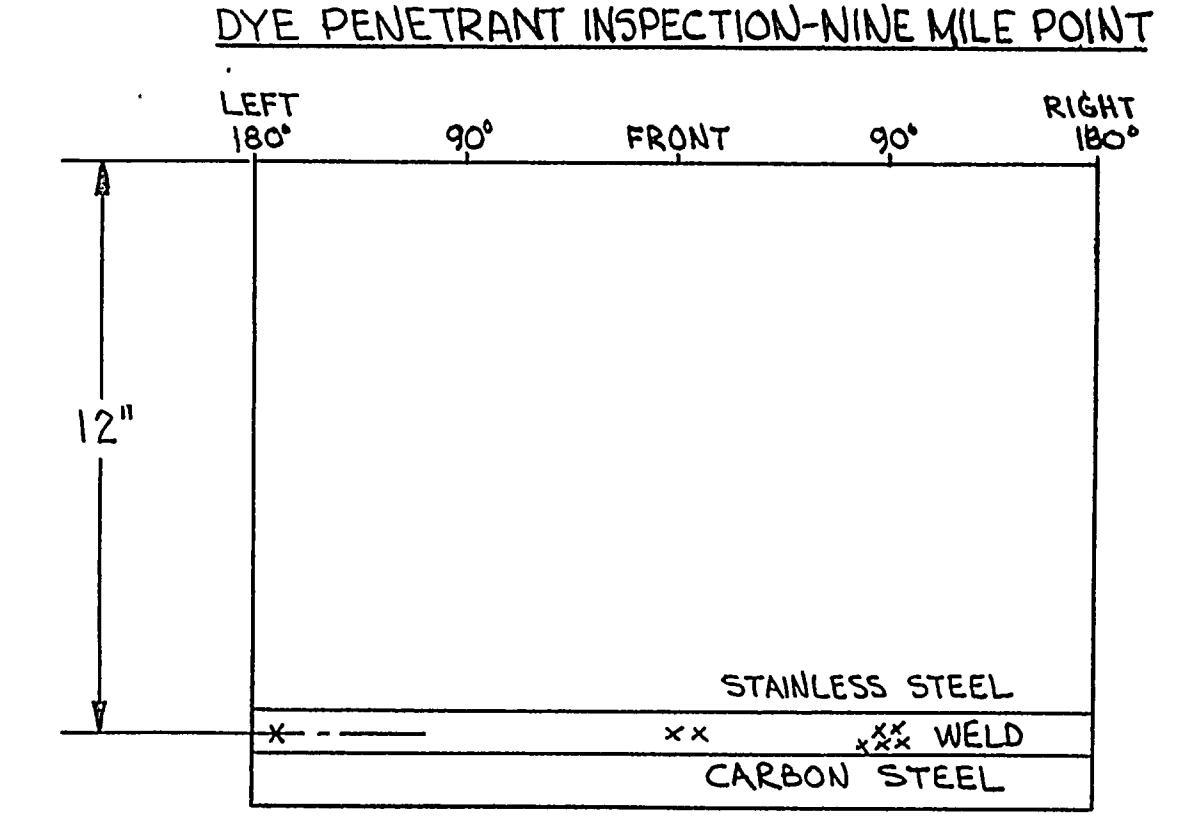
IDENTIFICATION: N7G-VESSEL HEAD SAFE END I.D. INSPECTION DATE: 3-28-70 BY: R.E. Lindman

REMARKS: PHOTO 3-1 SHOWS GO® RIGHT INDICATION PHOTO 3-2 SHOWS 150° LEFT INDICATION PHOTO 6-1 SHOWS LEFT 90° AFTER GRIND PT PROCEDURE USED: 21A8570

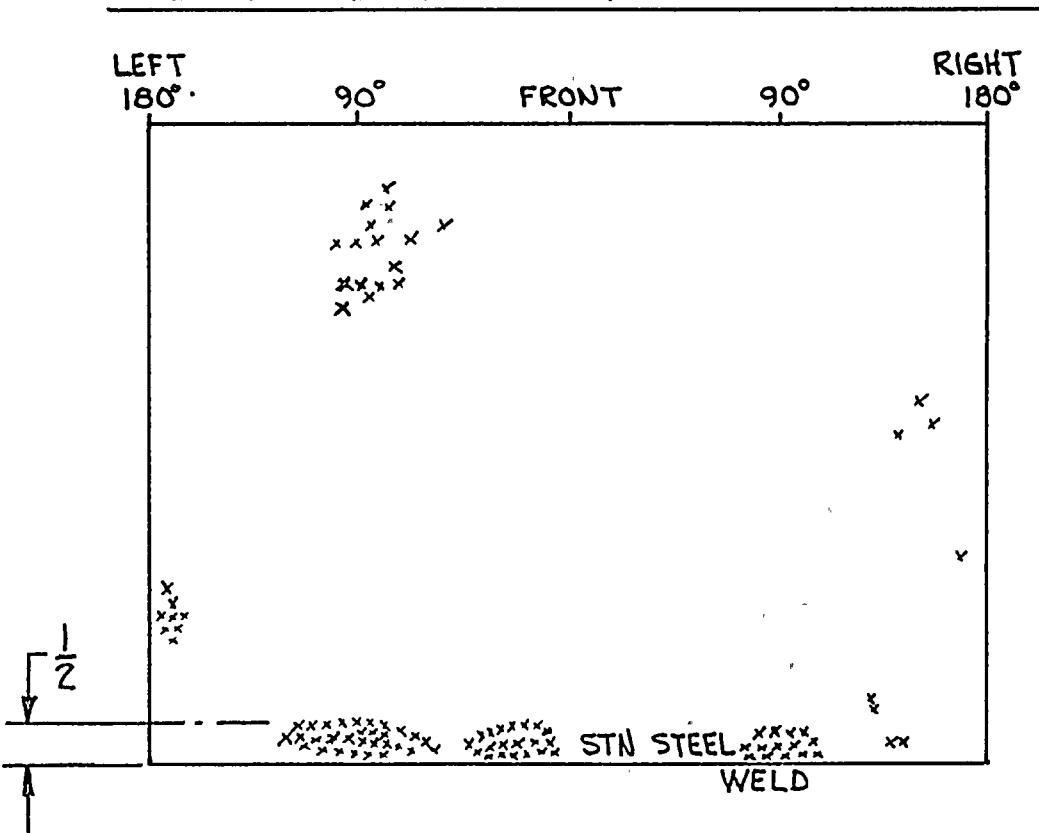
IDENTIFICATION: N7P-VESSEL HEAD SAFEEND O.D. INSPECTION DATE: 3-30-70 BY: B.E. Lindman

REMARKS: PHOTO 3-5 SHOWS FRONT LEFT INDICATION PHOTO 6-2 SHOWS RIGHT FRONT AFTER GRIND.
