REACTOR PRIMARY SYSTEM INVESTIGATION

AT NINE MILE POINT NUCLEAR STATION

May 1, 1970

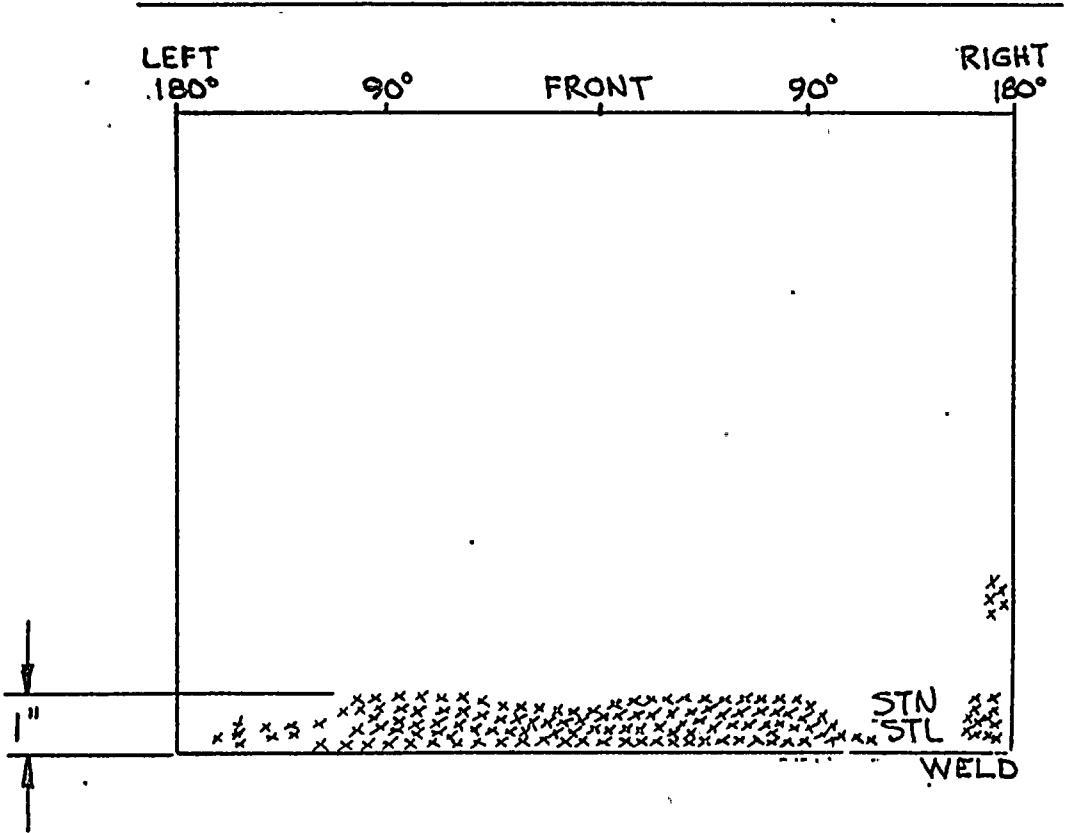
IDENTIFICATION:N7R-VESSEL HEAD SAFE END O.D. INSPECTION DATE: 3.30-70 BY: P.E. Lindunan

REMARKS: PHOTO 3-6 SHOWS FRONT RIGHT INDICATIONS. PHOTO 6-3 SHOWS RIGHT FRONT AFTER GRIND

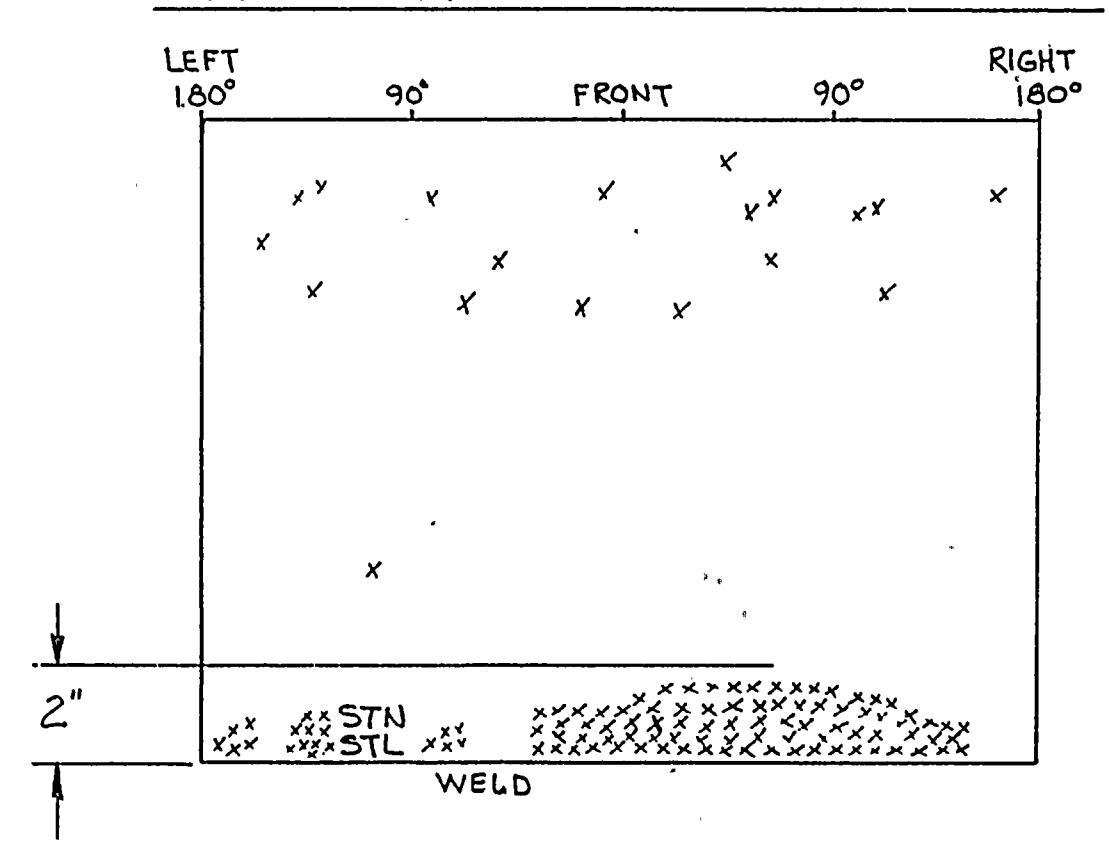
IDENTIFICATION: N75-VESSEL HEAD SAFE END O.D. INSPECTION DATE: 3-30-70 BY: R.E. Lindman

REMARKS : PHOTO 3-7 SHOWS 90° RIGHT INDICATION PHOTO 6-4 SHOWS LEFT FRONT AFTER LIGHT GRIND.

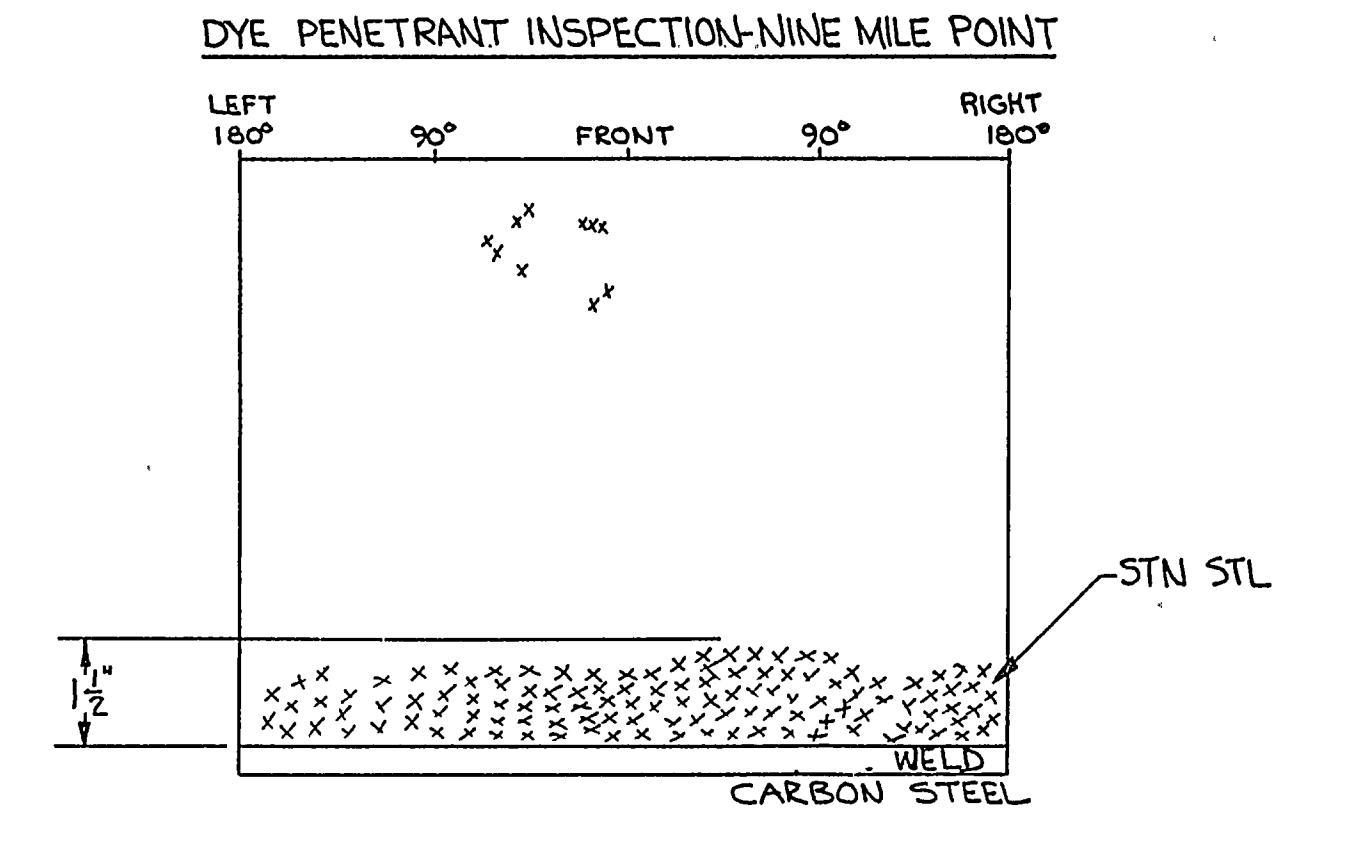
IDENTIFICATION: NT U-VESSEL HEAD SAFE END O.D INSPECTION DATE: 3-30-70 BY: R.E. Lindman

REMARKS PHOTO 3-8 SHOWS FRONT LEFT INDICATION. . PHOTO 6-5 SHOWS RIGHT 120° AFTER GRIND LESS INDICATION AFTER GRIND.

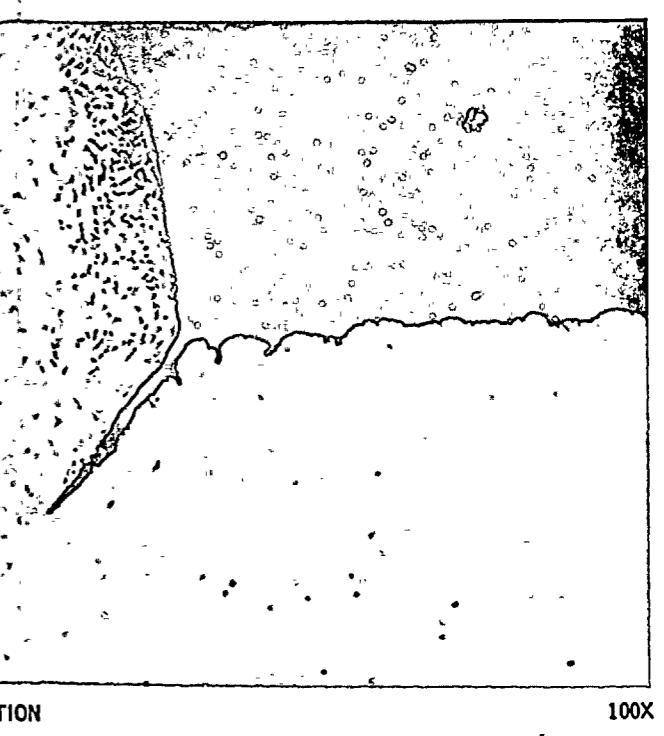
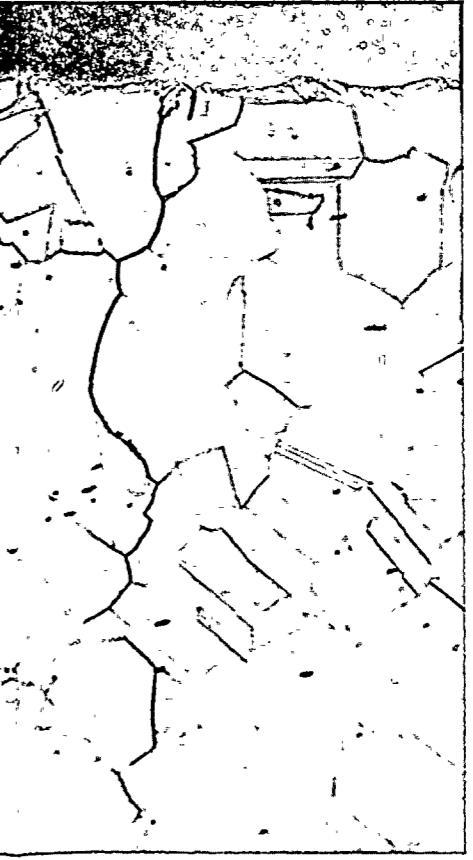
FIGURE C-2. ROOF OF SAFE END-TO-PIPE FIELD WELD CORE SPRAY SAFE END N6B-SAMPLE NO. 1

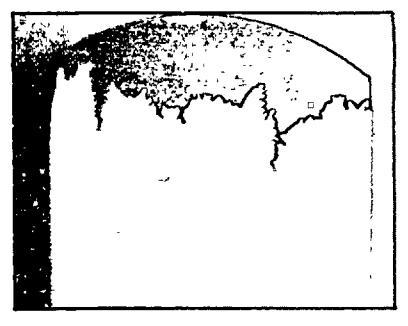
MORPHOLOGY OF AXIAL CRACKS IN FAILED FIGURE C-3. SAFE END - SAMPLE NO. 1

150 mils BELOW O.D. SURFACE

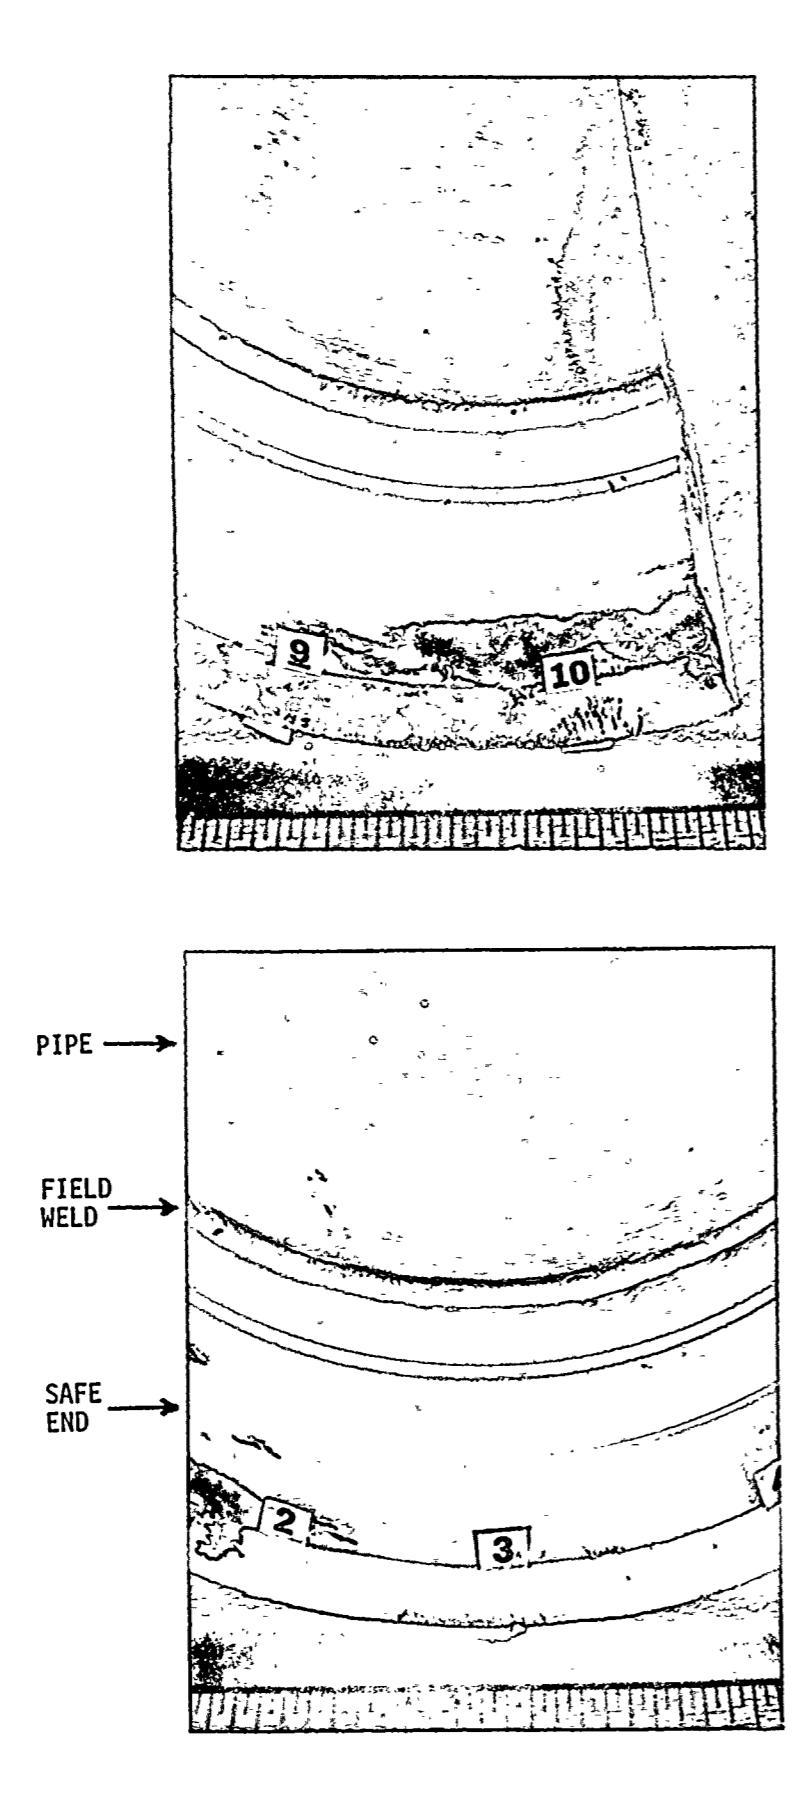
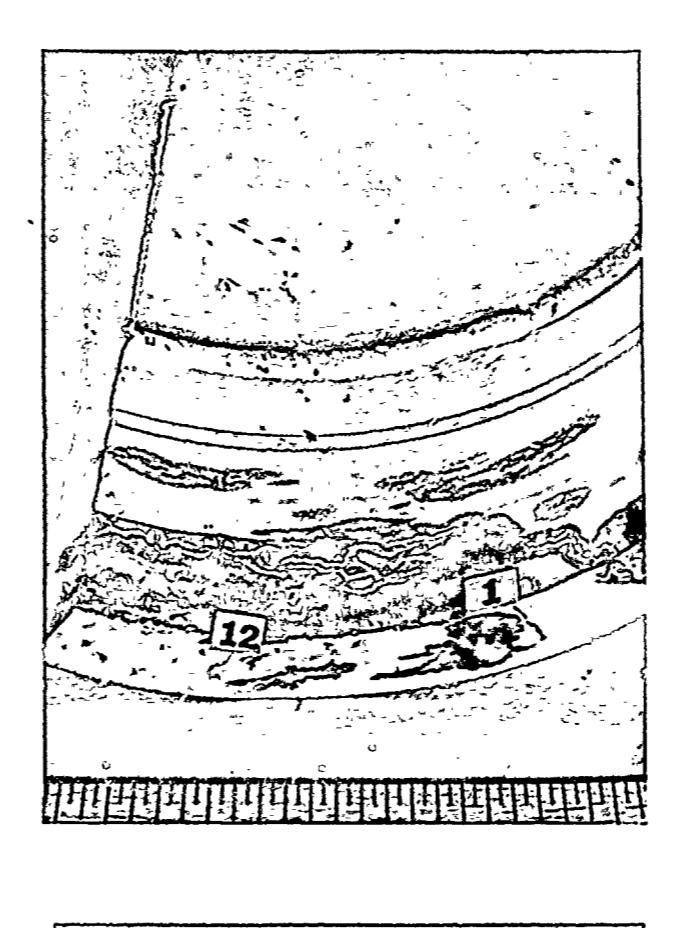
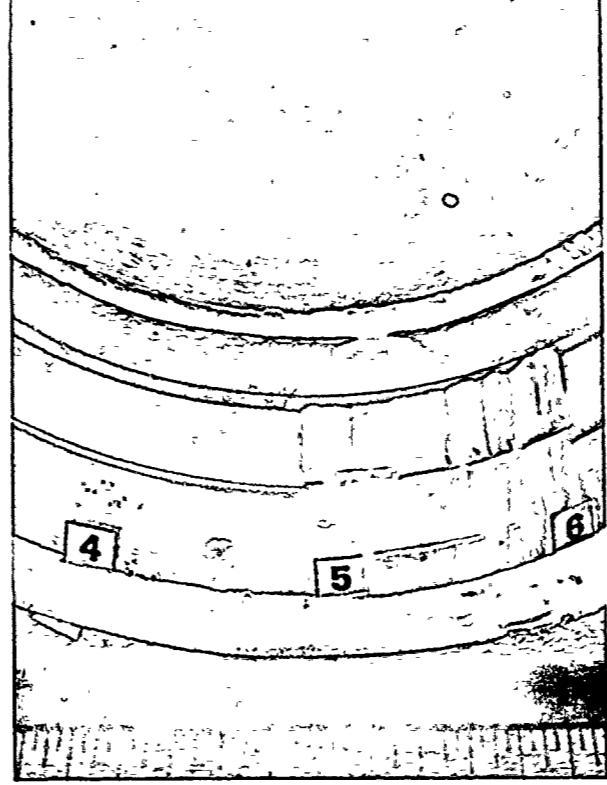
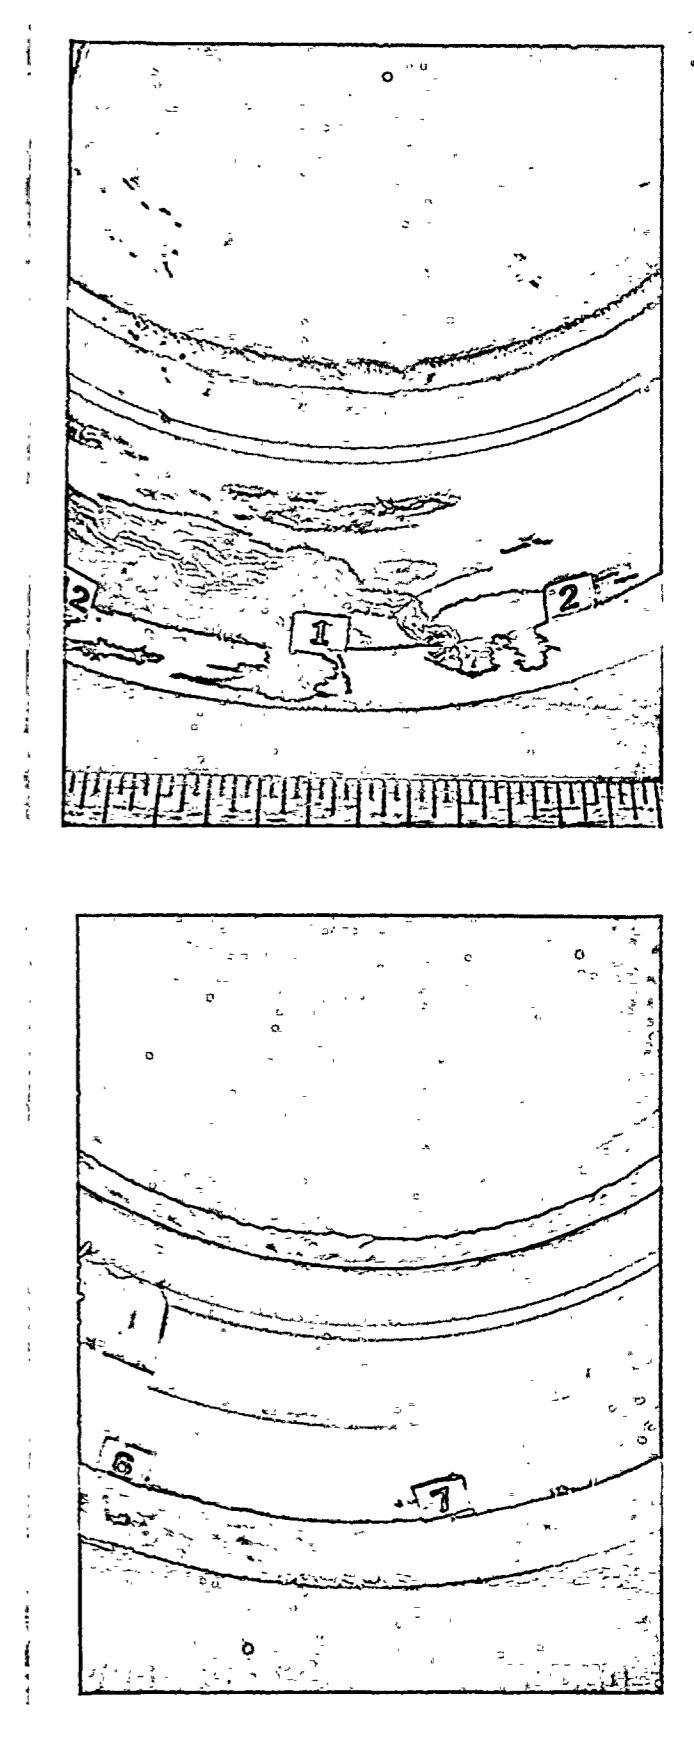
FIGURE C-10. LIQUID PENETRANT RECORD, AS RECEIVED, XAMPLE NO. 1, (I.D.), CORE SPRAY NOZZLE SAFE END N6B. Photos 50-53G, A, B, C, D, E.

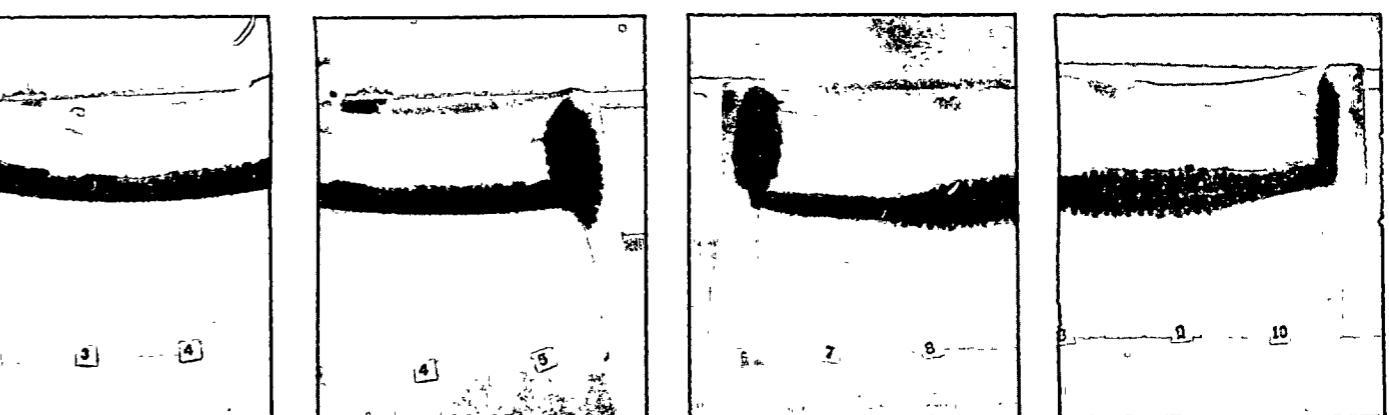
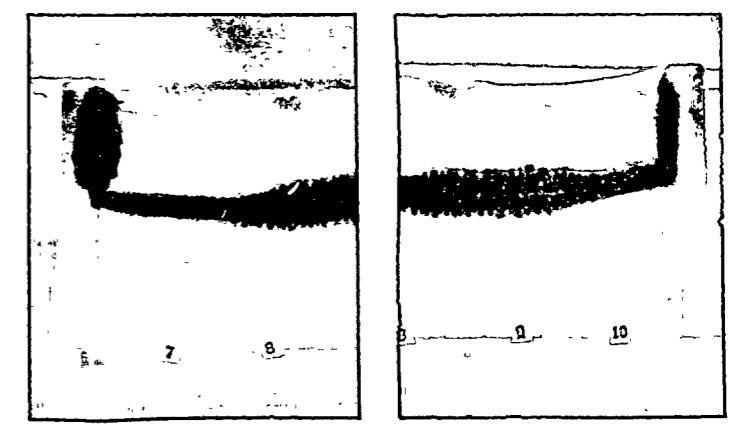
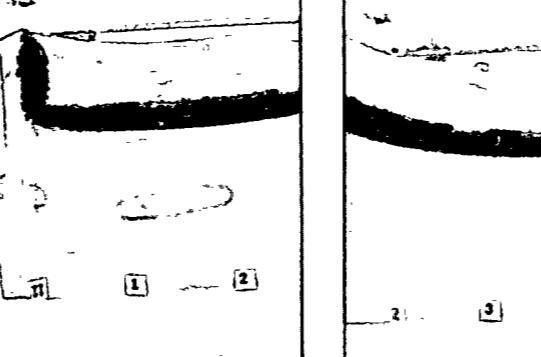
FIGURE C-11. DYE PENETRANT TEST OF SAMPLE NO. 3, I.D. AND O.D. • .

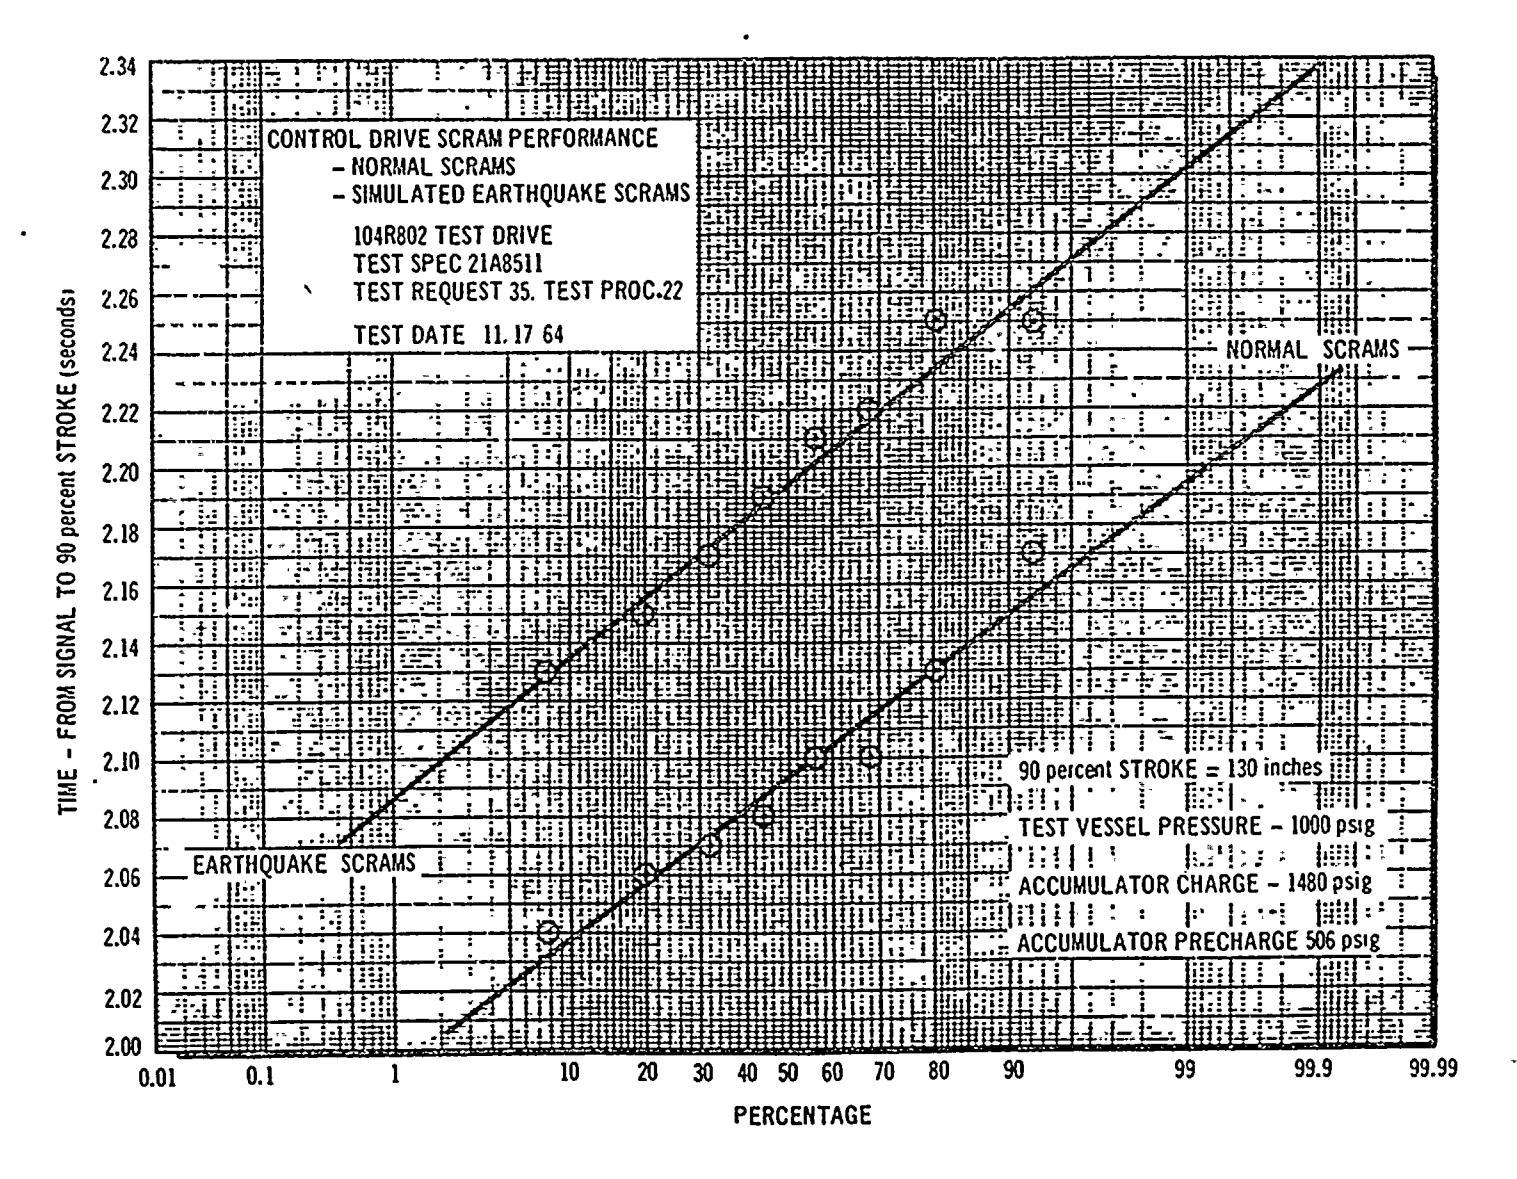
FIGURE 4-5 EARTHQUAKE SCRAM COMPARISON-PROBABILITY PLOT

The effect of misalignment of the drive housing with respect to the core was evaluated in a series of tests conducted on a prototype unit in 1964. Results from this test are shown in Figure 4-5. In this test, the bottom of the housing was displaced from the center line by 1 inch, corresponding to an angular misalignment of approximately 1/2 degree. The change in scram time was approximately 0.1 second. The test was run with the bottom of the housing being oscillated with a displacement of 1 inch at its natural frequency, and is not a direct measure of the performance with a fixed core displacement. It is, however, indicative of the magnitude of misalignment required to have a measurable effect on scram performance.

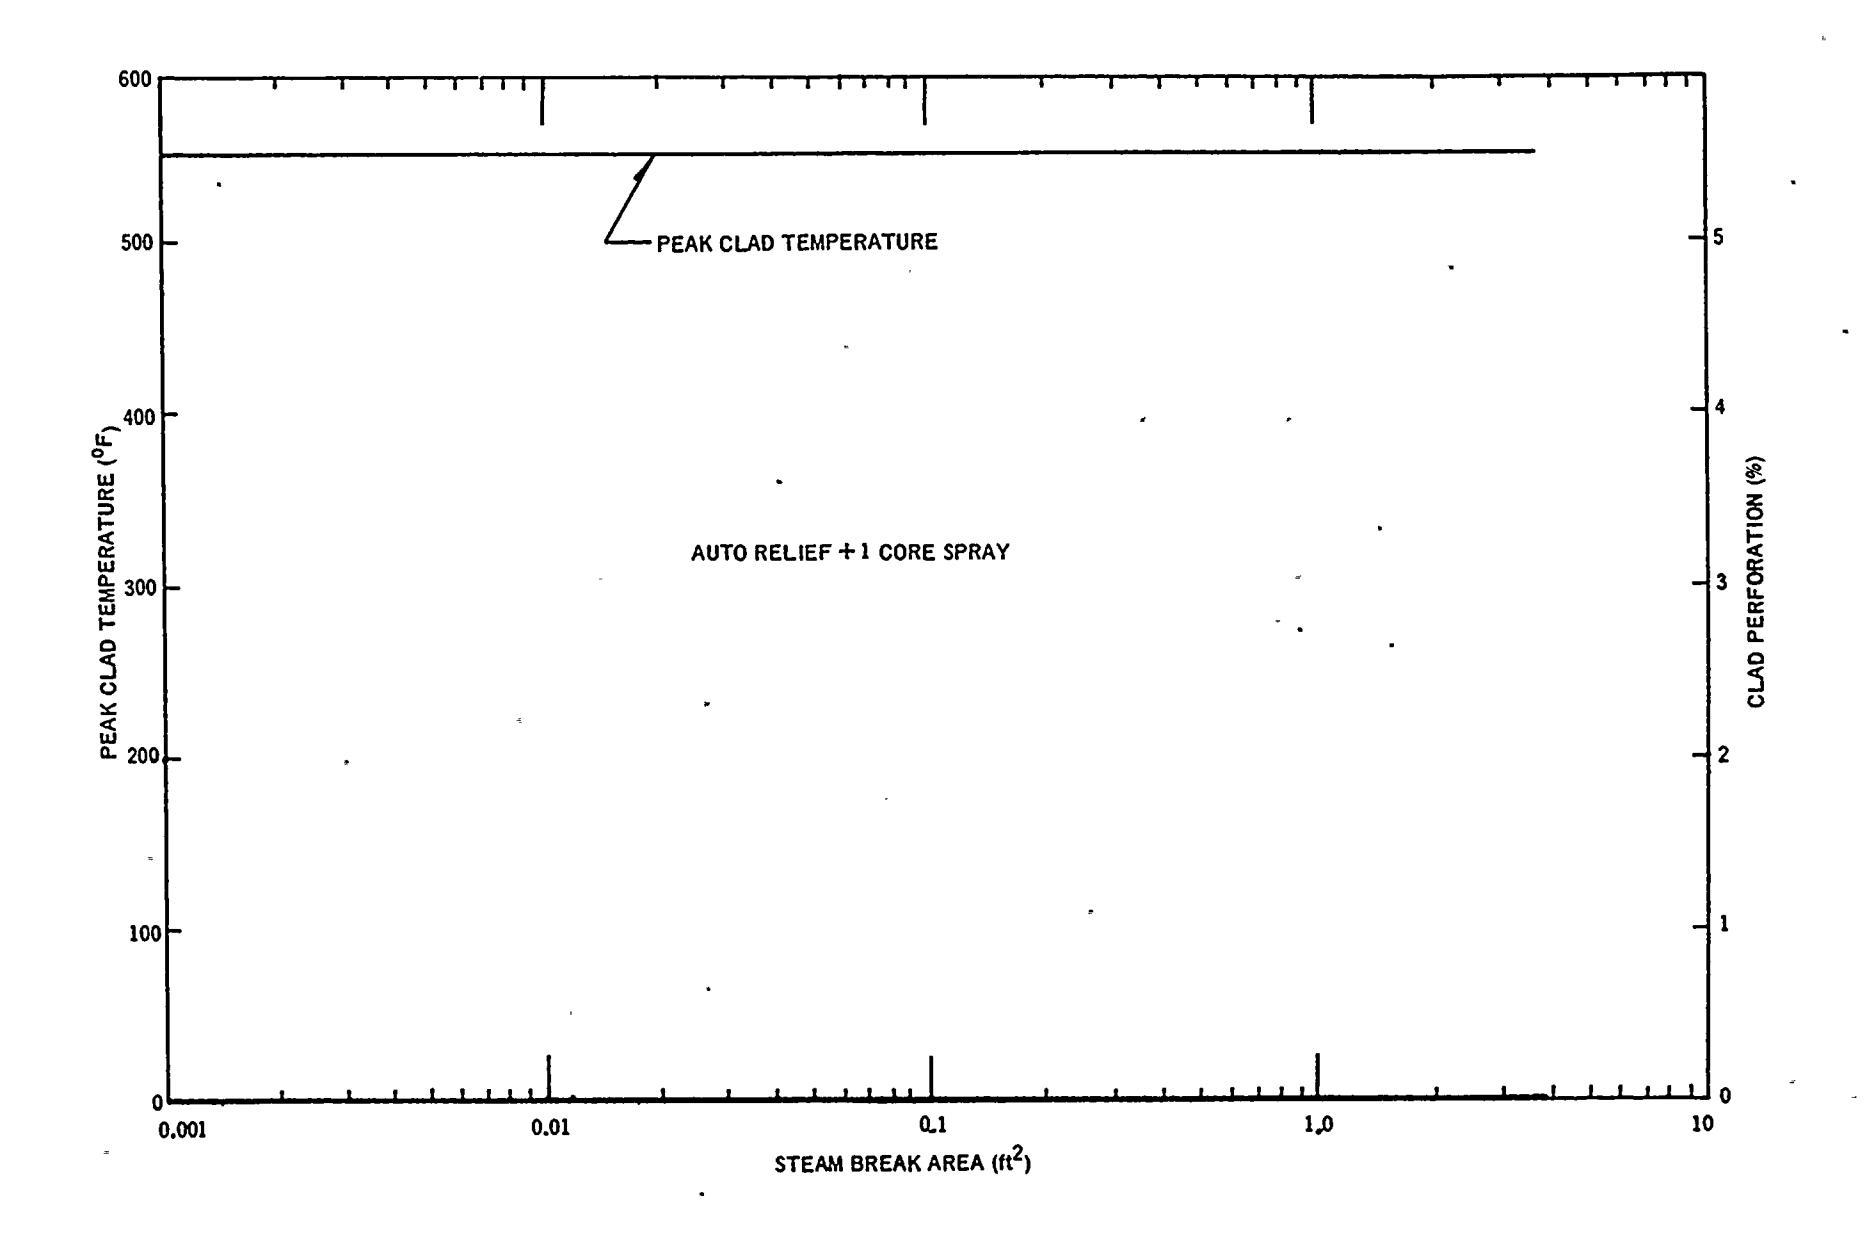
FIGURE4-8 PEAK CLAD TEMPERATURE VERSUS STEAM BREAK AREA

All of the liquid lines listed in Tables 4-2 and 4-3 are covered by the analysis results shown in Figure 4-7. Figure 4-8 shows peak clad temperature as a function of break size for steam breaks.' Steam breaks up to and including the main steam line (not a sensitized safe end) do not result in core uncovery, thus no clad temperature increase is experienced.

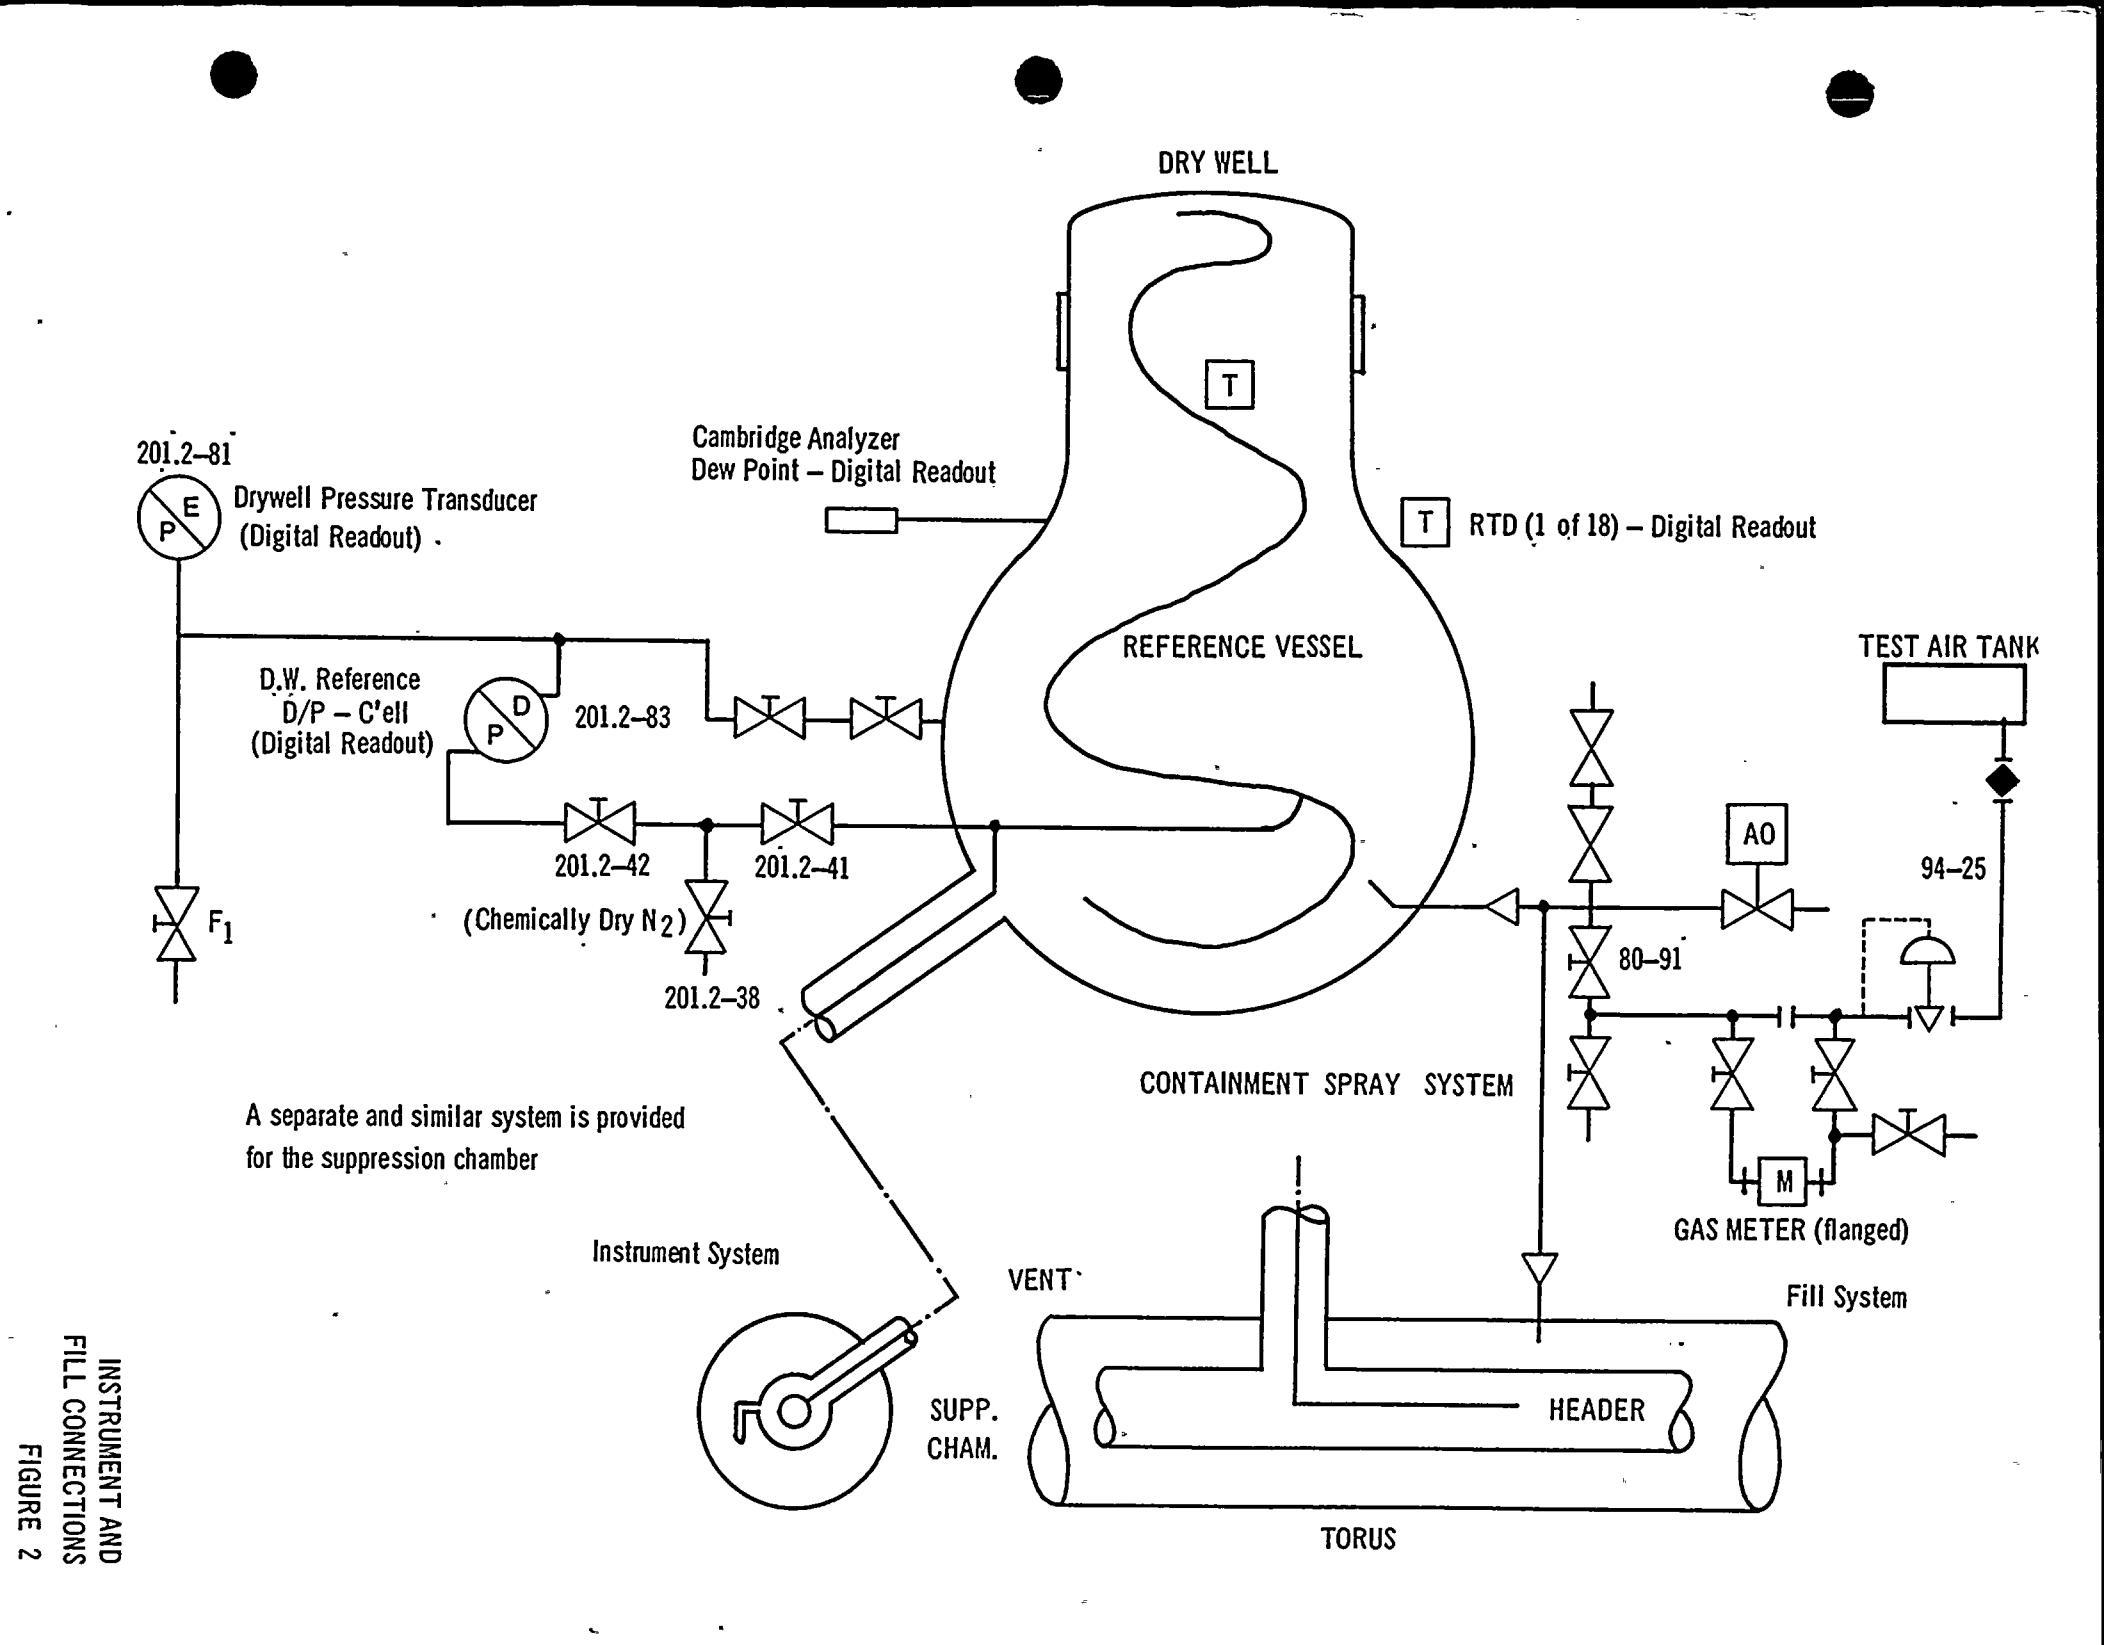
5.1 Overall leakage is measured using the reference vessel method. Calibrated resistance temperature sensors and suitably proportioned tubing type reference systems are distributed in the drywell and suppression chamber. Figure 1. A remote sampling system using heated probe extensions outside the vessel supplies a dew point detector. Read out is by means of precision electronic instruments. Test air is supplied through the containment spray system.

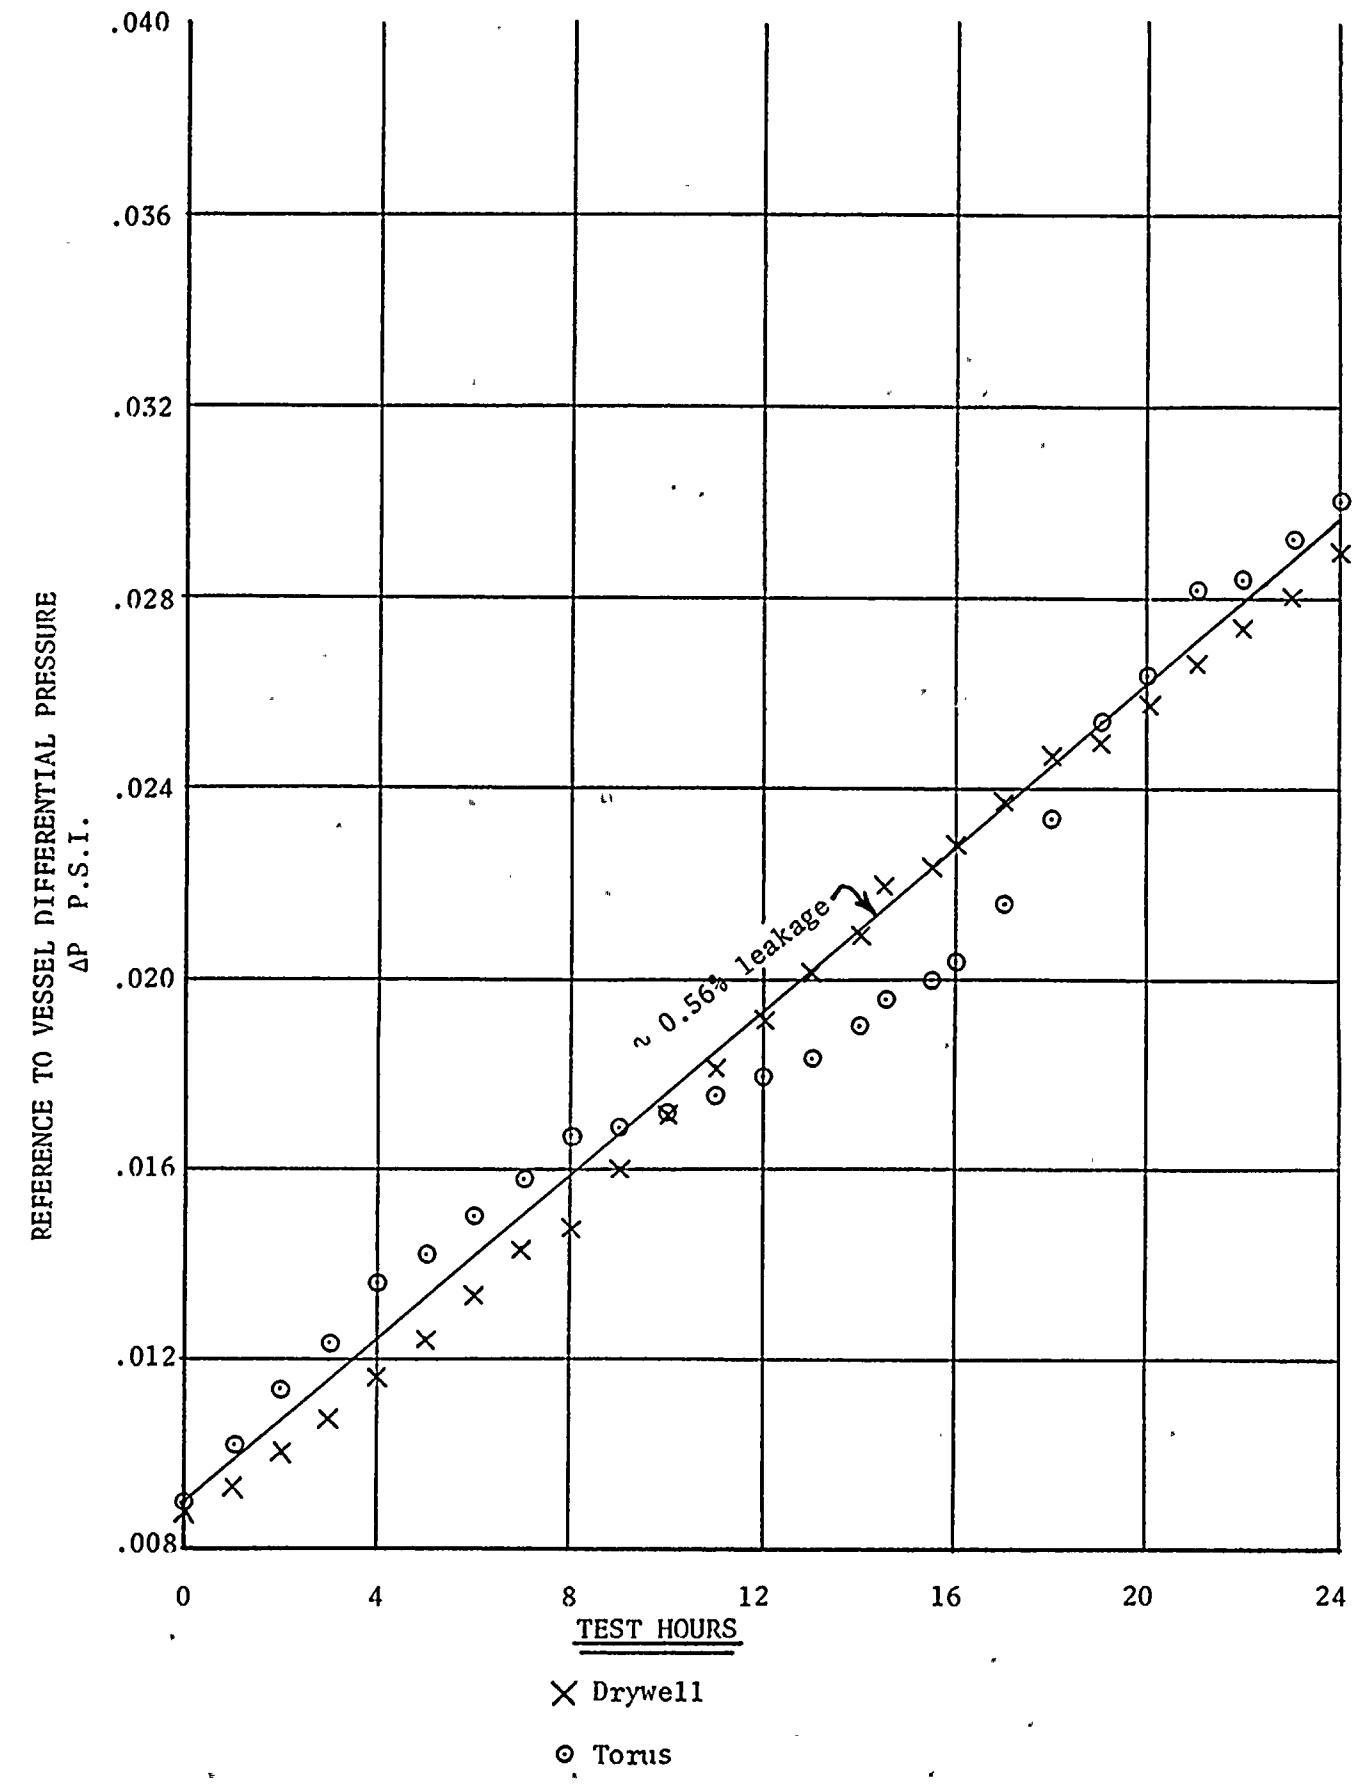
Test Data

#### % Leakage @ 22 psig = 0.56% in Drywell

### % Leakage @ 22 psig = 0.57% in Torus

Combined leakage (.61) (.56) + (.34) (.57) = 0.56%

As found on June 28, 1970, the primary containment leakage of 0.56% was well below the allowable operational leak rate  $[L_{to}_{(22)}]$  of 0.87% as derived from the Technical Specifications and the preoperational leak test of August, 1969.
