PLANT NAME: NINE MILE POINT #1

Re: Nine Mile Point Unit 1
Docket 50-220
DPR-63

Laboratory Examination of Cracked 6" Type 304 Pipe
From Nine Mile Point Cleanup System.

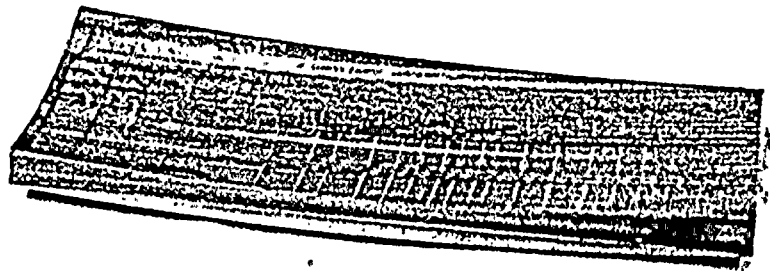
Figure 2. - Pipe Inside Surface

The outside of the pipe, as received, is shown in Figure 1. The crack appears to be longitudinal, on the outside surface of a 45° bend. A small area of the crack had been cleaned and polished by the customer prior to shipping the pipe. Radiation readings on the pipe were 5R at contact. In order to minimize personnel exposure, the section containing the crack was removed by sawing, and the remaining pieces were stored. The inside surface of the pipe is shown in Figure 2. The inside surface appears to have been severely deformed. This most probably occurred during removal of the mandrel used in the cold bending operation. The visible crack was longer on the inside surface than on the outside surface.
