Re: Nine Mile Point Unit #2
Docket No. 50-410

BIOLOGICAL SHIELD WALL

INTERIM REPORT

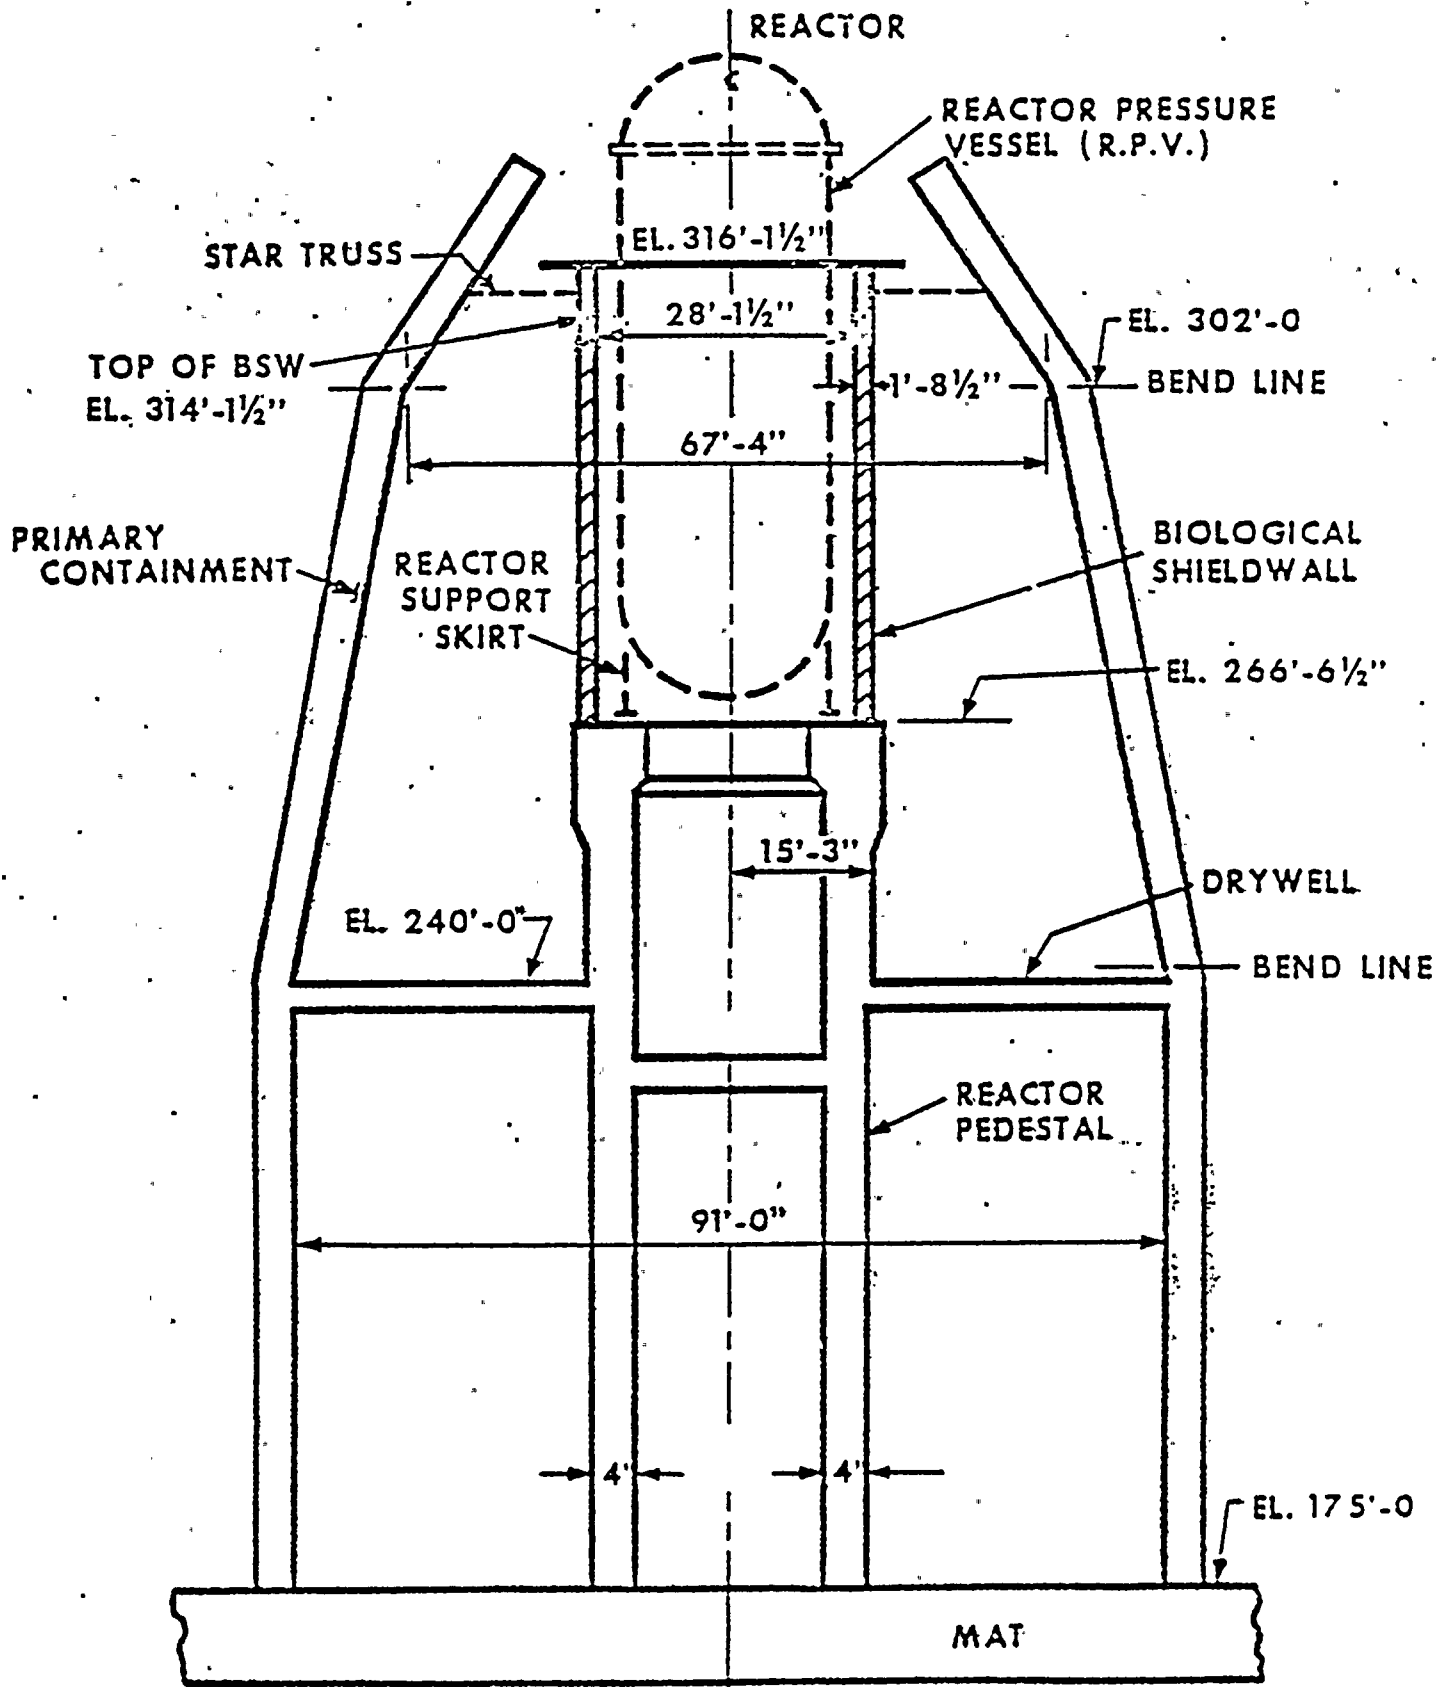
FIGURE 1

The biological shield wall will sit on the reactor pedestal (Figure 1) and will be attached to the pedestal by means of embedded anchor bolts (Figure 2). The biological shield wall consists of two concentric steel cylinders connected by horizontal and vertical stiffeners (Figures 3 and 4). The shield wall is 48 ft - 4 inches high and has an inner radius of 14 ft - 3/4 inch and an outer radius of 15 ft - 9 1/4 inches. The biological shield wall was fabricated in three rings, each approximately 16 feet high. Each ring was fabricated in three 120 degree sections. The inner and outer shells and the stiffeners are 1 1/2 inches thick, A537 Class 1 steel plates connected by full penetration welds. The space between the shells will be filled with nonstructural heavyweight concrete for neutron radiation shielding purposes. The shield wall is penetrated by air duct openings, inspection openings, instrumentation line pipe sleeve penetrations, and door openings for various piping systems. Attached to the wall are pipe restraints, a shield wall extension to support the star truss and stabilizer, clip angle supports for floor beams, and insulation support brackets.
