METALLURGICAL INVESTIGATIONS OF TWO
TWO FAILED COMPONENTS

PART ONE: PLUG AND VALVE STEM,
PART NO. FW-13A-FCV

PART TWO: STAINLESS STEEL WELD METAL
FROM FEEDWATER PIPE

NIAGARA MOHAWK POWER
CORPORATION

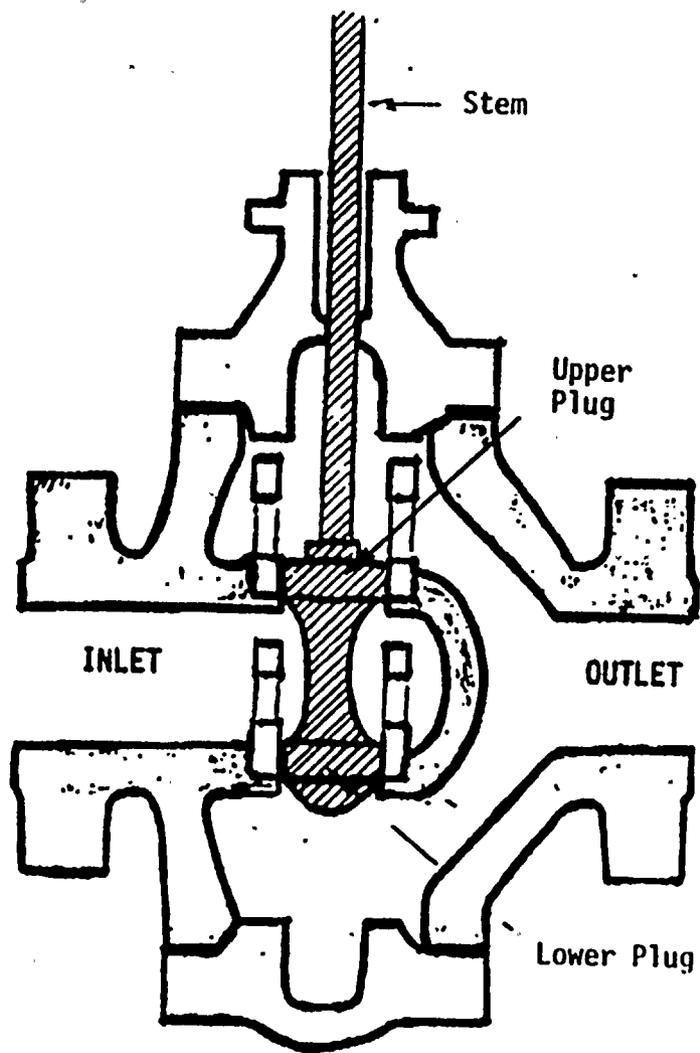
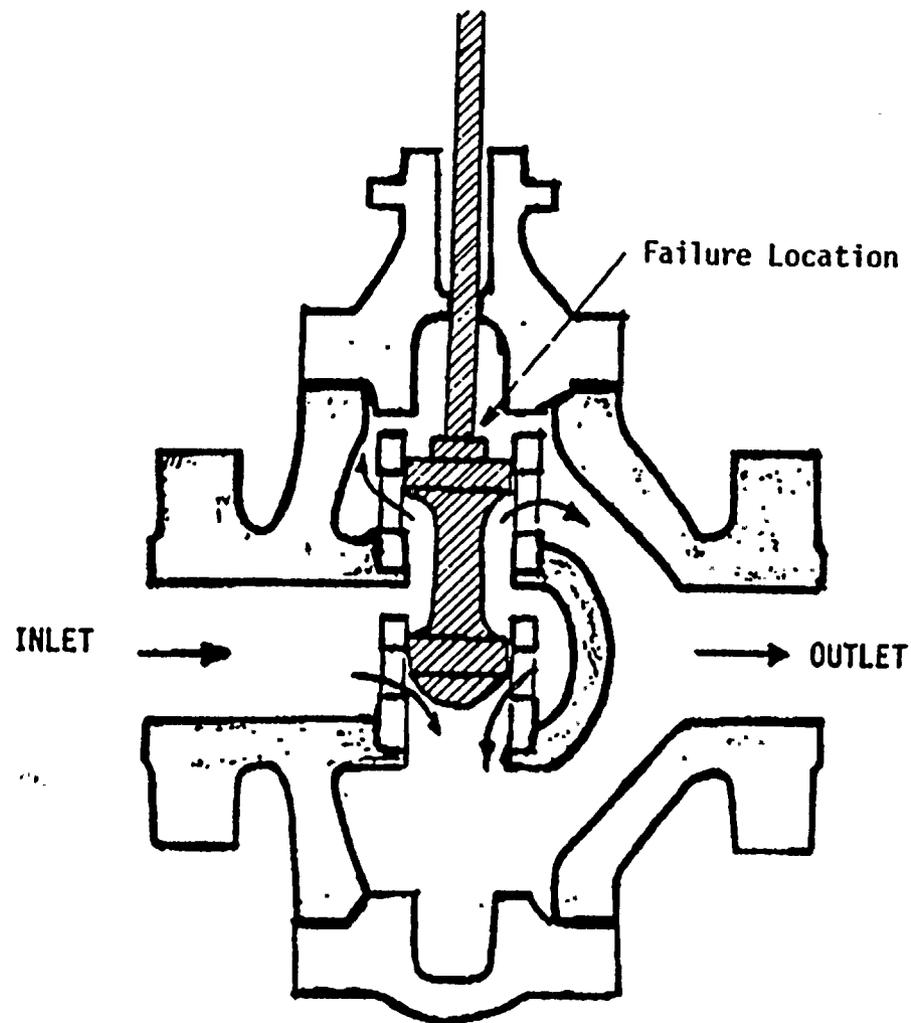
FIGURE 1. SKETCH OF THE FLOW-CONTROL VALVE SHOWING THE STEM/PLUG COMPONENT, PART NO. FW-13A-FCV
(Cross-hatched area) Drawing supplied by NMPC

Figure 1b. The failure was a transverse fracture of the 1-inch-diameter stem through the fillet weld.

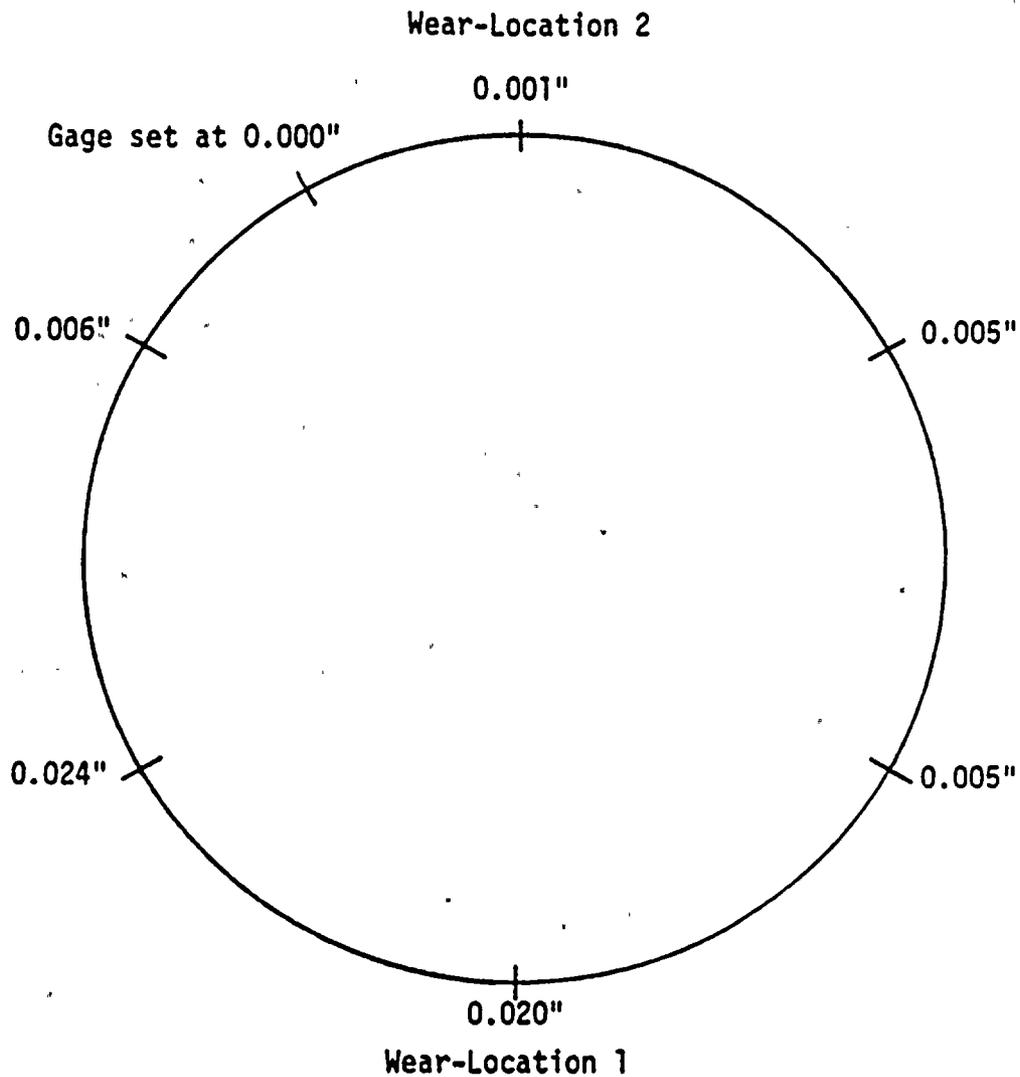
FIGURE 3. SKETCH SHOWING THE DEPTH OF WEAR AT THE 60-DEGREE WEAR LOCATIONS ON THE LOWER PLUG

Measurements of the depths of wear on the lower plug were made using a dial-displacement gage while the plug was rotated 360 degrees in a lathe. The gage was adjusted to zero at a location on the cylindrical surface midway between two wear areas. The results of the depth measurements are recorded in Figure 3. Two adjacent wear areas were worn to depths of 0.020 and 0.024 inch, respectively. The depths of the remaining wear areas were 0.006 inch or less. The primary fatigue-crack-origin region was found to be aligned with, and on the same side of the valve stem, as was the area, Wear-Location 1 in Figure 3, that was worn to a depth of 0.020 inch. The secondary fatigue-crack origin was on the same side and aligned with the wear area identified in Figure 3 as Wear-Location 2.

The primary fatigue-crack origin was approximately in alignment with, and on the same side of the stem, as was the side of the lower plug at Wear-Location 1 in the sketch. Similarly, the secondary fatigue-crack origin was in alignment with Wear-Location 2 in the sketch.

Recommendations to prevent such failures in the future are: (1) to increase the diameter of the stem and to use a streamline, elliptical, or parabolic form of fillet at the welded joint, and (2) to consider a change of design and/or material for the plug to provide better wear resistance of the lower end of the plug.

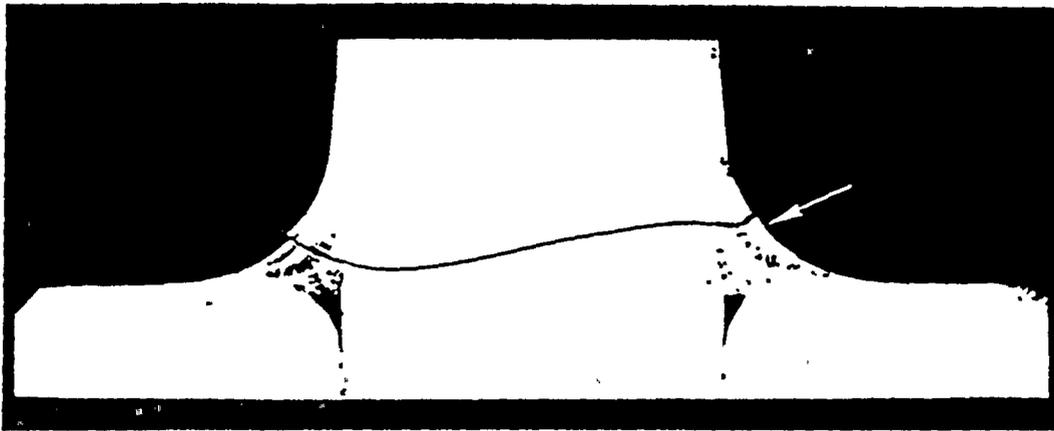
FIGURE 8. A METALLOGRAPHIC CROSS SECTION THROUGH THE PRIMARY FATIGUE-CRACK-ORIGIN REGION

The fracture was observed in the metallographic sections to be transgranular through the weld metal and across the stem. The microstructure of the weld metal was typical of the microstructure of Type 316 stainless steel weld metal in the as-welded condition. The microstructure of the stem was typical of the microstructure of wrought and annealed Type 316 stainless steel. No evidence of sensitization in the microstructure of the weld-heat-affected zone of the stem was observed. A photomicrograph of one of the seven serial sections is shown in Figure 8a. The primary fatigue crack was located on the side of the stem identified by the arrow in Figure 8a; a portion of the fillet weld and crack is shown in Figure 8b at a higher magnification.

The results of the fractographic examinations indicated that the mode of crack propagation was primarily fatigue. The mode of crack initiation, although not observed on the fracture surface since a specific site of crack initiation was not identified, apparently was fatigue also. The macroscopic features of the primary fatigue-thumbail pattern and the microscopic fatigue striations, which were observed, indicated that the general vicinity of the initiation site was subsurface near the root of the weld. The nature of a crack initiator at that location would most likely be that of a weld flaw, such as a hot crack or weld-metal pore. Flaws of that nature are frequently stress-raisers

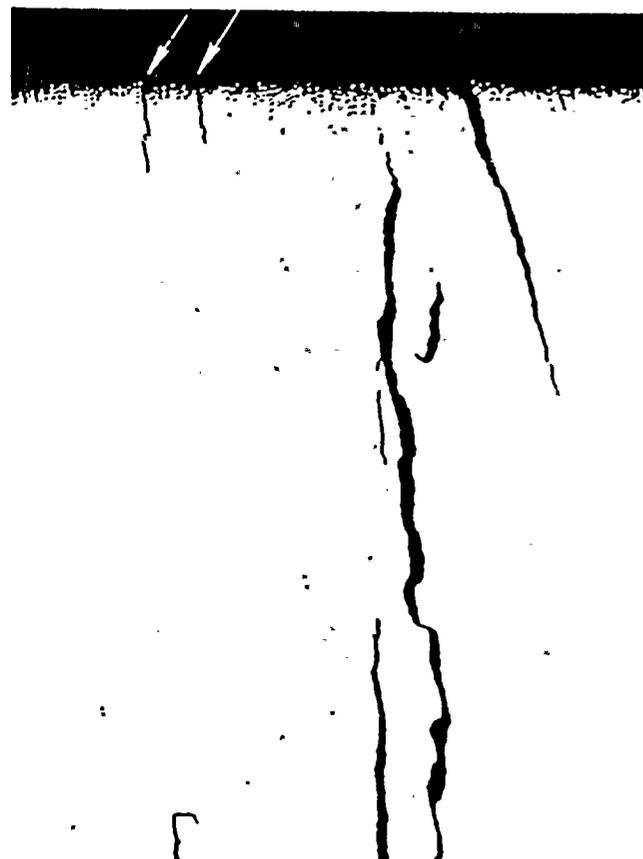
The portion of the metallographic cross section of the boat sample which contained the crack through weld metal is shown in Figure 11a. Intergranular fracture along the columnar grain boundaries of the weld metal is evident in Figure 11a. Figure 11b shows a portion of the intergranular fracture at the outside surface of the weld in a plane different from that shown in Figure 11a. In addition to the intergranular fracture, Figure 11b shows two small transgranular cracks in the outside surface of the weld; those cracks are identified in Figure 11b by arrows. Four other small transgranular cracks were observed elsewhere in the outside surface of the weld. One of the other four cracks is shown in Figure 12. All of the small transgranular cracks exhibited crack-branching; the appearance of the cracks was typical of transgranular stress-corrosion cracking in stainless steel. However, none of the cracks appeared to be associated with, or related to, the intergranular fracture through the weld metal.

b. Cross Section of the Weld at the Outside Surface (arrows identify secondary transgranular cracks)

FIGURE 11. METALLOGRAPHIC CROSS SECTION OF THE BOAT SAMPLE SHOWING THE NATURE OF THE INTERGRANULAR FRACTURE THROUGH WELD METAL

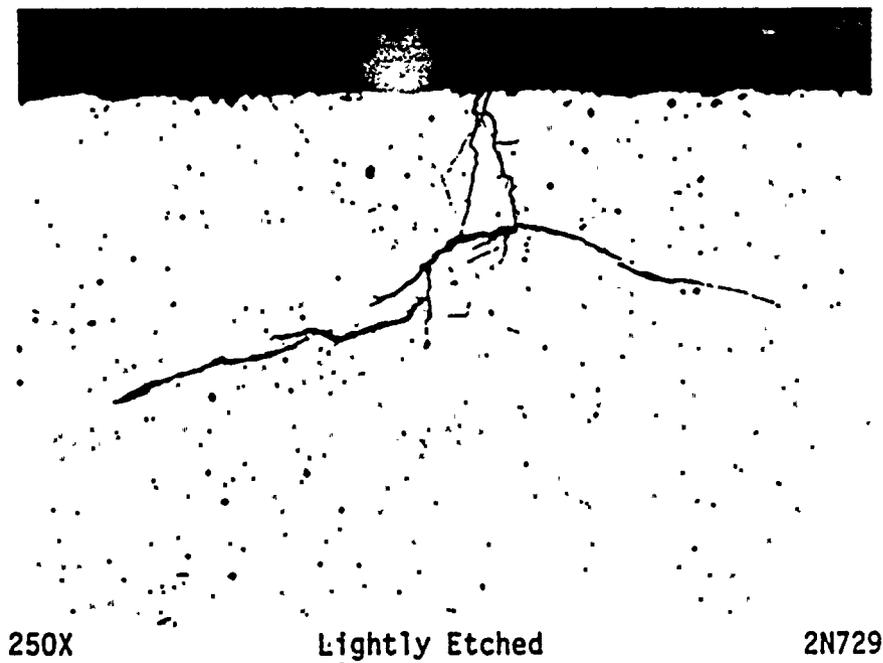
FIGURE 12. ONE OF THE SMALL TRANSGRANULAR STRESS-CORROSION CRACKS OBSERVED IN THE OUTSIDE SURFACE OF THE WELD METAL

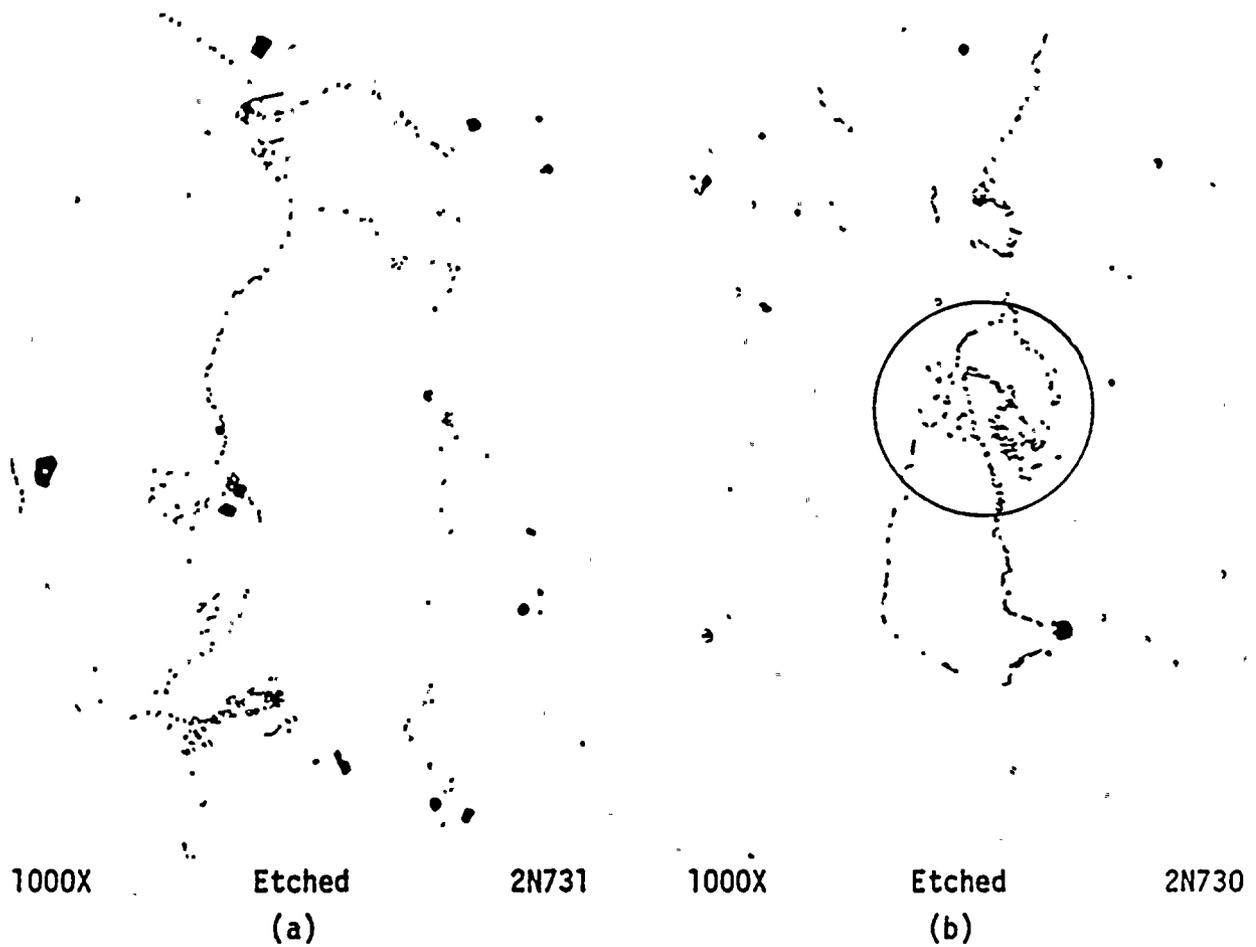
Figures 13a and 13b show examples of the intergranular phase in two areas of the weld metal where the phase was displayed most prominently. The phase was evident in virtually all of the weld-metal grain boundaries observed in the metallographic specimen. Occasionally, the phase exhibited a lamellar morphology, as shown in Figure 13b.

The circled area shown in Figure 13b was selected for the wavelength-dispersive (WDS) analysis. WDS is capable of detecting the presence of elements of atomic Number 5, boron, and higher. The intergranular phase was identified as a carbide by X-ray WDS microprobe analysis in conjunction with the scanning electron microscope. A SEM micrograph (secondary-electron image) of the area is shown in Figure 13c at a higher magnification. An X-ray distribution map of carbon in the area is shown in Figure 13d. The X-ray distribution map reveals a concentration (high-density of white dots in the X-ray distribution map) of carbon in the intergranular phase. A slight concentration of chromium and depletion of iron relative to the concentration of those elements in the surrounding weld-metal matrix also were detected in the phase by the WDS X-ray counts for those elements. Thus, the intergranular phase was most likely an iron-chromium carbide.

The most significant results of the laboratory examinations were (1) the presence of discolorations and corrosion on the fracture surface which was more evident toward the inside surface than toward the outside surface of the pipe, (2) a fracture mode identified as intergranular, and (3) the presence of an intergranular carbide phase. The distribution over the fracture surface of corrosion and discolorations indicated that the failure most likely started on the inside surface of the circumferential pipe weld. The surface of the earlier stages of crack propagation were apparently exposed to the corrosive environment for longer periods of time. The presence of intergranular carbides in the weld metal constituted a sensitized condition of the weld metal. Stainless steels derive their resistance to corrosion principally from the presence of chromium. The formation of intergranular iron-chromium

FIGURE 13. EXAMPLES OF THE INTERGRANULAR CARBIDE PHASE OBSERVED IN THE WELD-METAL GRAIN BOUNDARIES

c. Secondary Electron Image of the Area Encircled in (b) at a Higher Magnification

In order to eliminate sensitization and the subsequent potential IGSCC in austenitic stainless steel weld metal, it is recommended that a stabilized stainless steel welding electrode, such as E347, be used, and that prolonged heating or slow cooling of the weld metal through the temperature range of 1000 to 1550 F be avoided.

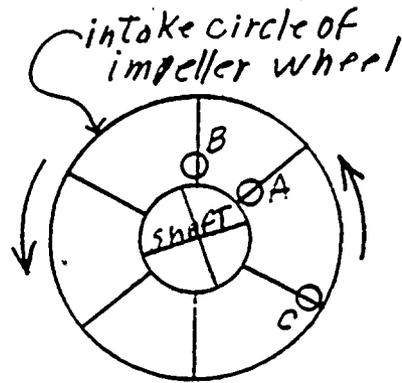
Figure 1.

Observations on the impeller are as follows. One vane of the six-vaned impeller was missing a section at the intake edge of the vane, as stated before. In Figure 1, this is indicated as vane A. A second vane, B in Fig. 1, upstream of vane A, carries a dent (1/4" wide) on the suction side of the leading edge. The centerline of the leading edge is slightly displaced by the dent. The third vane, at C in Fig. 1, has an unusually bright spot on the leading edge where the vane joins the outer rim of the intake circle. This spot is free of oxide and crud. No surface effects of impact can be seen.

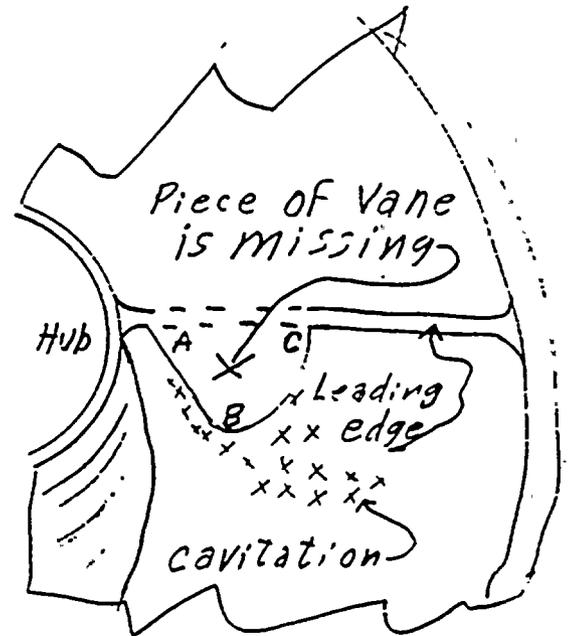
A sketch of the missing portion of a vane is shown in Figure 2. The broken surface extends from A to B to C. At A the surface is hackley, rough, seemingly porous - like the broken surface of a tensile specimen. This rough surface has about equal dimensions, that is length and width are about the same as the thickness of the vane at that point. As sketched in Figure 3A, there is what appears to be a beach mark separating the hackley zone at A from an adjacent very smooth area. The midportion between A and B displayed faint cherron marks when observed on December 29. Only a very slight suggestion of those chevron marks were found on Jan. 11. The broken surfaces appear to have been rubbed with rags, and scratches from tools exist between A and B.

The corner at B is very smooth and bright indicating considerable scrubbing action had occurred between the broken parts, as in fatigue. The region from B to C displayed about half the thickness rubbed smooth; also, a sizeable portion of the thickness was missing because of cavitation erosion on the low pressure side of the vane. A beach mark near C outlined an area of hackley fracture which terminated in a hinge lip as sketched in Figure 3B.
