U.S. NUCLEAR REGULATORY COMMISSION
REGION I

Report No. 85-21

Facility Name: Nine Mile Point, Unit 2

Meeting Summary: Management Conference on June 17, 1985
(Report No. 50-410/85-21)

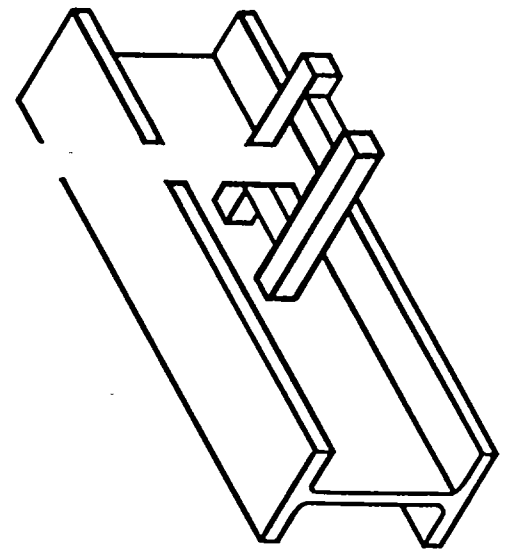
WELD SIZE SPECIFIED ON DRAWING	_____	0.25"
ACTUAL WELD SIZE	_____	0.19"
WELD SIZE NEEDED	_____	0.08"
SAFETY FACTOR = 0.19 / 0.08 = 2.4
