**INVESTIGATION OF SHUTDOWN OF UPS SYSTEMS
(2VBB - 1A, 1B, 1C, 1D, 1G) AT NIAGARA MOHAWK POWER CORP --
NINE MILE POINT 2 NUCLEAR POWER PLANT**

I. EXECUTIVE SUMMARY

**ROOT CAUSE REPORT FOR THE
EXIDE UPS 1A, B, C, D, G
TRIP EVENT OF AUGUST 13, 1991**

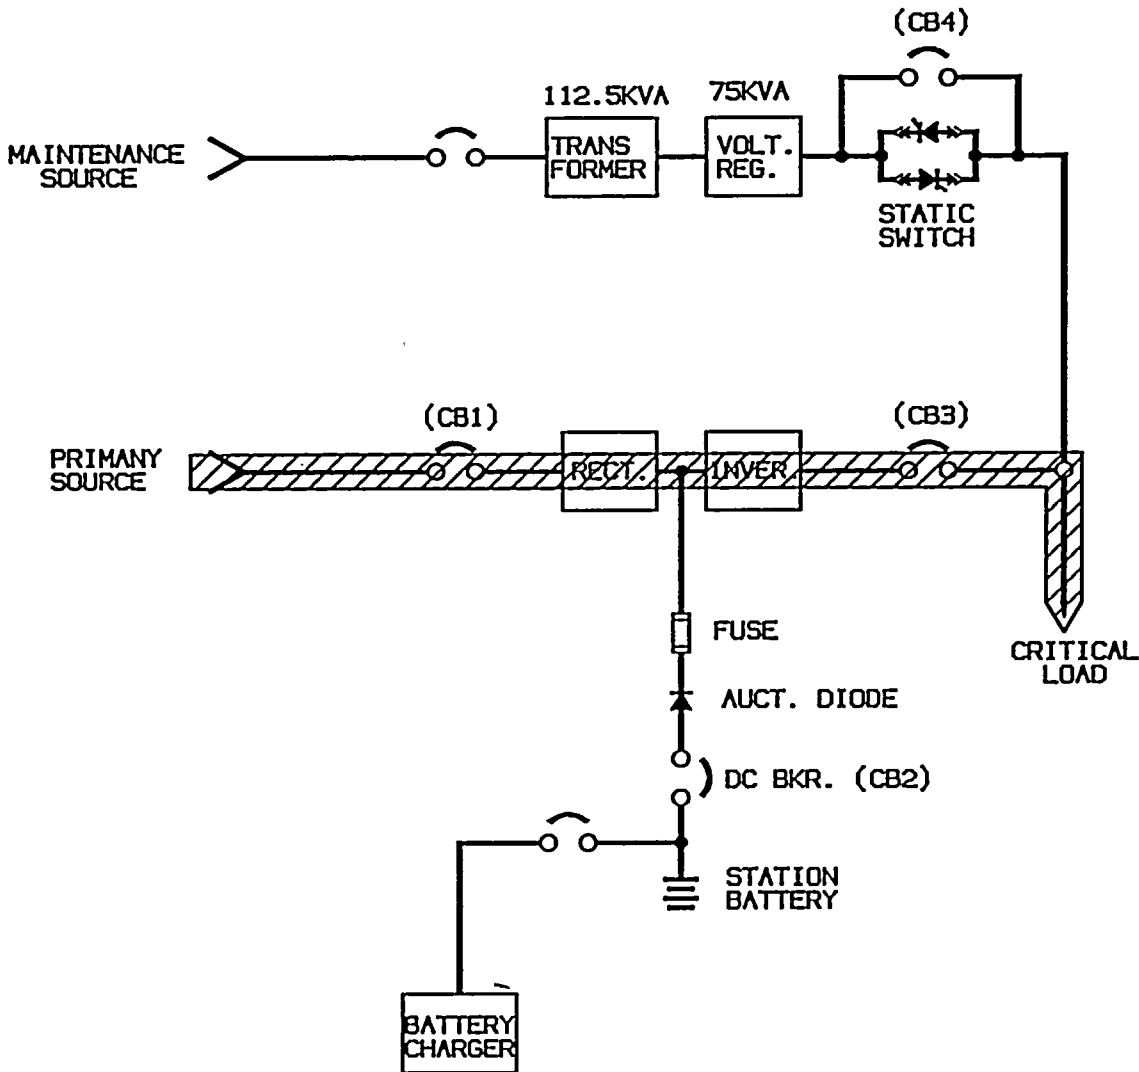
A) Normal UPS Operation

1) Primary source is supplying power through UPS to critical load.

NOTE: This was condition prior to primary source failure.

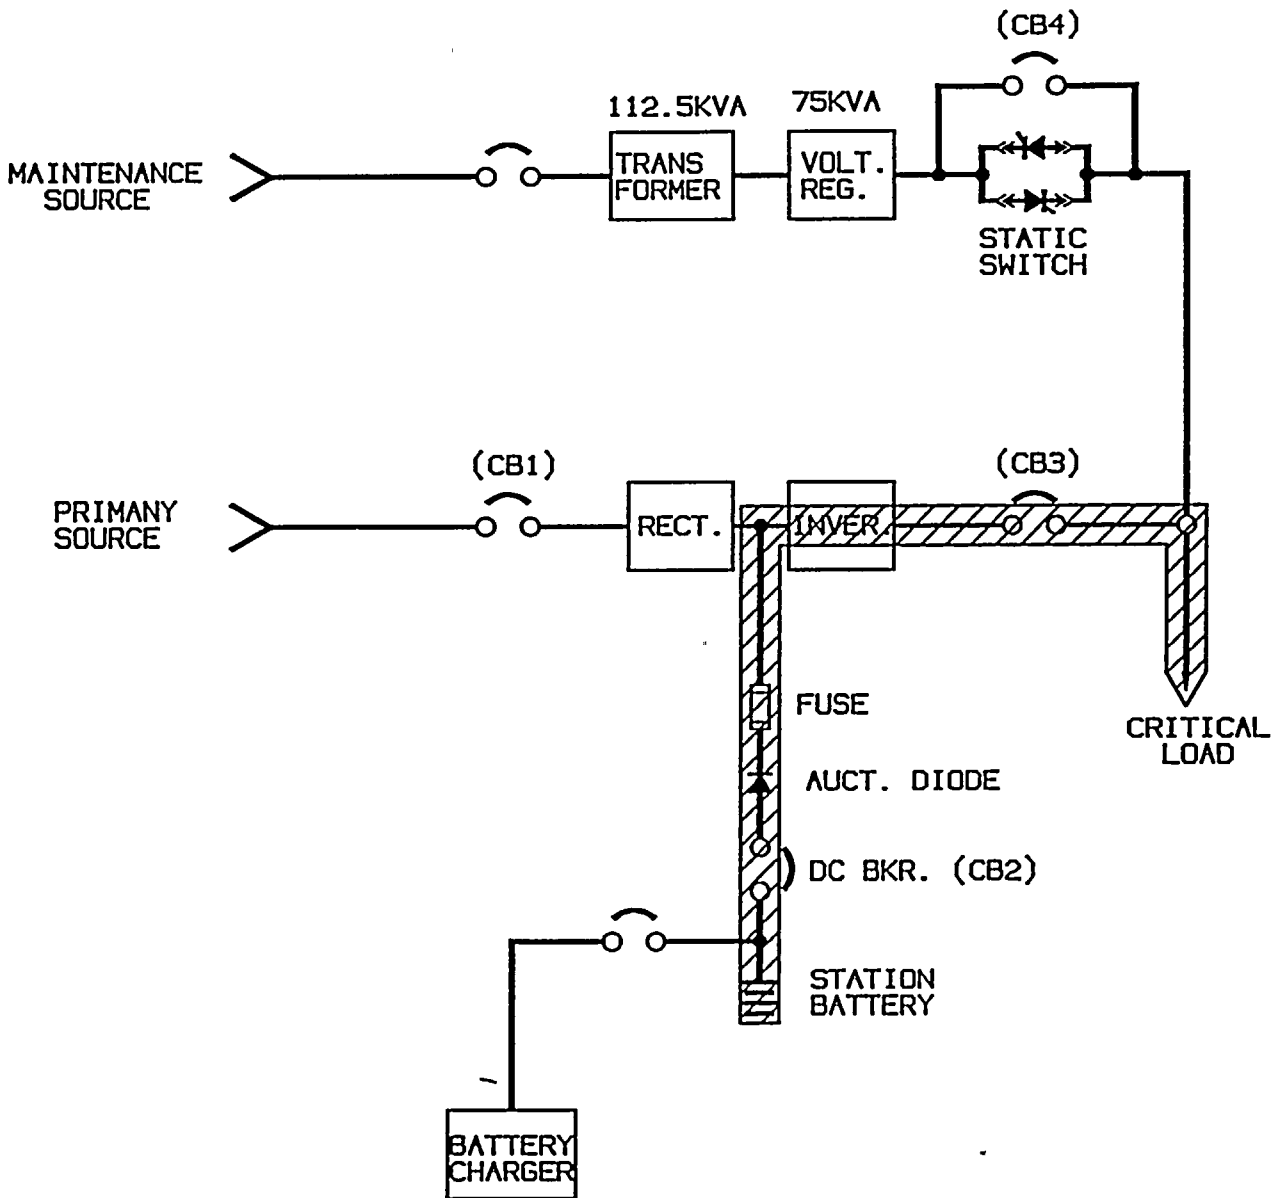
B) Failure of Primary Source or Failure of Rectifier

- 1) Rectifier stops.
- 2) Inverter continues with DC power from station battery.
- 3) Critical load is maintained uninterrupted.

NOTE: This would have been condition if UPS trip had not occurred.

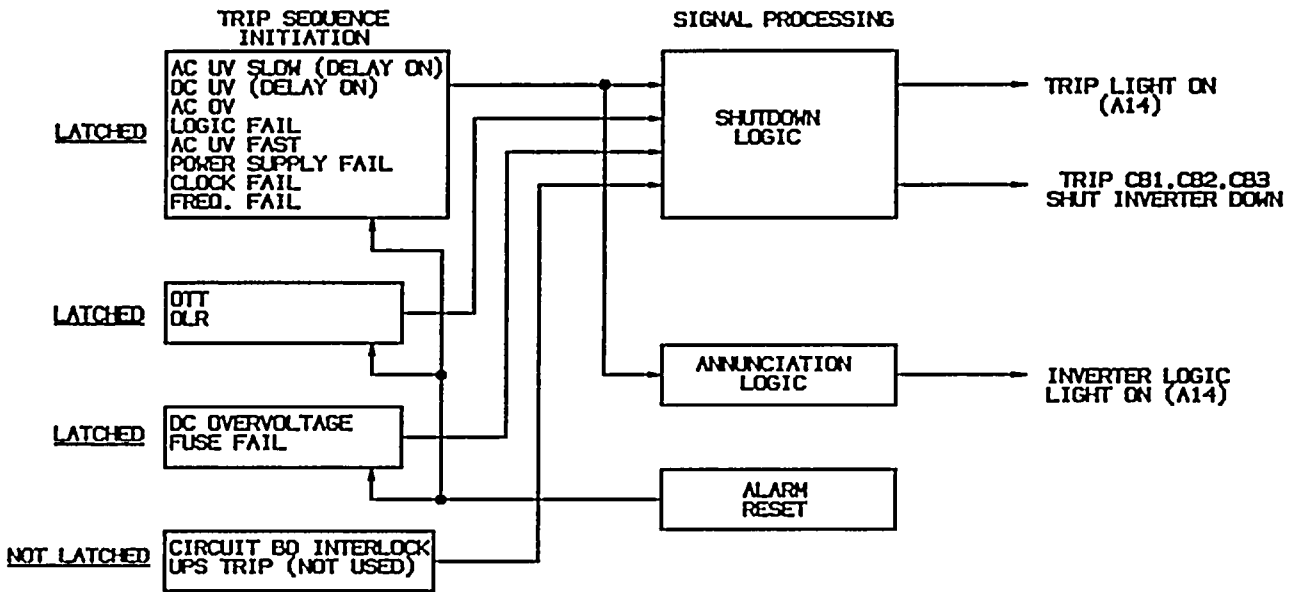
Figure 1: UPS Trip and Alarm Block Diagram

1) The following describes all events initiating a trip signal and its processing to trip (See attached pages 2-15 to 2-23 of Operations Manual for detailed description of items).

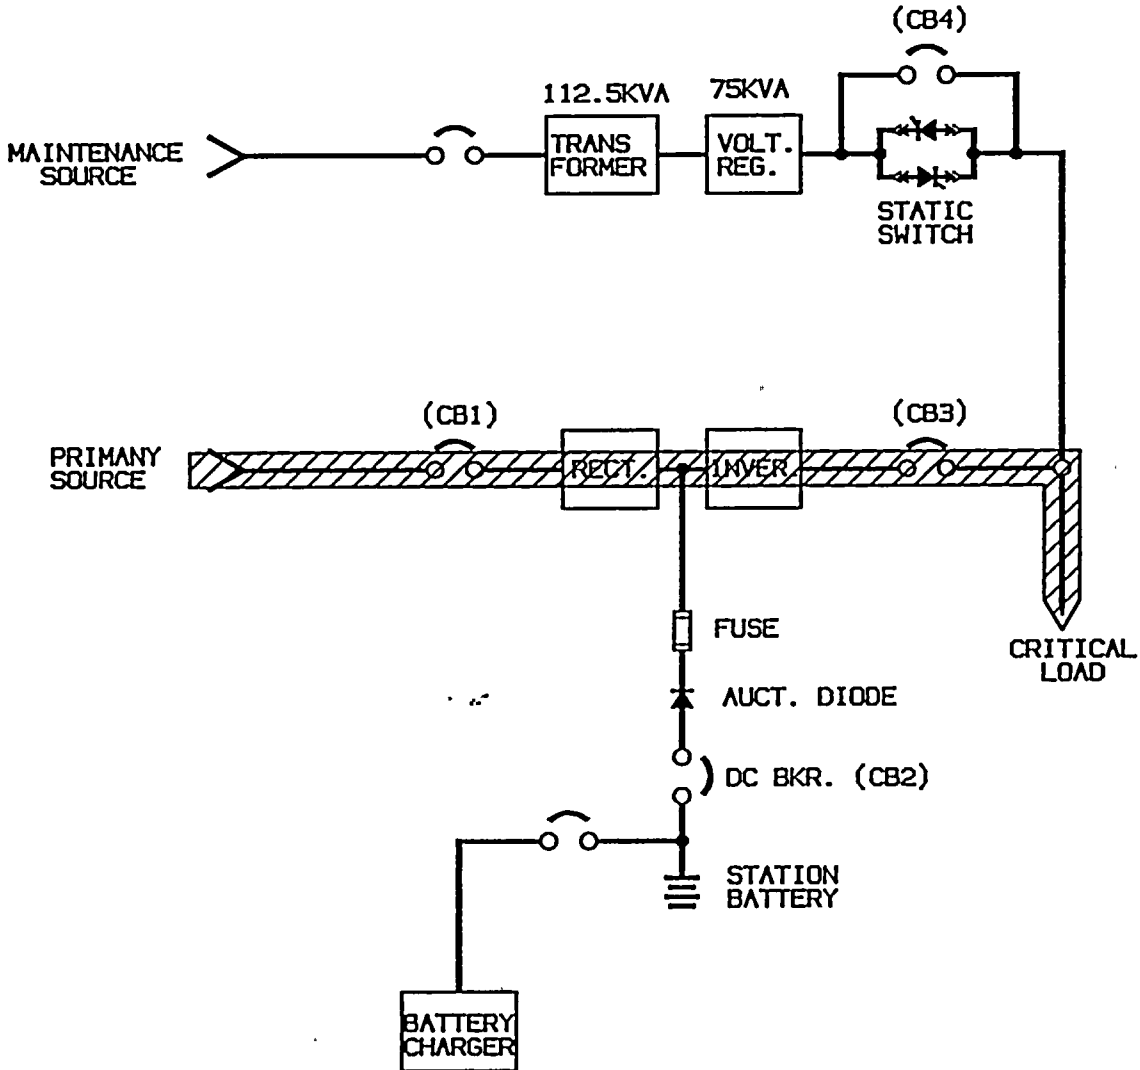
A) Normal UPS Operation

1) Primary source is supplying power through UPS to critical load.

NOTE: This was condition prior to primary source failure.

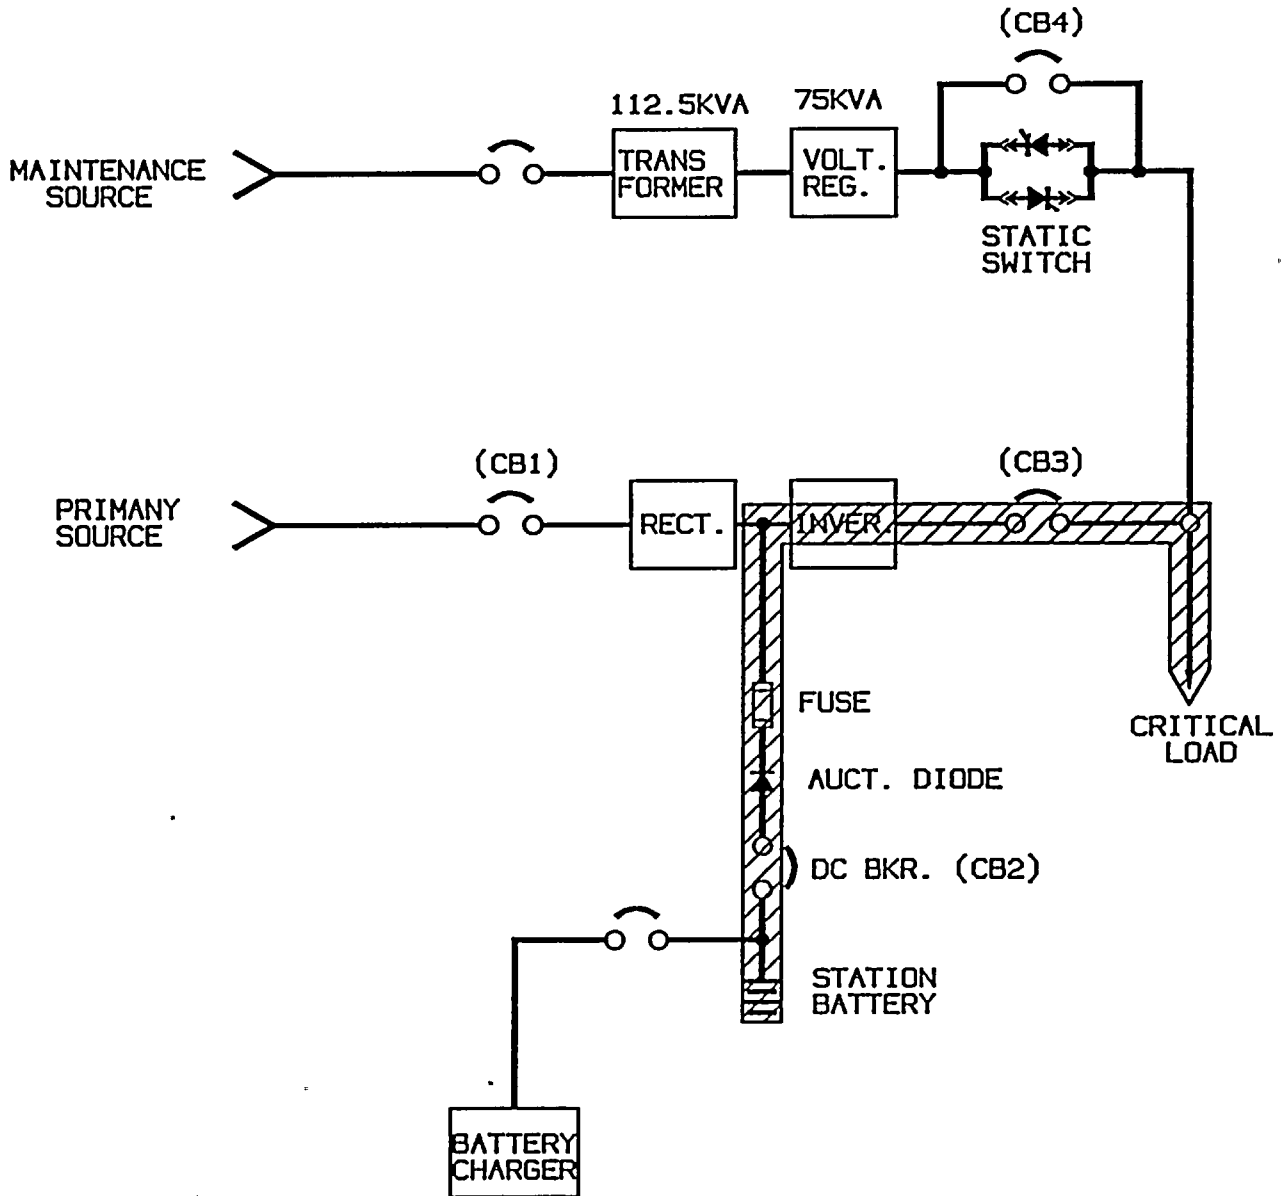
B) Failure of Primary Source or Failure of Rectifier

- 1) Rectifier stops.
- 2) Inverter continues with DC power from station battery.
- 3) Critical load is maintained uninterrupted.

NOTE: This would have been condition if UPS trip had not occurred.

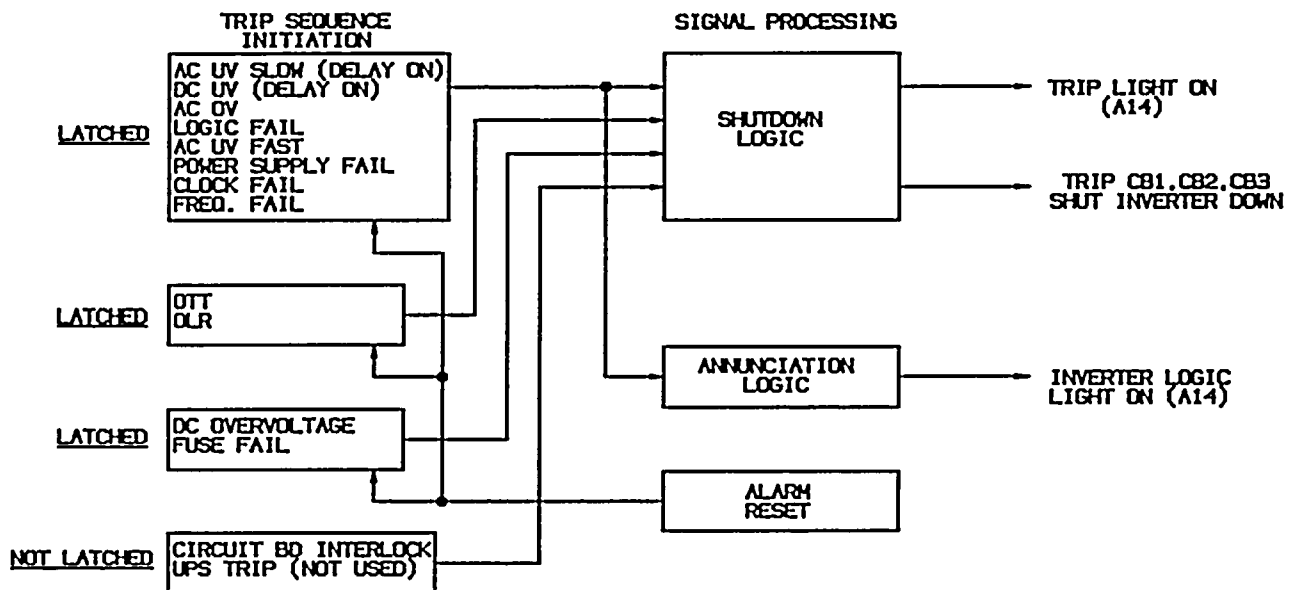
Figure 1: UPS Trip and Alarm Block Diagram

- 1) The following describes all events initiating a trip signal and its processing to trip (See attached pages 2-15 to 2-23 of Operations Manual for detailed description of items).

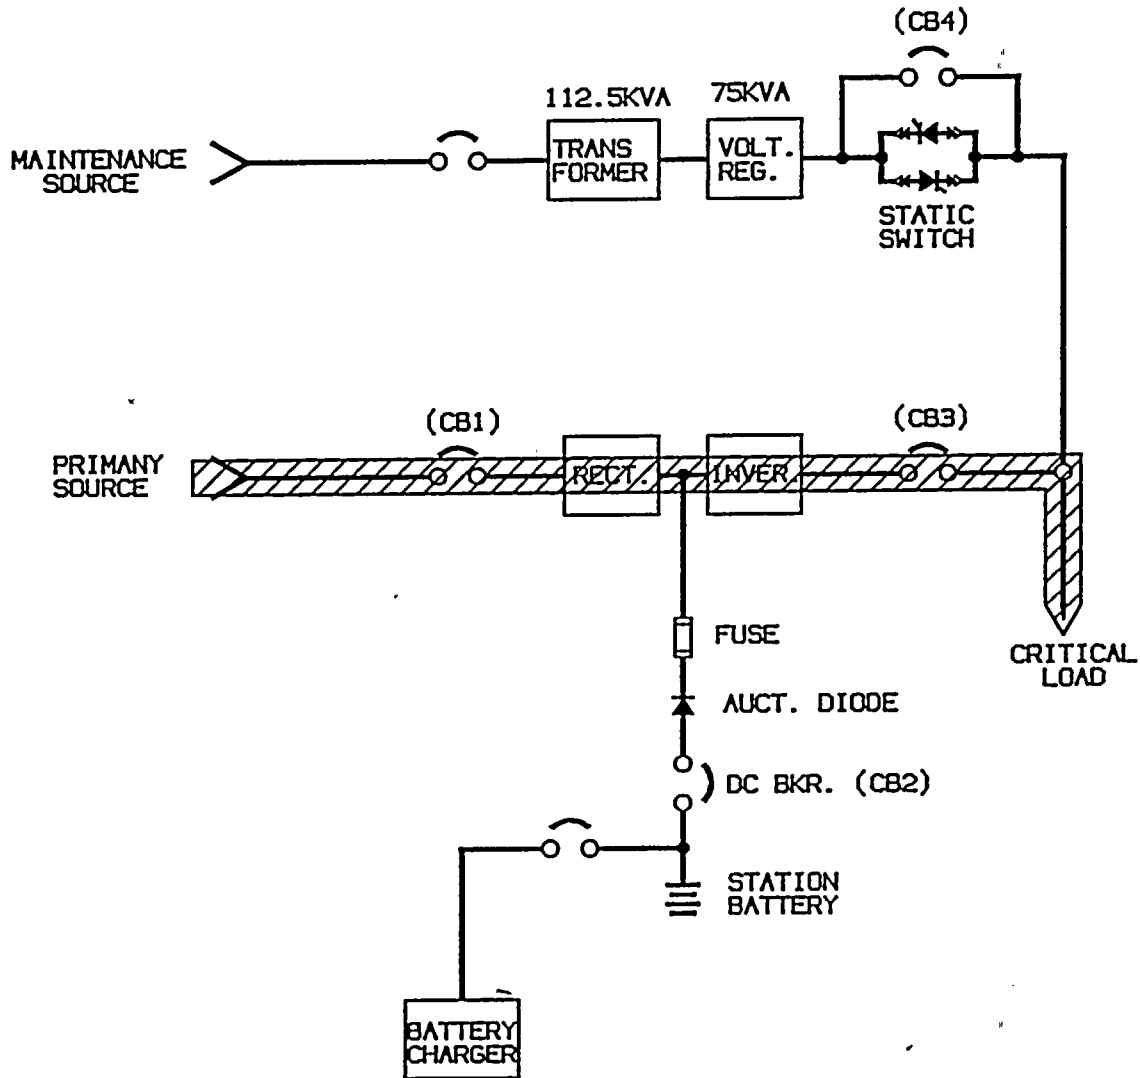
A) Normal UPS Operation

1) Primary source is supplying power through UPS to critical load.

NOTE: This was condition prior to primary source failure.

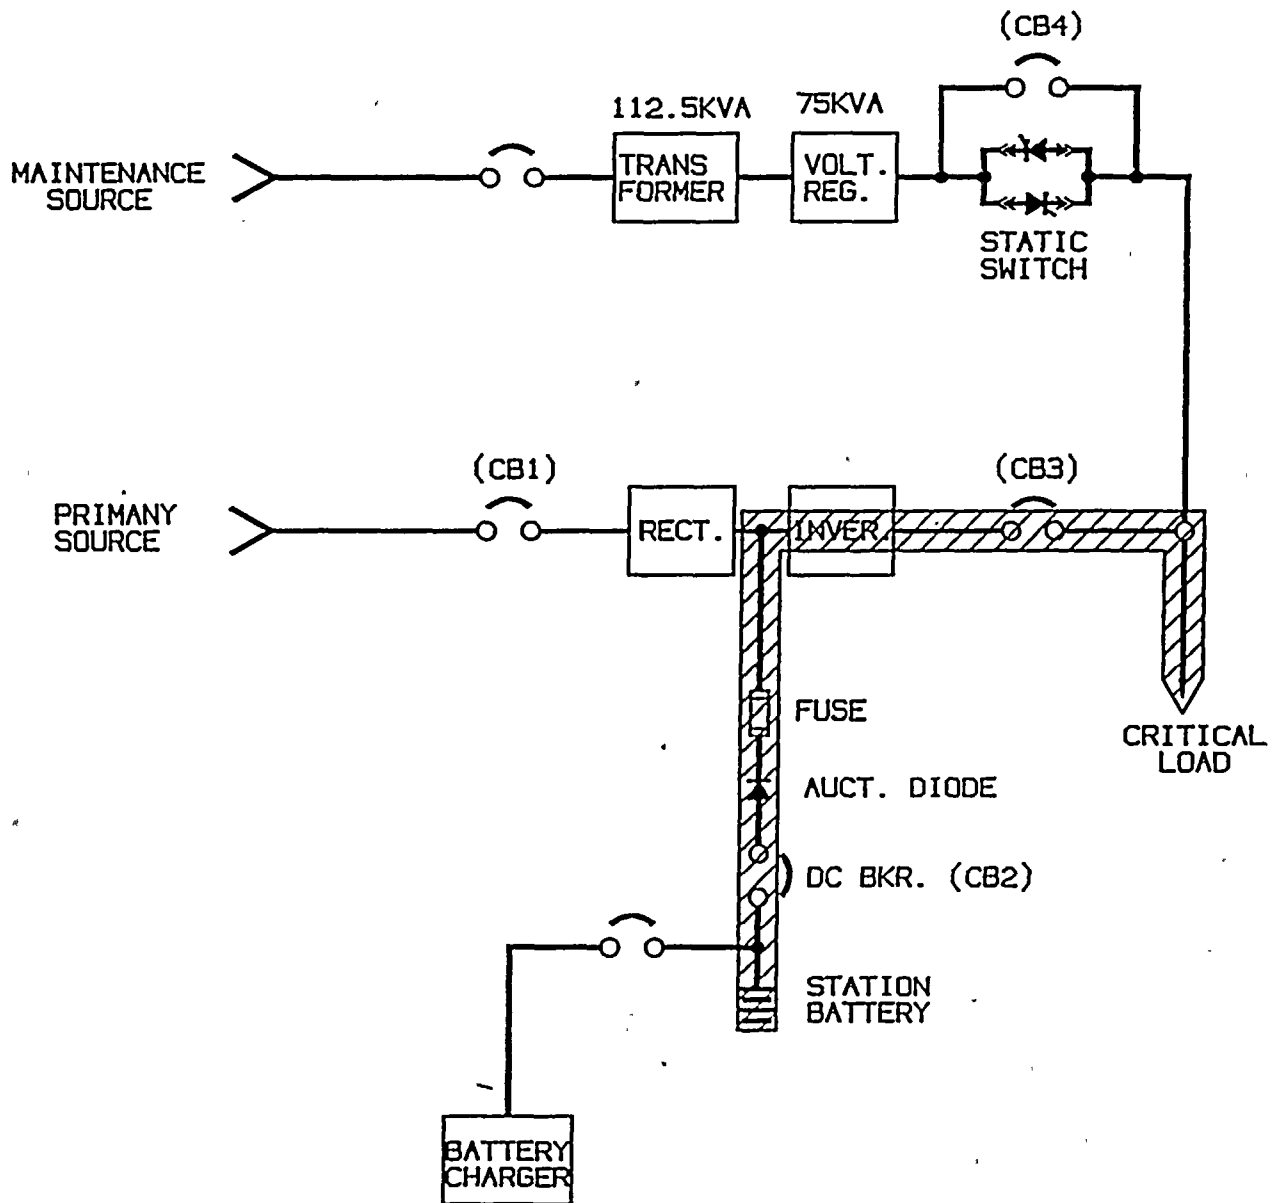
B) Failure of Primary Source or Failure of Rectifier

- 1) Rectifier stops.
- 2) Inverter continues with DC power from station battery.
- 3) Critical load is maintained uninterrupted.

NOTE: This would have been condition if UPS trip had not occurred.

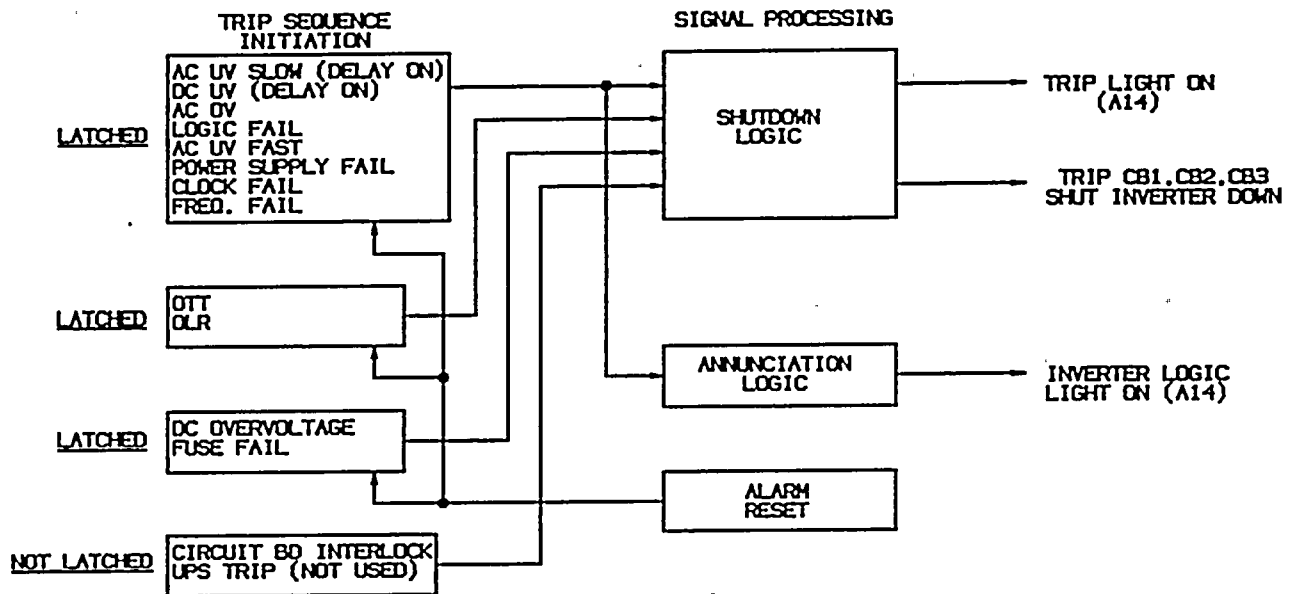
Figure 1: UPS Trip and Alarm Block Diagram

1) The following describes all events initiating a trip signal and its processing to trip
(See attached pages 2-15 to 2-23 of Operations Manual for detailed description of items).

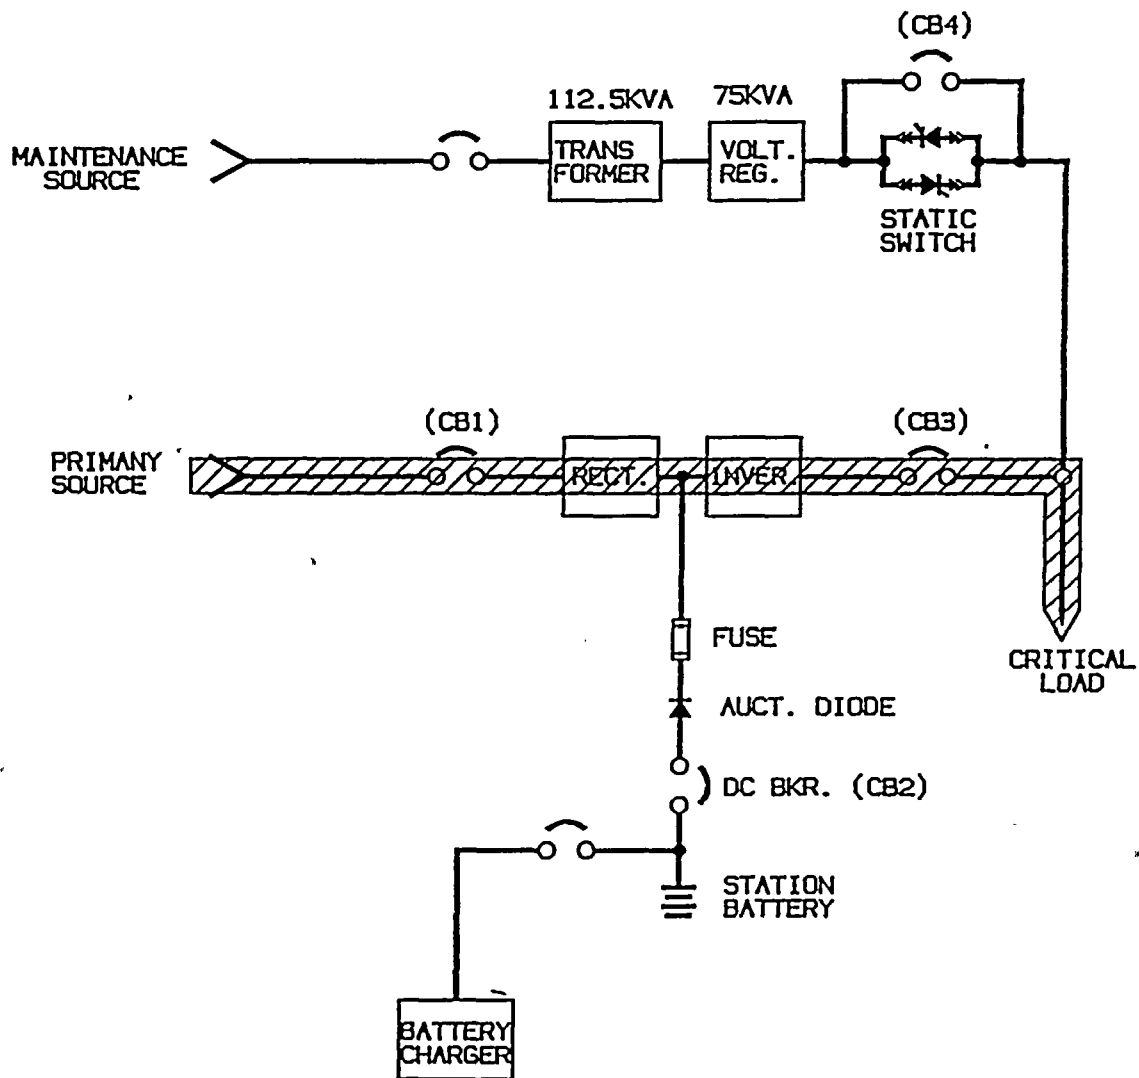
A) Normal UPS Operation

1) Primary source is supplying power through UPS to critical load.

NOTE: This was condition prior to primary source failure.

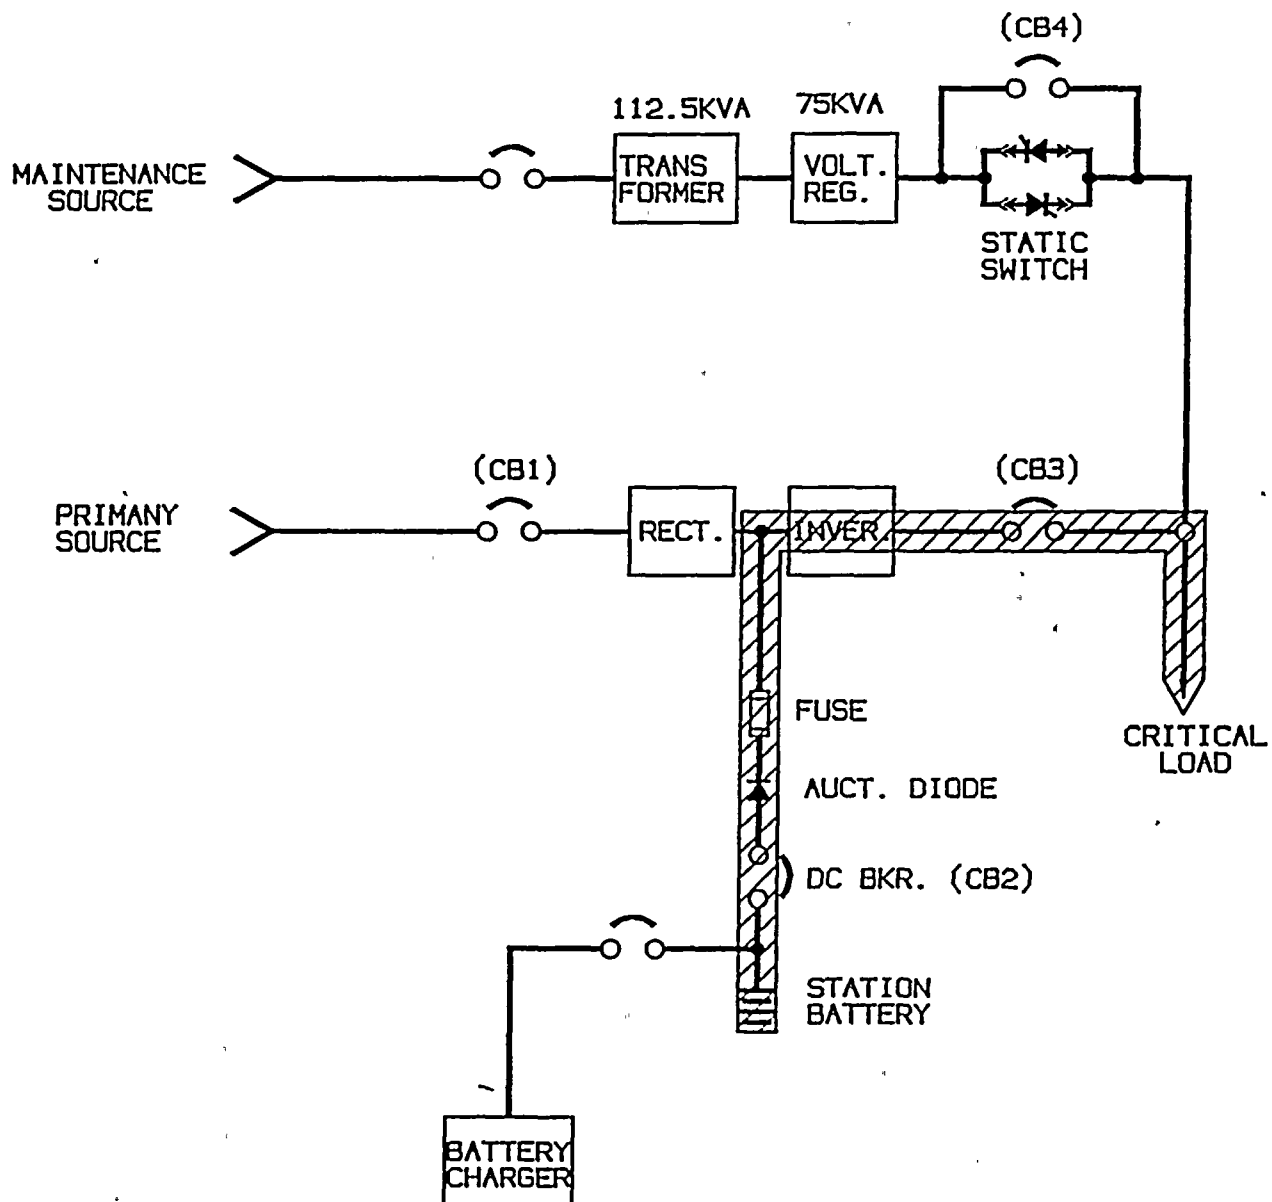
B) Failure of Primary Source or Failure of Rectifier

- 1) Rectifier stops.
- 2) Inverter continues with DC power from station battery.
- 3) Critical load is maintained uninterrupted.

NOTE: This would have been condition if UPS trip had not occurred.

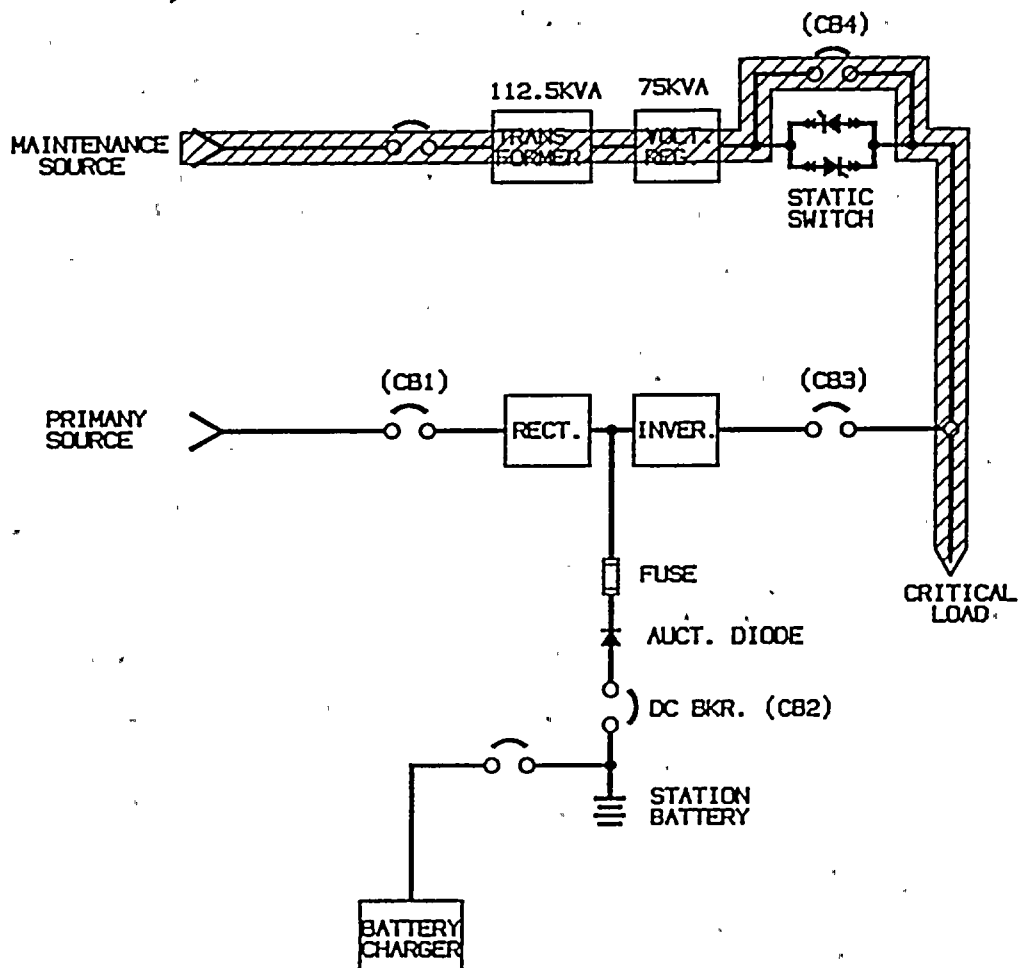
C) UPS Trip, Inverter Failure, or Simultaneous Failure of Rectifier and Station Battery Supply

- 1) Inverter stops.
- 2) Static switch and bypass breaker (CB4) transfer the critical load to maintenance source uninterrupted. But Maintenance Source must be:
 - available
 - within $\pm 10\%$ of the inverter output voltage
 - in sync with inverter output voltage
 - within ± 0.5 Hz of the inverter output frequency
- 4) If maintenance source does not meet transfer conditions, then critical load supply is lost.

Conclusion #1: Condition C4 existed during the event.

The maintenance source was not acceptable during the 12 cycles of phase B power failure and an UPS trip occurred during this time, resulting in critical load loss.

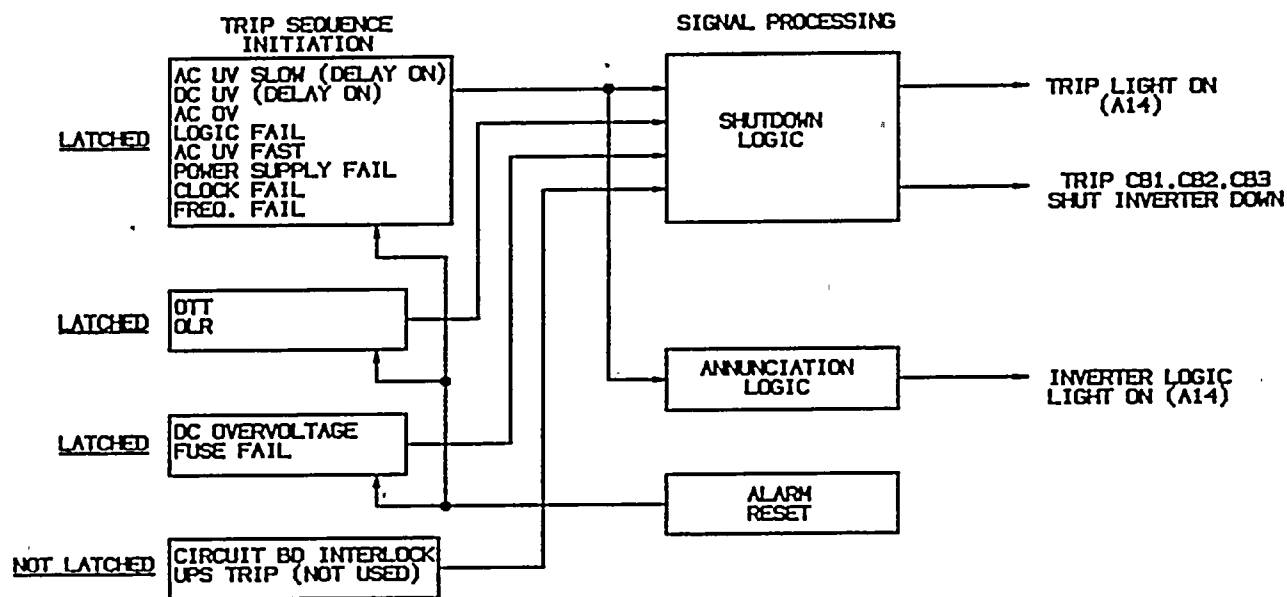
Figure 1: UPS Trip and Alarm Block Diagram

The cause of an UPS trip is indicated by lamp indications on the UPS Control Panel (A14) and the UPS Card Cage Panel (A13) accompanied by an audible alarm (horn). The horn can be silenced by pushing the button #23 on the control panel. Cause for trip (shut down) of the UPS is indicated by lamps #26 through #35 on the Card Cage panel followed by the inverter logic light #34 on the control panel. The resulting trip of the UPS is indicated by Lamp #24 on the control panel. All trip-related alarms are stored. There is an alarm unstore (reset) button #19 on the printed circuit card A13A21 on the Card Cage panel. The unstore button will extinguish all lamps on the Control panel and Card Cage panel simultaneously.

Circuit design requires a trip initiation lamp #26 through #35 on the Card Cage panel to light and be latched and stored before an inverter logic lamp #34 and trip lamp #24 on Control panel can be lit. Pushing of unstore button #19 on the Card Cage panel will extinguish all lamps #26 through #35 on A13 and #24 and #34 on A14 simultaneously. Reset (unstore) of lamps # 26 through #35 on A13 without reset (unstore) of lamps #24 and #34 on A14 should not be possible.

- 2) Reportedly, none of the trip initiation lamps #26 through #35 on the A13A21 circuit card were lit. But without trip initiation lamp indication, the cause for a UPS trip is not readily evident. The cause for the trip has to be reasoned out.

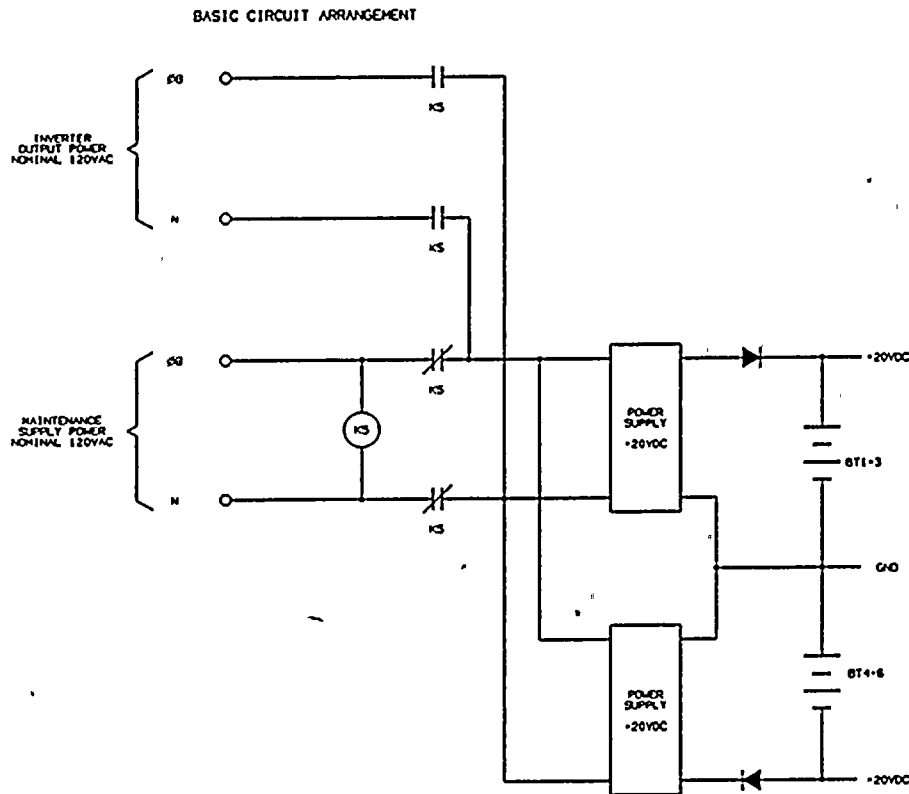
(See drawing 110 611 334 and Operators Manual)

Logic Power Supply components and circuits are located on Logic Power and Relay Panel A27. This panel contains positive and negative 20VDC power supplies (PS1 and PS2). These power supplies are powered through relay A27K5, which selects inverter output or maintenance source. Positive and negative 18V sealed batteries (A27BT1-BT6) are mounted on this panel and are kept charged by the power supplies. Circuit breaker A27CB1 disconnects the battery from the logic power bus, and the logic power supply switch A27S1 disconnects the power supply's 120 VAC input power (only from the maintenance power). The panel also contains card-mounted (A27A1) relays which interface the A13 controls with external items such as circuit breaker motor operators, shunt trip coils, and remote monitor panel functions. Control battery discharge sensing is located on the A27A1 card.

NOTE: K5 is shown energized.

Normally the maintenance source supplies power through the N.O. Contacts of the energized relay K5. If maintenance power fails, K5 drops out and switches to inverter power. In case of power supply fail, the control batteries supply logic power and issue a control battery discharge alarm (lamp #20 on A13A21 annunciation #2 printed circuit board). This alarm is issued if the +/- 20 VDC should fall below 18 VDC. It does not initiate a trip.

Should the \pm 20 VDC logic power supply drop below 16.5 VDC, then a logic power supply failed alarm and UPS trip is issued.

During the shutdown event, the maintenance power to the logic power supplies (phase B to neutral) has to drop from 120 VAC to about 50 VAC in response to the high voltage drop from 200 kV to 80 kV. This voltage may or may not cause K5 to drop out, depending on their individual dropout voltages. If K5 does not drop out, the power supplies may lose regulation and decrease their output DC voltage substantially. The control battery is incorporated as part of the logic power supply design to keep the logic supply voltage above 16.6 VDC during such incidents to avoid a shutdown of the UPS.

The need for battery power was for only 200 milliseconds, hardly a noticeable discharge for properly maintained and fully charged control batteries. After 200 milliseconds, the maintenance power was restored and all conditions should have returned to normal. But due to the batteries deficient state, the batteries were unable to supply control power for the 200 milliseconds required. This was the single contributor to the incident.

Conclusion #2: Deficient Control Batteries

These batteries were found to have degraded over time and measured only 0.6 VDC instead of the expected 18.0 VDC. The logic power control batteries had been in service over six (6) years. This is two (2) years over the recommended service life. Exide Electronics had recommended that these batteries be changed, at a minimum, every four (4) years.

1. Niagara Mohawk is aware that the current UPS systems represent technology that is over ten (10) years old. Exide Electronics current UPS systems represent three (3) technological advances and represent state of the art power protection. It is our recommendation that Niagara considers replacement of the present systems with our present designs.
2. If Niagara Mohawk chooses to have Exide Electronics maintain the UPS systems at Nine Mile Point, we recommend our Powercare Preferred Service Package that covers all facets of maintenance, 7 x 24 emergency service, Preventive Maintenance Inspections, modifications and parts.
3. If Niagara Mohawk chooses to continue maintaining this equipment, the following recommendations are applicable:
 - A. Inspect logic power control battery condition at least once every year. (See B. page 11)

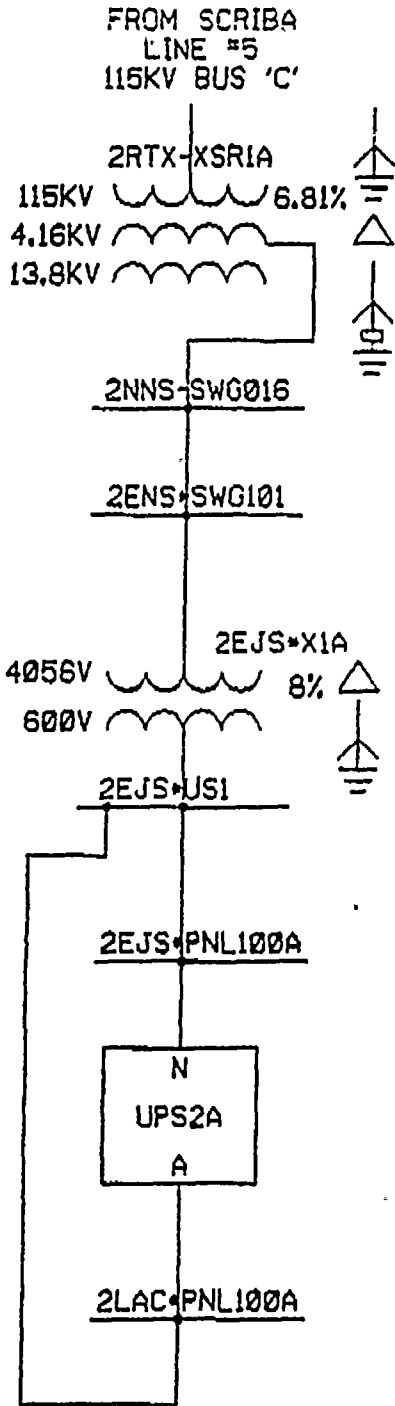
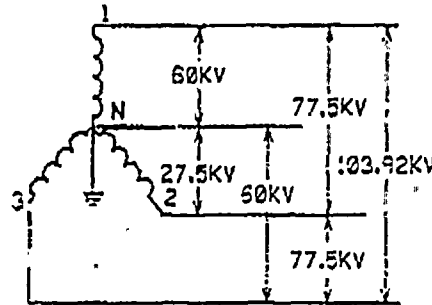
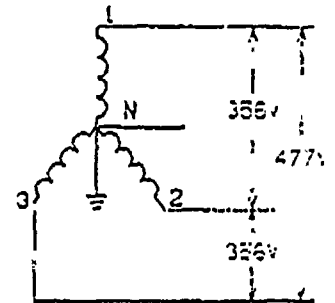
VOLTAGE PROFILE FOR THE NORMAL AND ALTERNATE POWER SUPPLY TO 2VBB*UPS2A

** 12 VOLT DROP FROM *US1 TO UPS2A

PHASE 1-2	344V
PHASE 2-3	344V
PHASE 3-1	465V

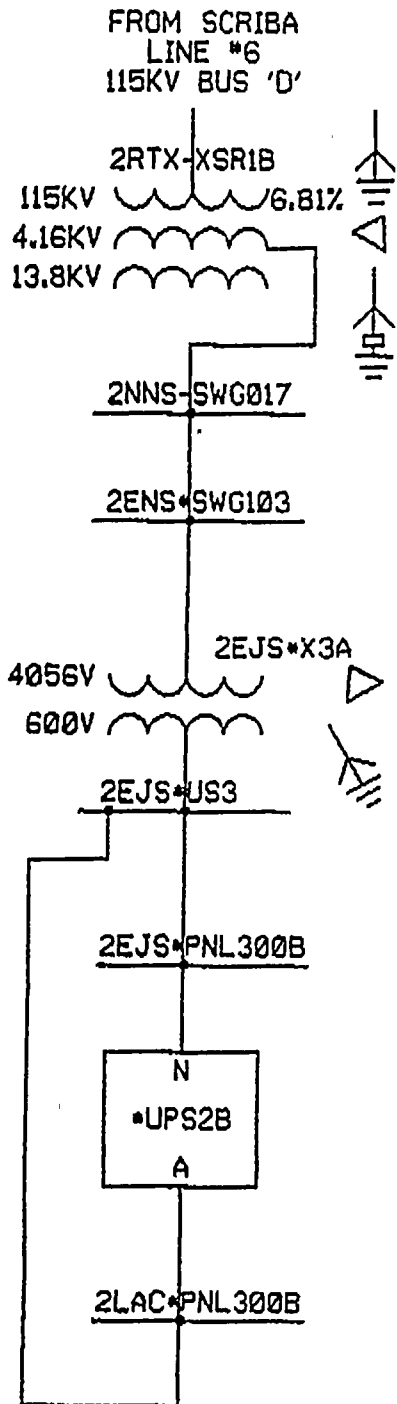
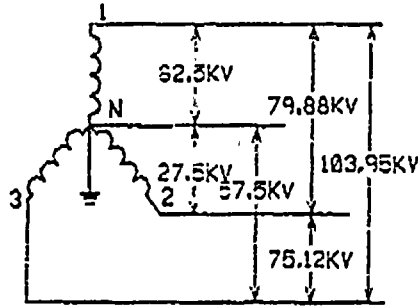
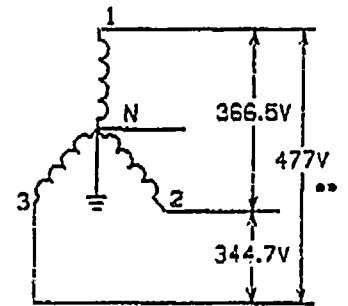
VOLTAGE PROFILE FOR THE NORMAL AND ALTERNATE POWER SUPPLY TO 2VBB*UPS2B

** 12 VOLT DROP FROM *US1 TO UPS2B

PHASE 1-2	354.5V
PHASE 2-3	332.7V
PHASE 3-1	465V

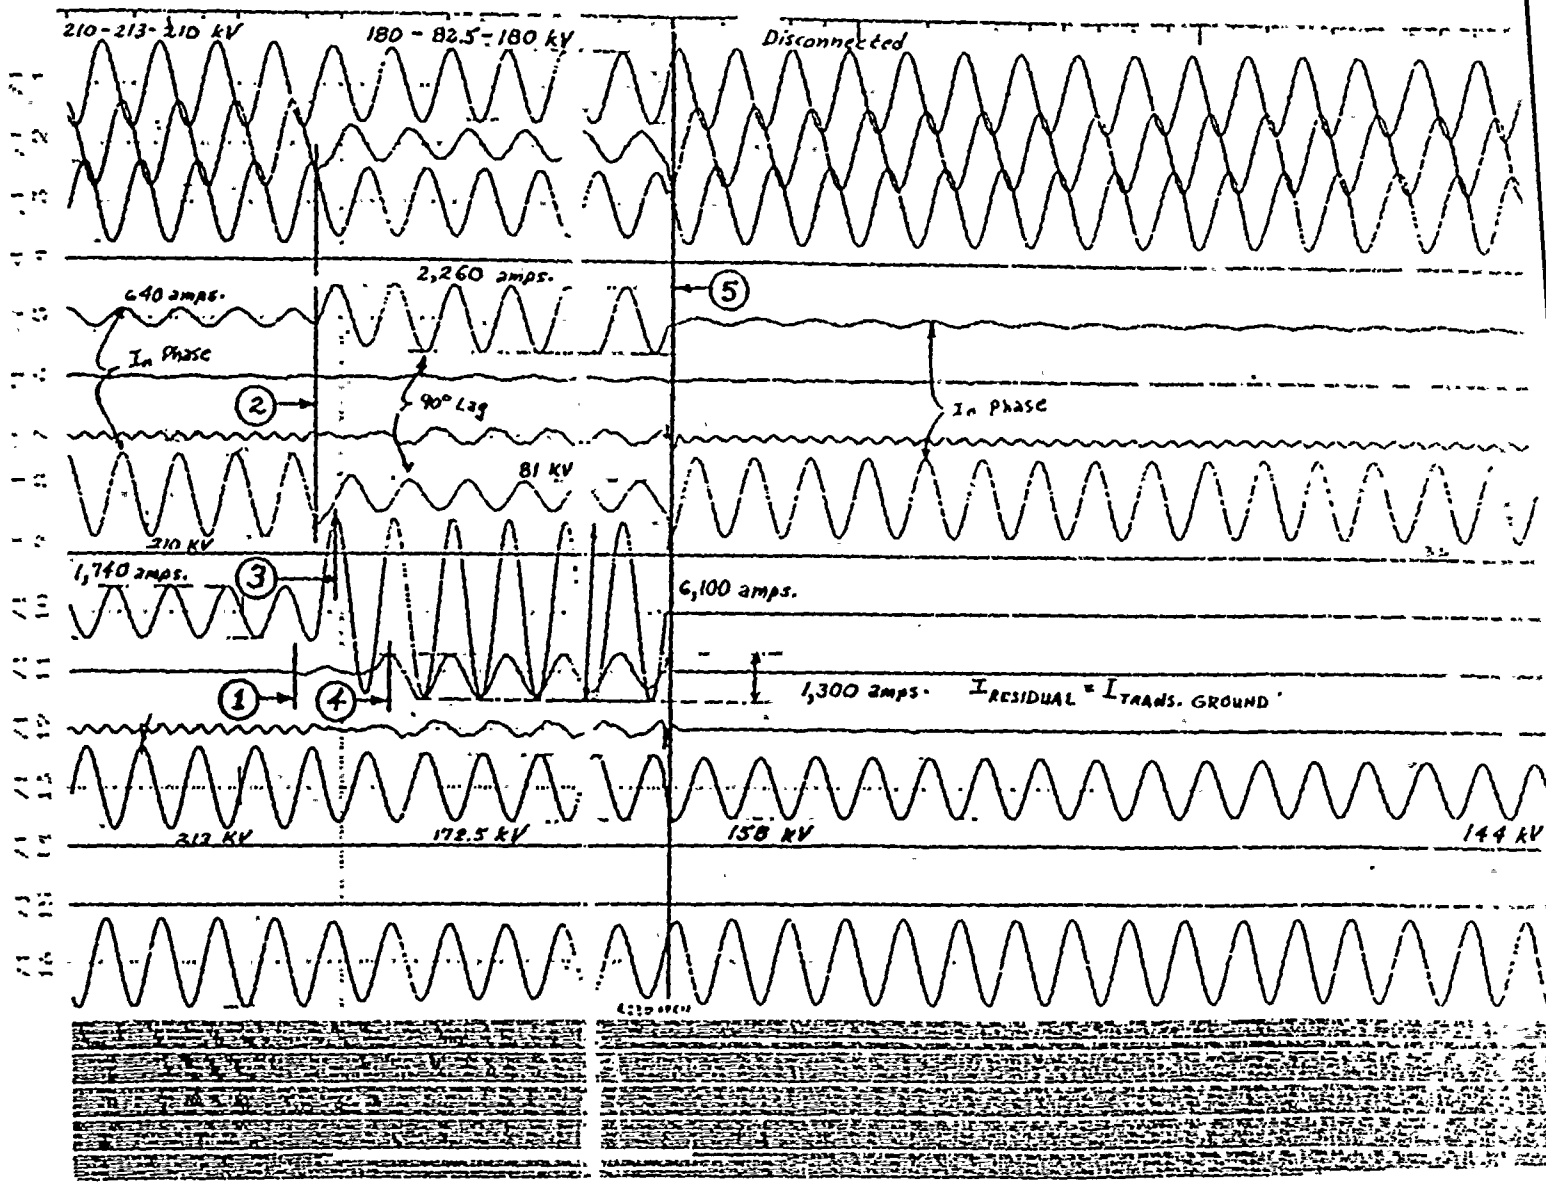
FIGURE A
 Notations by
 M.L. Crenshaw

SCRIBA CONTI - WSE 1 DALI 1

190-213-210 KV 180-82.5-180 KV Disconnected

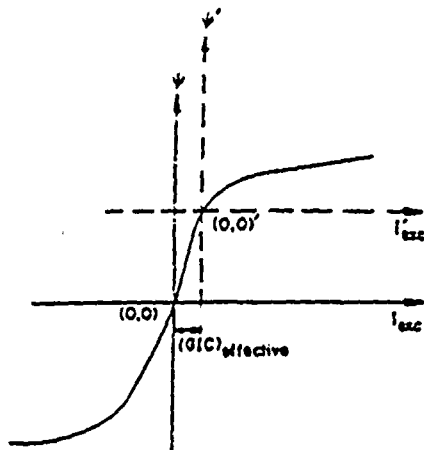
Figure 3. DC Bias of Transformer Core Flux Due to GIC.

many times larger than the RMS ac magnetizing current, resulting in a dc bias of transformer core flux, as in Figure 3.

The half-cycle saturation of transformers on a power system is the source of nearly all operating and equipment problems caused by GIC's during magnetic storms. The direct consequences of the half-cycle transformer saturation are:

- The transformer becomes a rich source of even and odd harmonics
- A great increase in inductive vars drawn by the transformer
- Possible drastic stray leakage flux effects in the transformer with resulting excessive localized heating.
