**INVESTIGATION OF SHUTDOWN OF UPS SYSTEMS
(2VBB - 1A, 1B, 1C, 1D, 1G) AT NIAGARA MOHAWK POWER CORP --
NINE MILE POINT 2 NUCLEAR POWER PLANT**

I. EXECUTIVE SUMMARY

**ROOT CAUSE REPORT FOR THE
EXIDE UPS 1A, B, C, D, G
TRIP EVENT OF AUGUST 13, 1991**

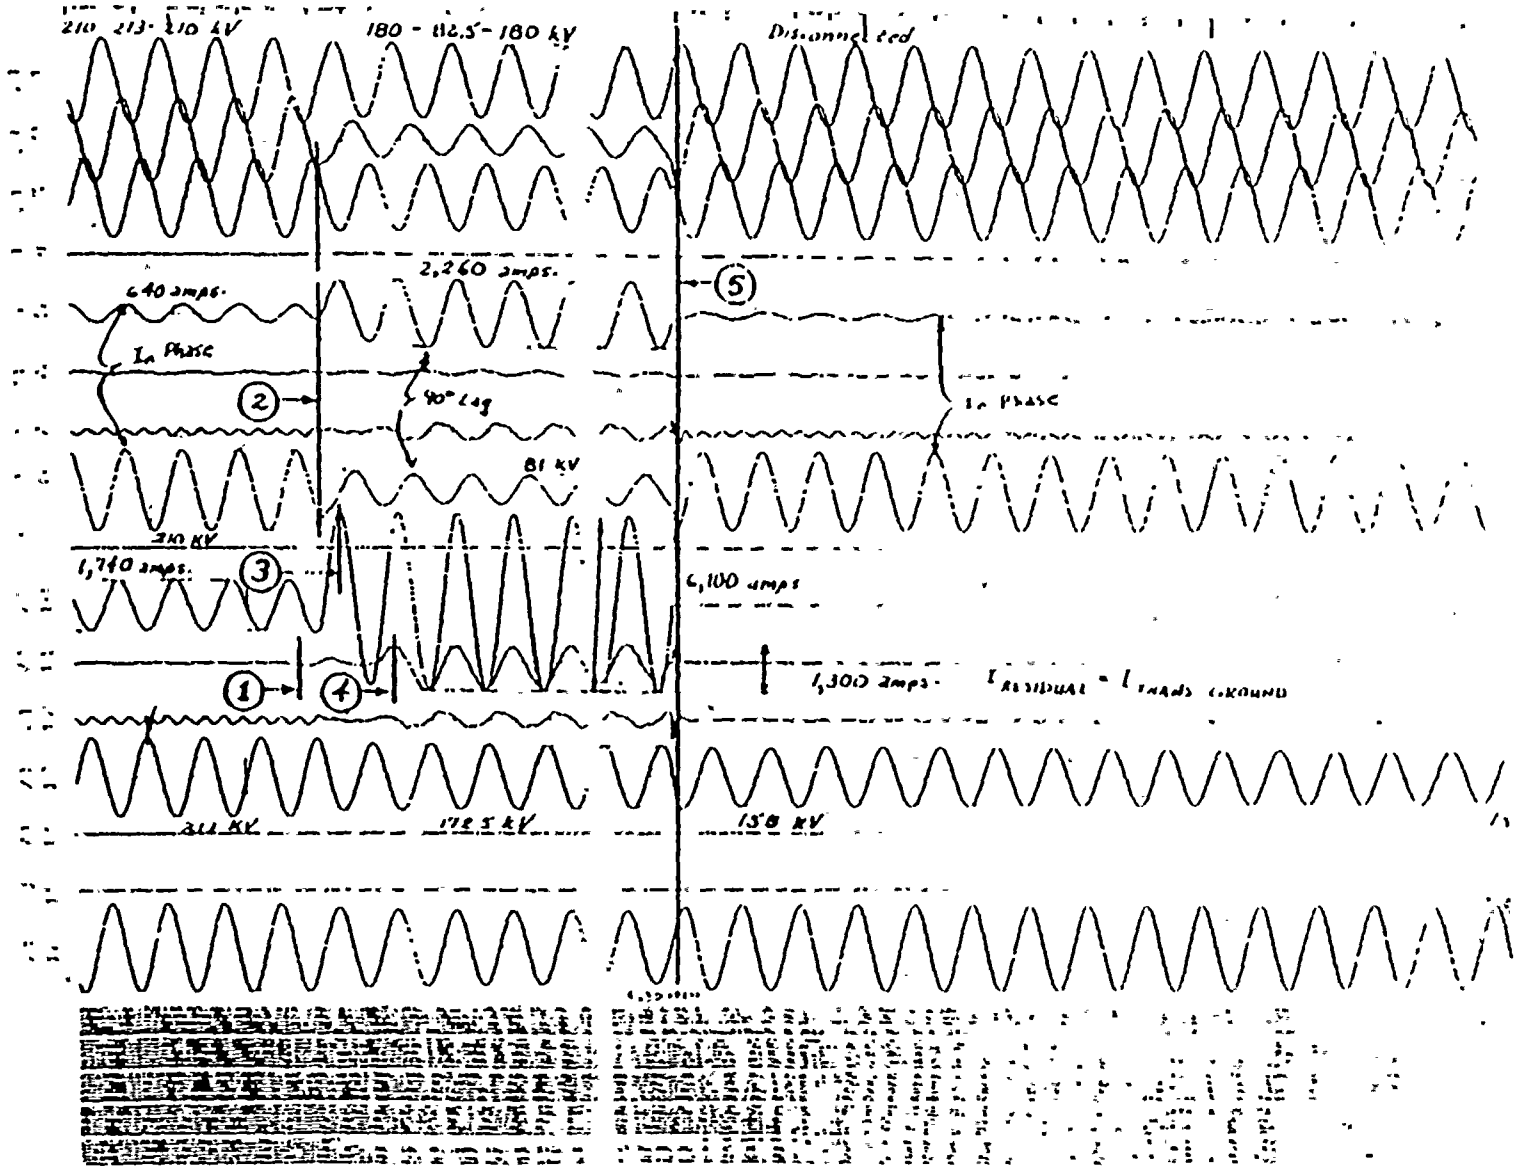
FIGURE A
 Notations by
 M.L. Creashaw

Following isolation of the generator and faulted transformer from the power grid, marked 5 on Figure A, only a single 345 kV phase to ground voltage record is available. The magnitude of this voltage on an unfaulted phase is 74% of the pre-fault value. Since generator neutral current is limited to less than 8 amperes, it is known that the faulted transformer appears as a line to line fault with some impedance to the generator. By trial and error calculation, generator line currents are found to be 0, 1.9 and 1.9, multiples of the rated value of 31.140 amperes. The line-to-line voltages have magnitudes 74% 74%, and 25% of the rated value of 25,000 volts. The decay of this voltage for 0.25 seconds of the recording has a measured time constant of 2.7 seconds. The calculated value of the impedance of the faulted transformer as seen by the generator is 0.23 per unit.

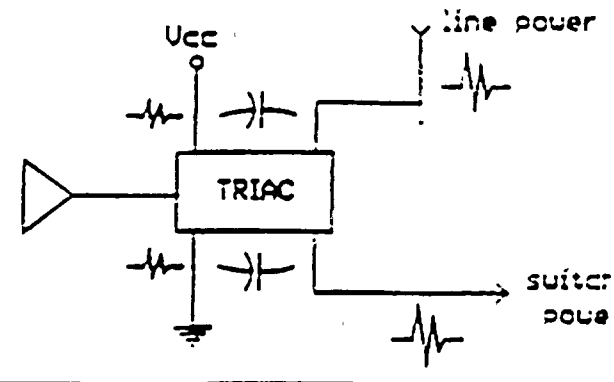
Figure 2. Transient feedback path.

to heavy equipment, which is characterized by heavy starting loads and inductive at turn off. Typically the electronic controller switch line power using relays or triacs. This exposes the back end of the controller to substantial line transients, which feed back to the circuit power and ground and disrupt the digital circuitry as shown in Figure 2.

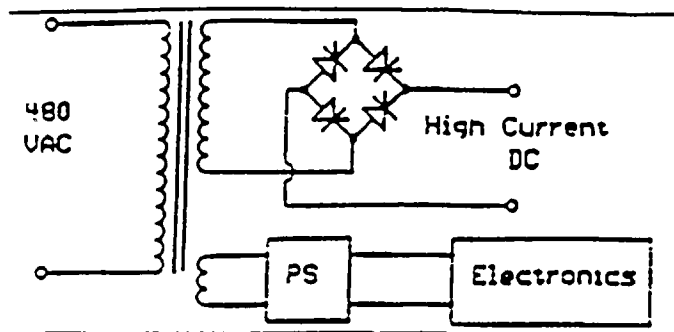
Figure 3. Common industrial power supply.

More often the problem is conducted, either via power or ground. The problem occurs due to power and ground disturbances caused by the equipment. It is an all too common practice to draw controller power from the same source as feeds the power equipment. This power may provide the necessary energy to drive the equipment, but it is not suitable to power the electronics (Figure 3).

Hopefully, all industrial equipment will have electronics powered from a separate low power 120 volt circuit. It solves several problems. First, it separates the electronics power from the probably very noisy industrial grade power, preventing the switching transients and startup sags from getting to the electronics. Second, if it is necessary to condition the electronics power from an external problem, it is far cheaper to condition the watts needed for electronics power than it is to condition the kilowatts required by the system.

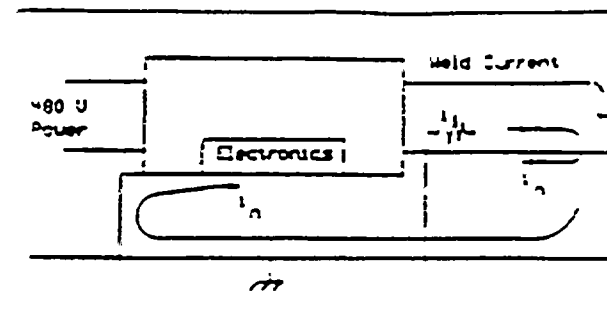
Figure 4. Multiple ground paths.

Ground Noise. Ground noise, inevitable in industrial environments, must be diverted from the electronics module. Multiple grounds in a system will often result in ground currents circulating through the equipment, and ground noise circulating through the electronics path will cause malfunction. Figure 4 shows some typical ground loop situations.

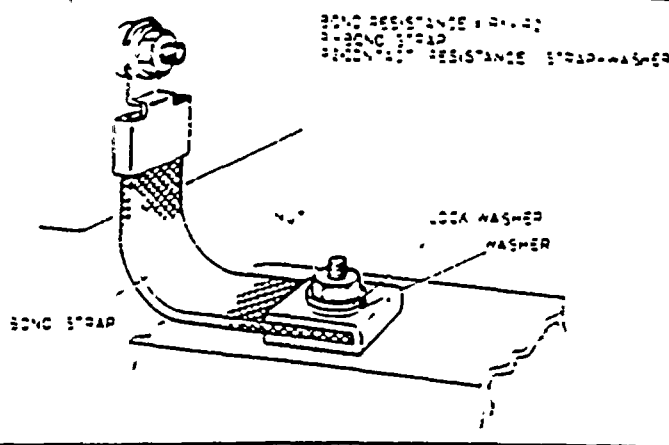
Figure 1. Bond resistance.

What happens with bonds to cause this change? Essentially a ground connection is a series of impedances from the strap through to the ground material, as shown in Figure 1. Each point of contact contributes to the total bond performance. As a result, a change in any contact condition can result in a change in the total bond resistance. As is well appreciated, the contact resistance between two metal surfaces is a function of the pressure. The pressure exerted by the tip of a drawing pin is vastly greater than that from the thumb pressing by itself. Thus the contact from a sharp point gives a much higher pressure than a flat point and therefore lower contact resistance. Measurements have shown that sharp points enable contact resistance of a few microhm to be achieved whilst similar pressures on flat surfaces result in milliohms of contact resistance. It might be felt that there is little or no difference between these values, but in reality there is. An essential aspect of a good bond is that it should remain so after the equipment has entered use. High pressures also have the effect of squeezing out corrosive materials and insulating films. The former causes

progressive degradation of bonds, whilst the latter can reduce the efficiency of the bond from the moment it is installed. It is particularly important in communications systems, where filters are installed and shielded cable terminations are made that the bonds are of low resistance and retain their performance.

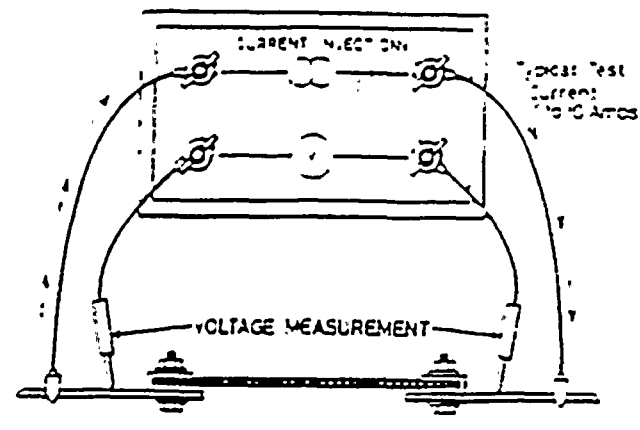
Figure 2. Four wire bridge method.

current the layers heat up and are vaporised. After the current is removed the film can return. Thus high current techniques are not recommended for testing EMI bonds. The new Defence Standard in the UK specifies a maximum probe voltage of 100 microvolts. This represents typically probe current of 50 milliamps under short circuit (< 1 mΩ) conditions. This is insufficient to destroy surface films. The classic method for measuring low resistance has been to use a four terminal bridge as shown in Figure 2. In this case the current is driven between two points and the voltage across the sample is measured with a high resistance probe. This removes the effects of the probe contact resistance and lead resistance. This is generally considered to be a laboratory method as the use of four contacts can be awkward. If the lead resistance can be removed by a calibration technique then the four terminals may be replaced with a two terminal system.

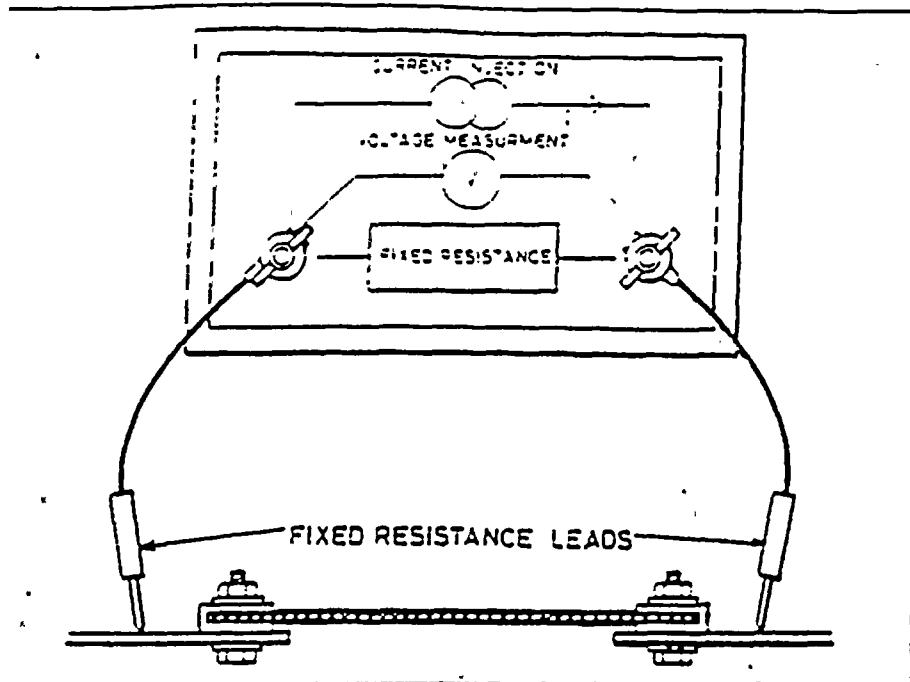
Figure 3. Two terminal bridge method.

A further possible refinement to the technique is to use a frequency that is not DC or 50/60/400Hz. In this case 10.4 Hz has been chosen. If an active filter is used to filter out all other electrical noise, then it is possible to use the bond resistance meter on powered up systems. It is worth noting that at this frequency the impedance is still largely represented by resistance rather than inductance. The two terminal method is shown in Figure 3.

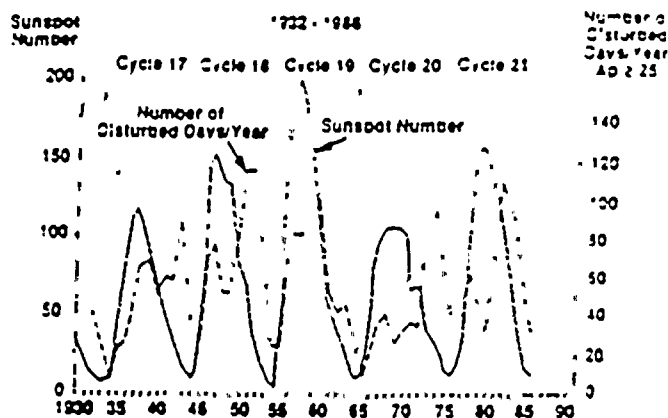
Figure 1. Variations of the Yearly-Averaged Sunspot Number and Geomagnetically Disturbed Days from 1932-1986.

On the average, solar activity, as measured by the number of monthly sunspots, follows an 11-year cycle. The present sunspot cycle 22 had its minimum in September 1986, and is expected to peak in 1990-1991. Geomagnetic disturbance cycles do not have the same shape as the sunspot number cycles, even though they are cyclical. Figure 1 shows the nature of the sunspot numbers and geomagnetic activity:

cycles from 1932 to 1986 (2, 3). Note that the geomagnetic disturbance cycles can have a double peak, one of which can lag the sunspot cycle peak. While geomagnetic activity in the present cycle is expected to maximize in approximately 1993-1994, severe geomagnetic storms can occur at any time during the cycle; the K-9 storm of March 13, 1989 was a striking example.

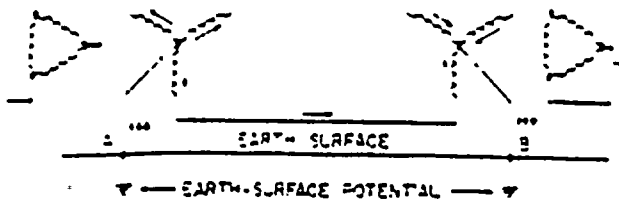
Figure 2. Induced Earth-Surface-Potential (ESPI) Producing Geomagnetically-Induced-Currents (GIC) in Power Systems.

The per-phase GIC in power transformer windings can be

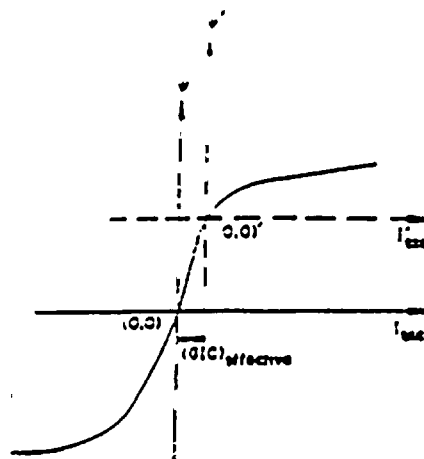
Figure 3. DC Bias of Transformer Core Flux Due to GIC.

many times larger than the RMS ac magnetizing current, resulting in a dc bias of transformer core flux, as in Figure 3.

The half-cycle saturation of transformers on a power system is the source of nearly all operating and equipment problems caused by GIC's during magnetic storms. The direct consequences of the half-cycle transformer saturation are:
