March 24, 1997

LICENSEE: Niagara Mohawk Power Corporation

FACILITY: Nine Mile Point Nuclear Station Unit No. 1

SUBJECT: SUMMARY OF TELEPHONE CONVERSATION OF MARCH 20, 1997, ON CORE SHROUD  
INSPECTION OBSERVATIONS (TAC NO. M98170)

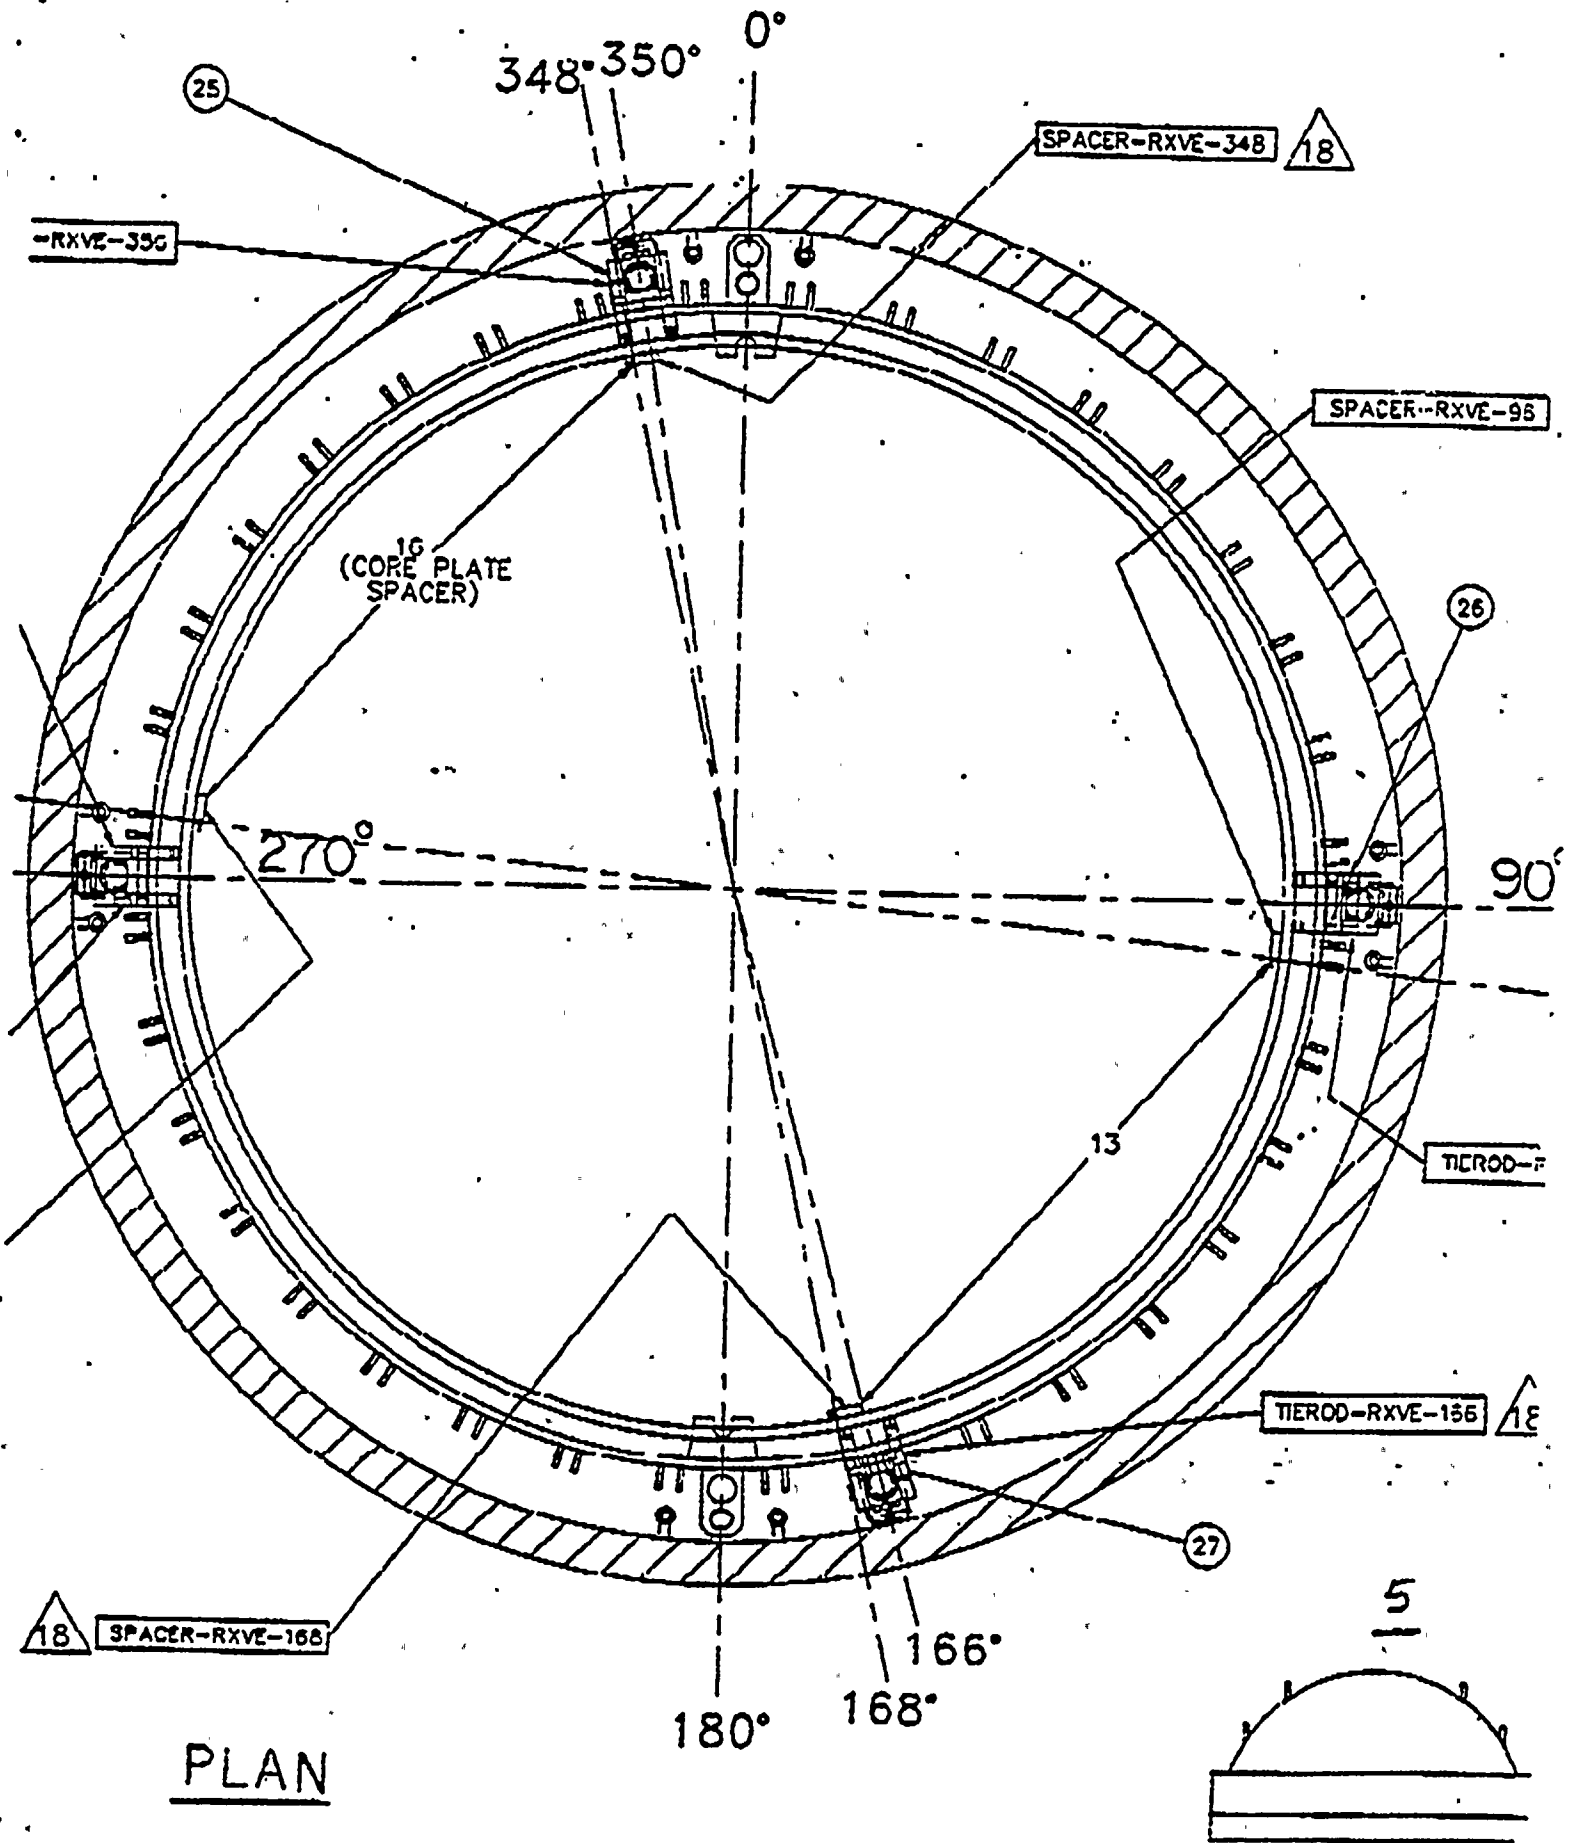
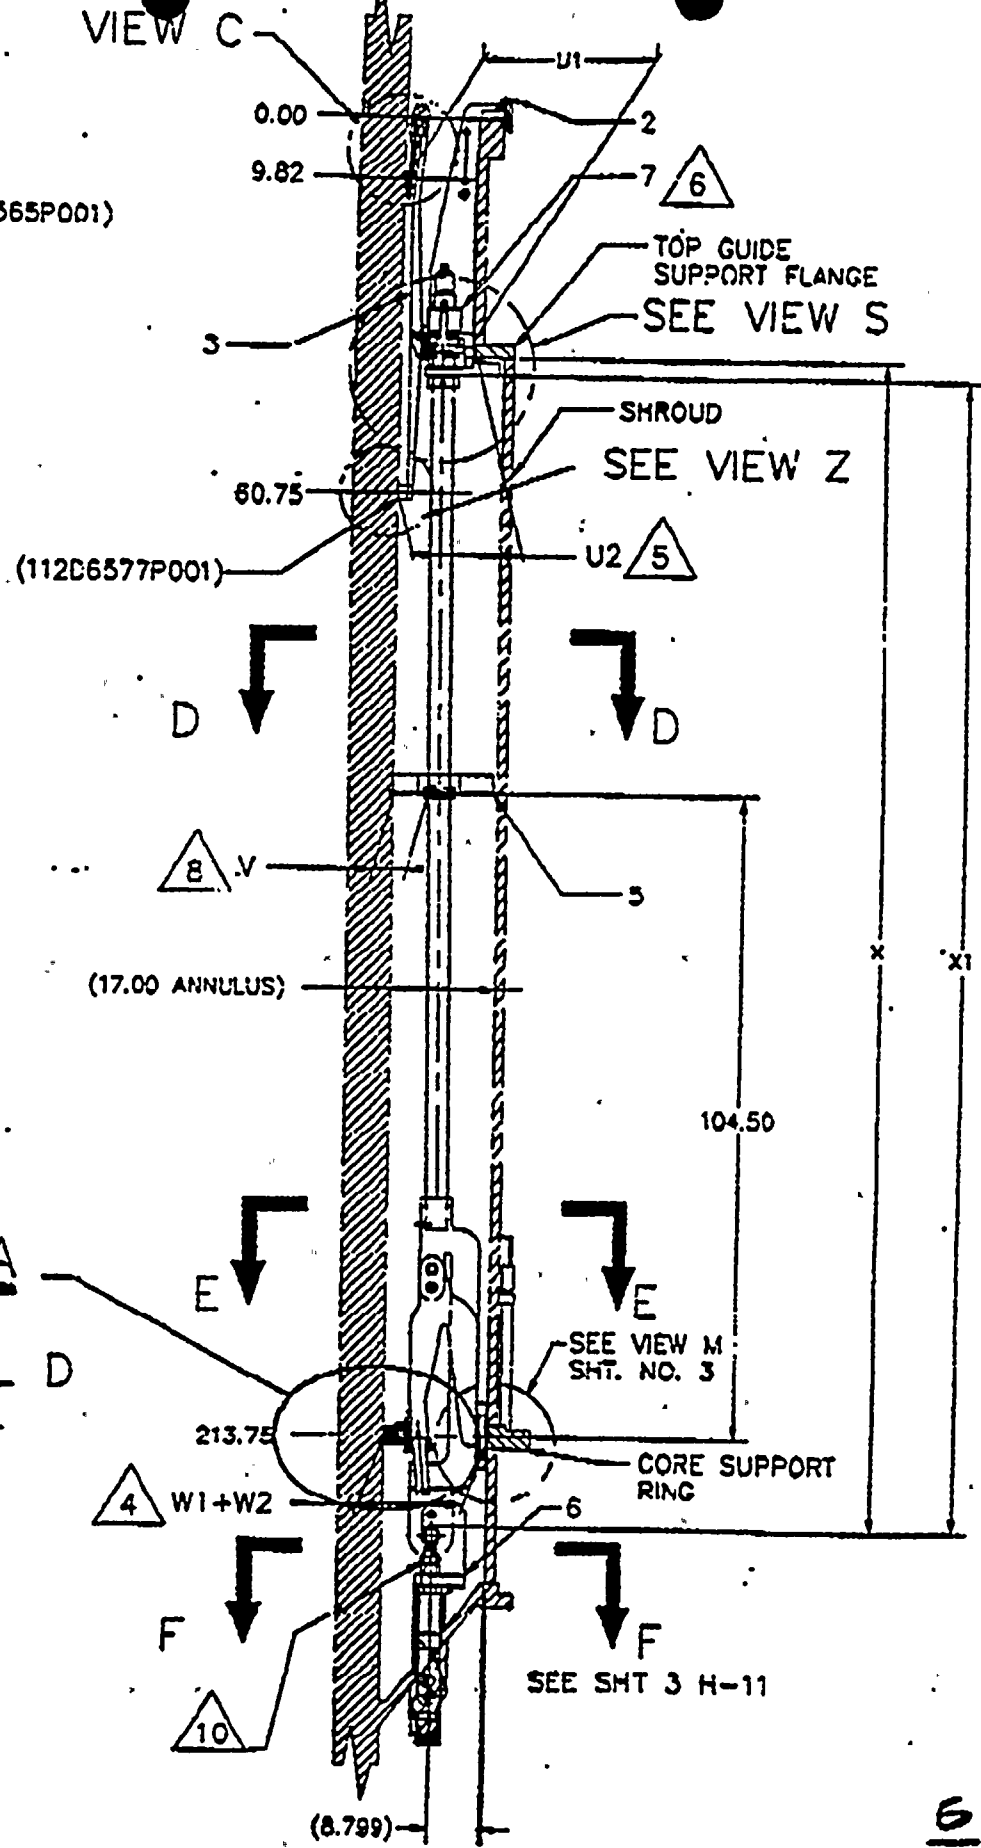
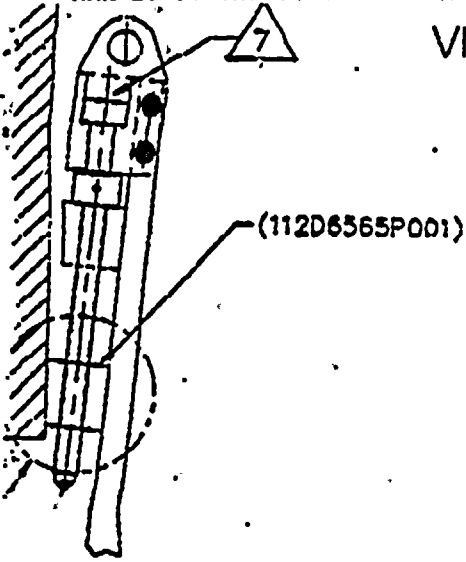
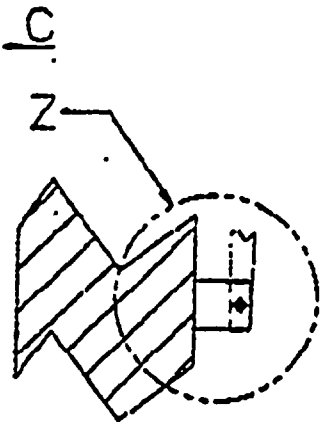
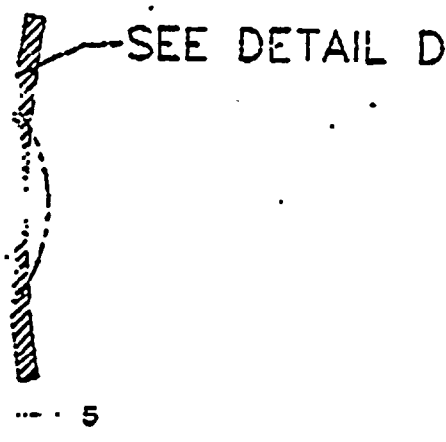
CORE SHROUD STABILIZERS

The latch (called a "retainer clip" on page 7 of Enclosure 2, handouts) in the lower portion of the 90° tie rod assembly was observed to be missing and the associated lateral support block had shifted downward until encountering a retaining pin. Visual inspection of the other three tie rod assemblies revealed apparent degradation (i.e., "discoloration") of latches in the 270° and 350° tie rod assemblies. The lateral support block for the 350° assembly has shifted downward about 1/4 inch. The licensee is preparing a Deviation/Events Report on the latches and evaluating the potential consequences of a postulated multiple loss of retainer clips.
