**Metallurgical Evaluation of Failed Shroud Tie Rod
Lower Spring Contact Wedge Latches**

Nine Mile Point Unit 1, RF014

**D. E. Delwiche, Program Manager
Metallurgical Evaluations
Plant Materials Technology**

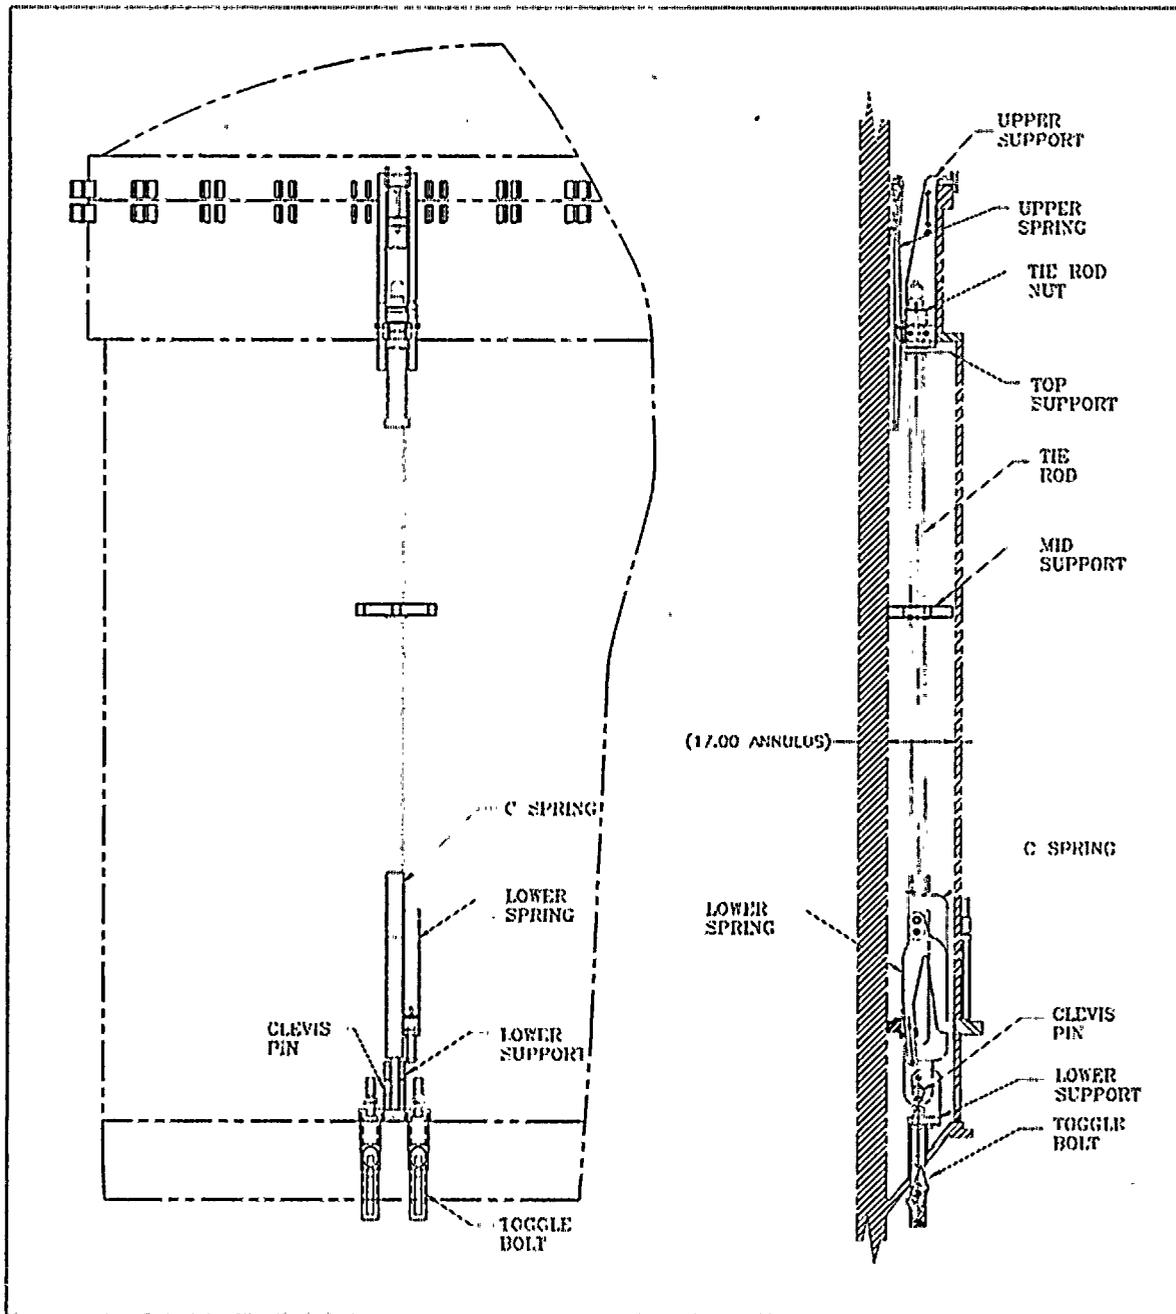
Figure 1 shows an elevation view of one set of shroud repair assemblies. There are four such sets at azimuths 90, 166, 270, and 350 degrees around the core shroud. The tie rod is the main component for reacting axial loads. The lower spring is the linear spring for supporting the shroud at the core plate elevation. The lower wedge is a component that was machined based on actual site measurement to fit between the RPV and the lower spring with a small compression of the lower spring at room temperature. The latch is a wishbone shaped piece, intended to prevent relative motion between the lower wedge and the lower spring. Figure 2 provides detail of the lower spring wedge latch within the shroud repair assembly. Similar latches are also used to prevent relative motion at the mid-support and at the upper spring. The lower support is an assembly that connects the shroud repair hardware to the shroud support cone. The tie rod nut is at the top of the tie rod and is used to tighten the assembly. During installation, the tie rod nut was torqued to preload the assemblies to assure minimal tightness of components. The mid-support is used to limit relative motion between the middle of the shroud and the RPV. The upper spring is a linear spring for supporting the shroud at the top guide elevation. For more extensive description, see Reference 1.

Figure 1. Shroud Repair Assemblies

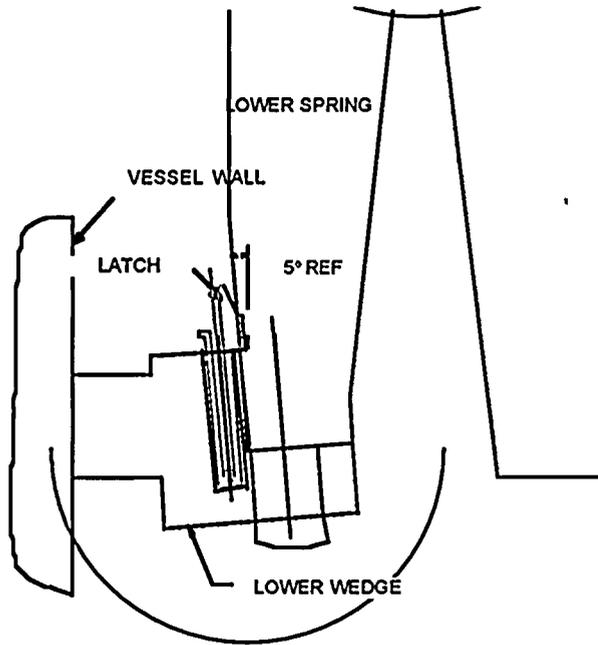
Figure 2. Shroud Repair Lower Support Configuration

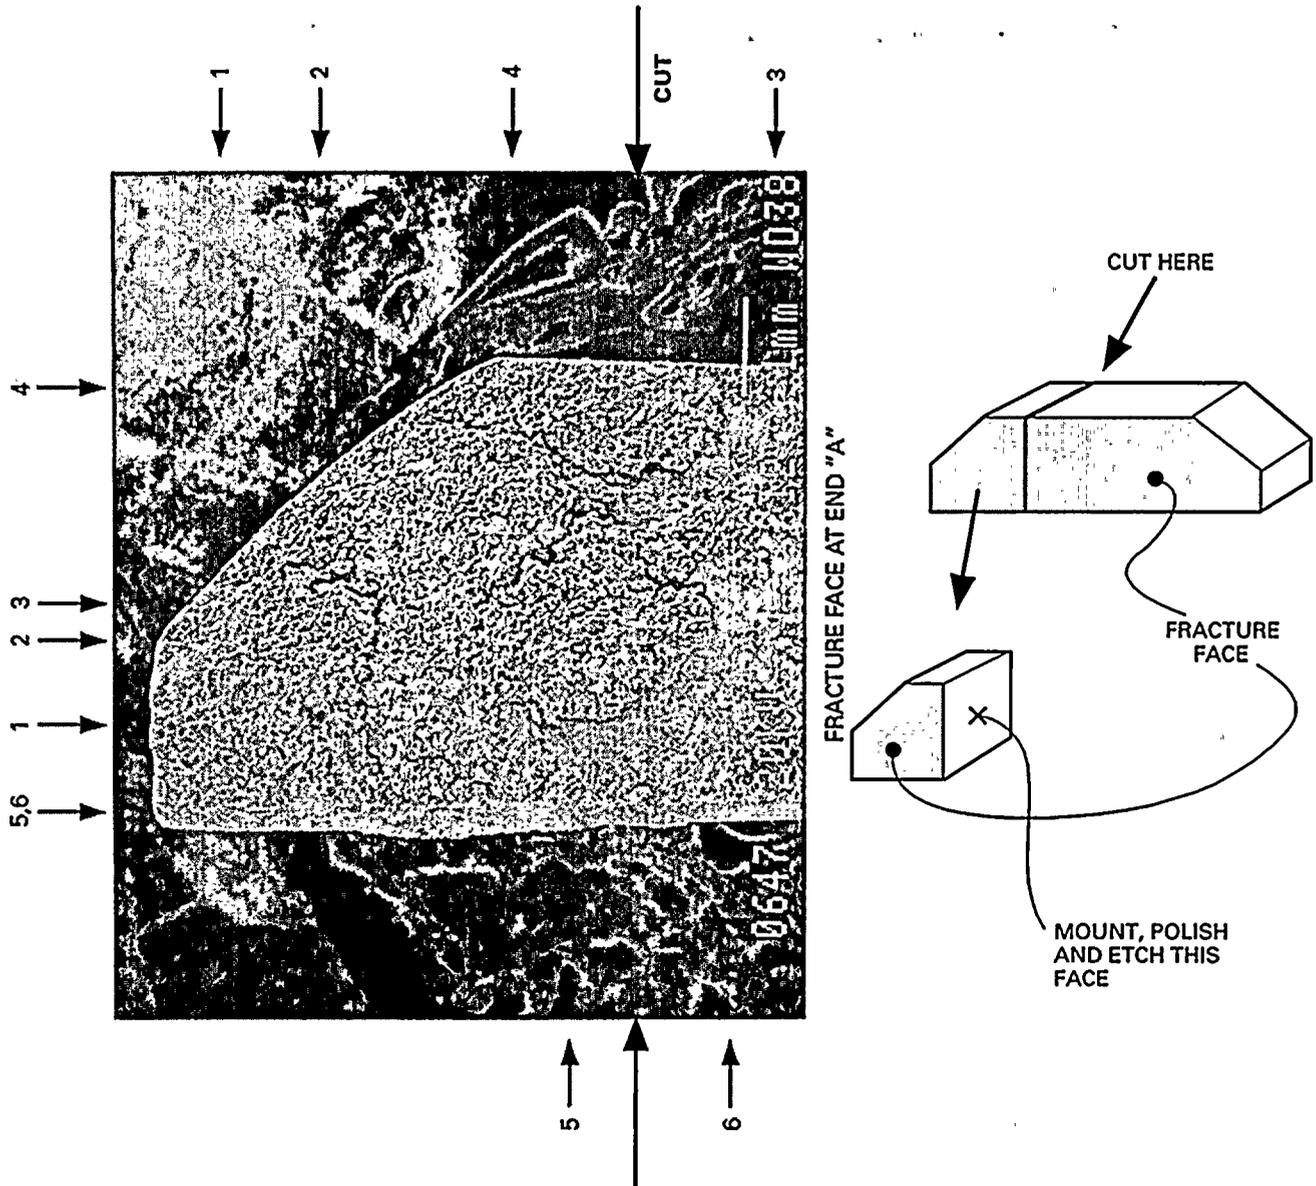
Figure 24. Sketch of sectioning location for optical microscopy - 350 degree wedge latch.

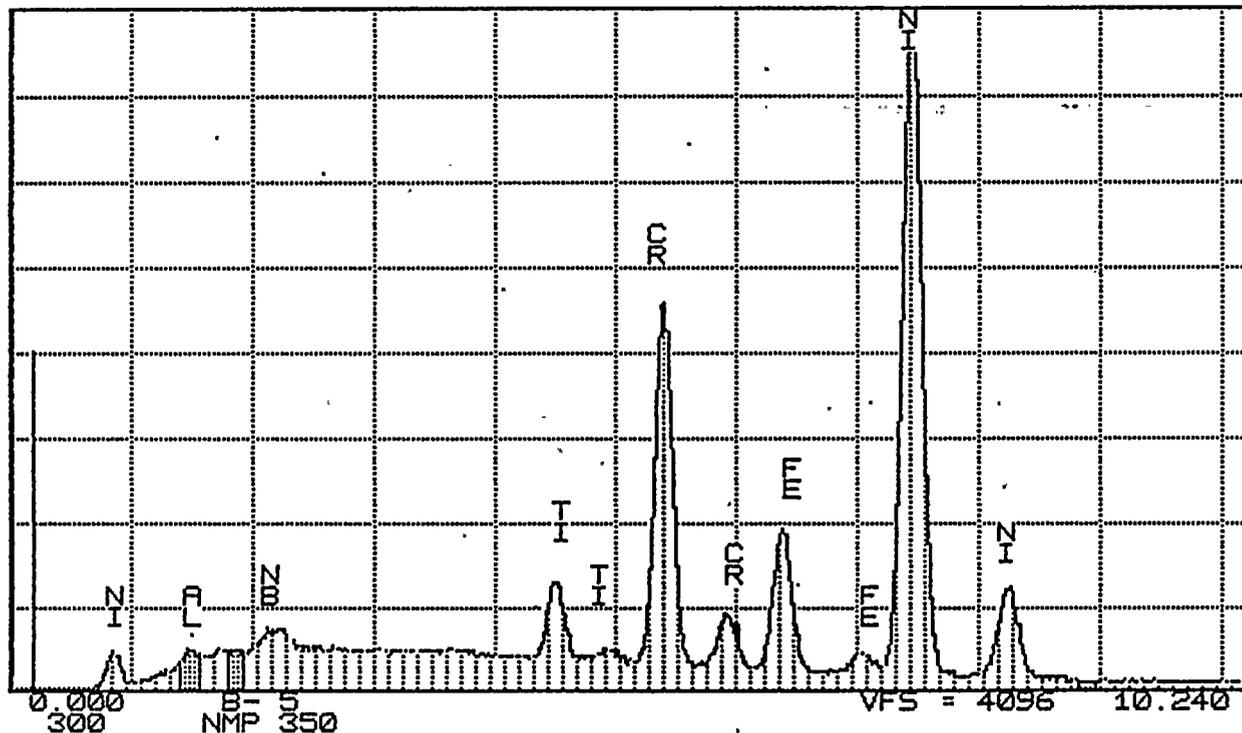
Initial compositional analysis screening was performed at the time of the SEM fracture surface study. Figure 38 is EDS (Energy Dispersive X-ray Spectroscopy) data used to qualitatively check composition of the latch material. The scan was prepared on a relatively clean (low oxidation) region of the fracture face. The data are consistent with Alloy X-750.

Normalized Elemental Wt%					
Al	Nb	Ti	Cr	Fe	Ni
0.40	1.55	3.05	18.09	9.35	67.56

Figure 38. EDS (Energy Dispersive X-ray Spectrum) data use to qualitatively check composition of latch material. Scan was prepared on a relatively clean (low oxidization) region of the fracture face. The data are consistent with Alloy X-750.
