SUBJECT: Forwards response to NRC 810309 request for info re breakwaters. Breakwater damage would not result in configuration for which intake facility safety features are not qualified. Written confirmation requested.

Re: Docket No. 50-275
Docket No. 50-323
Diablo Canyon Units 1 & 2

SAFETY IMPLICATIONS OF DAMAGED BREAKWATERS

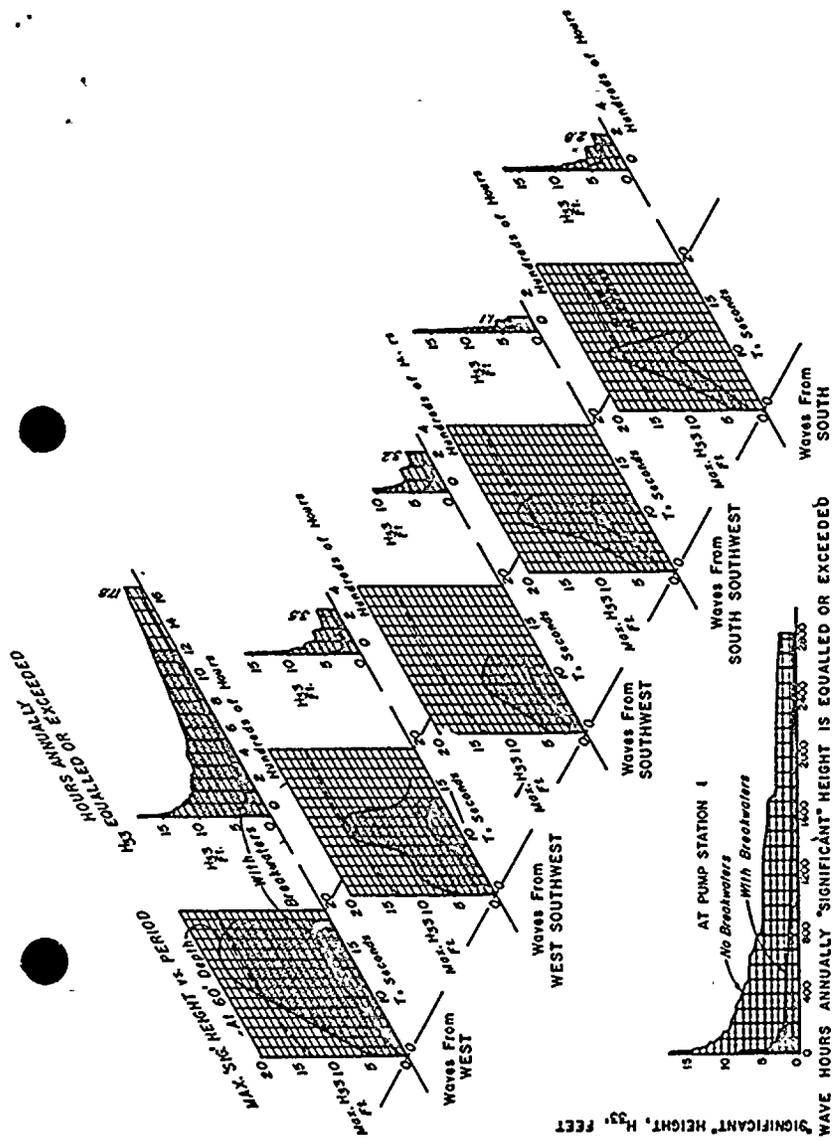
Fig. 4 Heights and Durations of Waves at Pump Station 1, With and Without Shelter

Figure 4 illustrates important aspects of the wave climate calculated for the site, and the mitigation available with breakwaters. The maximum "Significant" heights of refracted waves at the site were extracted from the calculations and plotted against their respective periods, separately for each 22.5° sector centered West, West Southwest, Southwest, South Southwest and South. Those plots appear as five skewed grid graphs. The upper curves show maximum "Significant" heights for each wave period at the cove's headlands. The dot-shaded upper curves are the same waves at the -20 feet contour in the cove, if no breakwaters were built. The two curves are identical, for practical purposes, except where the larger waves would break at depths of 20 feet or less.

Alongside to the right of each $H_{33\max}$ vs. T graph is a duration plot of "Significant" heights for all waves originating in the represented sector of deep water directions. At the bottom of Fig. 4 appears H_{33} vs. Duration, combining the wave durations from all of the 5 sectors. The line above the hatched area represents height durations if breakwaters were provided and the upper line is height durations if no breakwaters were provided.

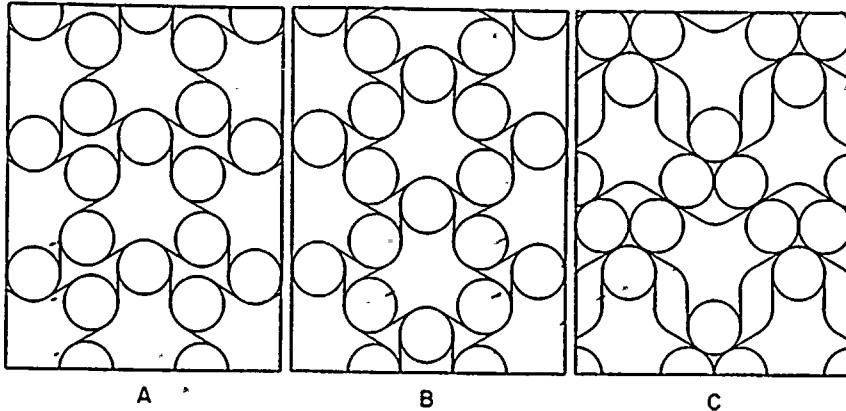
Fig. 13 Geometric Patterns for Tribar Placing

Placement of Tribars.—Three different geometric patterns have been used for placing single-layer Tribar armorings. They are illustrated by Fig. 13. Pattern A might be called the "Reversing Files" placement. It was used in the Diablo model tests. A theoretically perfect pack in this pattern (a "100%" pack) would use a gross area per Tribar equalling $5.0079D^2$, where D is the diameter of any cylindrical element of the Tribar. Pattern B, called the "Hexagonal Modular" placement, also uses $5.0079D^2$ units of area. It was specified for construction, because all pieces are lowered to placement with the same orientation, minimizing confusion during construction operations and giving a double "heel-in" downslope for each piece. The third pattern, C, called "Reversing Ranks", occupies more gross area per piece, $5.6329D^2$. Using it would reduce Tribar requirements 11 per cent, but they would interlock less effectively, could rotate out of pattern more easily, and for those reasons it was not favored.

Specifications for Tribar placement were rigorous. They required putting the pieces, as nearly as practicable, in the "Hexagonal Modular" pattern shown at B in Fig. 13. The specifications obligated the contractor to:

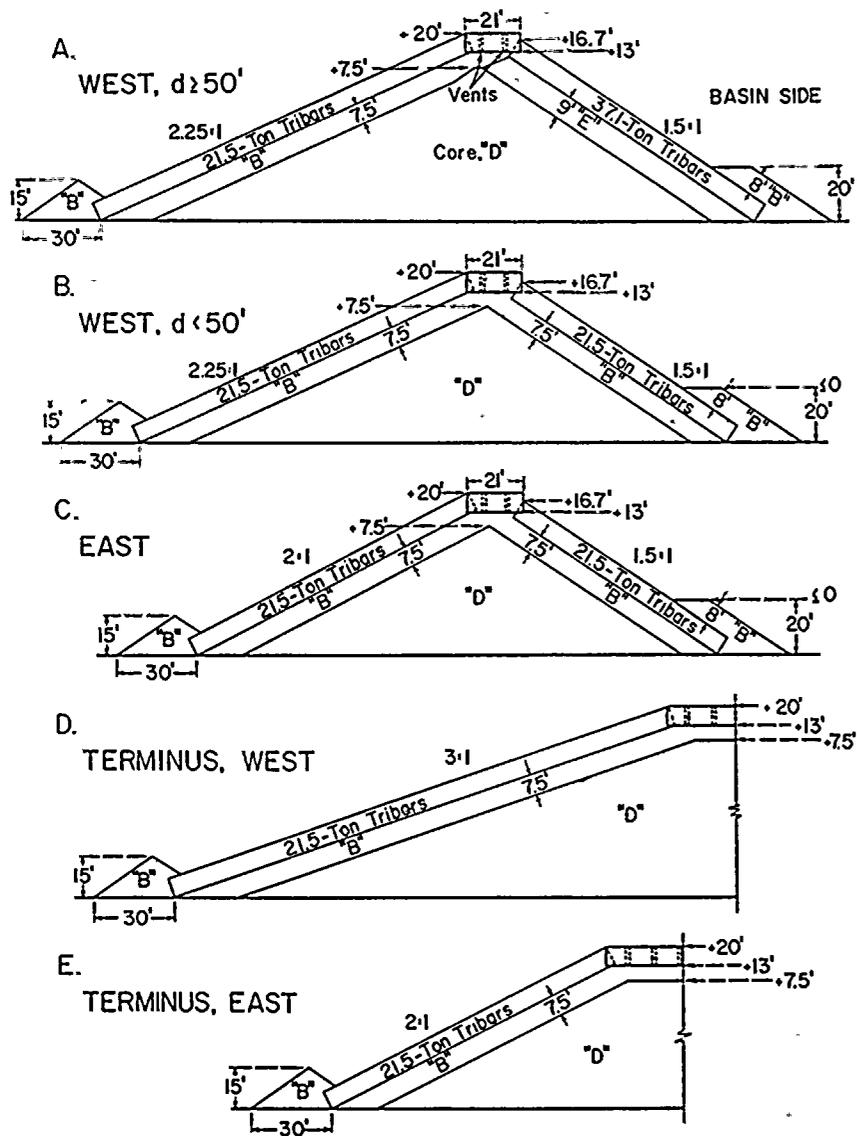
Fig. 12 Constructed Cross-Sections

Adopted Cross-Sections.—Figure 12 shows the principal cross-sections adopted for construction. The core material, D stone, was produced by levelling Patton Peak, the hill with summit at elevation +199 feet seen at the extreme right of Figs. 3 and 5. The underlayer "B" and "E" stone was granitic material produced at a quarry about 30 miles away and trucked to the site. The Tribars, unreinforced, were specified to weigh not less than 145 pounds per cubic foot at the time of fabrication. Concrete was specified to be made with air entrainment, using a modified Type II cement, standard compressive strength of 5,000 pounds per square inch or more was required of 90 per cent of all test specimens; Tribars showing either less than 4,500 pounds per square inch compressive strength or weighing less than 140 pounds per cubic foot at time of installation were stipulated for rejection. Cap concrete required the same air entrainment and kind of cement as the Tribars, but its compressive strength requirement was 3,000 pounds per square inch.

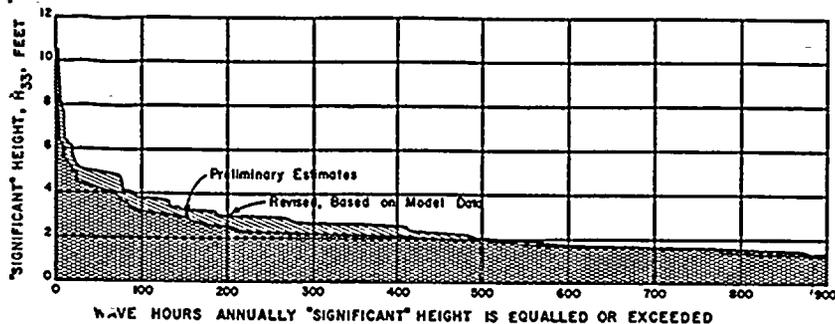
Fig. 7 Wave Height-Duration, Model vs. Preliminary Computations

Comparison of Results.—Wave motion was recorded at several locations within the model basin and compared with the heights of the waves at the 60 foot depth curve just seaward of the basin entrance. Curves were derived from those recordings, generally fitted by considering the least reduction in wave height found among several runs for each period, to refine the height:duration estimates from the preliminary studies. It was not surprising that the model-related duration data showed a slightly bigger highest wave at Pump Station 1, because the preliminary studies had not added the uncertain effect of aggravated heights inside the basin caused by re-forming of waves, from the cascading water overtopping the breakwaters. That the number of hours when H_{33} would be 3 feet or higher was so little different in magnitude from the preliminary estimates, 200 hours compared with 150, was very gratifying. Fig. 7 shows both duration curves. The area under the original distribution curve is hatched by lines running downward from left to right, while under the model-related curve they run upward from left to right.

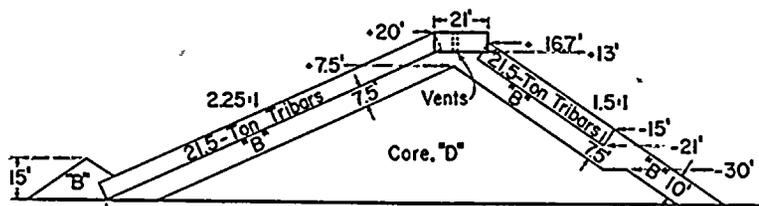
Fig. 8 Preliminary Deep Cross-Section, For Tests

Preliminary Design for Modelling.—Figure 8 shows the preliminary design cross-section for the deepest location along West Breakwater. The seaward armoring to be tested, 21.5-ton Tribars in single layer, fitted arrangement, was sized by application of prior experience (1) with the piece and discussions with its inventor, Robert Q. Palmer, F. ASCE. Figure 9 shows the Tribar's proportions. In Fig. 10 the reader can see and appreciate the dimensional size of the 21.5-ton armor piece. The right half of Fig. 10 shows forms for these smaller Tribars. The 21.5-ton pieces are 7.17' high; larger ones 37.1 tons each, and 8.58' high, subsequently were also used on West Breakwater's basinward side. The Tribars were bedded on a very open, porous layer of "B" stone. The "B" stone was specified by volume definition rather than by weight per piece. Doing so has logic, it seems, because dimensional size is really the important parameter. The minimum size piece was set at 10 per cent of the volume of the Tribar it would underlie. The median piece of the "B" stone was specified to be twice the volume of the minimum, and the maximum size would be twice the median. The seaward armor slope was selected at 2.25:1, and its nominal surface

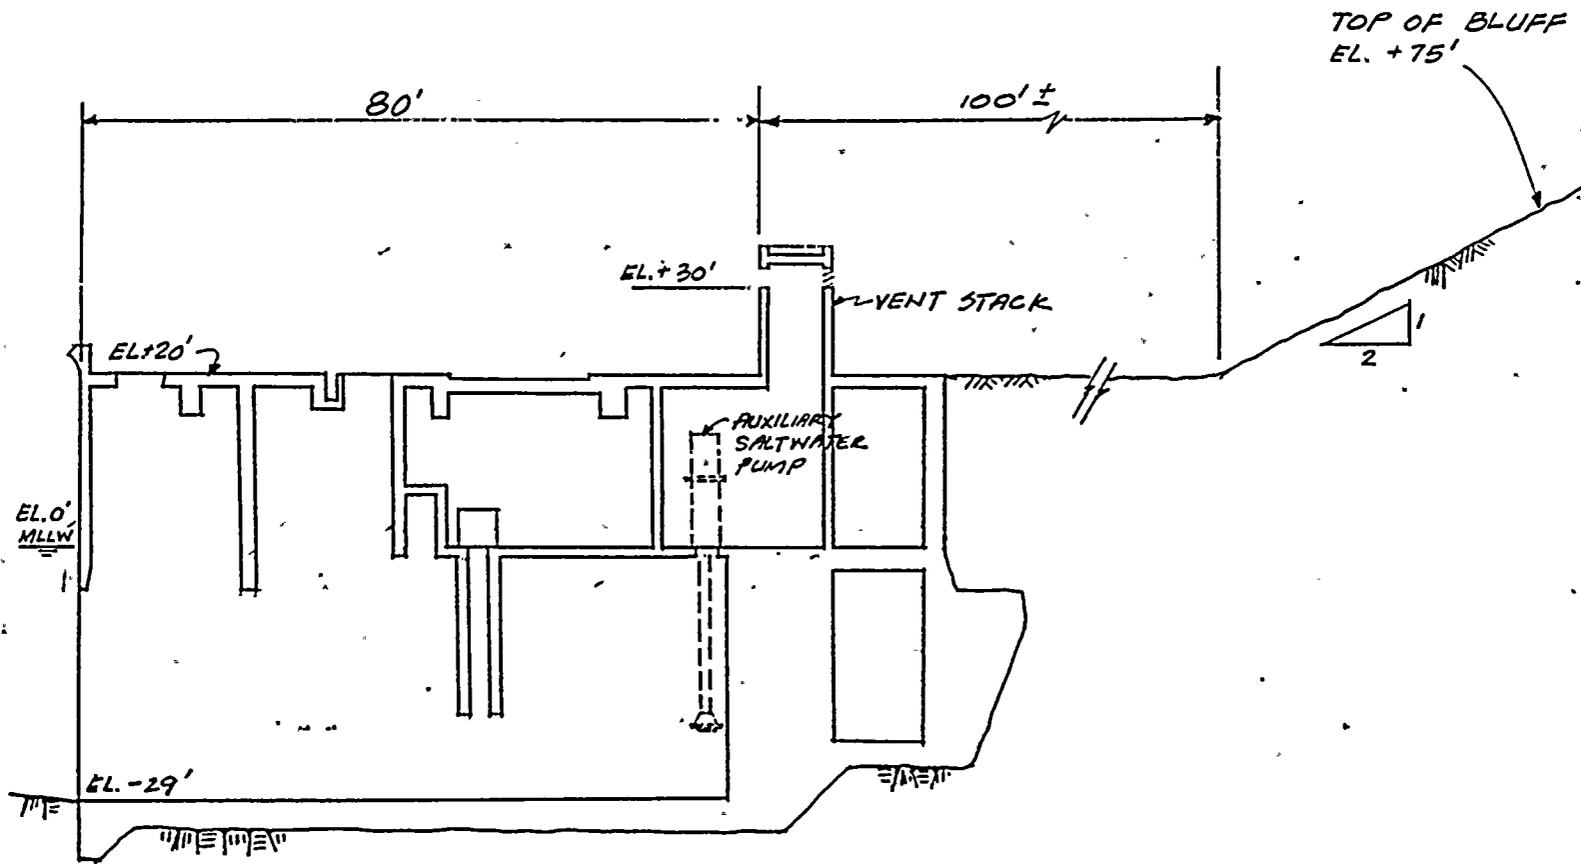
FIGURE 1

The only safety-related items located in the intake structure are the auxiliary saltwater pumps together with their associated piping and equipment. The pumps are installed in the intake structure in watertight compartments which will accommodate any combination of sea waves, extreme tides, storm waves, storm surge, and tsunami effects up to elevation +30 feet, referenced to Mean Lower Low Water (MLLW). These compartments are located in the central section of the structure between the two sets of main circulating water pumps. This location is set back 80 feet from the front wall of the structure. Ventilation air for the auxiliary saltwater pumps is provided through air intakes located in the walls of two concrete vent stacks each with plan dimensions of 10 feet by 9 feet. The bottom of the air intake louvers is at elevation +30 feet (MLLW). This arrangement is shown in the attached Figure 1.
