LICENSEE: Pacific Gas and Electric Company (PG&E)
FACILITY: Diablo Canyon Nuclear Power Plant, Unit 1
SUBJECT: SUMMARY OF OCTOBER 20, 1992 PUBLIC MEETING TO DISCUSS STEAM
GENERATOR FEEDWATER NOZZLE CRACKING

STEAM GENERATOR FEEDWATER NOZZLE CRACKS

AT DIABLO CANYON UNIT 1

**PACIFIC GAS AND ELECTRIC COMPANY
DIABLO CANYON POWER PLANT
PRESENTATION ON FEEDWATER NOZZLE ISSUES**

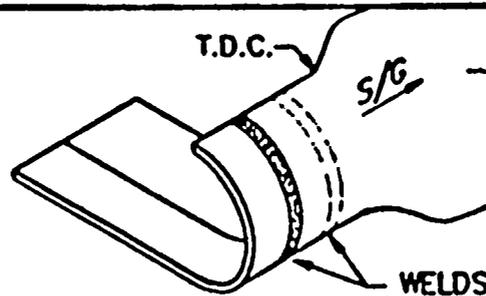
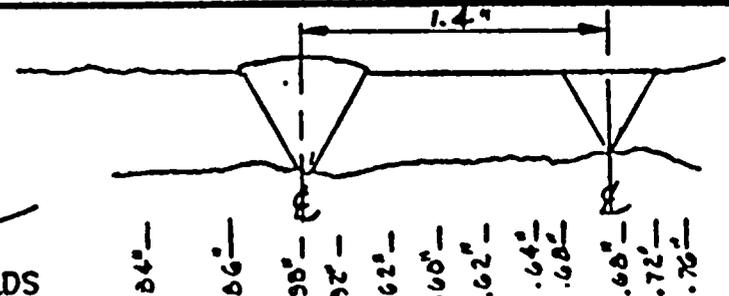
STEAM GENERATOR: 1-1
 WELD NO. WICG 101A1-1
 INSPECTOR NAME: HECHT/HOLLOW
 DATE: 9/24/92
 SCALE: NONE

ROLLOUT

PROFILE

- **Metallurgical Sample Taken on 1-3 and 1-1 Spools**
- **Results Show UT Very Conservative**
 - UT Sized at "0.35" Deep
 - Samples Shows "0.037" Deepest
- **Evidence of Microcracking in Spools**
- **^{**} Segregates Found in Material**
 - May Mislead UT Sizing
- **Must Factor Into UT Analysis (Long Term)**

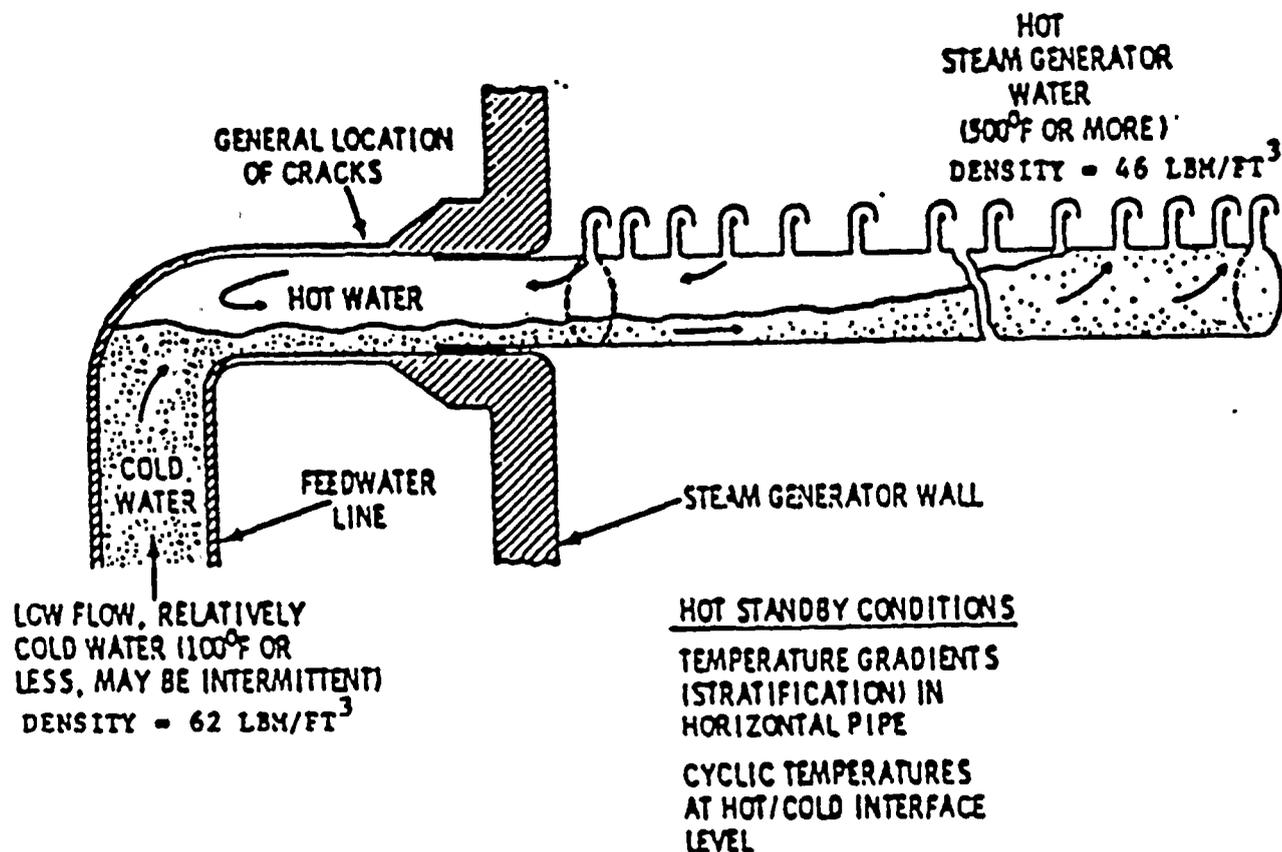
SCHEMATIC OF THERMAL STRATIFICATION AT LOW FLOW IN PWR FEEDWATER NOZZLES

- Thermal Fatigue
 - Stratification
- Erosion/Corrosion
- Corrosion Fatigue
 - Contributory Mechanism
- Overstress
 - Waterhammer
 - Locked/Bound Supports
 - Global Stratification:
- Fabrication

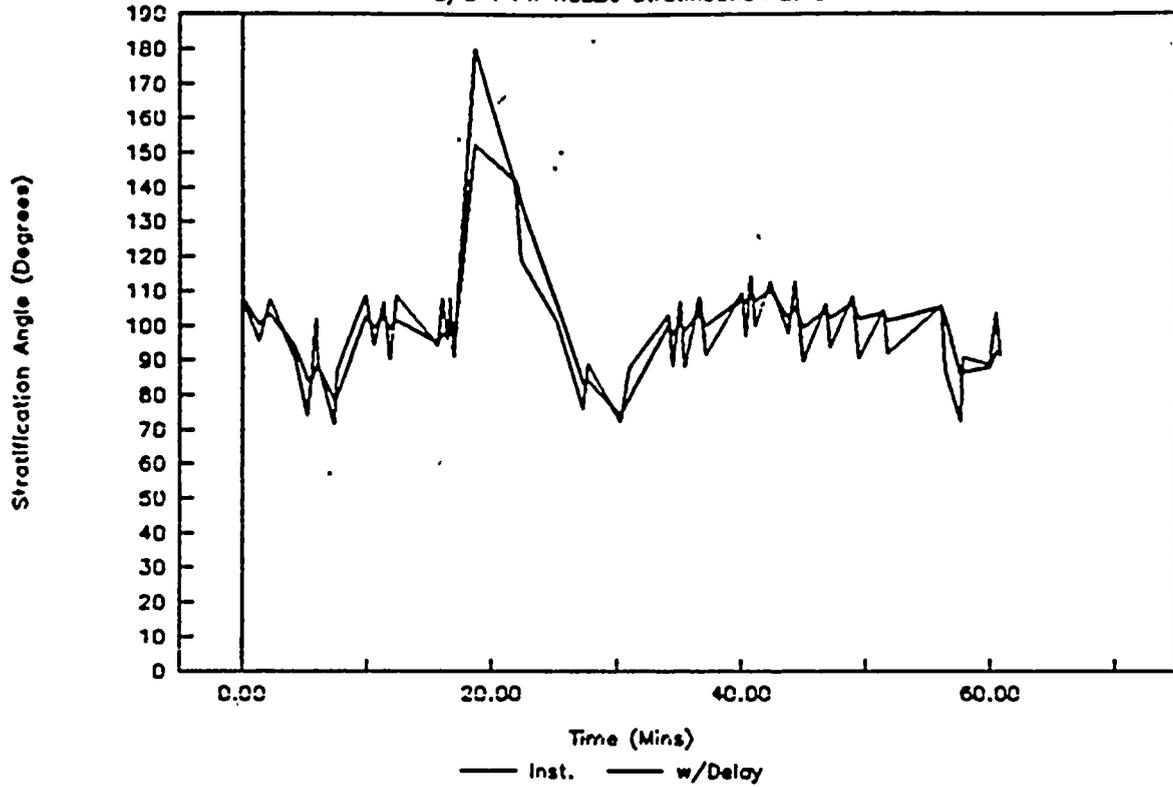
S/G 1 FW Nozzle Stratification Level

- **Observed Cracking in Unit 1:**
 - **Significantly Below Code Allowables**
 - **Consistent with Industry Experience (IEB-79-13)**
 - **Consistent with DCPD AFW Flow/Stratification Cycles**
 - **Would Not Have Grown to Unacceptable Depth for Several Subsequent Fuel Cycles**

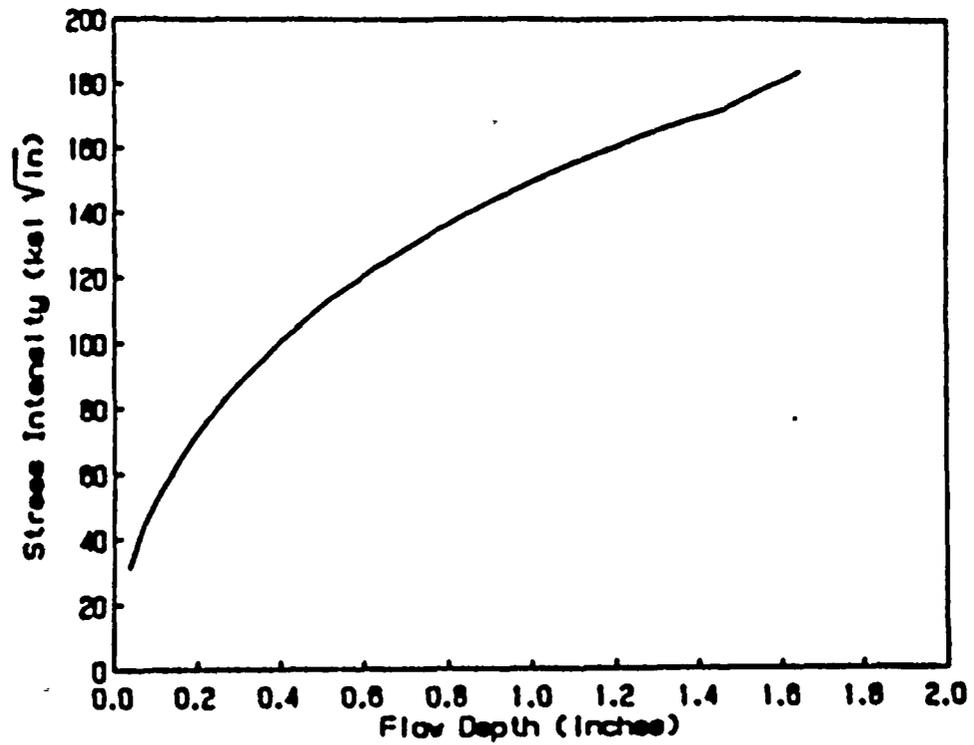
ALLOWABLE FLAW SIZE: FEEDWATER NOZZLE BORE

- Results: Nozzle Bore

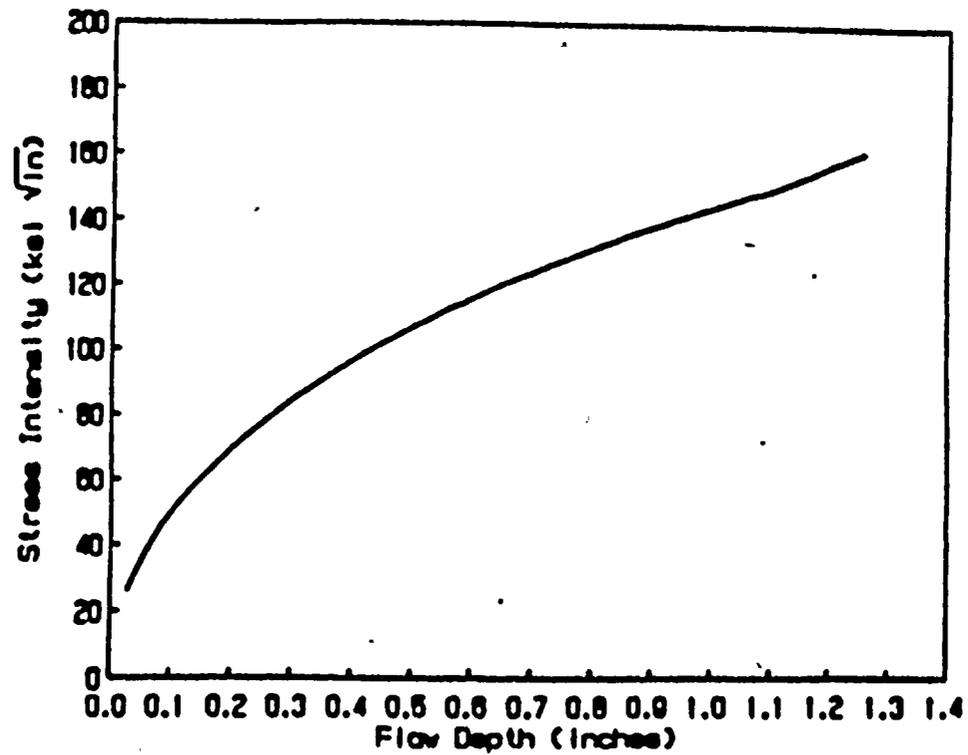
ALLOWABLE FLAW SIZE: FEEDWATER NOZZLE FACE

- **Cracks in the Knuckle Region are not Predicted for Diablo Canyon**
 - **Fatigue Usage is Low**
 - **Severity of Thermal Stratification Loads is Much Less Than at the Plant Where Cracking Was Found**
 - **A Recent UT Inspection of One Nozzle Revealed no Cracking (2-15-91)**
- **Although Cracking is not Predicted, if Worst Case Cracks were to Exist in the Nozzle Region, the Predicted Size Would be Acceptable to Section XI**
- **Predicted Future Growth of Worst Case Cracks Was Found to be Relatively Small for a Future Service Period of 4 Years or 100 Days in Mode 2/Mode 3**
- **Therefore the Integrity of the Feedwater Nozzle Will be Maintained Through the Next Several Years of Service**

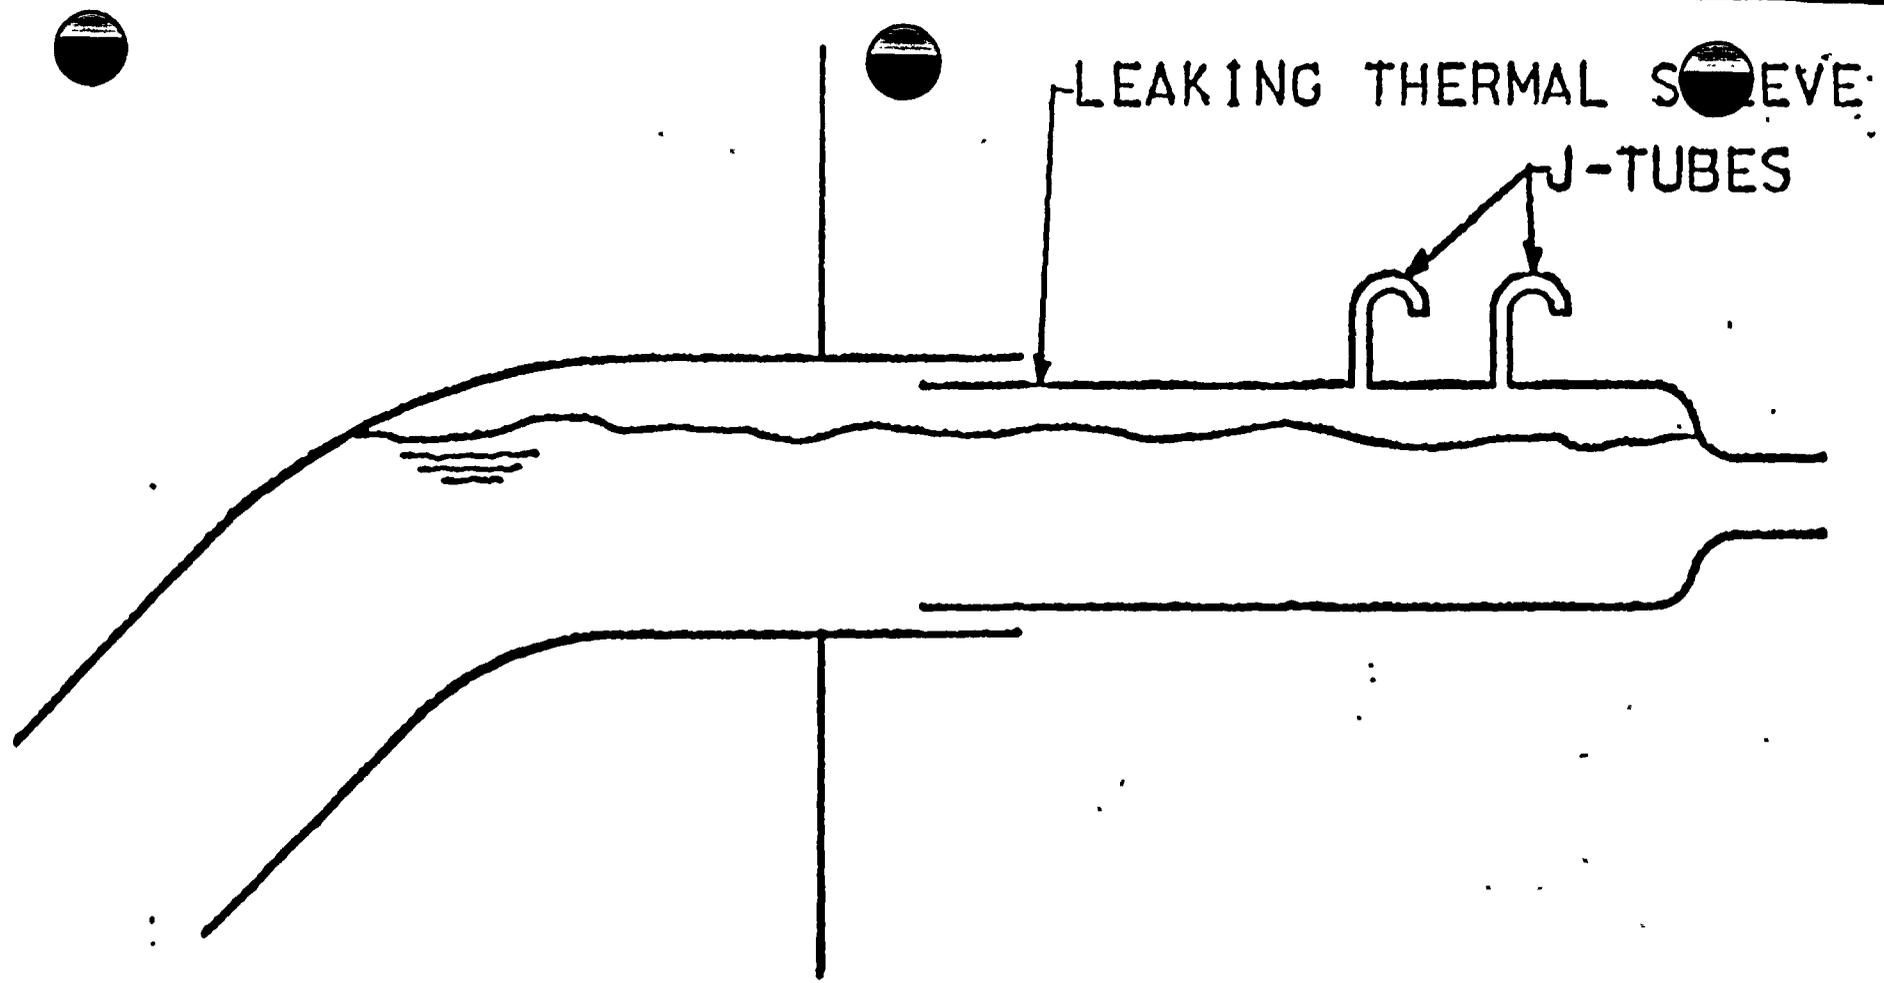
DIABLO CANYON LAYOUT

-
- Both Filling and Draining Configurations Require the Ability of the System to Isolate an Upper Section of Piping From the Steam Supply, the S/G
 - The Configuration at Diablo Canyon Does Not Lend Itself to Such Isolation

- **Waterhammer will Not Occur During Draining, Because, by Design the J Tubes and Thermal Sleeve Allow Steam to Replace the Water as the Feedline Drains**
- **Waterhammer is also Unlikely During Filling, Because of the J Tubes, but Cannot be Ruled Out, Because of the Possibility of Wave Action**
- **Therefore, the Cases of Waterhammer During Filling were Considered:**
 - **A Steam Volume Occupying 10% of the Pipe Cross-Section Extending from the Thermal Sleeve to the Elbows**
 - **A Steam Volume Occupying 10% of the Pipe Cross-Section Extending from the J Tube Nearest the Elbow to the Elbow**
