Commonwealth Edison
 One First National Plaza, Chicago, Illinois
 Address Reply to: Post Office Box 767
 Chicago, Illinois 60690

Subject: Dresden Station Unit 2
 Feedwater Nozzle Temperature Transients
NRC Docket Nos. 50-237

DRESDEN UNIT-2 FEEDWATER NOZZLE
TEMPERATURE DATA REVIEW AND TESTING

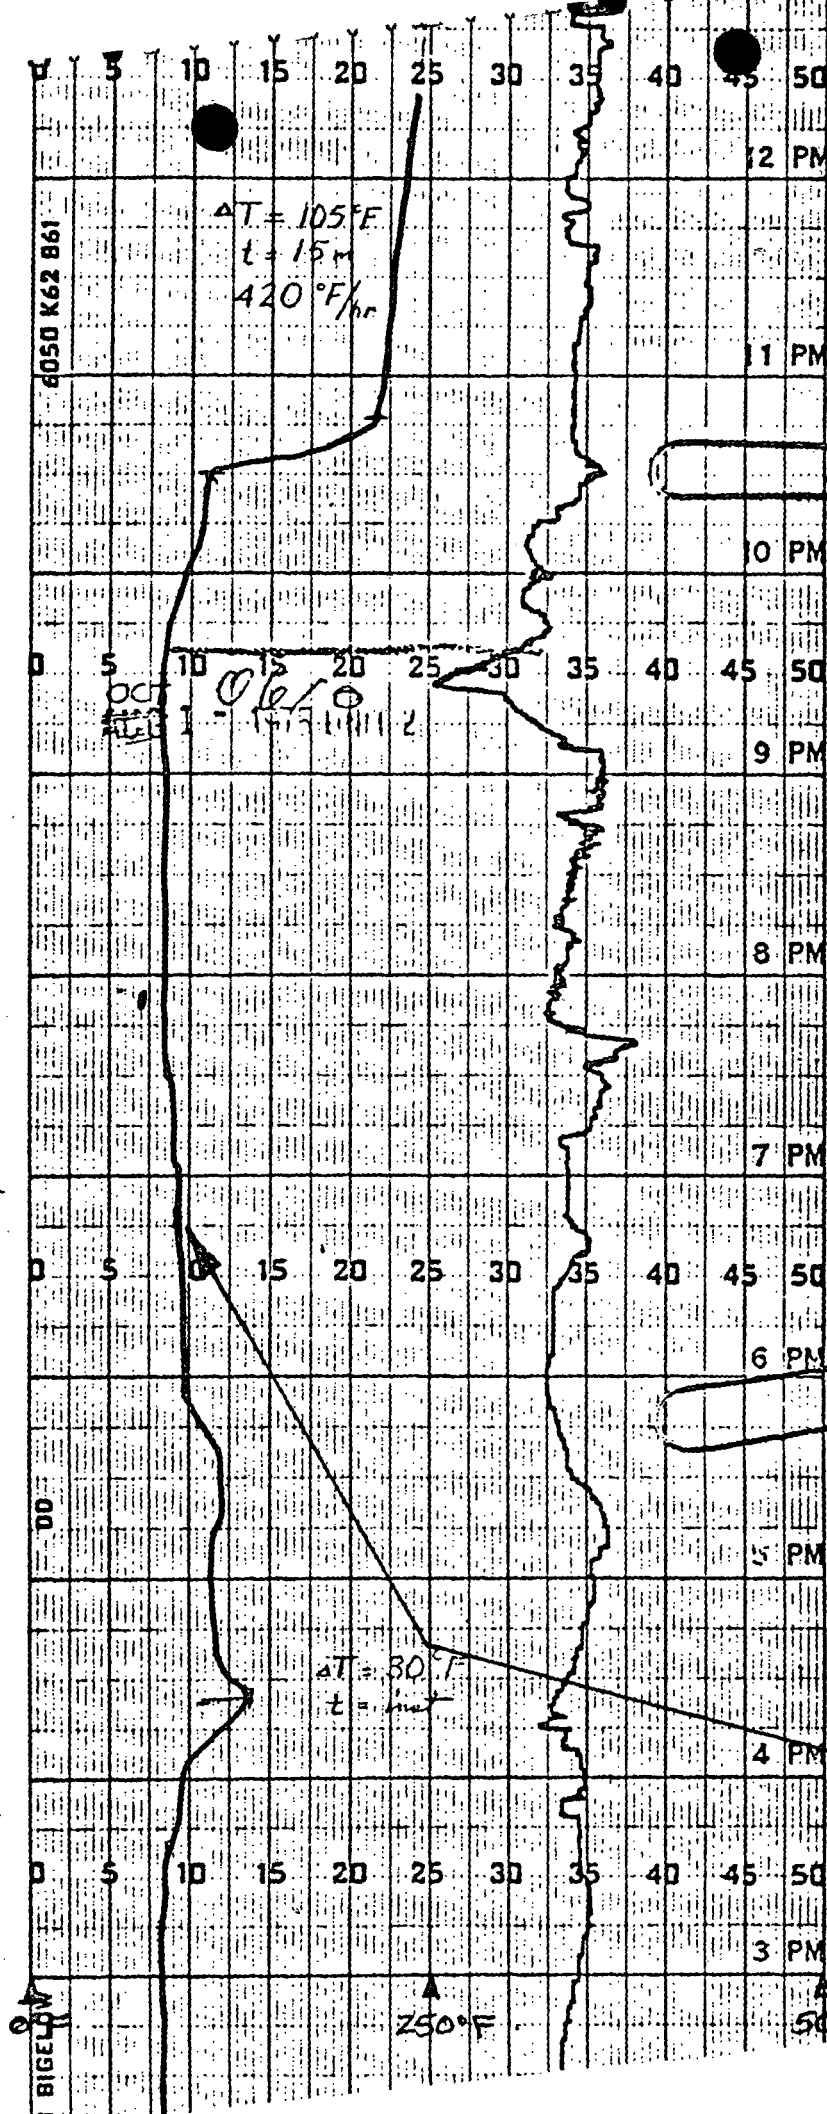
DRESDEN UNIT 2 FINAL
FEEDWATER TEMPERATURE
DURING ROUTINE STARTUP

The charts of final feedwater temperature showed that the largest temperature changes (those 100°F/hour or greater) occurred during plant startups and shutdowns.

Most of the events during a reactor startup or shutdown which caused a significant change in final feedwater temperature were tied to the cutting in and out of feedwater heaters.

In order to investigate a possible method for limiting final feedwater temperature changes, a special operating procedure was prepared for cutting in feedwater heaters. This special procedure directed the operator to limit the final feedwater temperature increase to 100°F/hour. This rate of increase was controlled by slowly opening the extraction
