# DRESDEN NUCLEAR POWER STATION UNIT 2

## Supplementary Information

Special Report  
of  
Incident of June 5, 1970

Commonwealth Edison  
Company

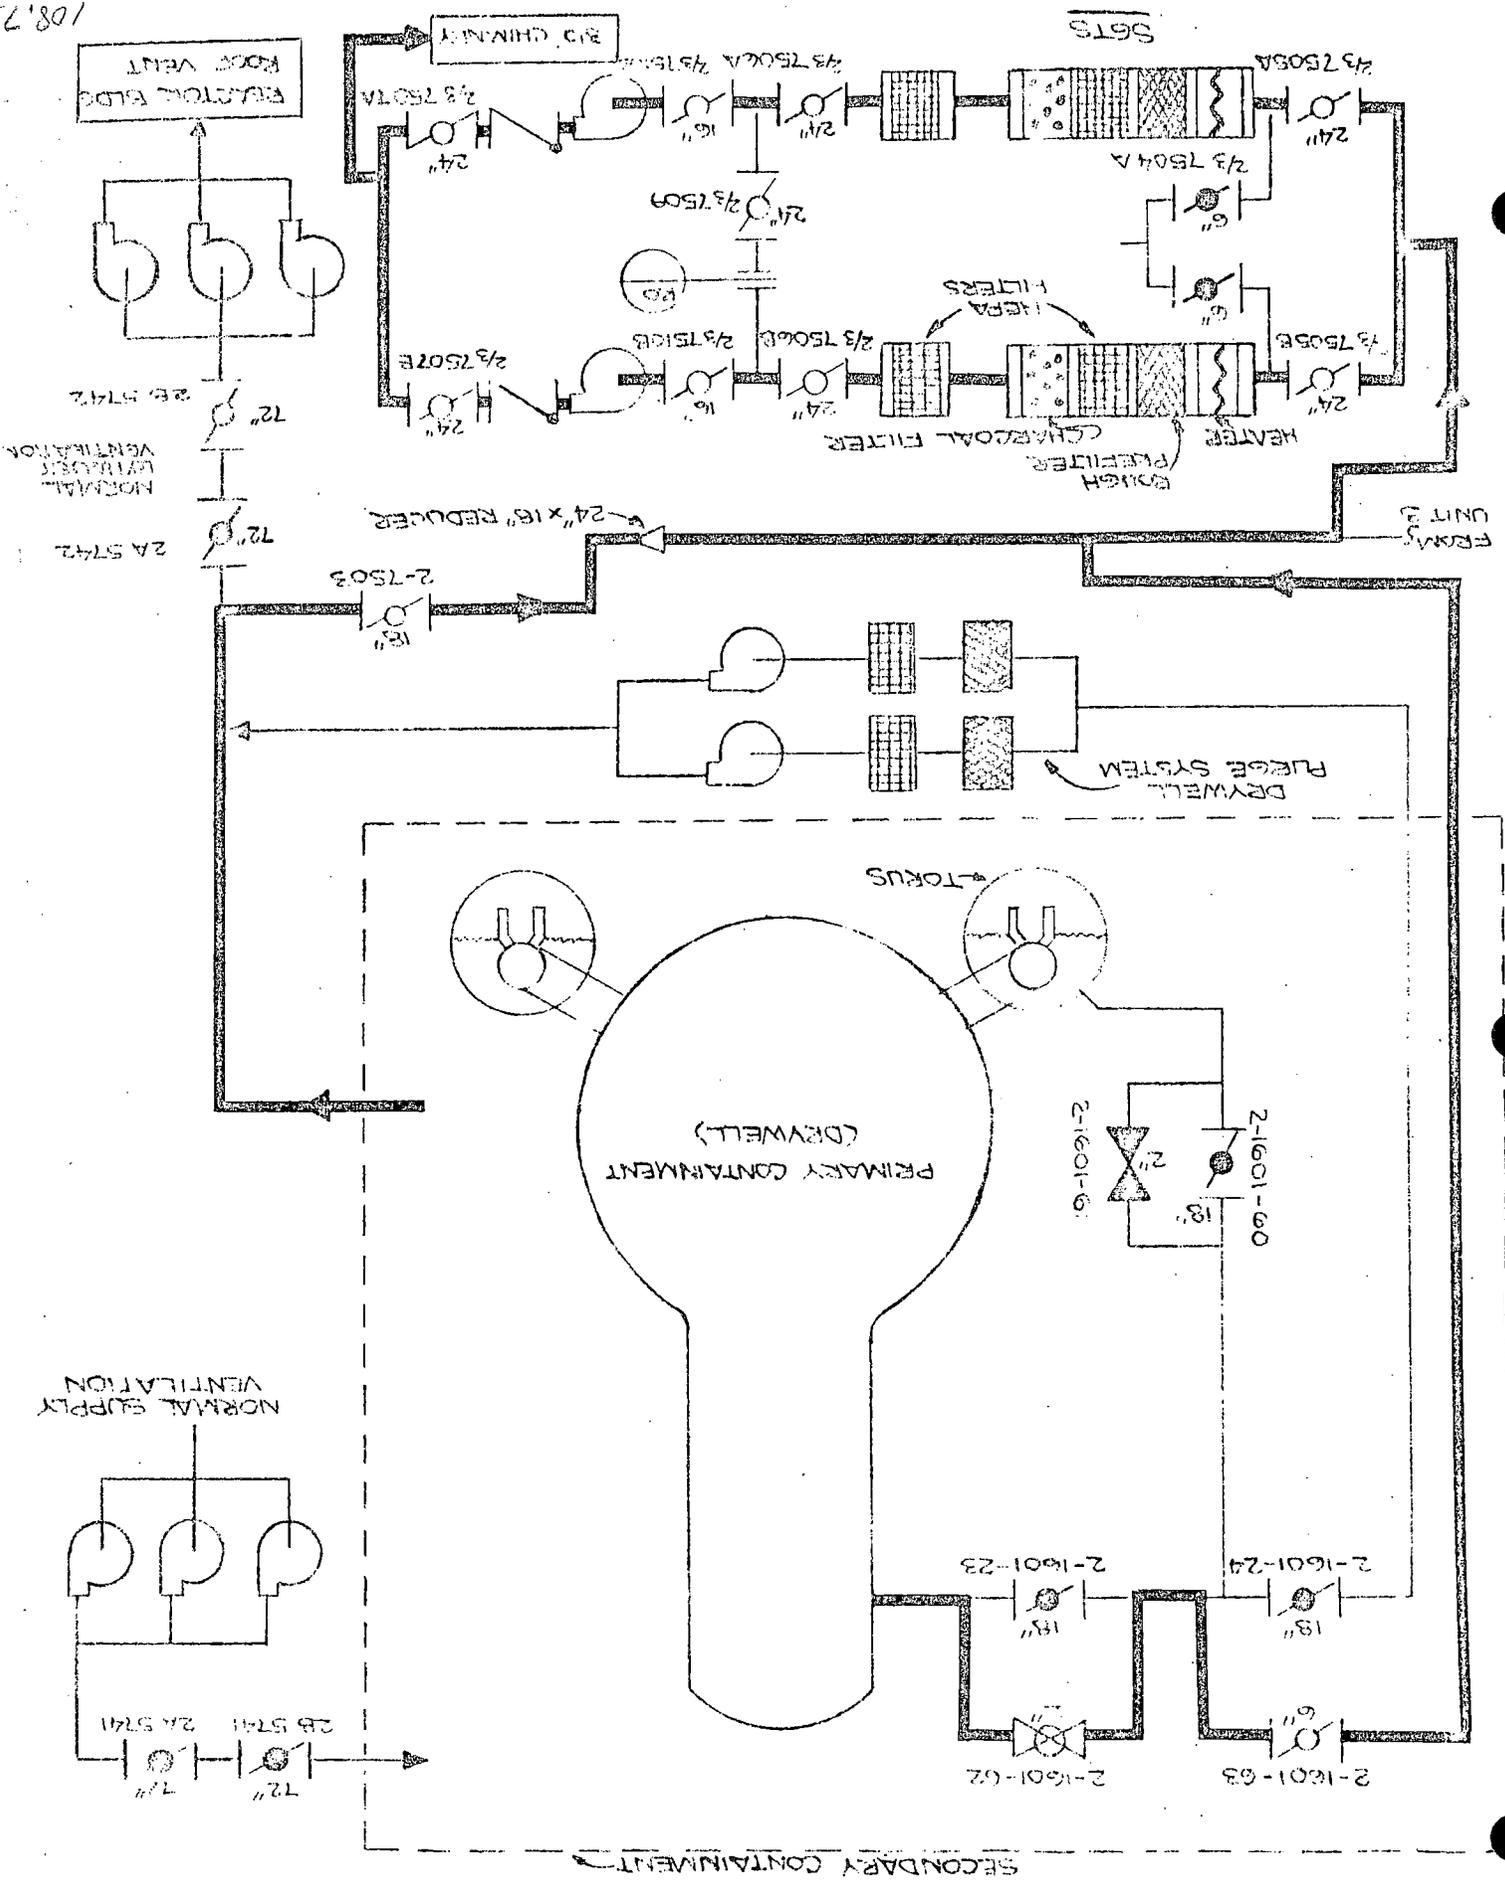
FIGURE 1. DRESDEN 2 DRYWELL VENTING DURING INCIDENT OF JUNE 28, 1970.

If it is postulated that the containment spray was turned on after the drywell wall had heated uniformly to 320°F, the drywell pressure and wall temperature would respond as shown in Figure 1. After 10 minutes the containment pressure has dropped to about 1 psig and the wall temperature to 300°F. Again this combination of buckling load would be less than the design case. In fact, even if the temperature was still 320°F and the pressure as low as 0.2 psig, the buckling load would be no worse than the design case (281°F @ 0 psig). Finally as indicated in the incident report, at 320°F and 0 psig the safety factor compared to allowable loading is 2.0.
