U.S. NUCLEAR REGULATORY COMMISSION
REGION I

Report Nos. 50-387/89-37
50-388/89-36

Facility Name: Susquehanna Units 1 & 2

Meeting Topic: Susquehanna Emergency Diesel Generator Crankcase
Explosions of Cooper EDGs

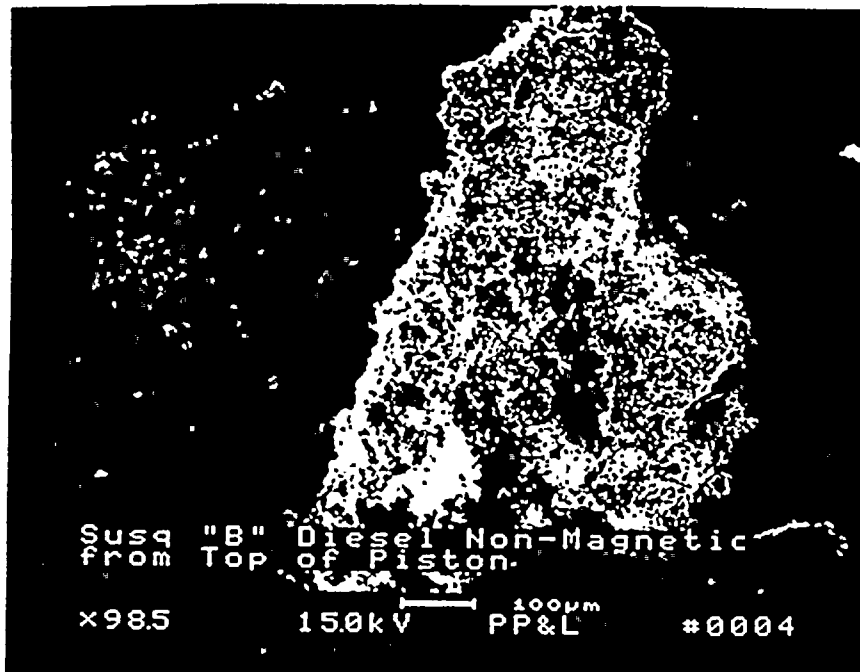
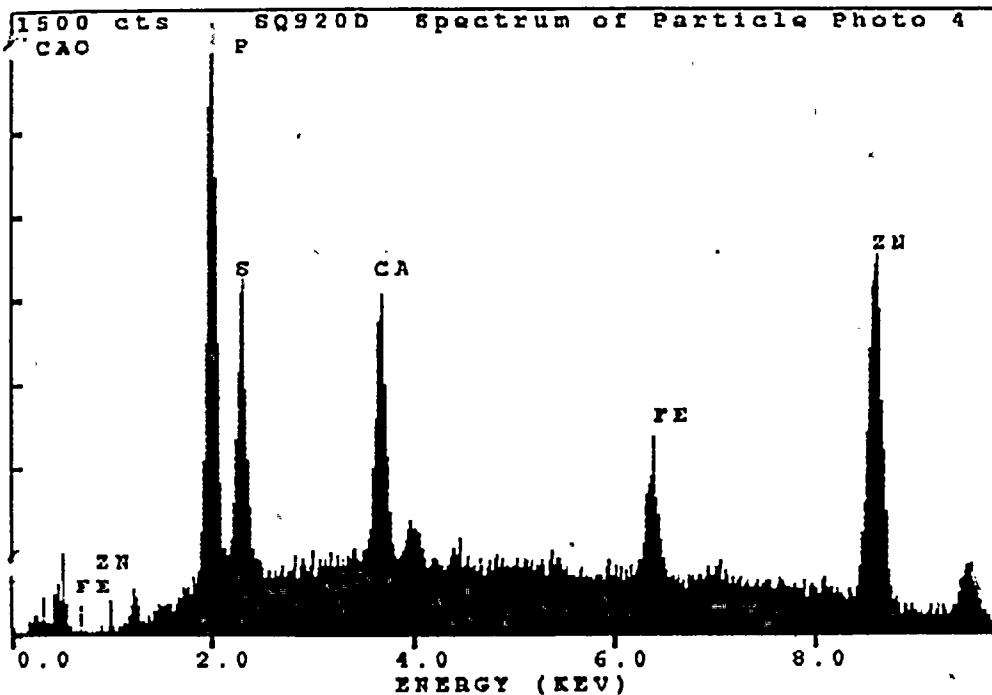
Figure B-4. Micrograph and EDS analysis results of non-magnetic debris taken from the head of the B diesel 7L piston.

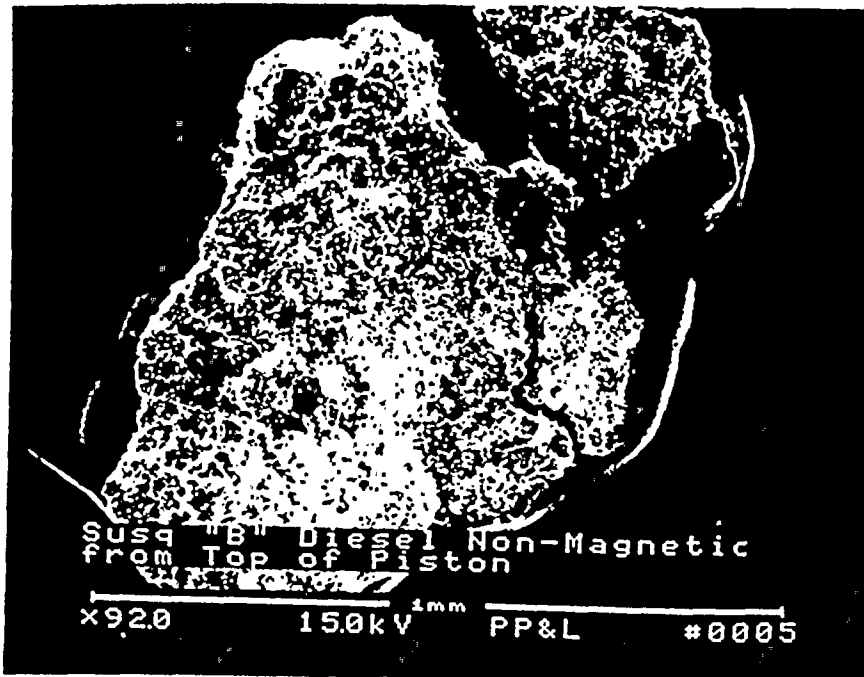
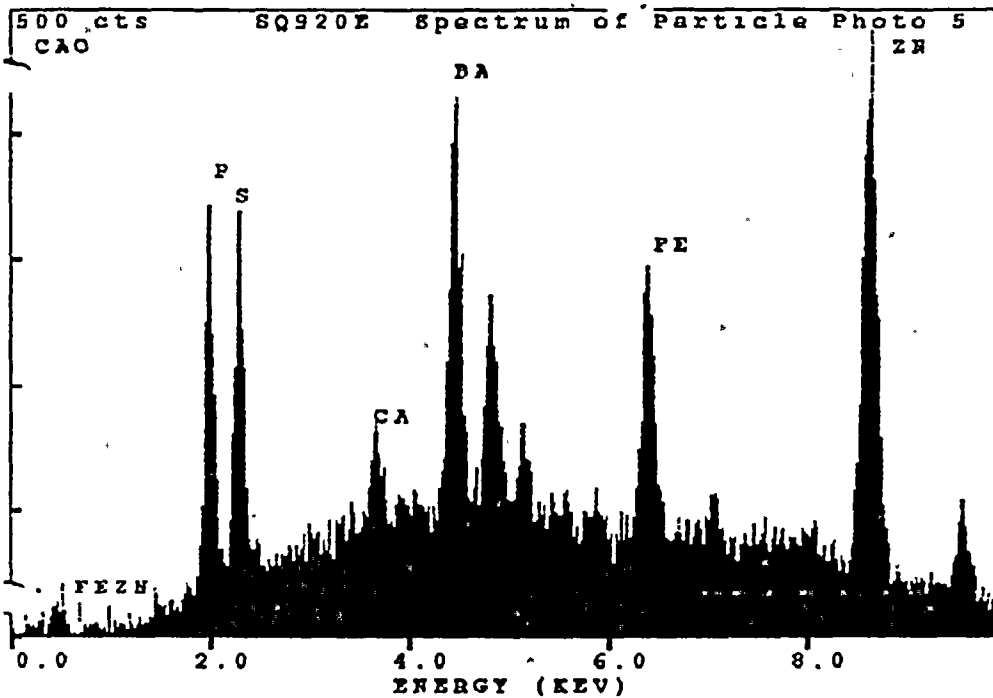
Figure B-5. Micrograph and EDS analysis results of non-magnetic debris taken from the head of the B diesel 7L piston on another particle from that analyzed in the figure B-4.

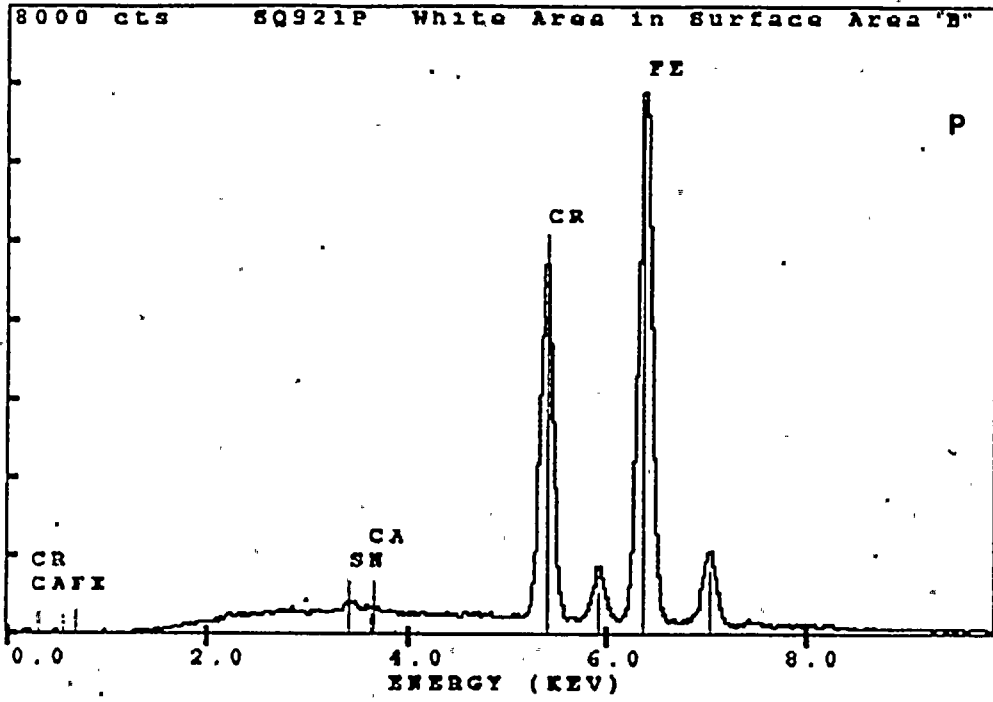
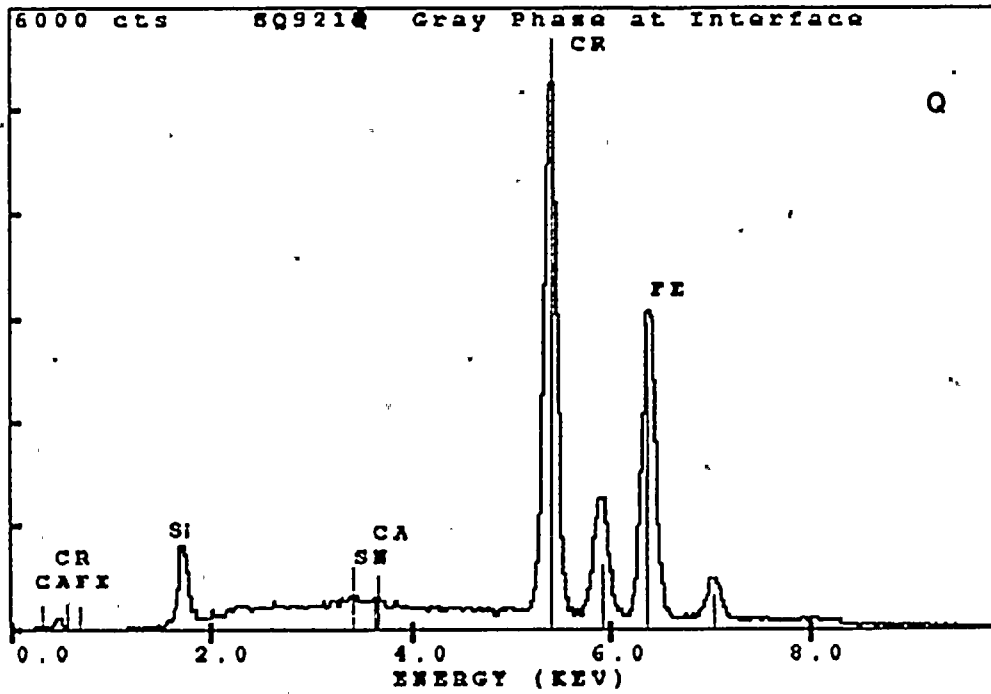
Figure B-8. EDS analysis of areas 'P' and 'Q' in figures B-7 and B-6.

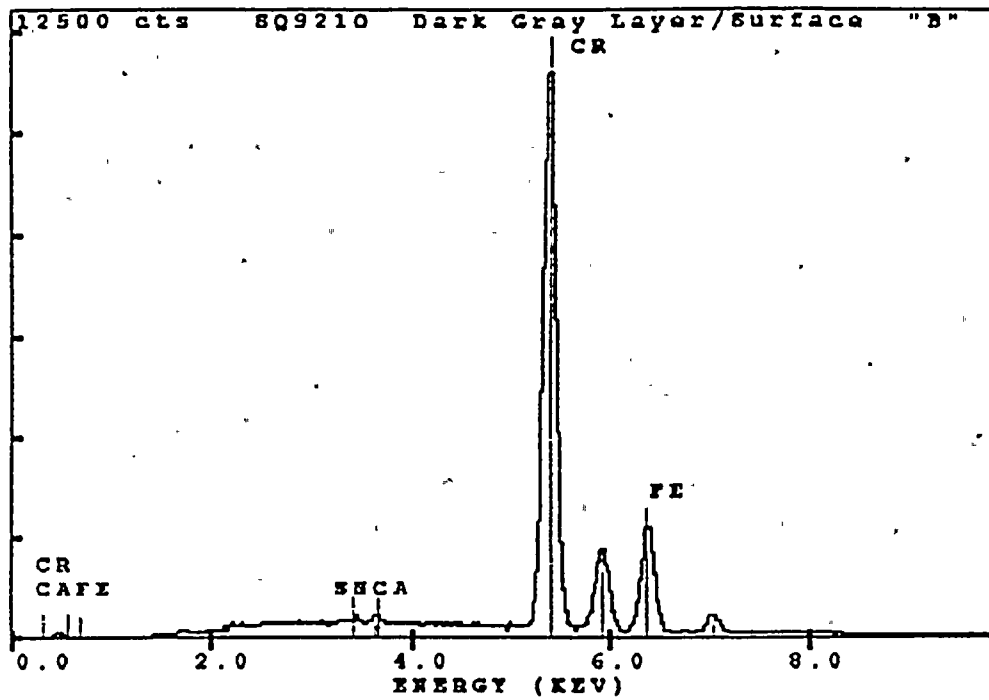
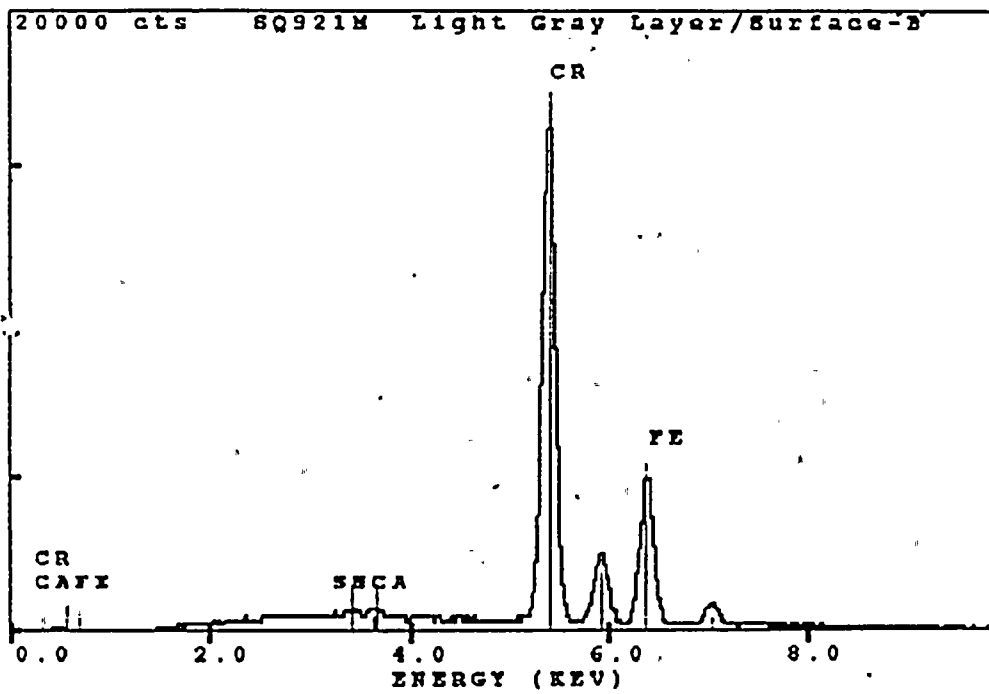
Figure B-9. Spectra of the light and dark phases in figure B-7.

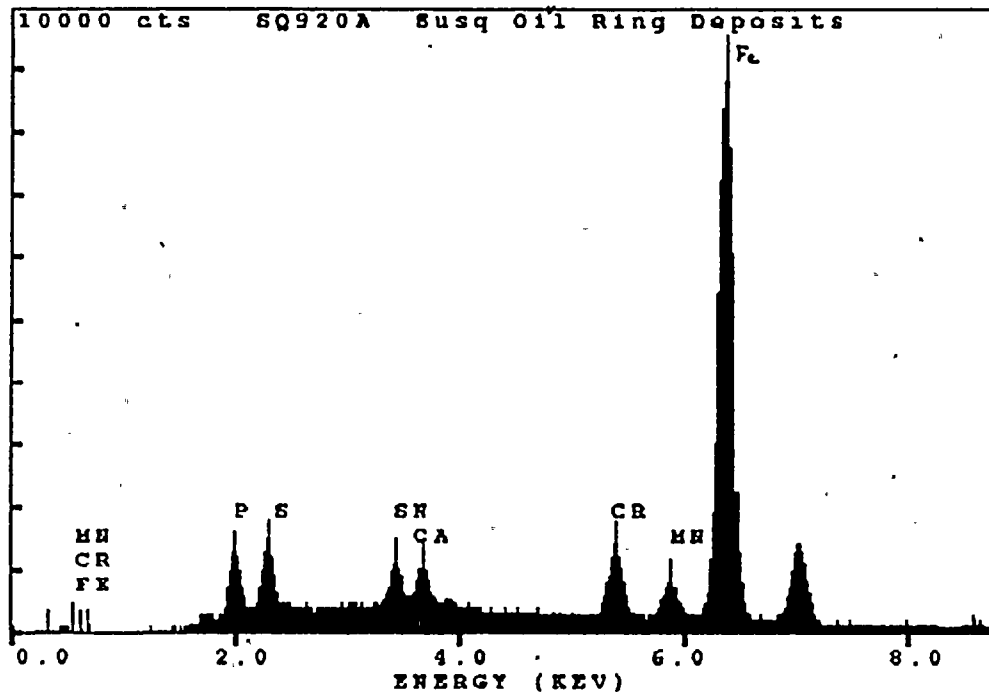
Figure B-14. Debris EDS analysis from the spring behind the lower oil ring from the B diesel 7L piston.

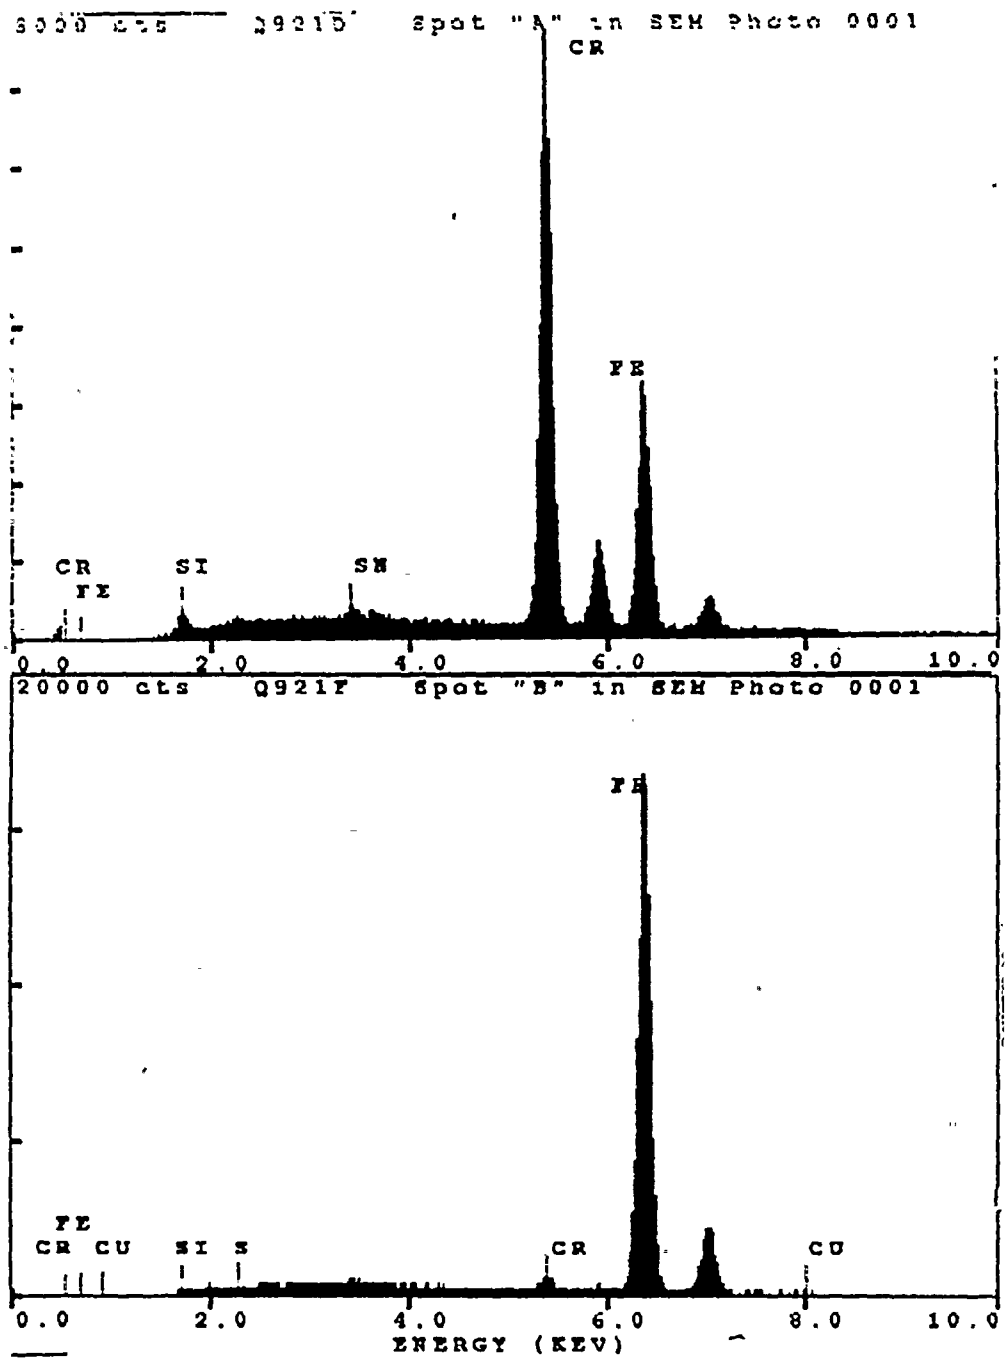
Figure B-15. Smeared metallic deposits found on the #4 compression ring of the B diesel, 7L piston are shown here as the dark gray area labeled 'A'. EDS analysis of area 'A' shows it to contain Cr, Fe, Si(trace) and Sn(trace). Area 'B' shows only Fe with a trace of Cr.

Figure B-16. EDS analysis of the #4 compression ring from the B diesel 7L piston in areas 'A' and 'B' of Figure B-15.

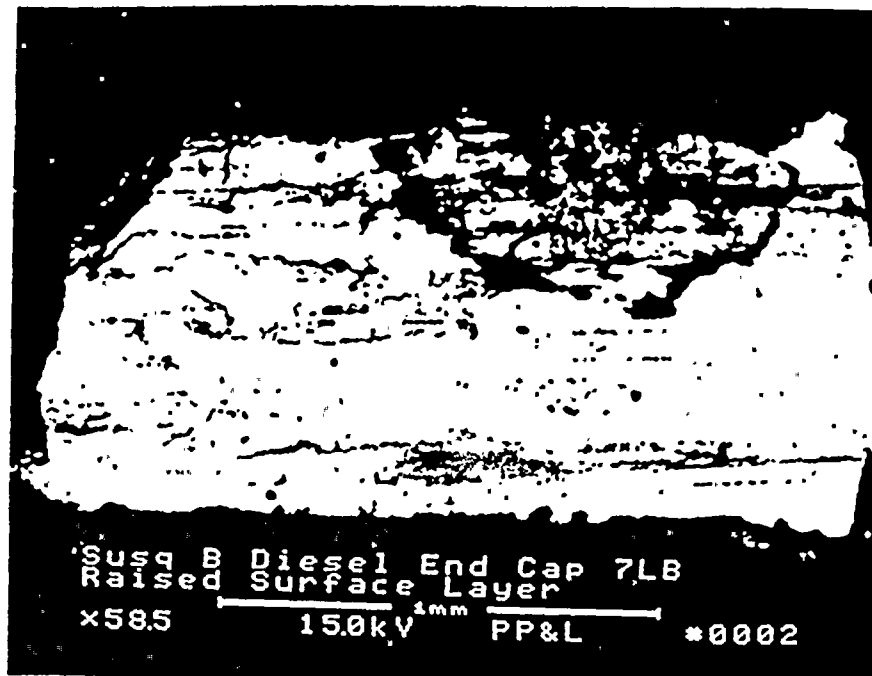
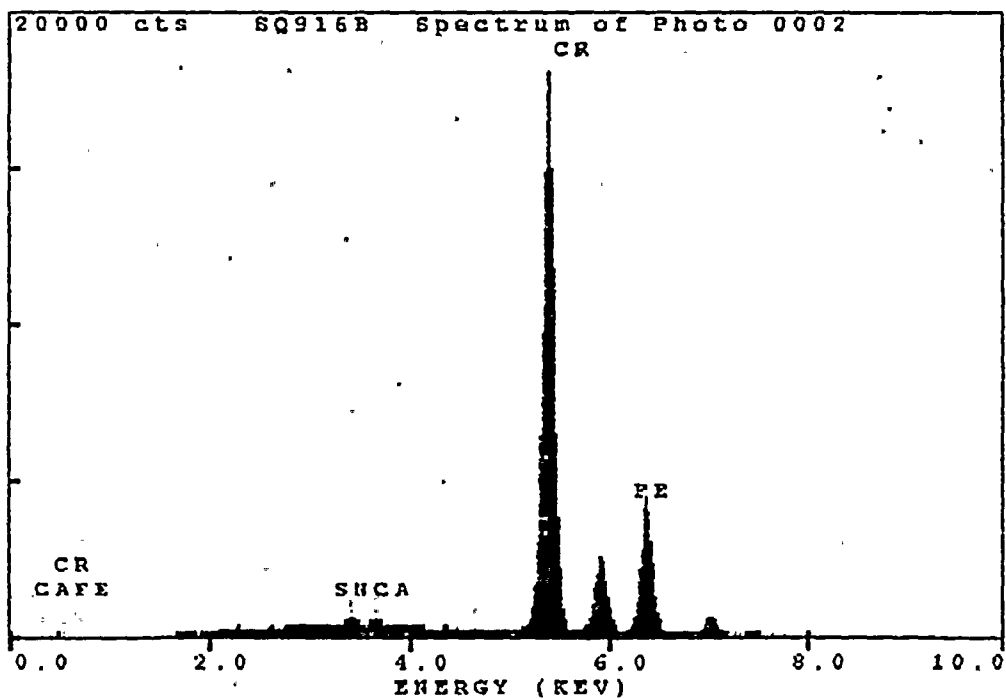
Figure B-20. Particle of smeared metal removed from pin end cap 'B' from the B diesel 7L piston. The EDS analysis shows that it consists primarily of Cr with some Fe and a trace of Ca and Sn.

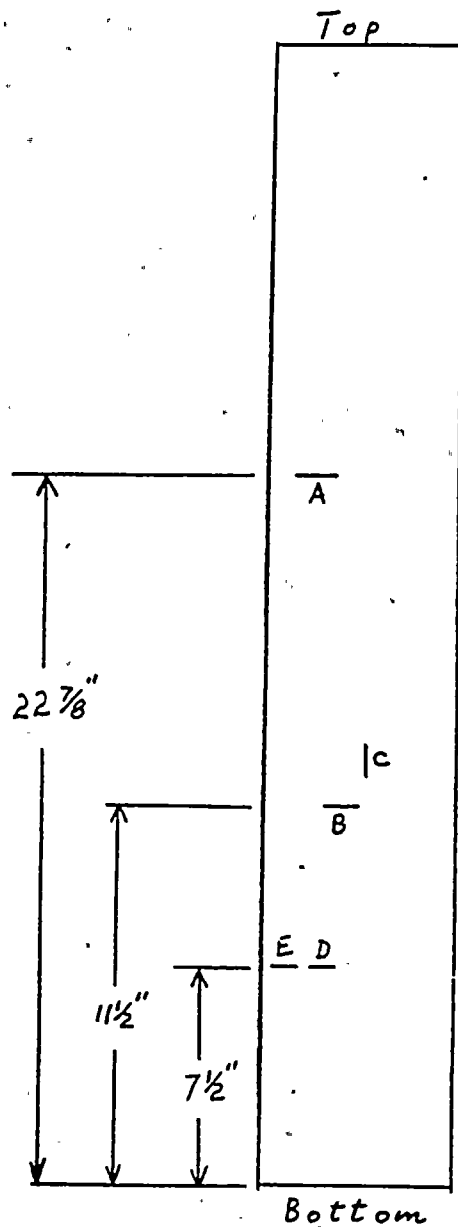
Figure B-26. Sketch of the thrust side of the B diesel 7L liner showing the location and orientation of the sections removed for metallurgical cross-sectioning (part labeled B-1).

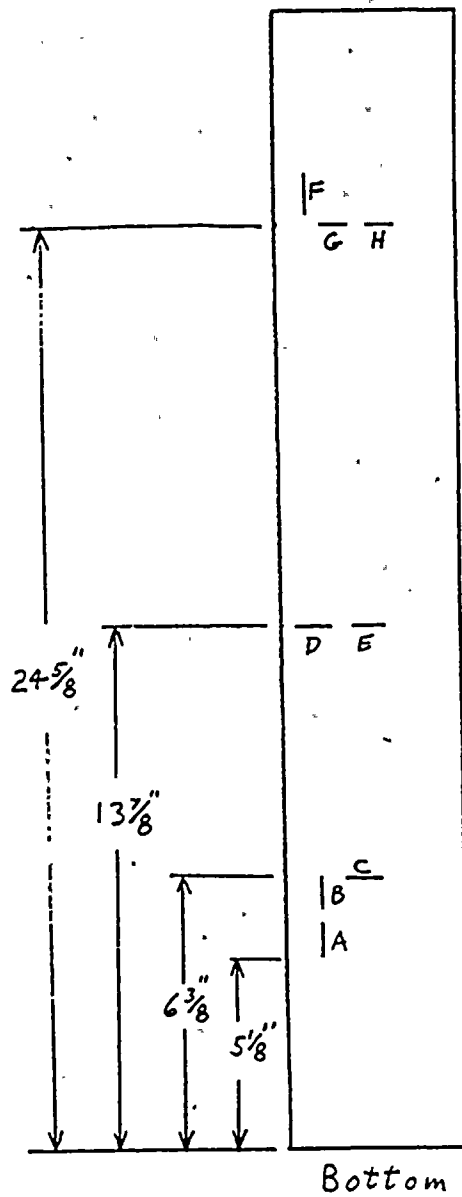
Figure B-33. Sketch of the end cap side of the 'B' diesel 7L liner showing the locations of the metallurgical samples taken for cross-sectional examinations (part labeled B-2).

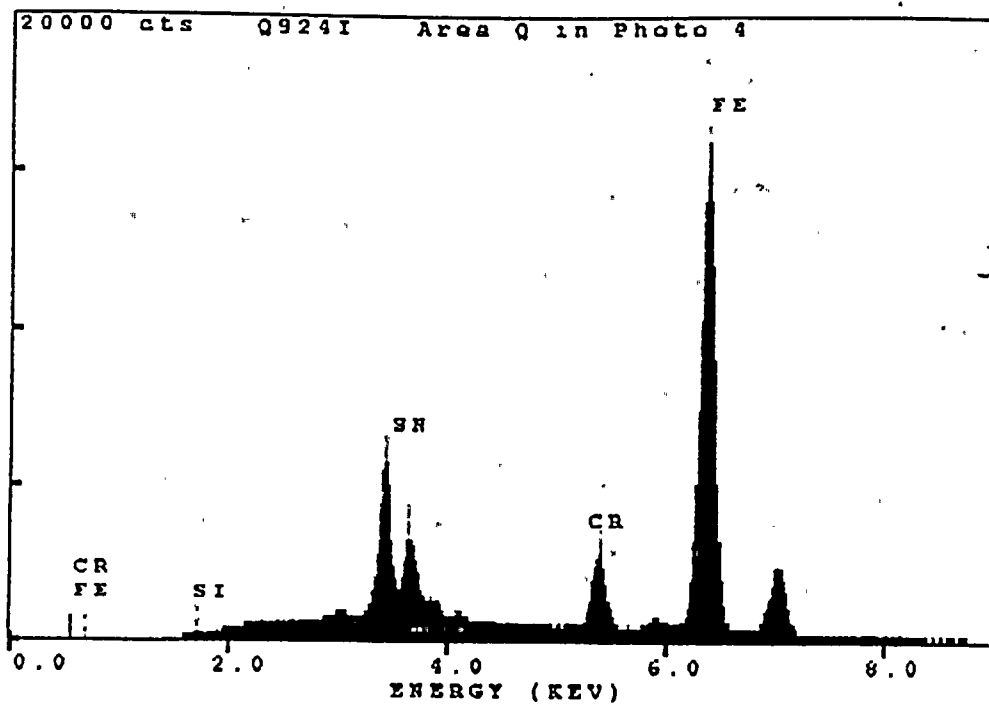
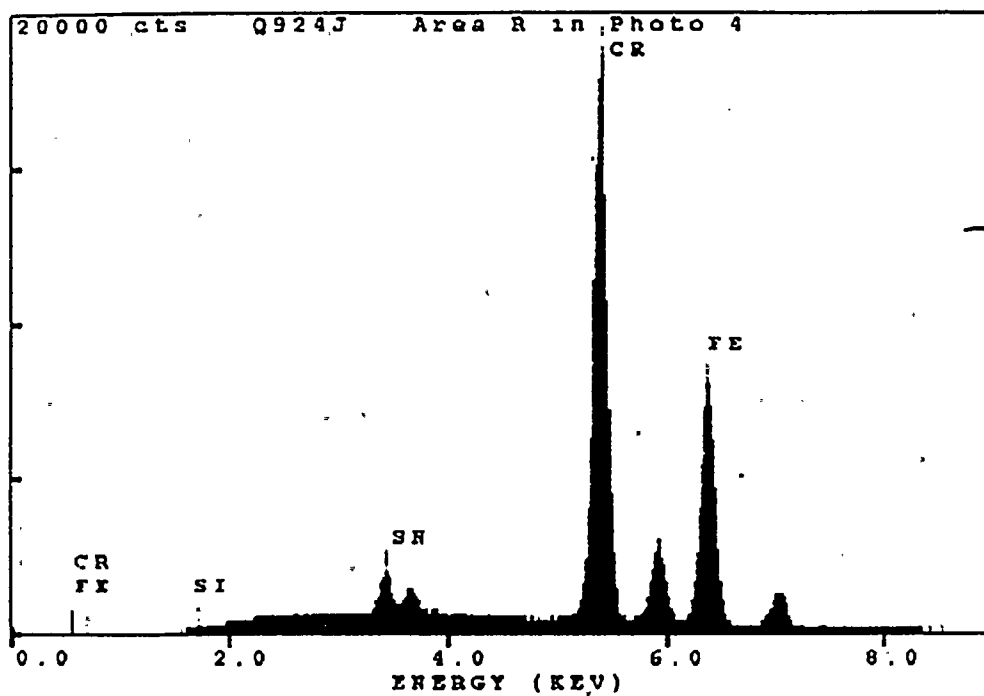
Figure B-36. EDS analysis of areas Q and R shown in figure B-35.

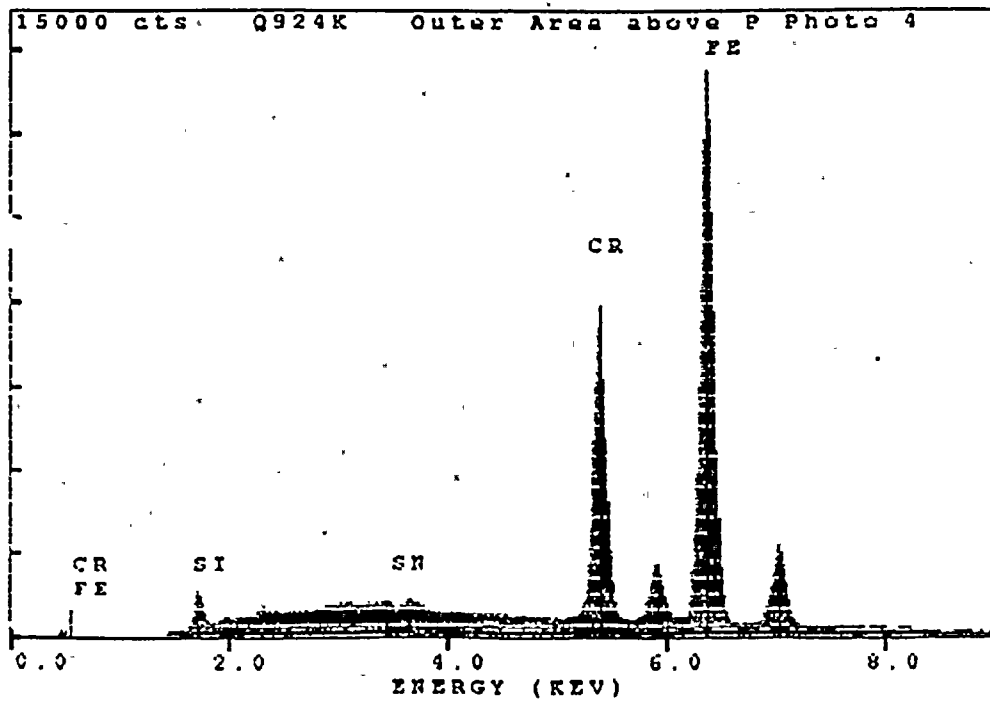
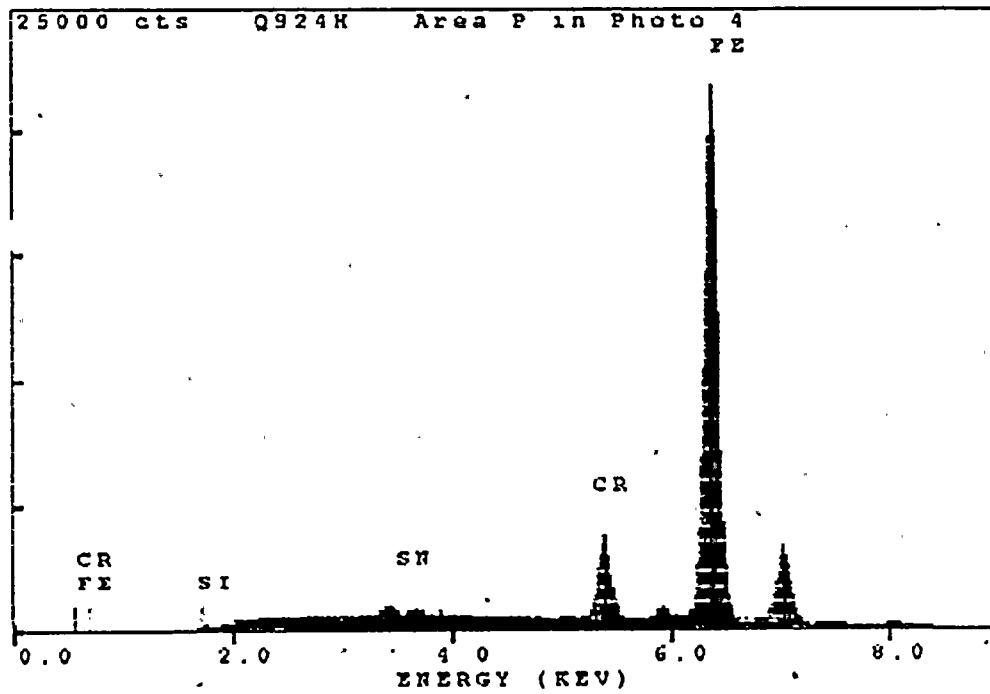
Figure B-37. EDS analysis of area P and the Dark layer above P in figure B-35.

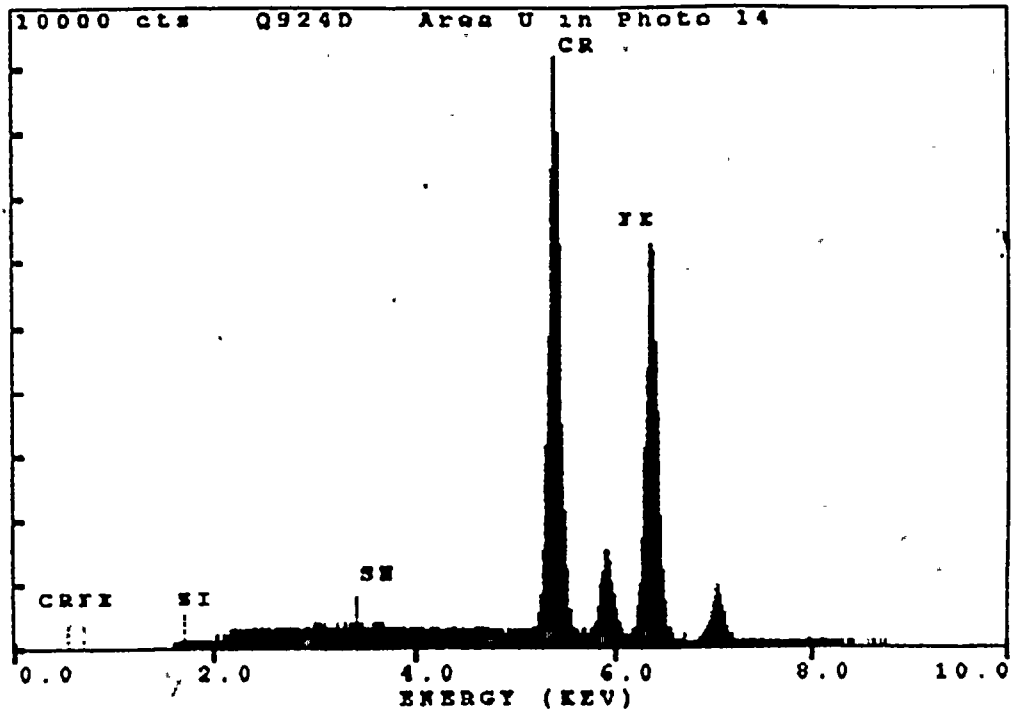
Area U: 10000 cts Q924D

Figure B-41. EDS analysis of areas U and W shown in figure B-40.

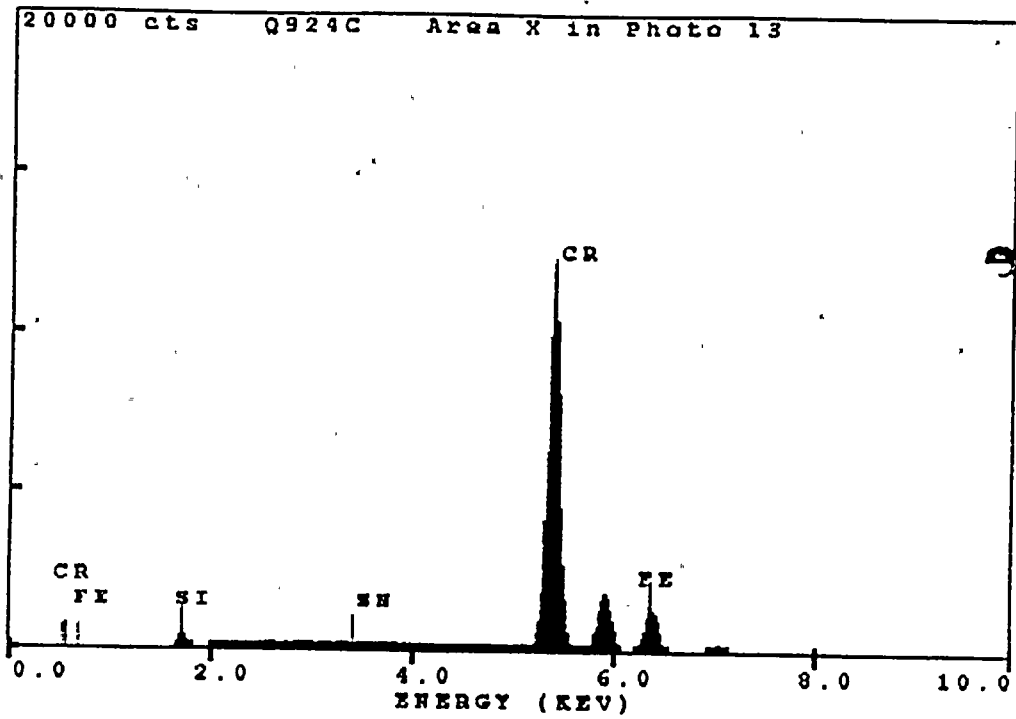
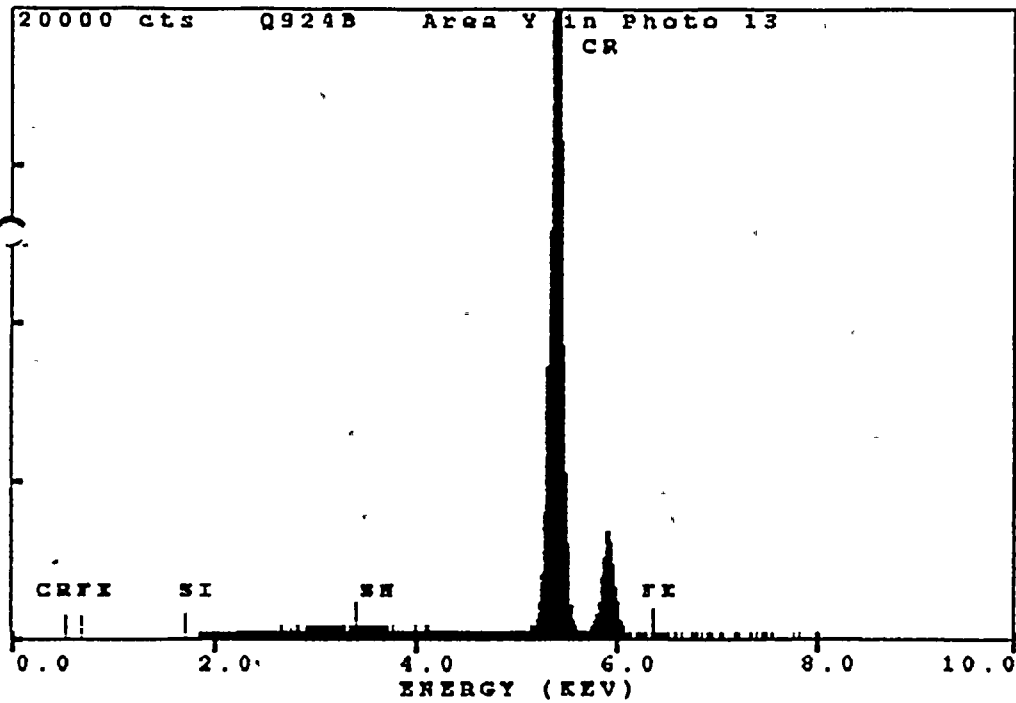
Figure B-42. EDS analysis of areas x and y shown in figure B-41.

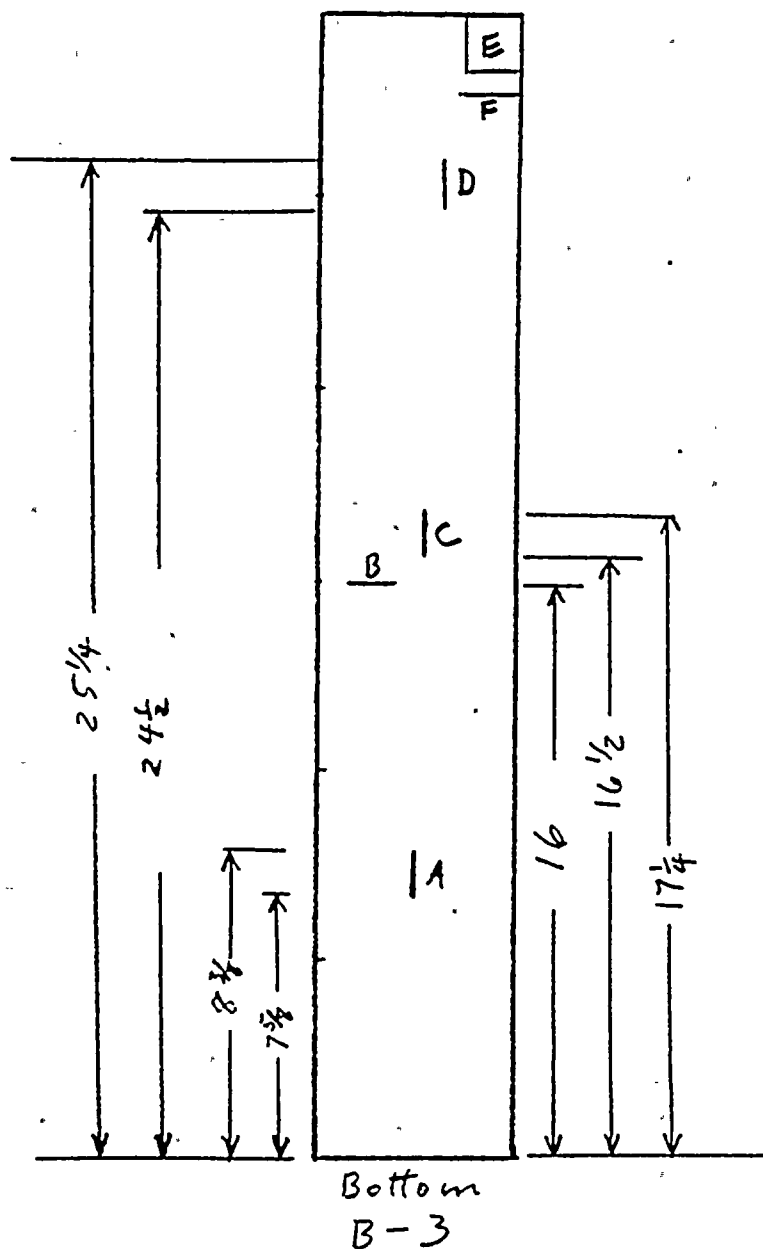
Figure B-45. Sketch of the non-thrust side of the B diesel 7L liner (designated B-3), showing the location and orientation of the metallurgical sections A, B, C, D, E, and F. Section E was for surface examinations, while the others were for cross-sections.

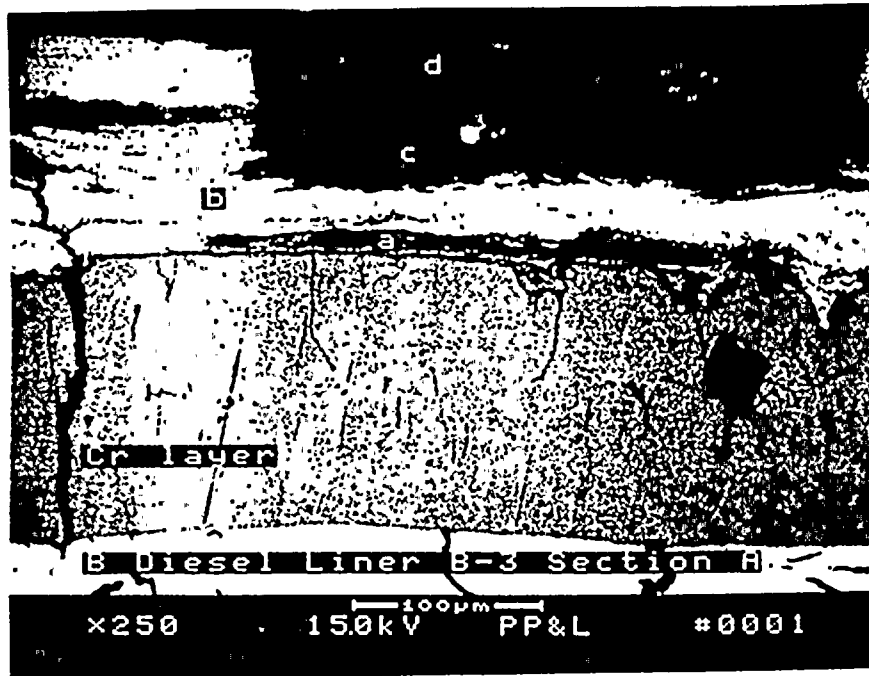
Figure B-46. Longitudinal section of the B diesel 7 L liner taken from an area 7 5/8 to 8 3/8 inches from the bottom. EDS analysis results are shown in figures B-47 and B-48.

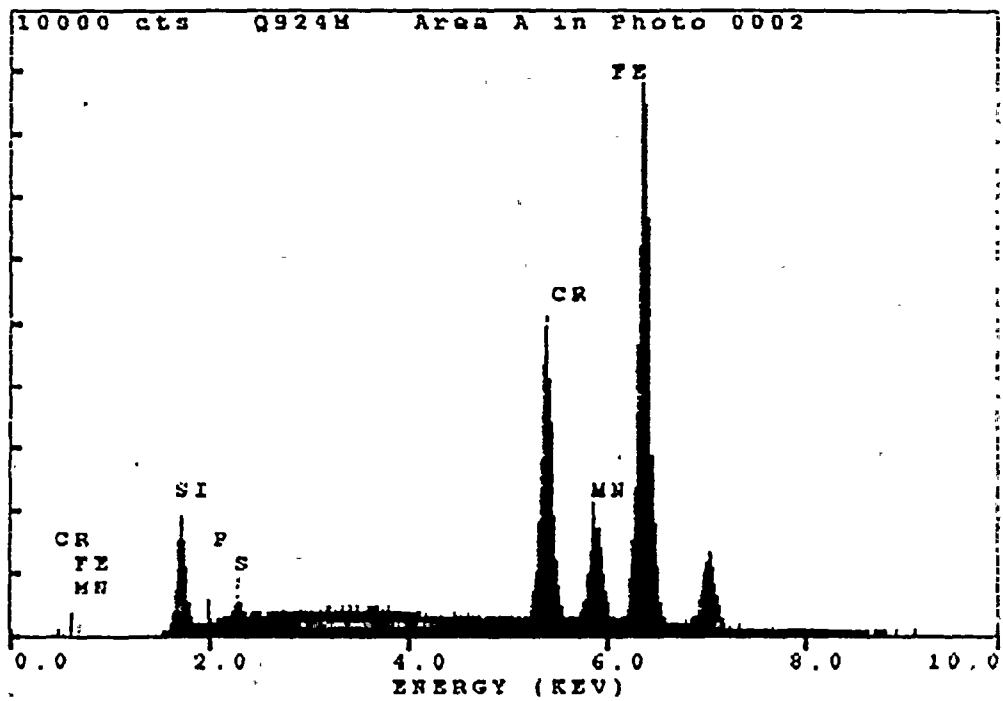
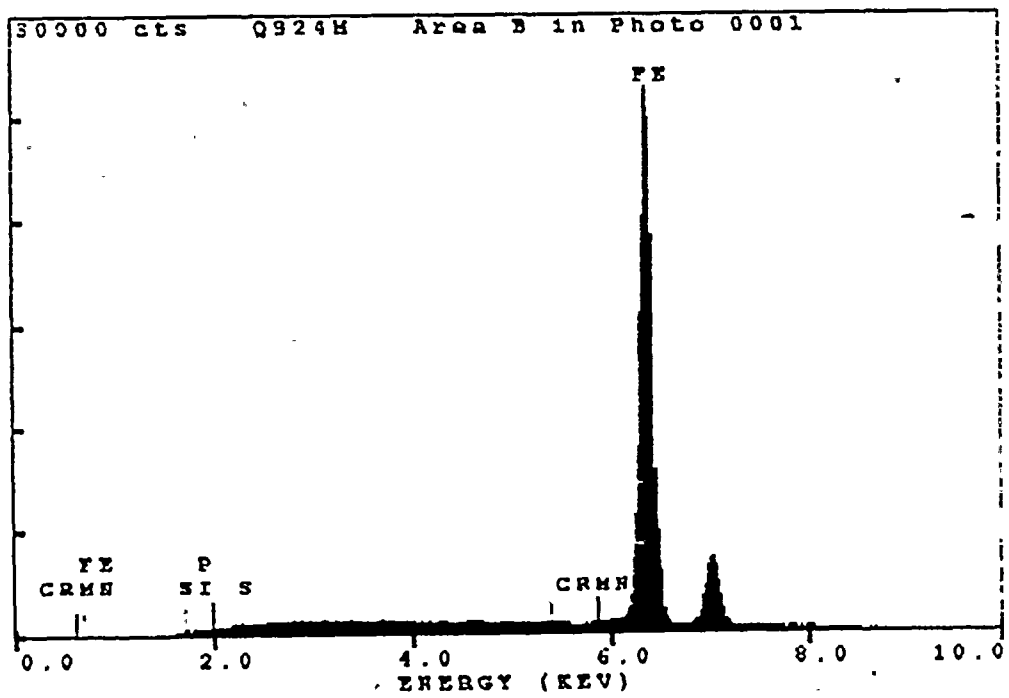
Figure B-47. EDS analysis of areas a and b in figure B-46.

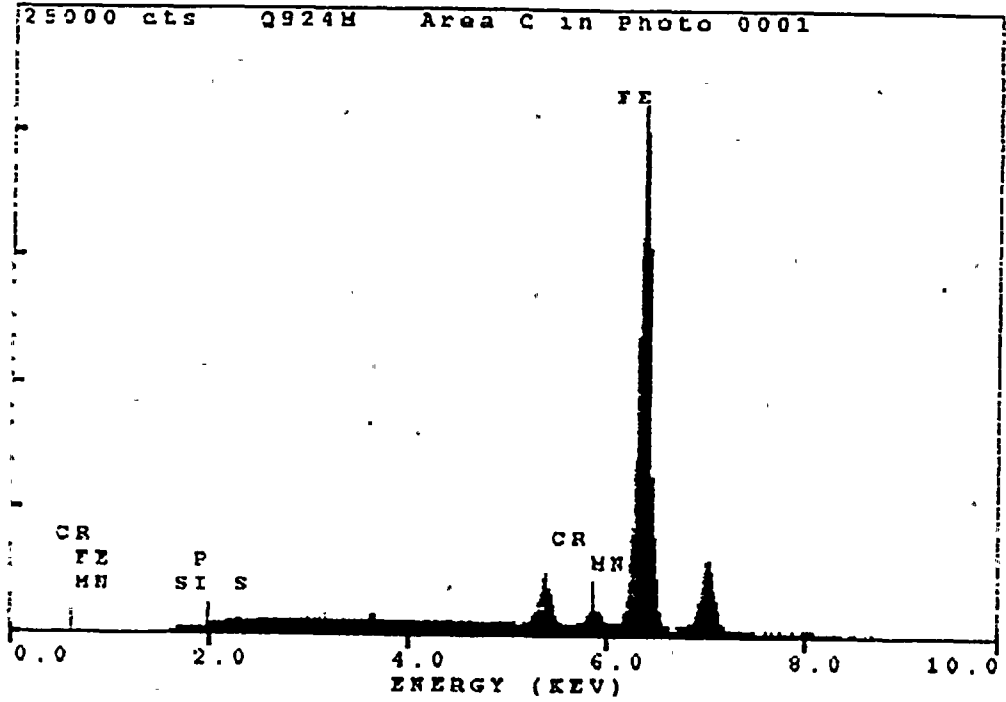
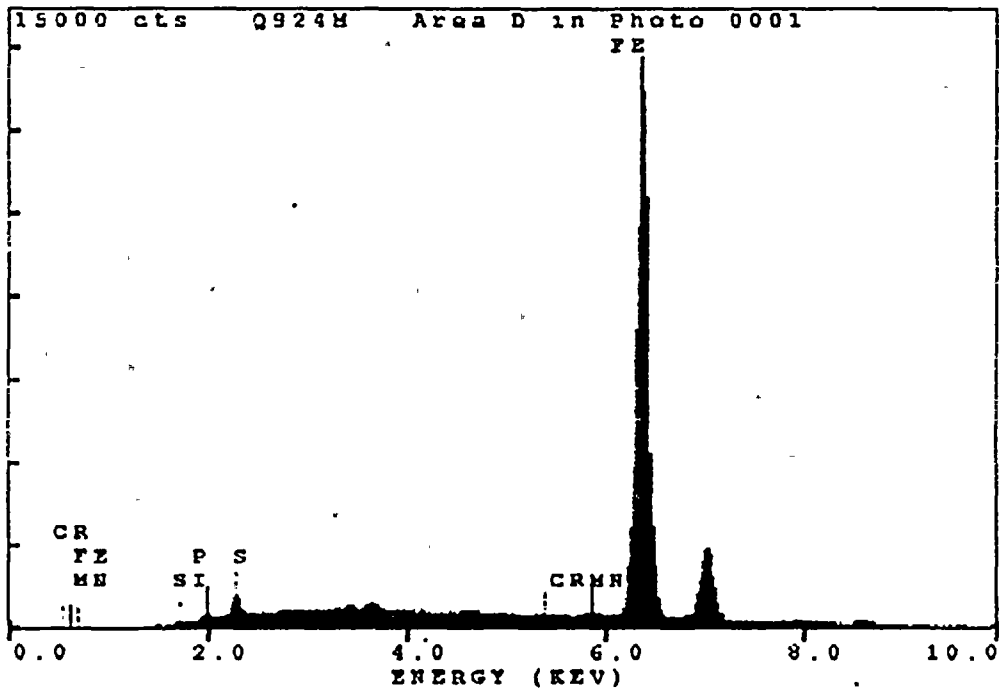
Figure B-48. EDS analysis of areas c and d in figure B-46.

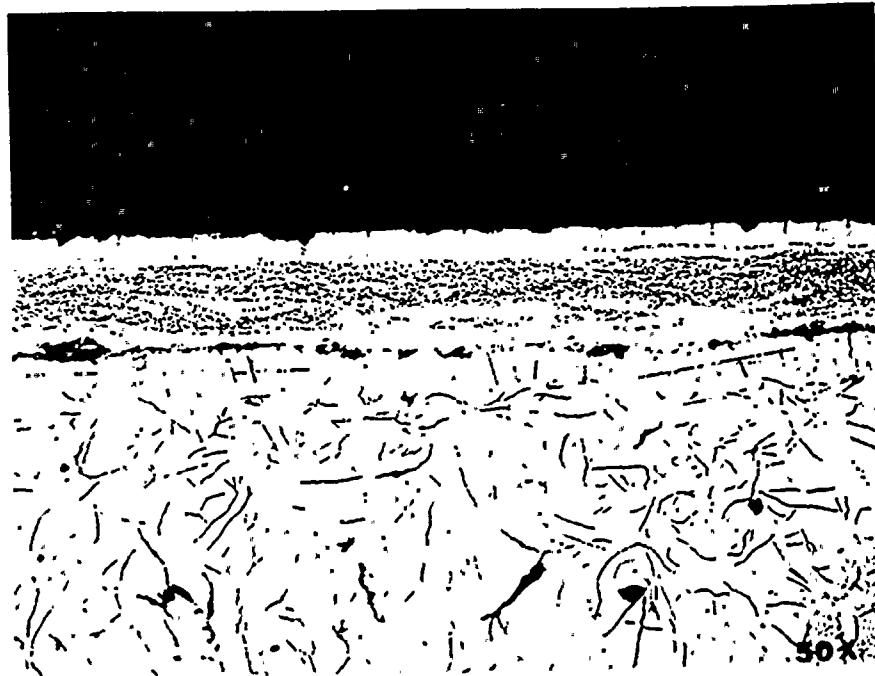
Figure B-51. Longitudinal cross-section of the B diesel 7L liner taken 7 5/8 inches from the bottom showing a very thick layer of metallic deposits covering the chromium plating.

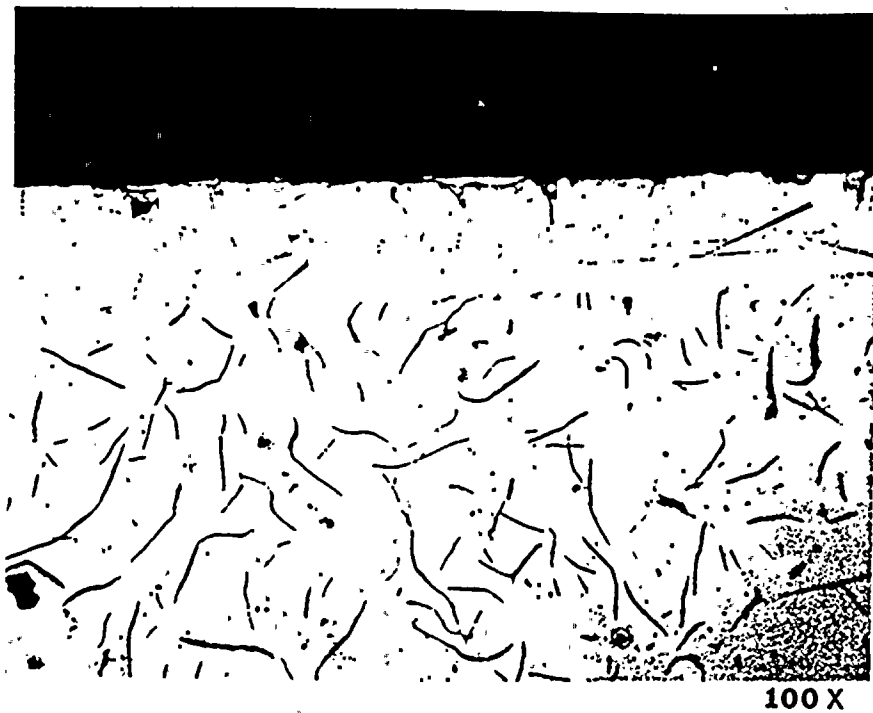
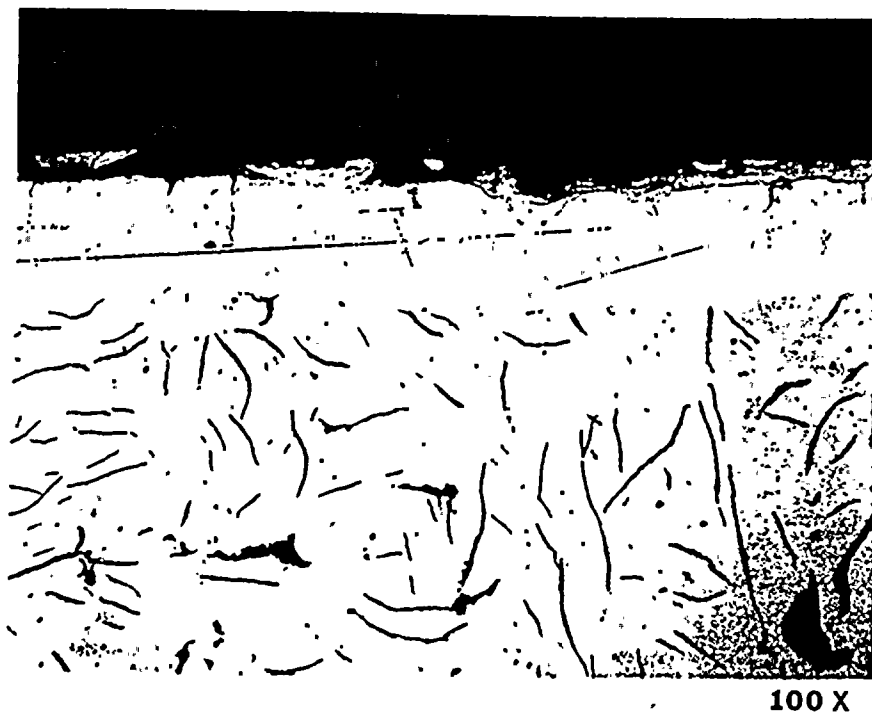
Figure B-52. Transverse cross-section of a typical area of the non-thrust side of B diesel 7L liner 16 inches from the bottom (B-3 area B) showing the filled pores and the deposited metal from this location.

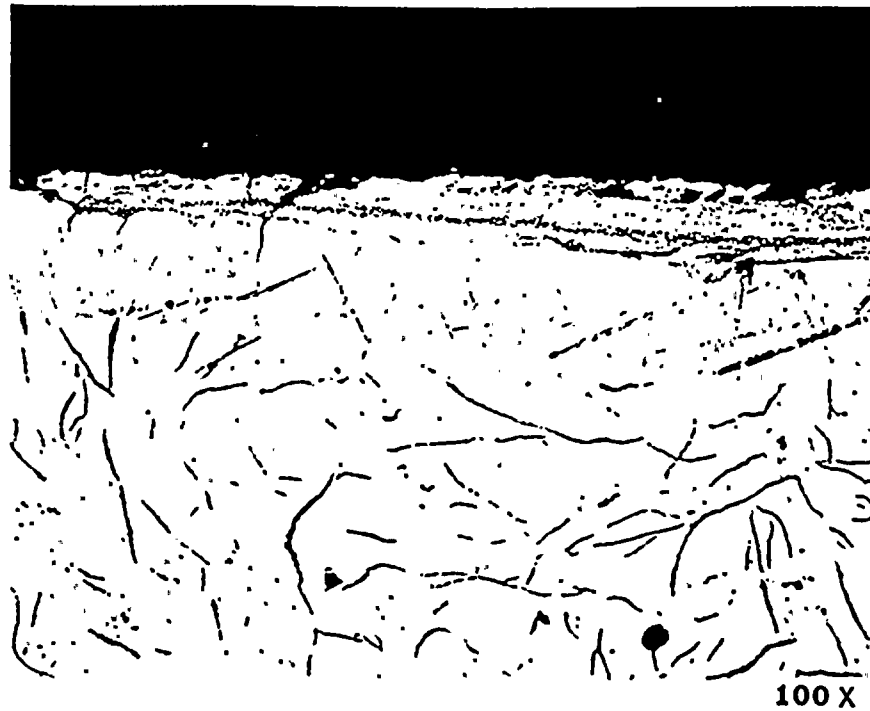
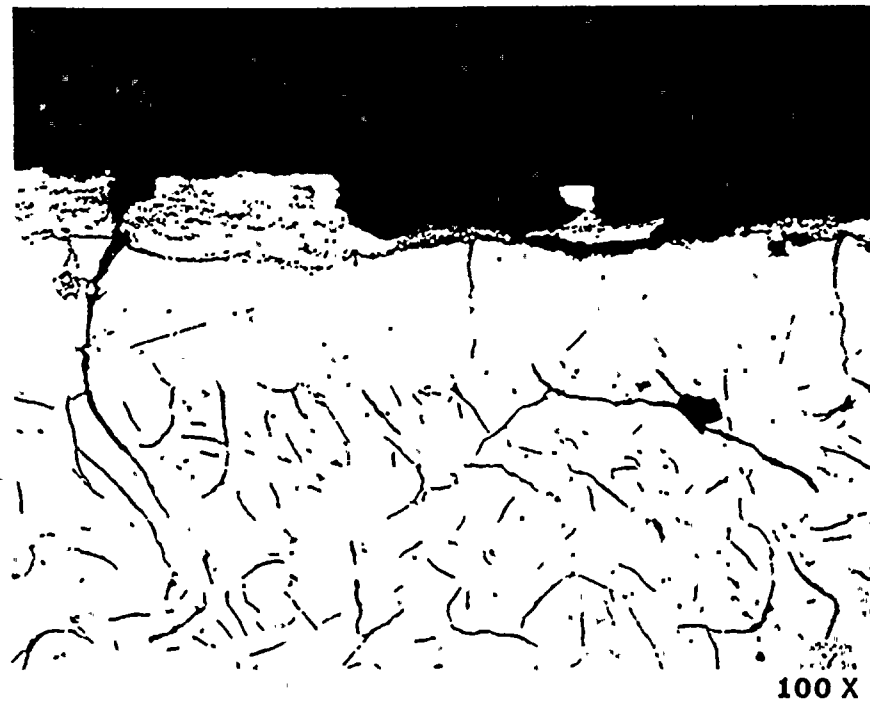
Figure B-53. Longitudinal cross-section of the non-thrust side of the B diesel 7L liner taken 16.5 inches from the bottom of the liner. Typical examples of the metal deposited from the piston and rings on the Cr plating.
